RHOOSE PRIMARY SCHOOL, VALE OF GLAMORGAN: HISTORIC ENVIRONMENT STATEMENT

Prepared by Dyfed Archaeological Trust
For: AECOM

RHIF YR ADRODDIAD / REPORT NO. 2019/40

HISTORIC ENVIRONMENT STATEMENT

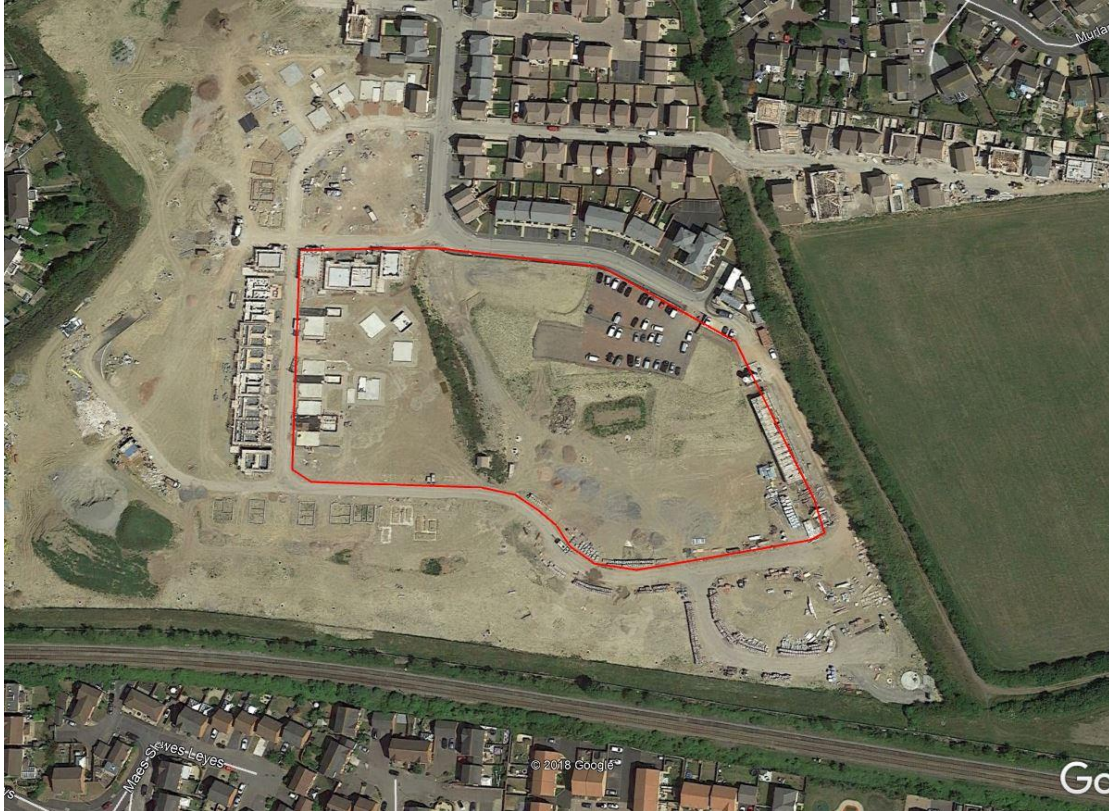
from June 2018 and shows the entire area as having been stripped with development already completed to the northeast of the school site and underway to the west. A surfaced parking area is located in the northeastern part of the school site.

Figure 2: Aerial image of the site area from Google maps with the school site area overlaid in red (image supplied by AECOM)

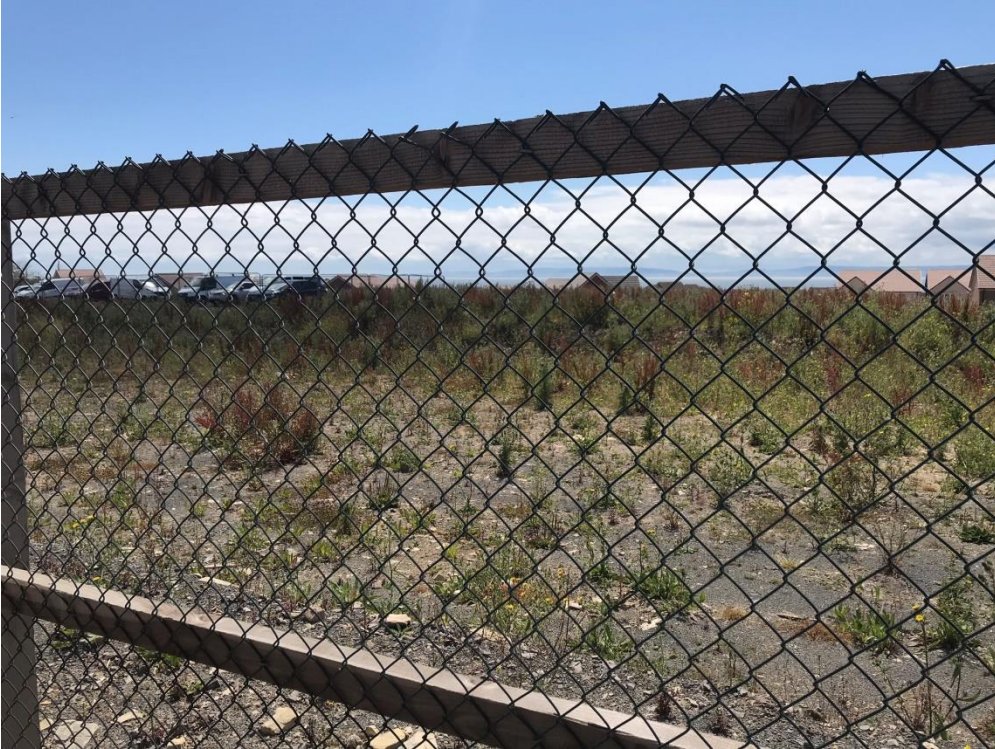
- 4.7 Based on the evidence from the aerial photographs a brief site visit was undertaken on the 7th July 2019 to determine the present state of the site area. It was clear that most of the residential development has been completed and that the site for the proposed Rhoose Primary School remains fenced off and undeveloped. It was also clear from the site visit and aerial photographs that the entire site area has been topsoil stripped and tracked over, as well as having been used for storage of materials including stone chippings. Vegetation is starting to grow back, as the area remains undeveloped but this was patchy and sparse growing through the rough underlying surface.

Photo 1: View across the fenced school development area, viewing southeast

- 5.1.2 The proposed school development site has been subject to previous topsoil stripping as well as other ground disturbance through the laying of vehicle routes for plant traffic and parking areas for site contractors. The ground surface appears to be barren, with only some sparse vegetation growing after the topsoil strip. It has evidently been driven over and seems to have been used for storage of materials for the surrounding residential developments. It is possible some landscaping has occurred, but the extent of this is not known.

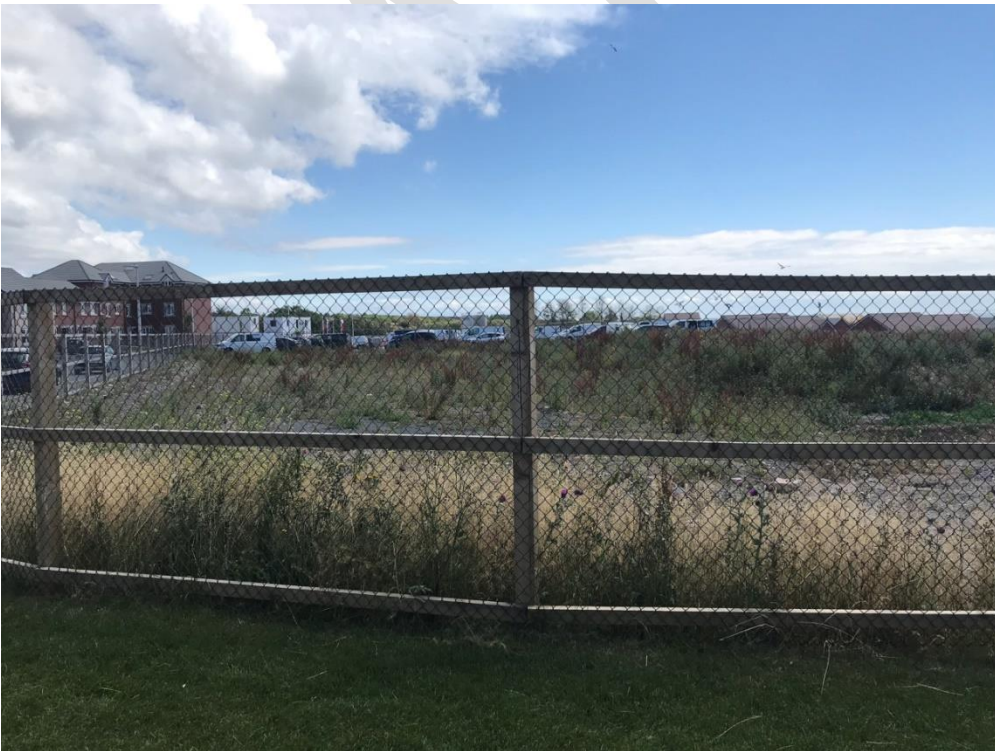
Photo 2: View east across northern part of proposed school development site showing contractor parking area on its northeastern side

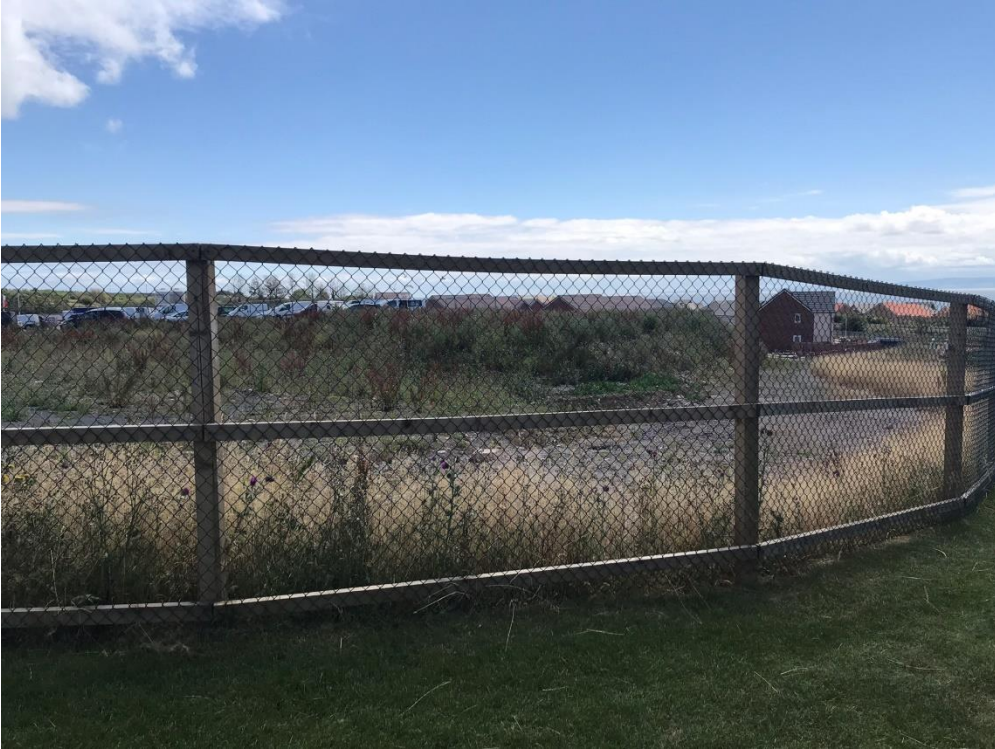
Photo 3: View south across western side of area showing former vehicle route around perimeter of school site
