PROJECT:
COSMESTON FARM,
PENARTH

FIGURE 2:
GEOLOGICAL INSPECTION OF
CLIFFLINE AND FOOTPATH

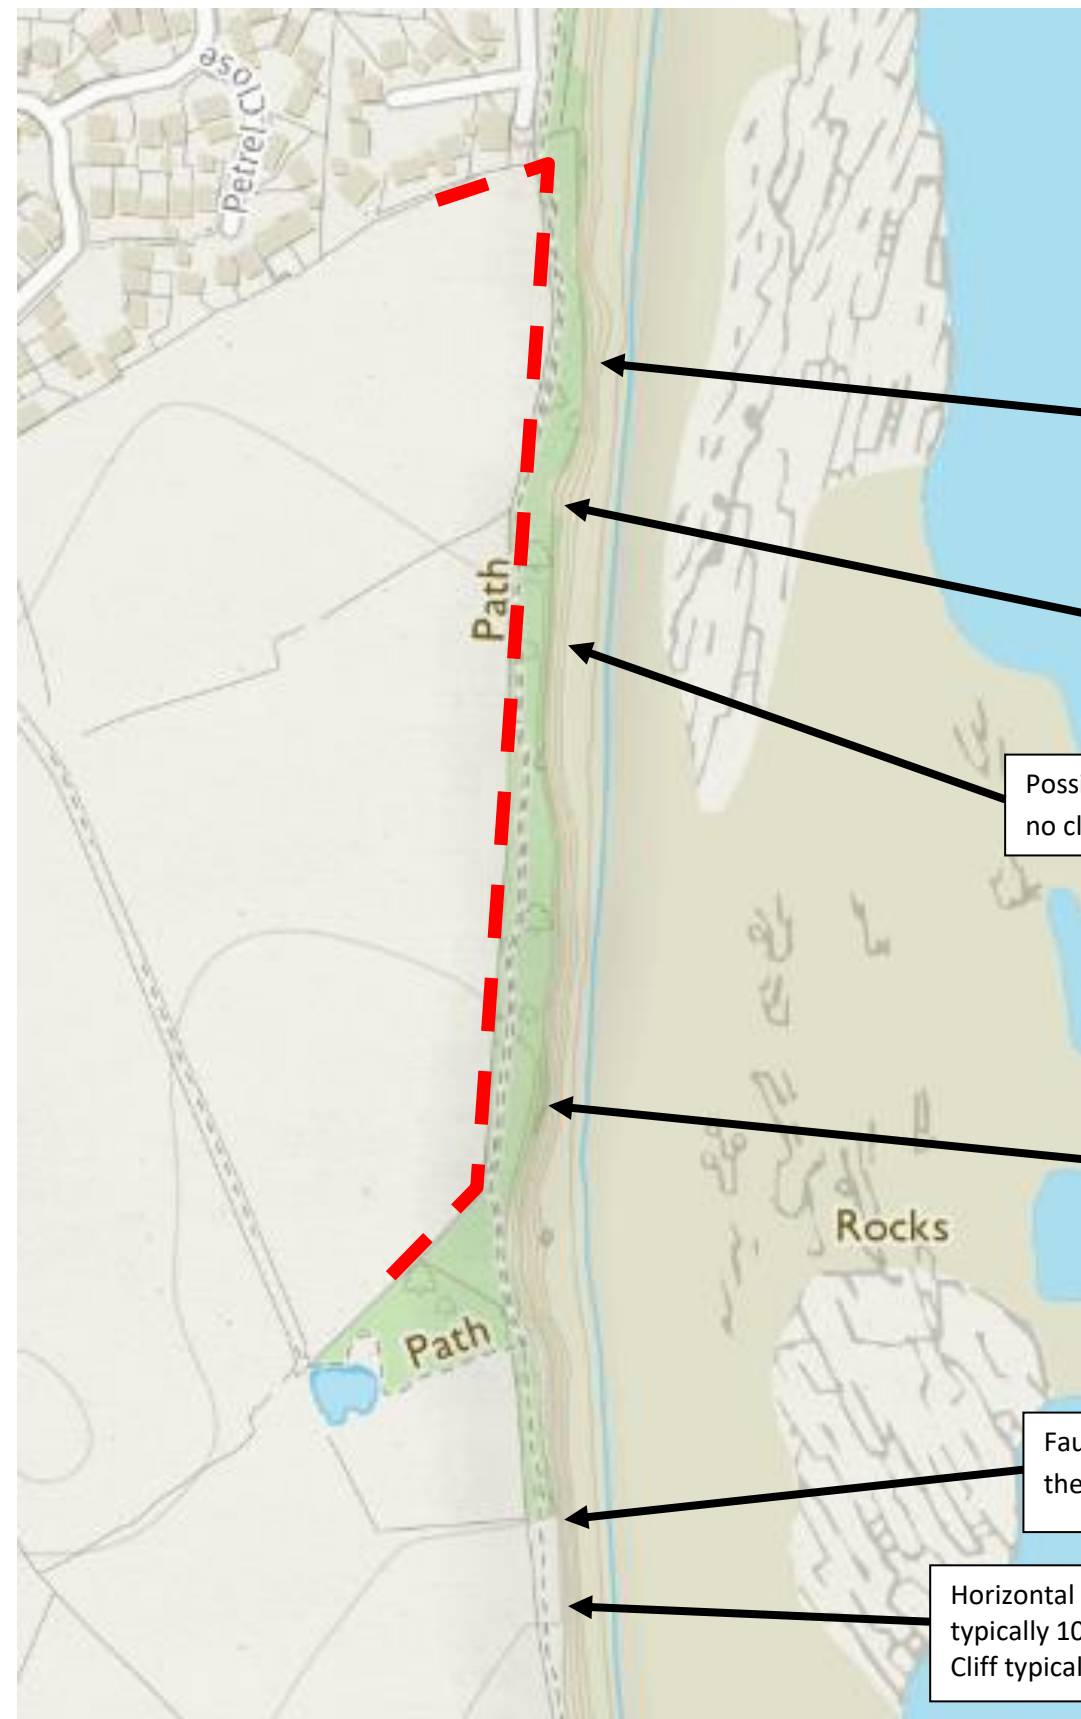
Horizontal bedding in Blue Anchor Formation and Penarth Group. Beds typically 100-300mm thick. Fault pairs and downthrown blocks evident. Minor undercutting at base of cliff. Cliff typically standing at around 80-degrees.

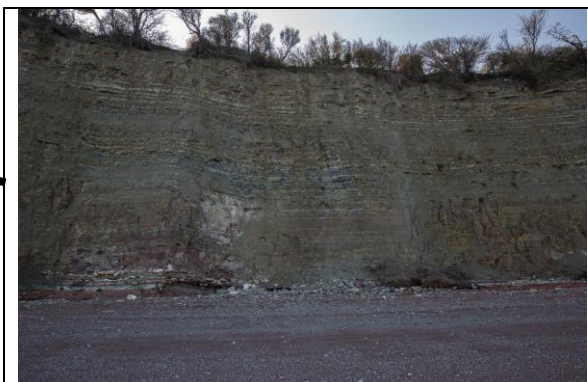
Horizontal bedding in Blue Anchor Formation and Penarth Group. Beds typically 100-300mm thick. More frequent blocks around 0.1m in size with minor falls collecting at cliff base. Cliff typically standing at around 80-degrees.

Possible Fault 310/85w, no clear displacement.
