**WELSH GOVERNMENT**

**COSMESTON**

**GREAT CRESTED NEWT SURVEY REPORT**

**AUGUST 2018**

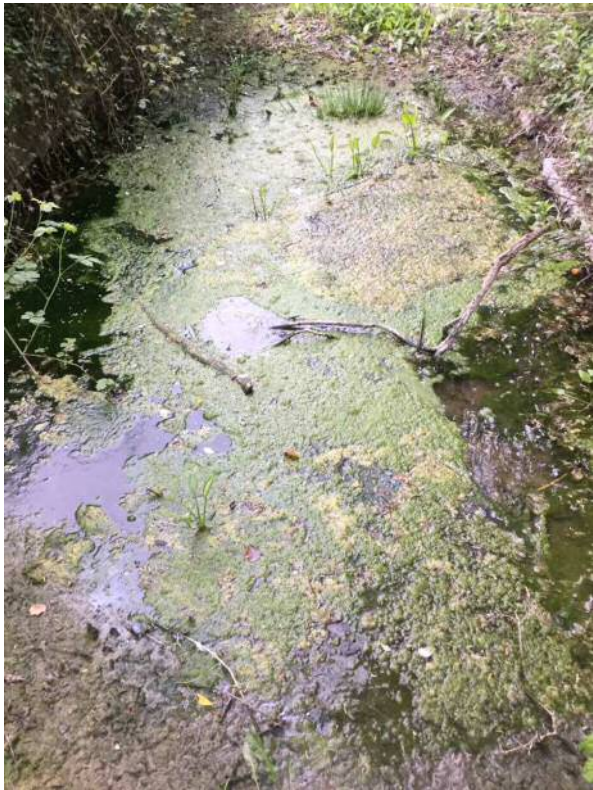
Reference	Pond Description	Photograph
1	<p>Very shallow, small pond surrounded by woodland and scrub. Has steep banks &gt; 45 degrees covered in bramble scrub. Algae mat covering pond.</p> <p>Photo taken 25<sup>th</sup> April 2017.</p>

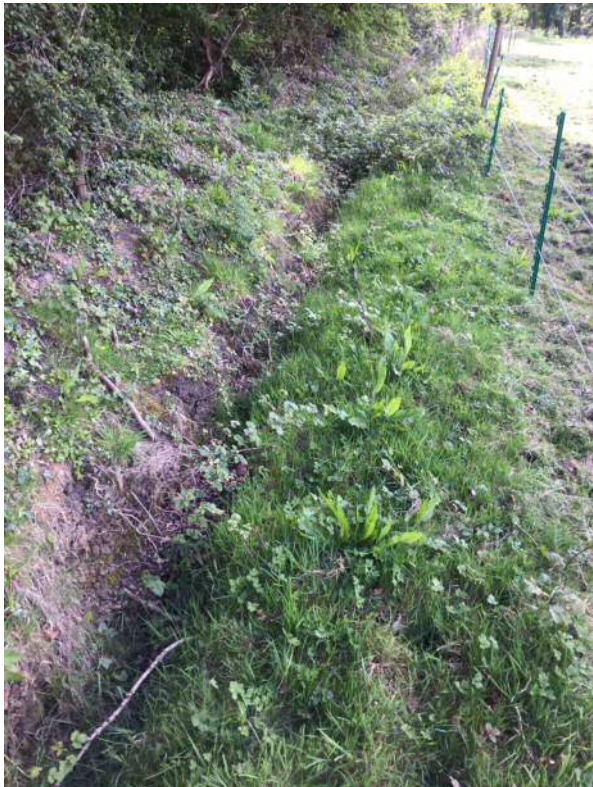
2	<p>Dry field ditch adjacent to woodland.</p> <p>Photo taken 25<sup>th</sup> April 2017.</p>

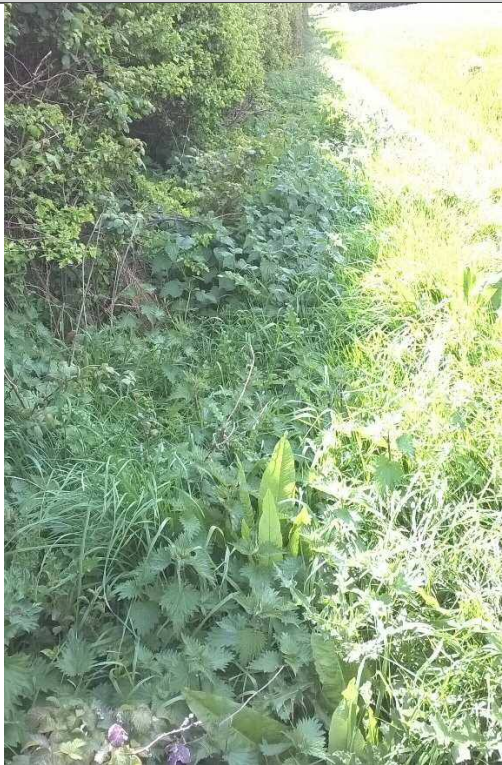
Reference	Pond Description	Photograph
3	<p>Overgrown dry ditch.</p> <p>Photo taken 25<sup>th</sup> April 2017.</p>

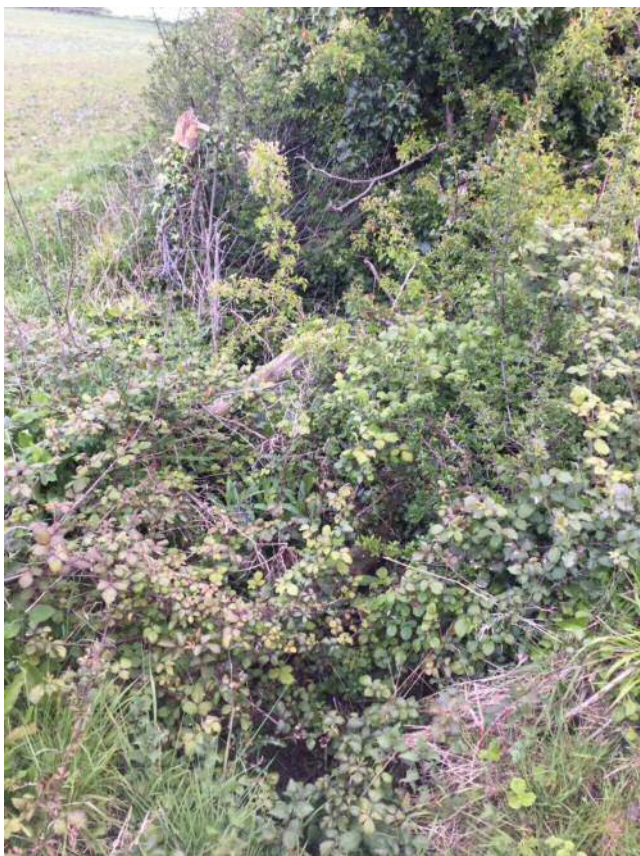
4	<p>Dry, overgrown field ditch adjacent to hedgerow.</p> <p>Photo taken 25<sup>th</sup> April 2017.</p>

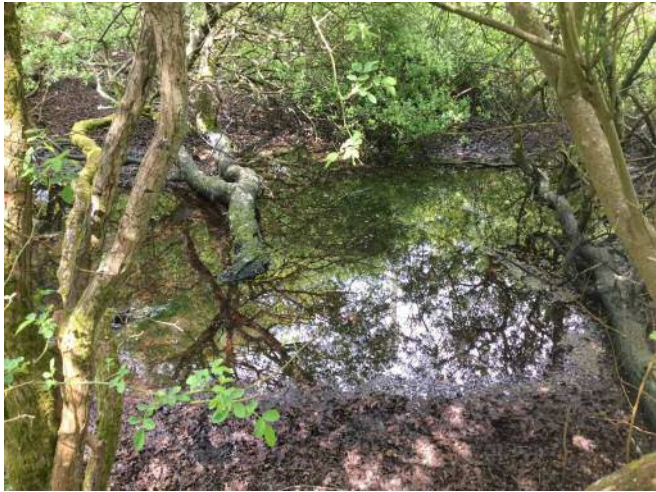
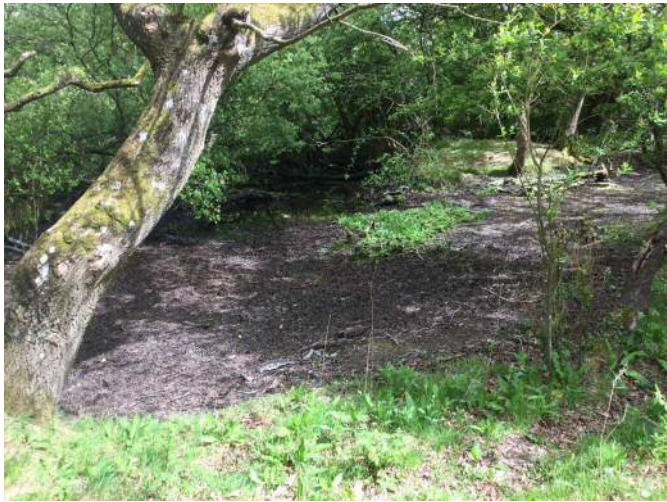
Reference	Pond Description	Photograph
5	<p data-bbox="355 248 660 421">Small woodland pond, with soft ground around small patch of water. &lt; 45 degree shallow bank.</p> <p data-bbox="355 488 619 566">Photo 1 taken 25<sup>th</sup> April 2017.</p> <p data-bbox="355 880 611 958">Bankside vegetation of mature trees.</p> <p data-bbox="355 1025 619 1104">Photo 2 taken 25<sup>th</sup> April 2017.</p>	<p data-bbox="699 248 715 271">1</p>

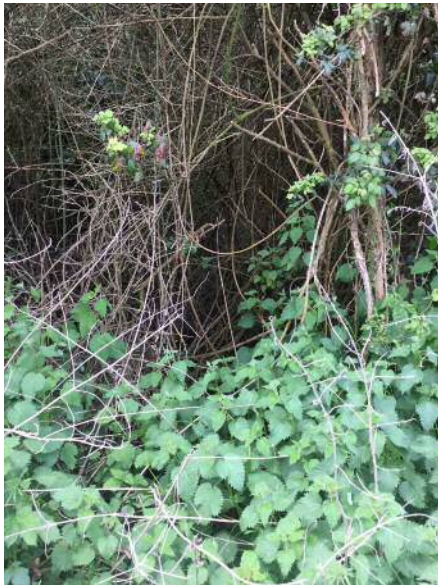
6	<p data-bbox="355 1413 627 1491">Dry ditch surrounded by mature scrub.</p> <p data-bbox="355 1559 667 1592">Photo taken 25<sup>th</sup> April 2017.</p>

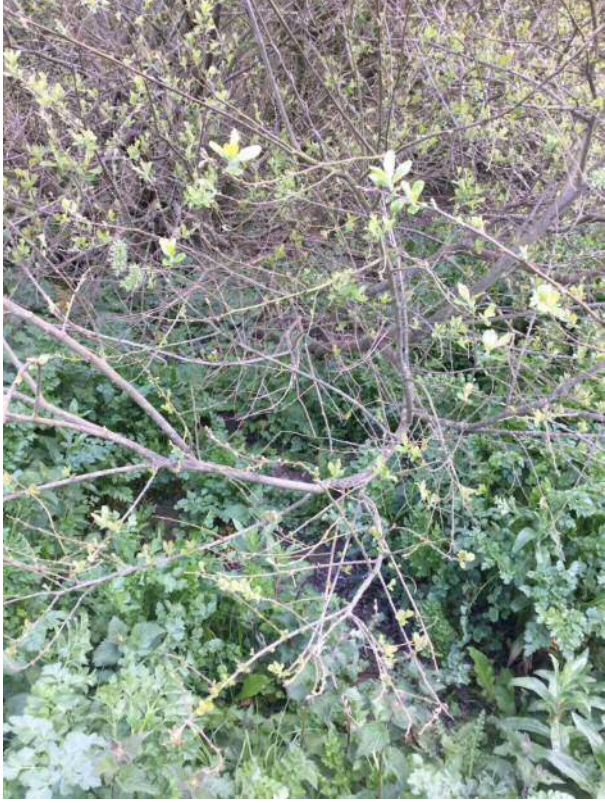
Reference	Pond Description	Photograph
7	<p data-bbox="357 248 624 322">Dry ditch surrounded by mature scrub.</p> <p data-bbox="357 394 663 423">Photo taken 25<sup>th</sup> April 2017.</p>

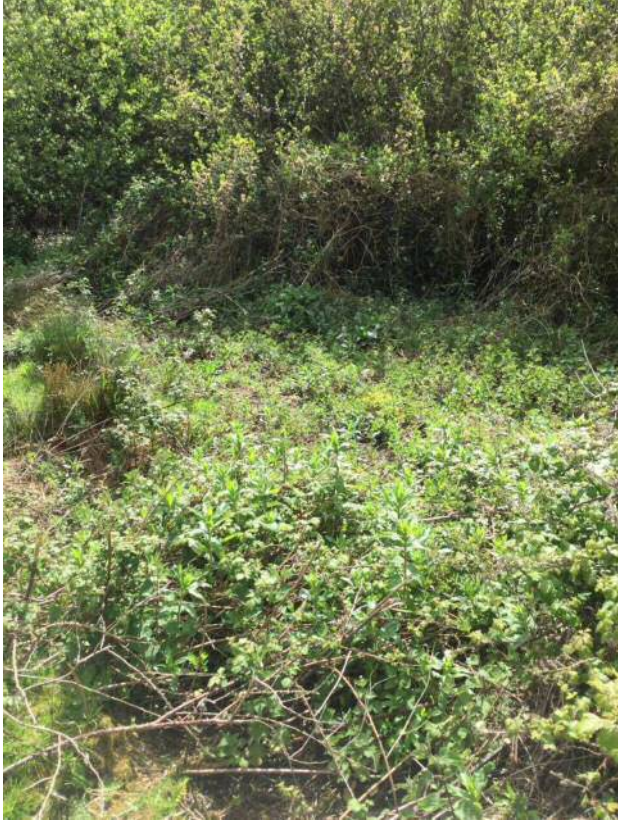
8	<p data-bbox="357 1126 663 1249">Dry depression in field with dry ditch leading away from it.</p> <p data-bbox="357 1321 663 1350">Photo taken 25<sup>th</sup> April 2017</p>

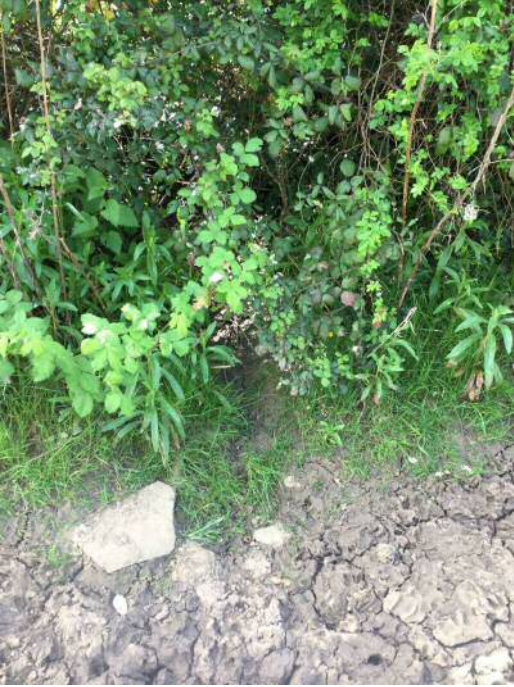
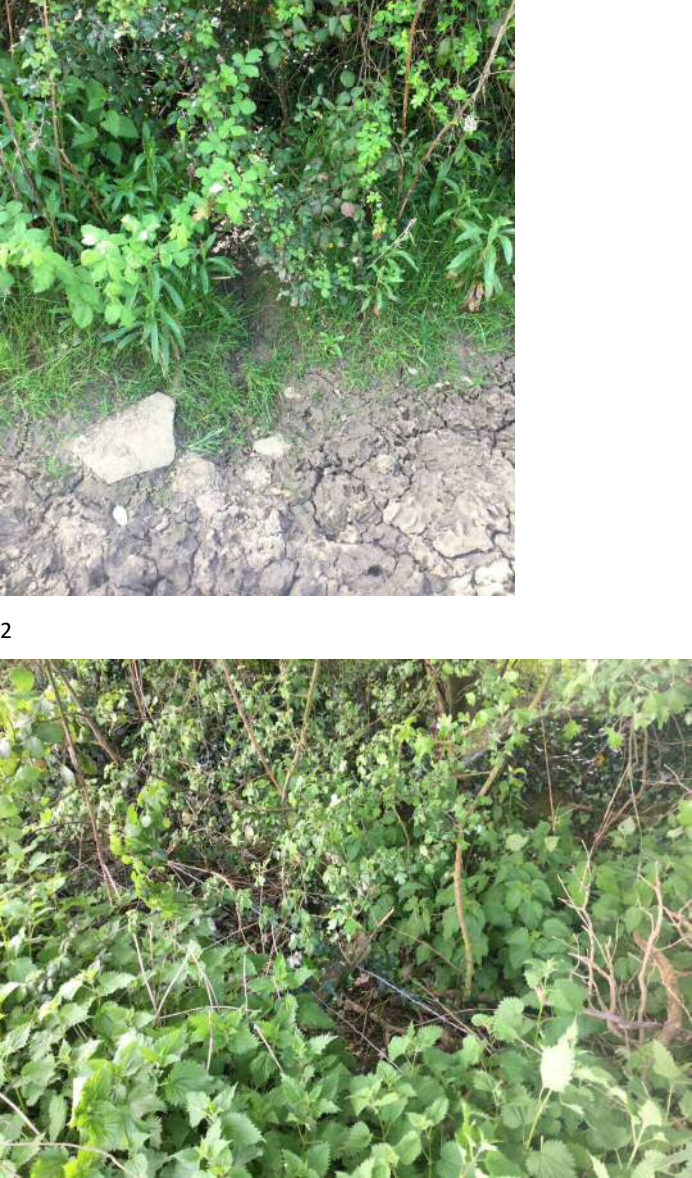
Reference	Pond Description	Photograph
9	Ditch dry	
10	Dry ditch.	1
	Photo 1 taken 25 <sup>th</sup> April 2017.

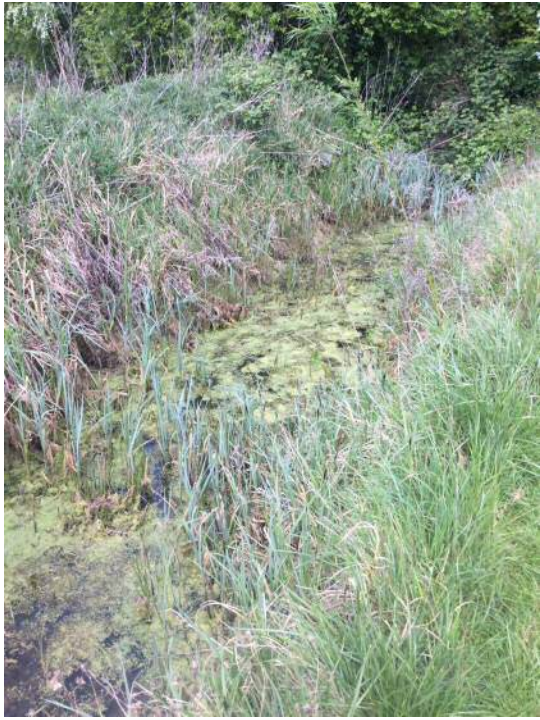
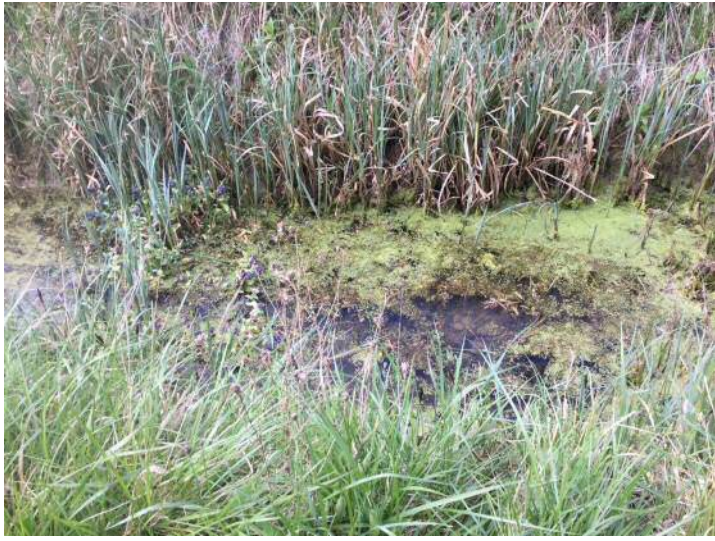
Reference	Pond Description	Photograph
11	<p data-bbox="355 248 647 517">2m wide ditch in medieval village garden. Steep &gt;45 degree banks. Bankside vegetation supports amenity grassland and scrub.</p> <p data-bbox="355 636 619 712">Photo 1 taken 25<sup>th</sup> April 2017.</p> <p data-bbox="355 1122 651 1397">Floating vegetation of duckweed (<i>Lemnoideae</i>) and some water mint (<i>Mentha citrata</i>). Marginal vegetation of black sedge (<i>Carex nigra</i>).</p> <p data-bbox="355 1464 619 1541">Photo 2 taken 25<sup>th</sup> April 2017.</p>	<p data-bbox="699 248 715 271">1</p>

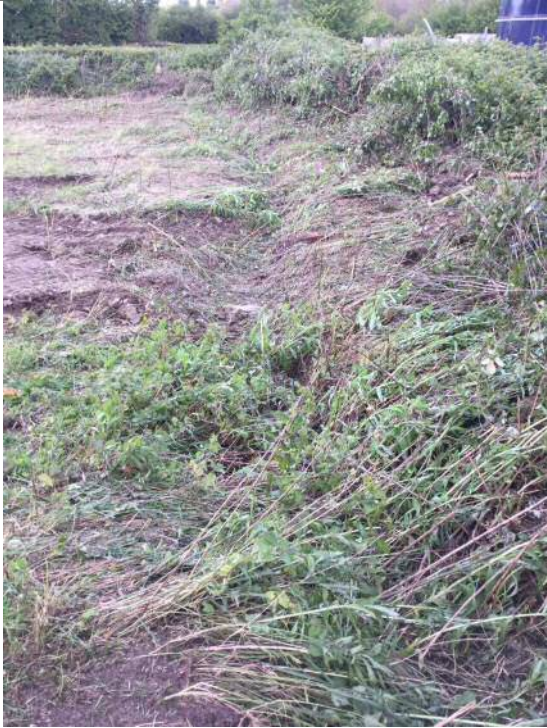
Reference	Pond Description	Photograph
12	<p data-bbox="357 248 520 277">Dry field ditch.</p> <p data-bbox="357 344 667 374">Photo taken 25<sup>th</sup> April 2017.</p>

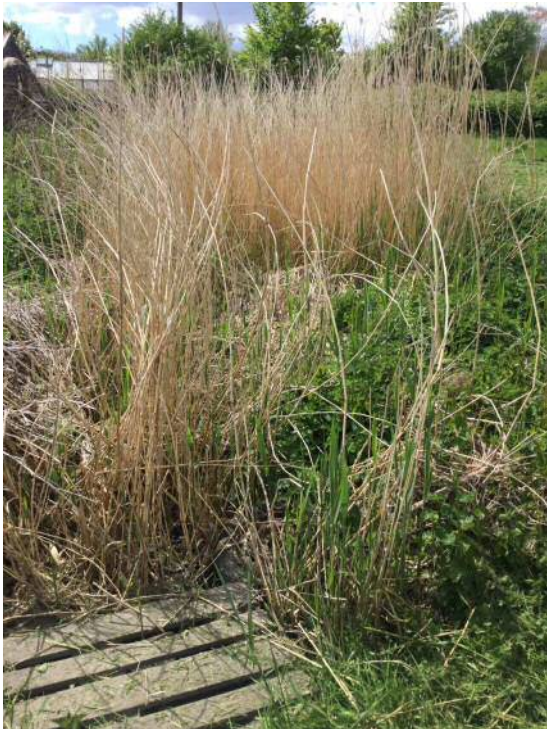
13	<p data-bbox="357 1028 662 1102">Dry drainage ditch adjacent to track.</p> <p data-bbox="357 1171 667 1200">Photo taken 25<sup>th</sup> April 2017.</p>

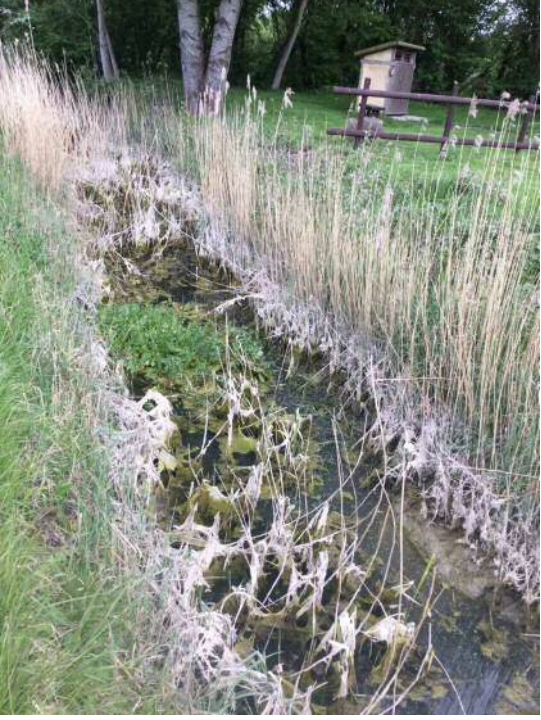
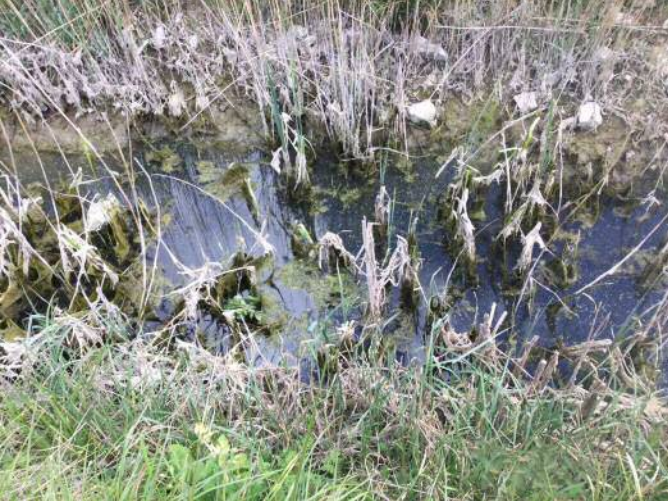
Reference	Pond Description	Photograph
<p data-bbox="201 253 236 275">14</p> <p data-bbox="360 253 635 376">2m wide ditch within medieval village gardens. Steep &gt; 45 degree banks.</p> <p data-bbox="360 443 619 521">Photo 1 taken 25<sup>th</sup> April 2017.</p> <p data-bbox="360 1077 671 1249">Floating vegetation of algae. Marginal vegetation of common reed (<i>Phragmites australis</i>).</p> <p data-bbox="360 1317 619 1395">Photo 2 taken 25<sup>th</sup> April 2017.</p>		<p data-bbox="695 253 715 275">1</p>

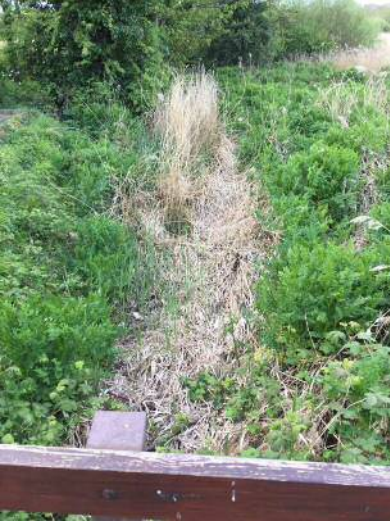
Reference	Pond Description	Photograph
16	<p data-bbox="355 248 655 421">Water level &lt;0.5m. Steep &gt; 45 degree banks, very overgrown with scrub and common reed.</p> <p data-bbox="355 490 619 566">Photo 1 taken 25<sup>th</sup> April 2017.</p> <p data-bbox="355 880 619 956">Photo 2 taken 25<sup>th</sup> April 2017.</p> <p data-bbox="355 1413 619 1489">Photo 3 taken 25<sup>th</sup> April 2017.</p>	<p data-bbox="699 248 715 271">1</p>   <p data-bbox="699 835 715 857">2</p>   <p data-bbox="699 1417 715 1440">3</p>

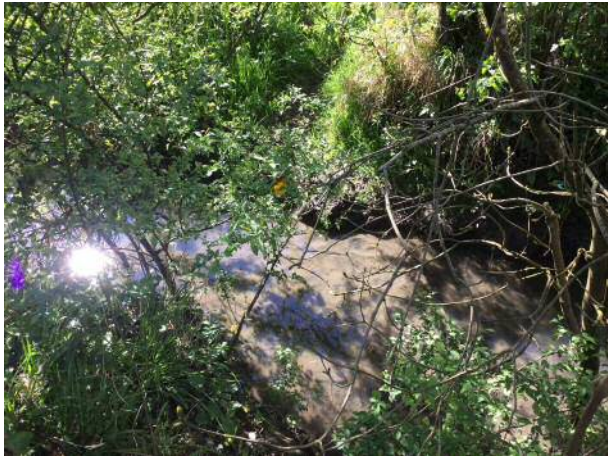
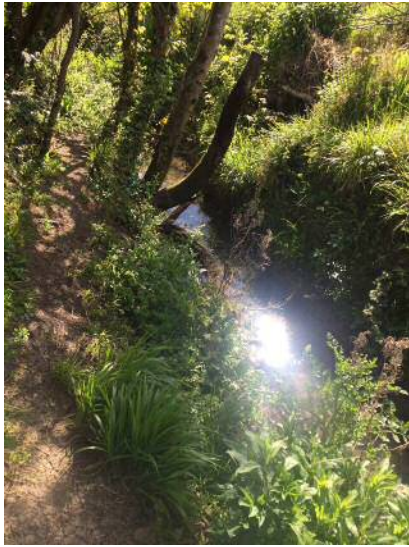
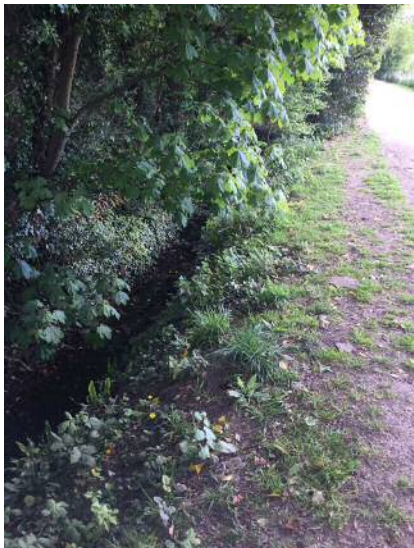
Reference	Pond Description	Photograph
17	<p>1.5m wide slow flowing stream with shallow water (approx.. 5-10cm deep) and no aquatic vegetation. Mature scrub and common reed along steep &gt; 45 degree banks.</p> <p>Photo 1 taken 25<sup>th</sup> April 2017.</p> <p>Photo 2 taken 25<sup>th</sup> April 2017.</p> <p>Photo 3 taken 25<sup>th</sup> April 2017.</p>	<p>1</p>

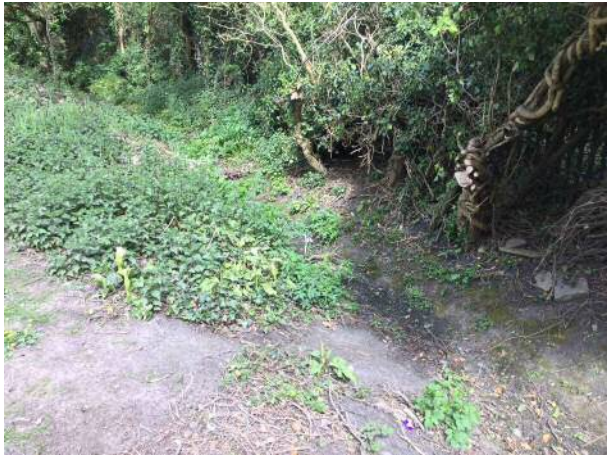
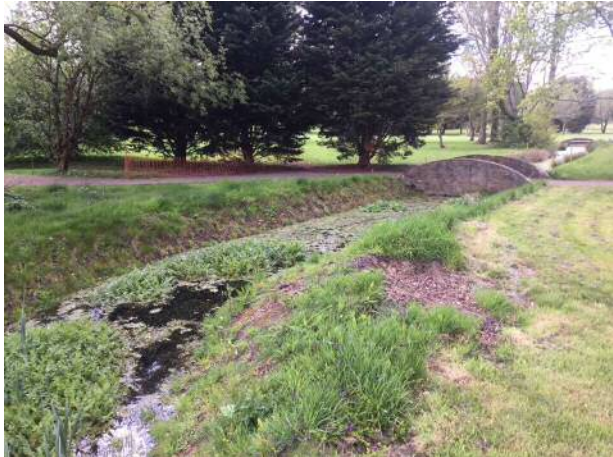
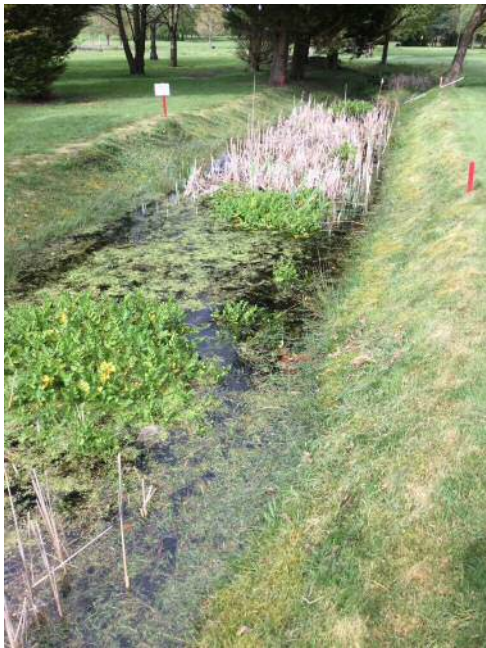
Reference	Pond Description	Photograph
18	<p>Section of ditch 18 adjacent to track which was dry,</p> <p>Photo 1 taken 25<sup>th</sup> April 2017.</p> <p>3m wide wet section of the ditch on golf course.</p> <p>Photo 2 taken 25<sup>th</sup> April 2017.</p> <p>Duckweed (<i>Lemnoideae</i>) present. Marginal vegetation of yellow flag iris (<i>Iris pseudacorus</i>) and rushes (<i>Juncaceae</i>). Steep &gt; 45 degree bankside of amenity grassland.</p> <p>Photo 3 taken 25<sup>th</sup> April 2017.</p>	<p>1</p>

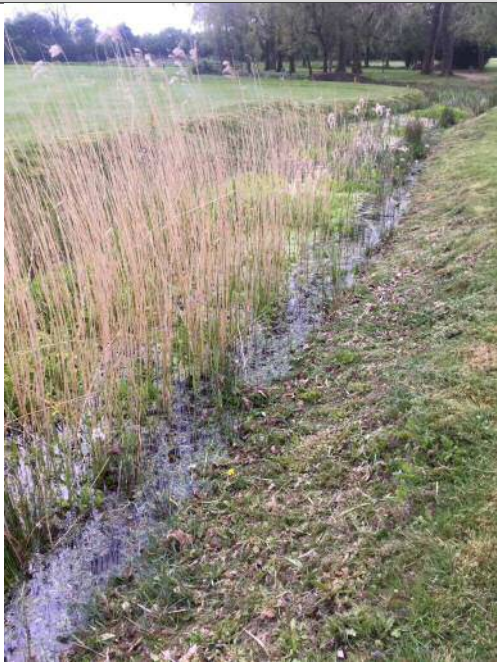
Reference	Pond Description	Photograph
18a	<p>Continuation of 4m wide ditch on gold course. Steep &gt; 45 degree bank of amenity grassland. Contained duckweed (<i>Lemnoideae</i>). Marginal vegetation comprising bulrush (<i>Typha</i>), common reed (<i>Phragmites australis</i>) and yellow flag Iris (<i>Iris pseudacorus</i>).</p> <p>Photo taken 25<sup>th</sup> April 2017.</p>

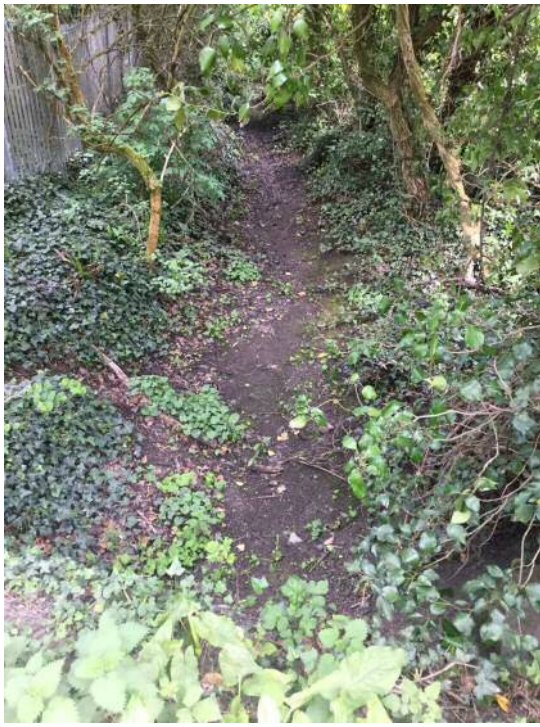
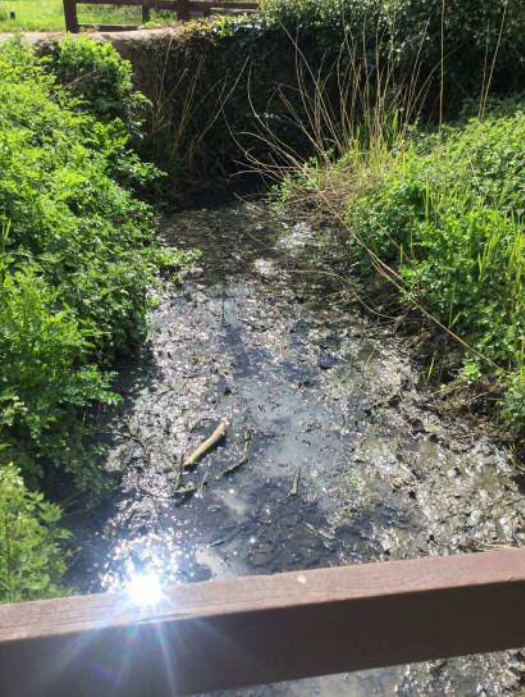
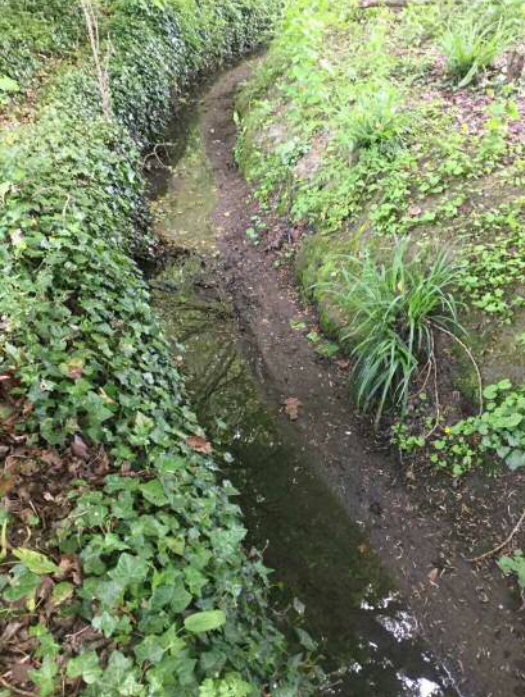
19	<p>Stream dry at Cosmeston lakes end.</p> <p>Photo 1 taken 25<sup>th</sup> April 2017.</p>	<p>1</p>

Reference	Pond Description	Photograph
	<p data-bbox="355 248 676 667">Slow flowing stream with shallow water (approx. 5-10cm deep) with no aquatic vegetation along golf course. Steep &gt; 45 degree bank with mature scrub. Agreed with Council's Ecologist could be scoped out for further survey.</p> <p data-bbox="355 734 619 813">Photo 2 taken 25<sup>th</sup> April 2017.</p> <p data-bbox="355 1126 619 1205">Photo 3 taken 25<sup>th</sup> April 2017.</p>	<p data-bbox="699 248 715 271">2</p>

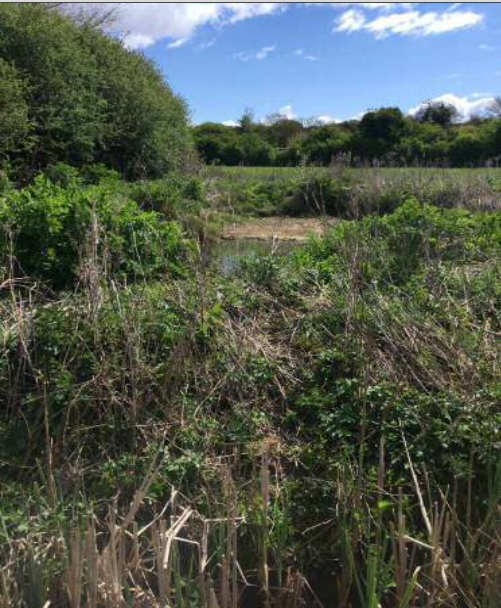
Reference	Pond Description	Photograph
20	<p>Small pond surrounded by large bund. No access due to ditch and steep banks with mature scrub and grassland surrounding pond. Marginal vegetation of rushes and sedges.</p> <p>Photo taken 25<sup>th</sup> April 2017.</p>

2.8.2 Waterbody 20 was not surveyed as it was inaccessible due to the presence of a ditch, bund and scrub.

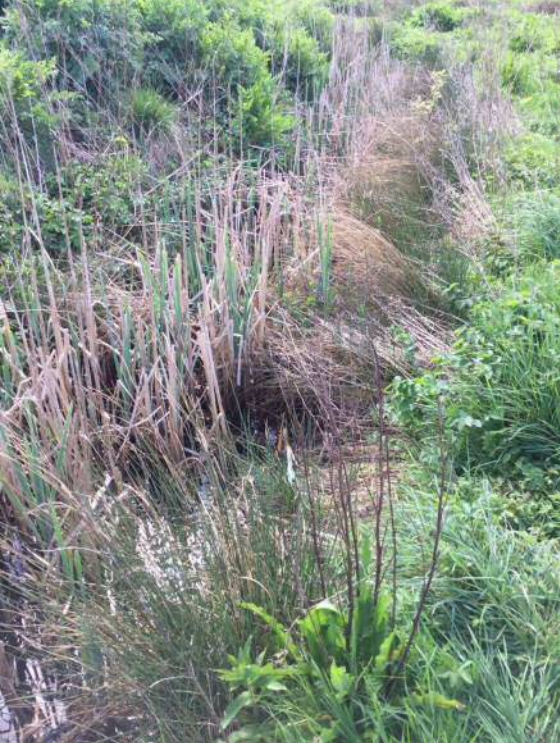
21	<p>Heavily vegetated ditch. Shallow bank &lt; 45 degrees with vegetation of rushes and grassland.</p> <p>Photo taken 25<sup>th</sup> April 2017.</p>

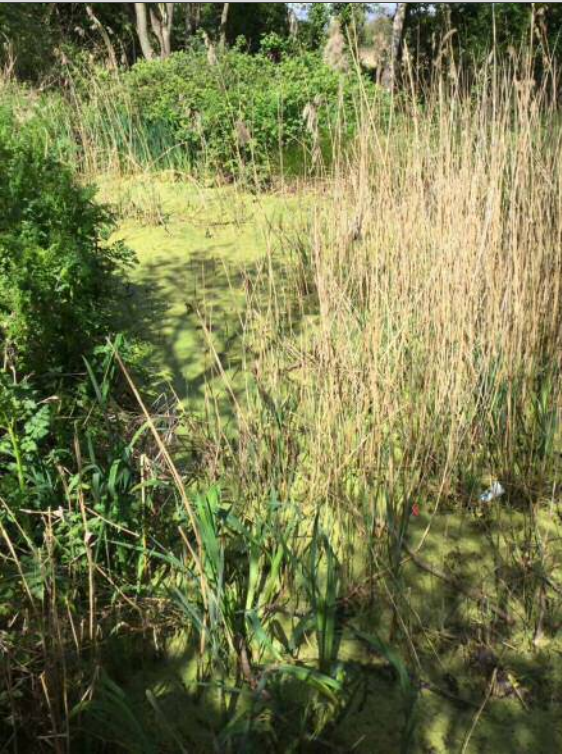
Reference	Pond Description	Photograph
22	<p>Medium sized pond covered in duckweed (<i>Lemnoideae</i>). Surrounded by steep &gt; 45 degree banks and marshy areas. Bankside vegetation of mature scrub, hogweed (<i>Heracleum sphondylium</i>) and common reed (<i>Phragmites australis</i>).</p> <p>Photo taken 25<sup>th</sup> April 2017.</p>

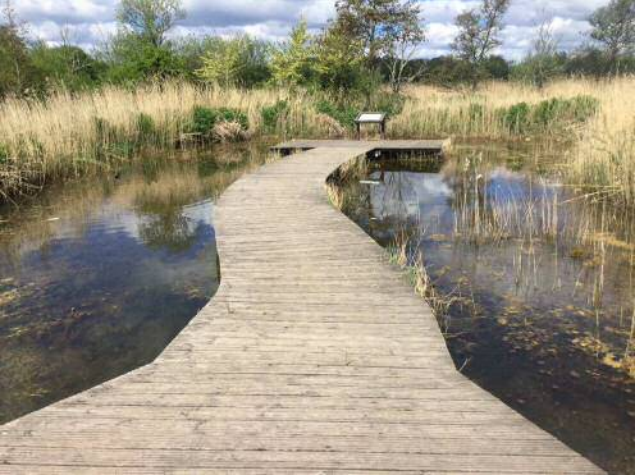
23	<p>Medium sized pond surrounded by common reed (<i>Phragmites australis</i>). Boardwalk out onto pond. Steep &gt; 45 degree bank. Lily pads (<i>Nymphaeaceae</i>) present.</p> <p>Photo taken 25<sup>th</sup> April 2017.</p>

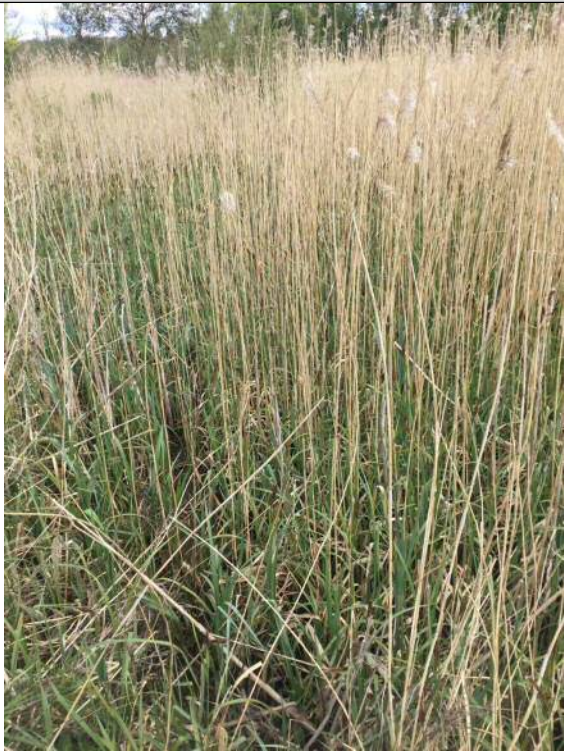
Reference	Pond Description	Photograph
24	<p>Marshy pond area covered in common reed (<i>Phragmites australis</i>) and sedges (<i>Cyperaceae</i>).</p> <p>Photo taken 25<sup>th</sup> April 2017.</p>

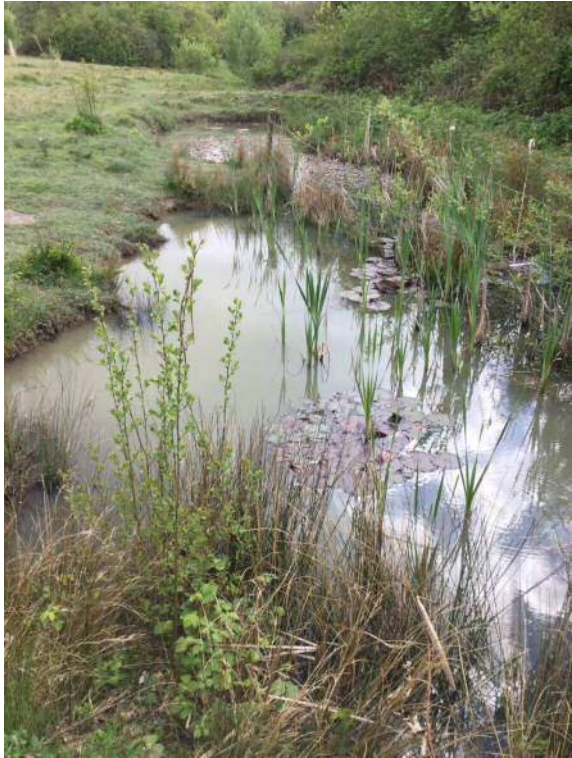
25	<p>Small field pond adjacent to stream corridor. Shallow &lt; 45 degree bank of mature scrub and semi-improved grassland. Marginal vegetation of rushes (<i>Juncaceae</i>) and bulrushes (<i>Typha</i>). Lily pads (<i>Nymphaeaceae</i>) and broad-leaved pondweed present (<i>Potamogeton natans</i>).</p> <p>Photo taken 25<sup>th</sup> April 2017.</p>

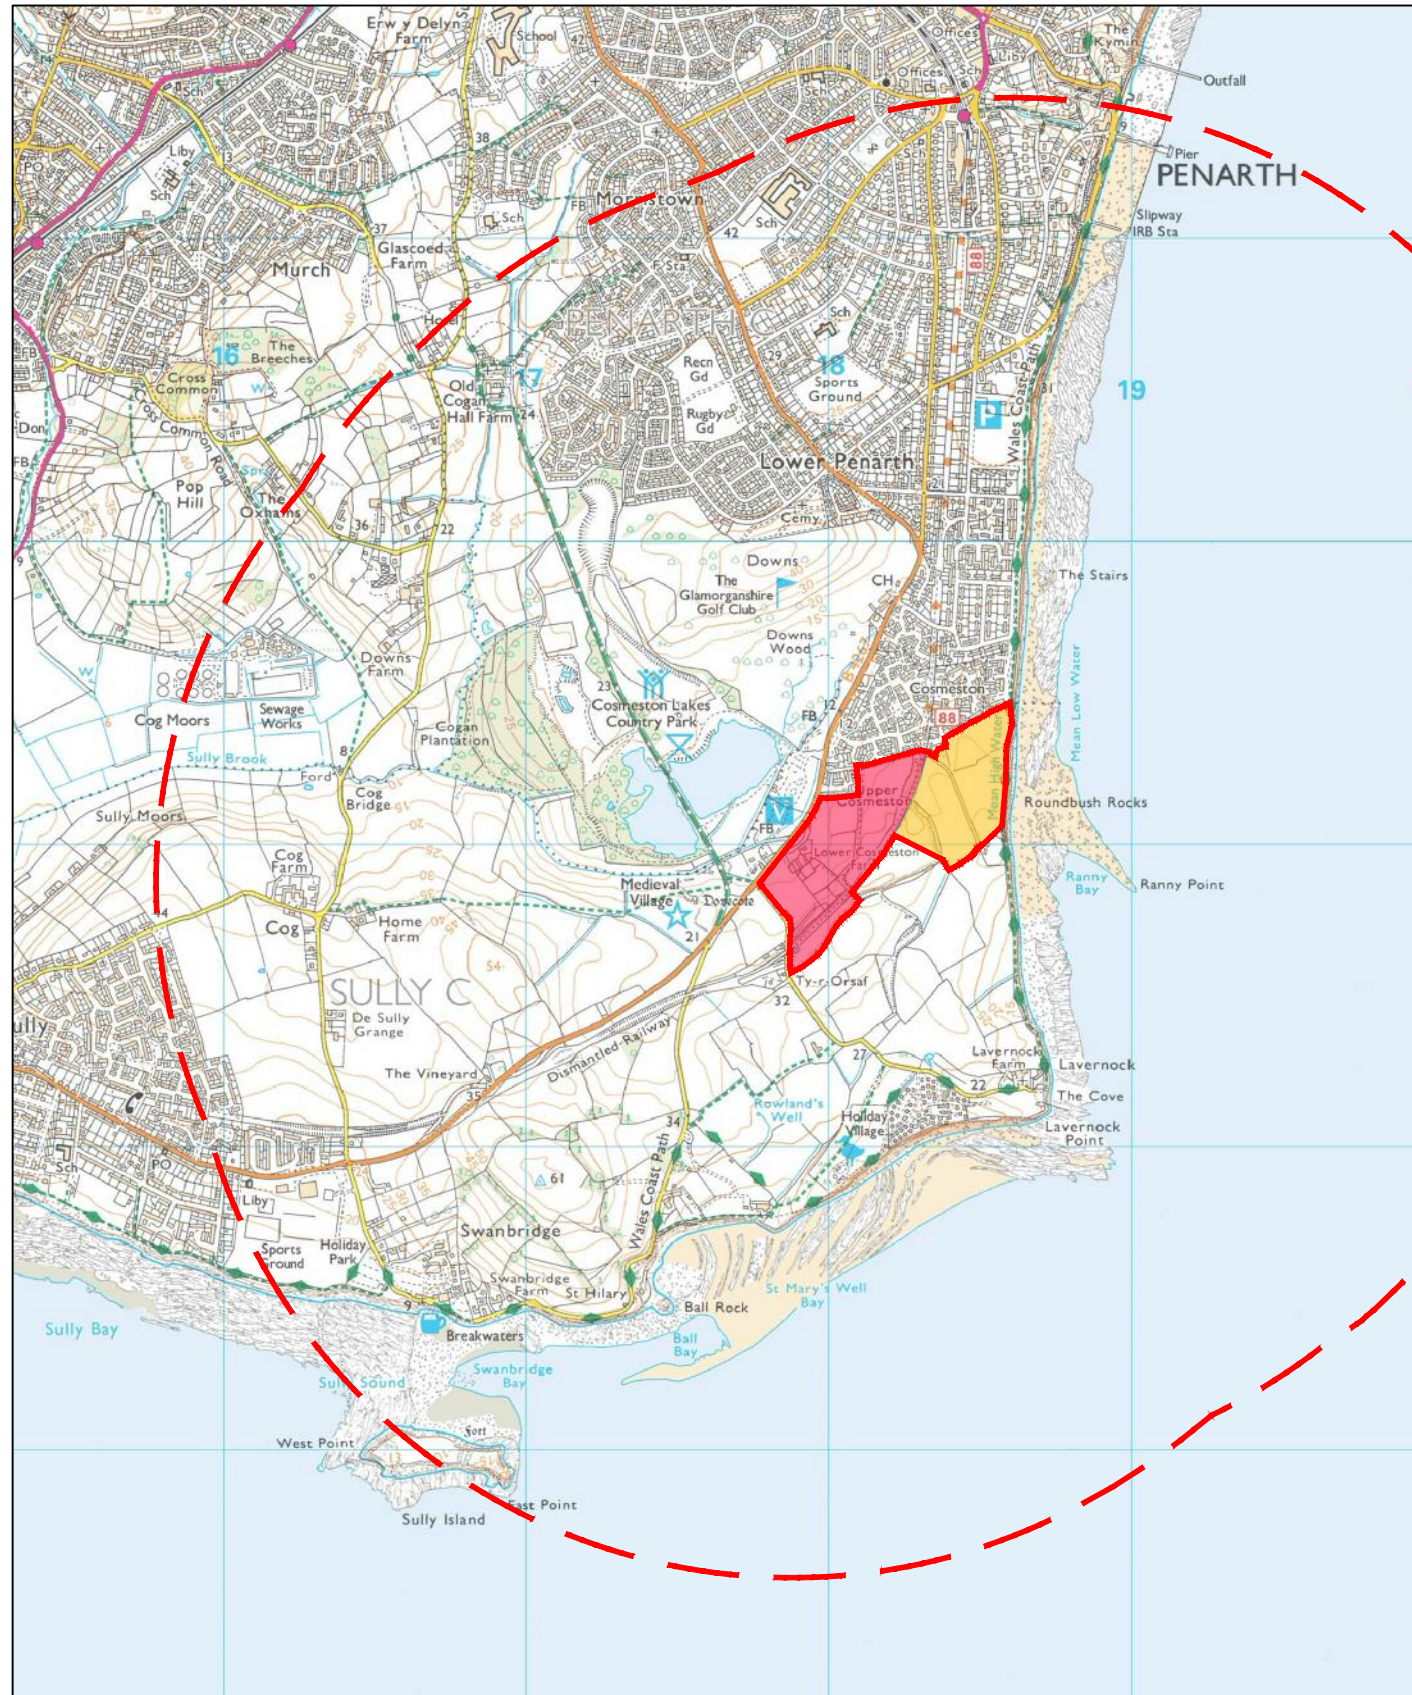
**SITE LOCATION PLAN & ECOLOGICAL SURVEY AREA**

1.3.1 The location of the site is shown on Drawing Number CA11040-001/RevA. The site is situated in the Vale of Glamorgan to the east of Lavernock Road (B4267) and south of 'Lower Penarth' housing estate as shown on Drawing Number CA11040-001 (Site Location and Survey Area). Farmland borders the site immediately to the east beyond which is the coastline of the Severn Estuary, with further agricultural land present to the south east. Part of the south-western part of the site is bordered by the 'Fort Road' which leads to the Lavernock Holiday Village.
