COSMESTON

Phase 1 Desk Study and Phase 2 Geo Environmental and Geotechnical Assessment Report

JULY 2018

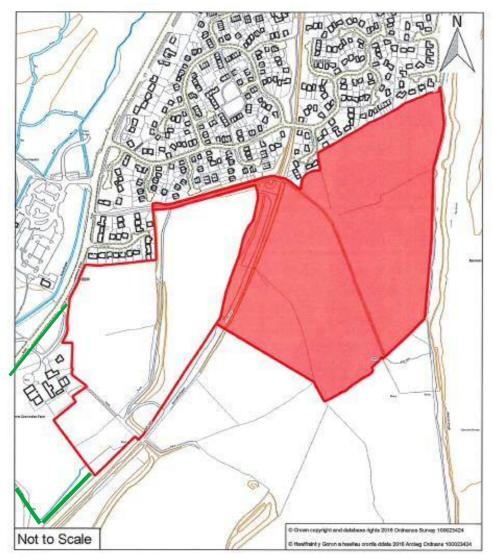
Figure 1 Red Line Boundary showing the area allocated for housing by Vale of Glamorgan

The site at Cosmeston is shown in Figure 1 below. The original allocation was on the western side of the site outlined in red, however this was extended by the Vale of Glamorgan Council to include the eastern area highlighted in red.

In addition to the area within the red line boundary, an extra area shown by the green line to the south west including the farm and the field to the south was also investigated and whilst not within the current red line boundary, the findings will be included within this report for completeness.

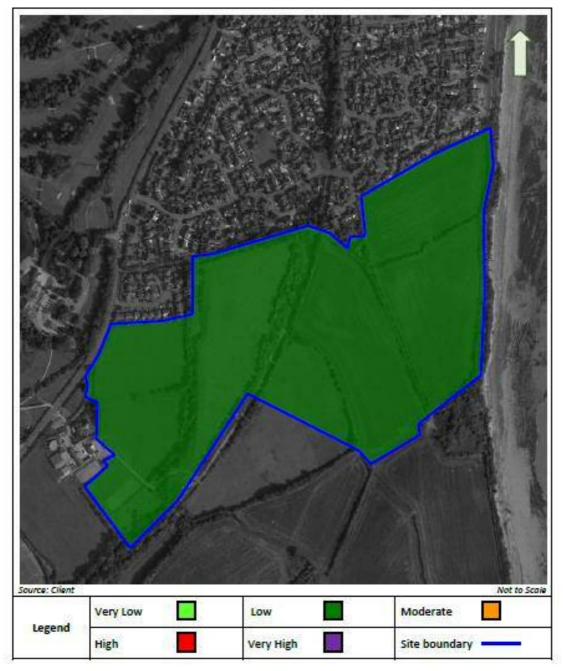
Figure 2 – UXO Hazard zone plan of the Site (taken from Zetica report)

It is considered that the Site has a low UXO hazard level, as shown in Figure 2 below.

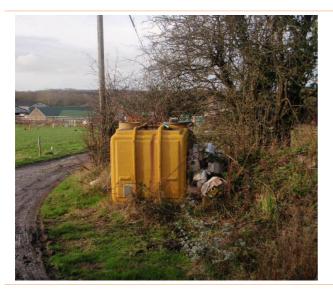
Plate 11: Storage tank and other smaller plastic containers

The historical railway line is used for storage of various materials, much of this is related to highways work including fencing, signage, cones and metal ISO containers present. Plastic tubs containing mortar, cement, lubricants and tarmacadam products were stored directly on the ground along with bottles of propane gas and an electrical generator. There were many metal drums, most of which were corroded/rusted and labelled with various contents including gasoline, frozen orange juice, lubricants and oils. Fly-tipped rubbish including fridge-freezers, ovens, sofas, possible asbestos containing materials, timber, metal and general domestic rubbish was also noted on parts of the site. There was an open drum with evidence of spilled contents on to the bare ground, with an oily sheen present on surrounding surface water.
