Appendix B Topographical Survey

PROJECT:
TOPOGRAPHICAL SURVEY AT
CARDIFF & VALE COLLEGE CAMPUS,
WEYCOCK CROSS,
WENVOE.

Appendix C Soakaway Investigation

DRAFT SITE INVESTIGATION: Land off Weycock Road, (A4226), Barry, CF62 3AA.

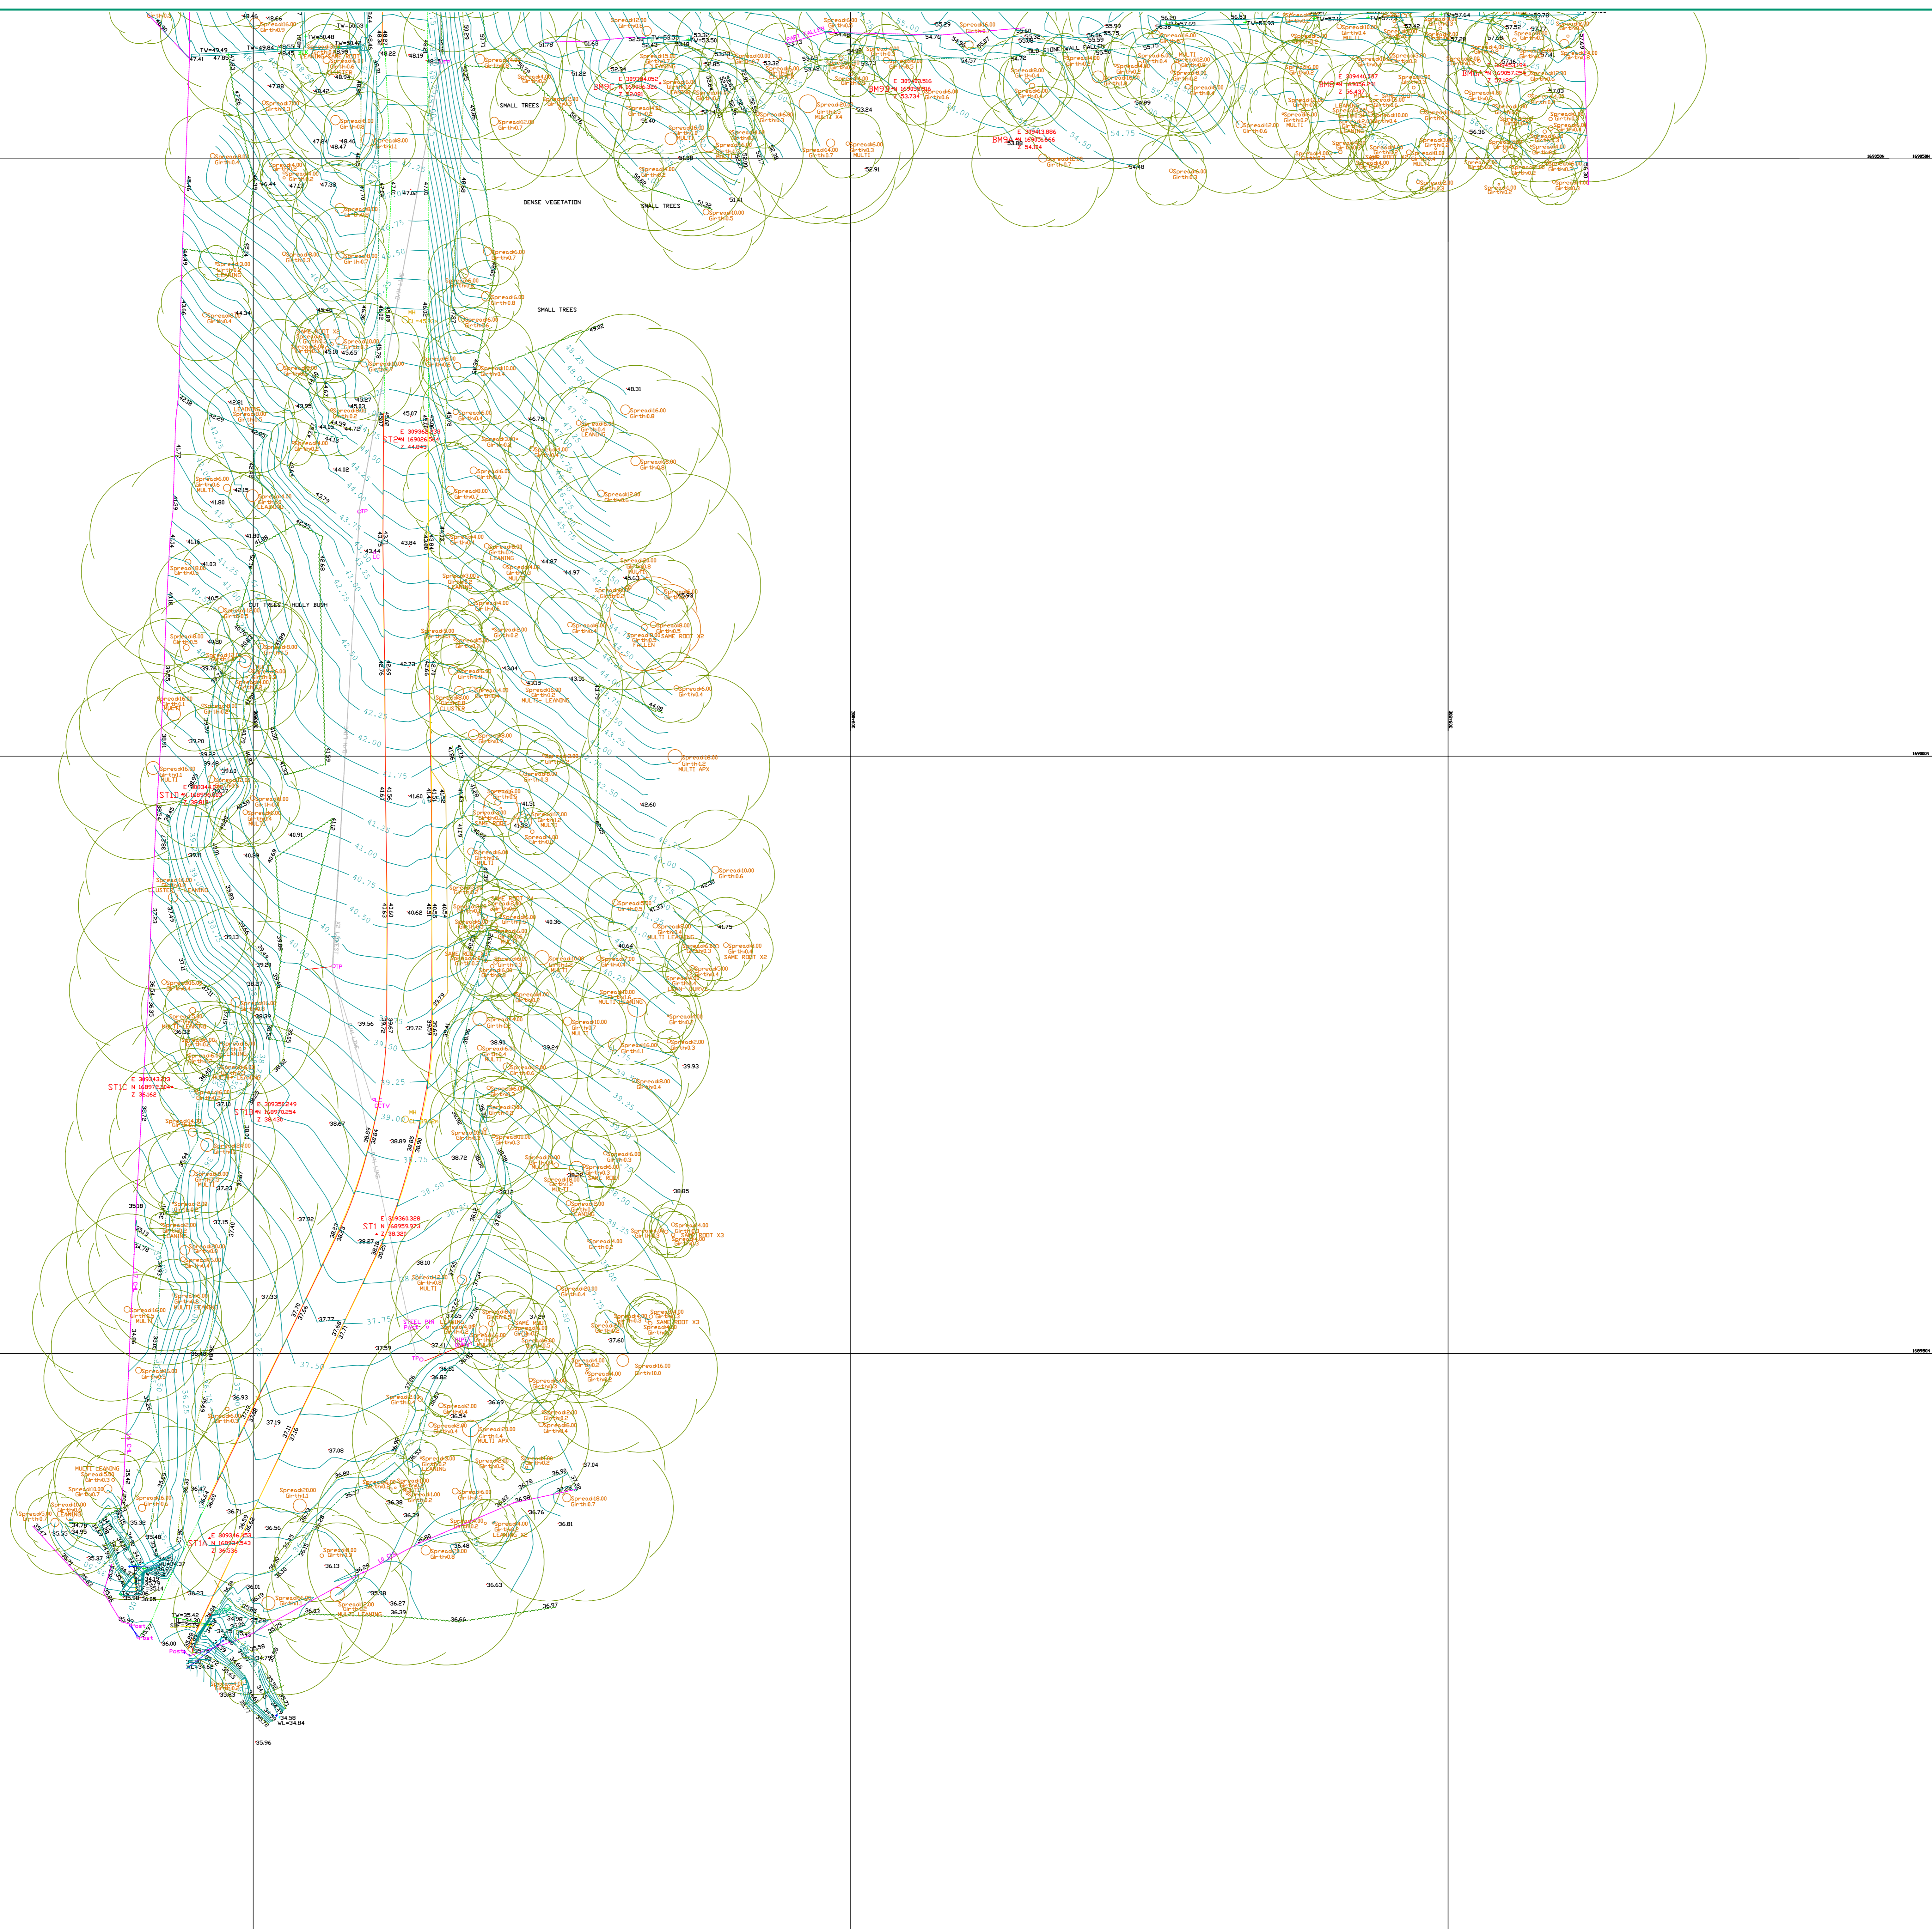
Surveyed by BM	Date	26/04/2022
Drawn BM	Date	29/04/2022
Scale 1:200@A0	Checked	TC
Project Reference No. ALS/4496		
Drawing Number	LFWC/02

PROJECT:
**TOPOGRAPHICAL SURVEY AT
CARDIFF & VALE COLLEGE CAMPUS,
WEYCOCK CROSS,
WENVOE.**

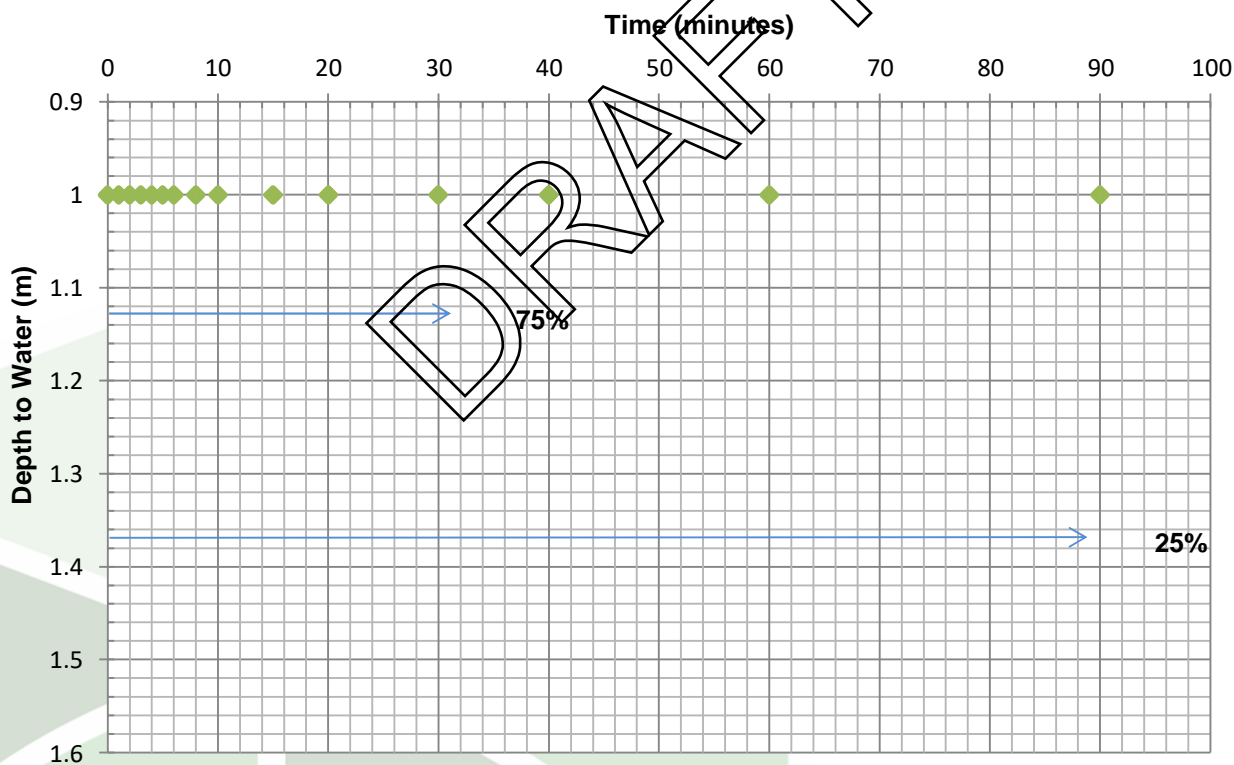
TrialPit: TP01

Length	1.50 m
Width	0.50 m
Depth	1.50 m
Fill Level	1.00

V_{p75-25} 0.049 m³
 a_{p50} 0.589 m²
 t_{p75-25} 0 minutes

insufficient flow to calculate infiltration rate

Insufficient infiltration observed, test cancelled.

The soakaway test recorded insufficient infiltration and was subsequently terminated early. It is considered that soakaway drainage is unsuitable at the locations and depths tested.

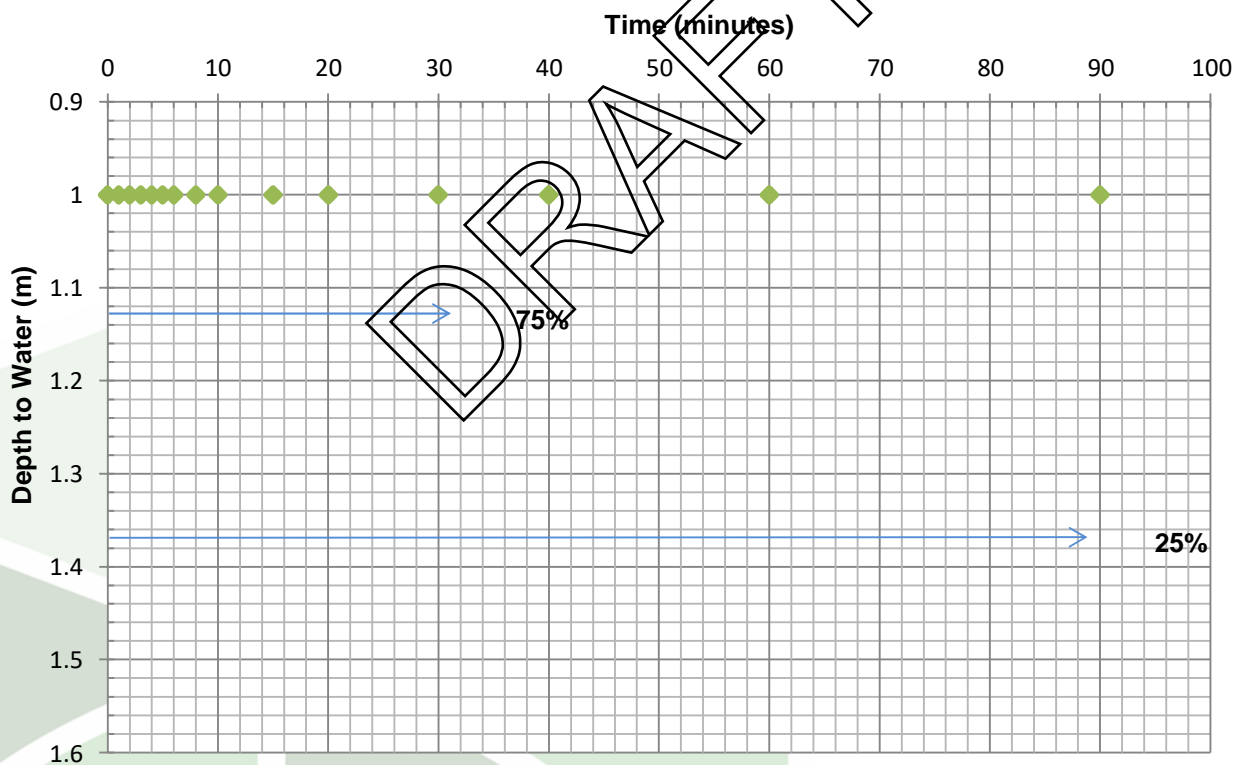
TrialPit: TP02

Length	1.50 m
Width	0.50 m
Depth	1.50 m
Fill Level	1.00

V_{p75-25} 0.049 m³
 a_{p50} 0.589 m²
 t_{p75-25} 0 minutes

insufficient flow to calculate infiltration rate

Insufficient infiltration observed, test cancelled.
