**Five Mile Lane – Former Griffiths  
Compound / Materials Storage Area  
(Land south of Amelia Trust Farm)**

**Investigation into Depth and  
Quality of Placed Fill.**

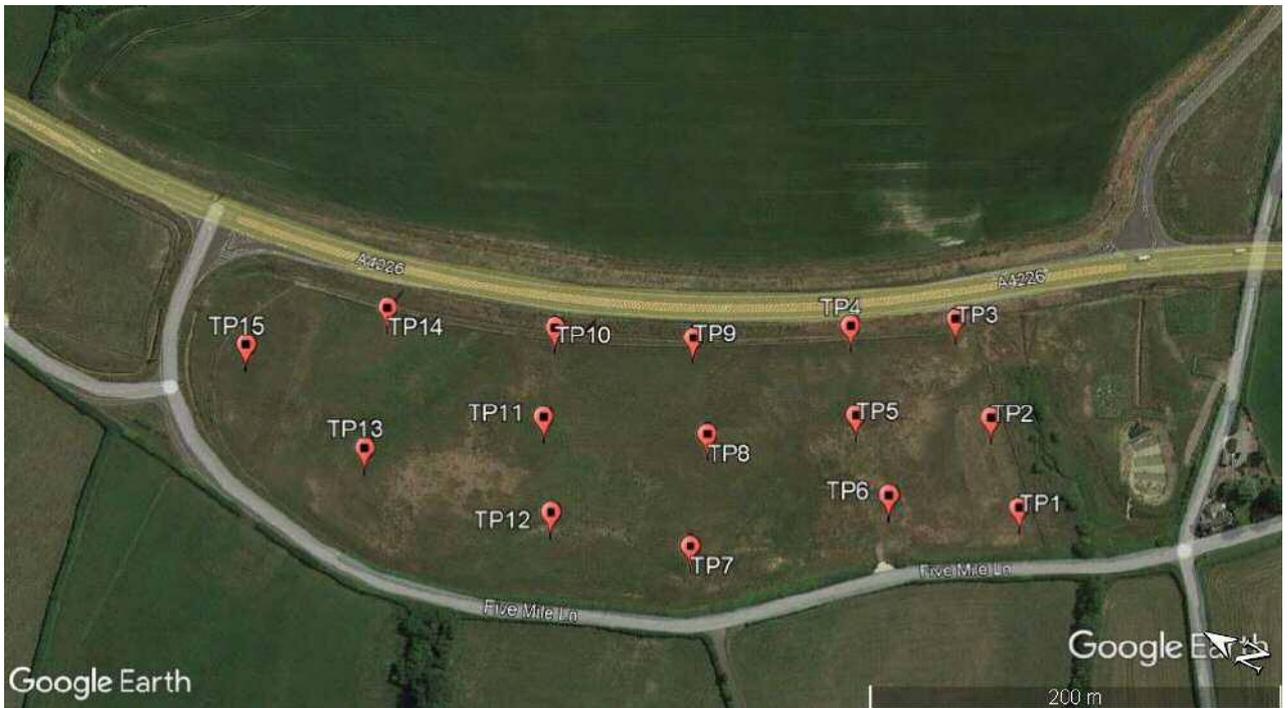
Figure 12: Trial Pit Locations overlain onto Aerial Image of Operational Site.

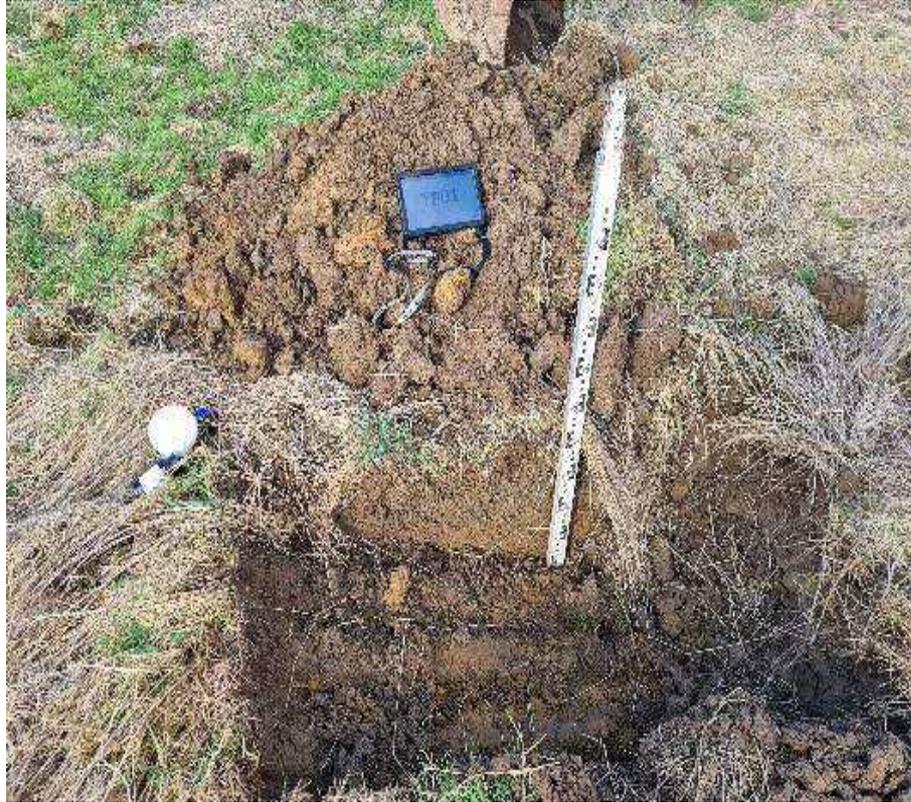
*Figure 13: Trial Pit 1*

5.2.1 Trial pit 1 was dug to a depth of 0.46m at the edge of the field. The top 0.30m of the hole was clean top soil and the bottom 0.16m of the hole was lightly coulered sandy loam soil. The sample was taken at a depth of 0.40m.

5.2.2 No ground water was encountered. 1no soil sample was taken from the sandy loam layer of the soil.

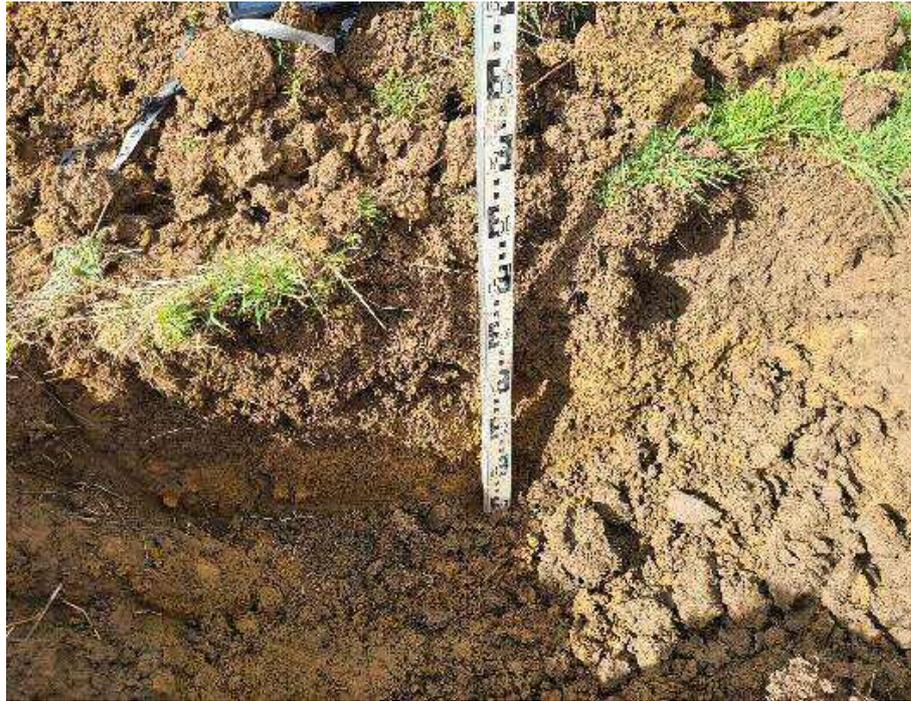
*Figure 14: Trial Pit 2*

5.3.1 Trial Pit 2 was dug to a depth of 0.52m. the top 0.18m was clean top soil and the lower 0.34m consisted of light brown coloured sandy loam soil with nothing notable to be seen. A soil sample was taken at a depth of 0.45m. There was no water at this trial hole. The trial pit is on the northern boundary of the site and it is believed that soils encountered were indigenous to the plot.

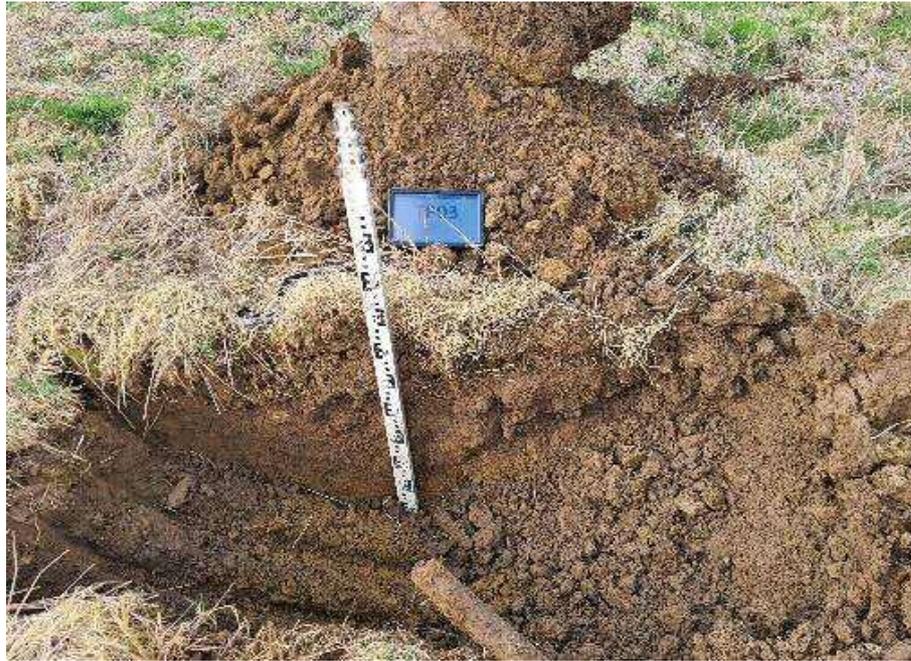
**Figure 15: Trial Pit 3**

5.4.1 Trial Pit 3 was excavated to a depth of 0.6m near the southern boundary of the plot. The trial pit comprised 0.35m of clean light brown top soil, underlain by 0.25m of clean dark brown sandy clay with no evidence of made ground. A soil sample was taken at a depth of 0.52m and ground water was not encountered. It is likely that the soils encountered are indigenous to the site.

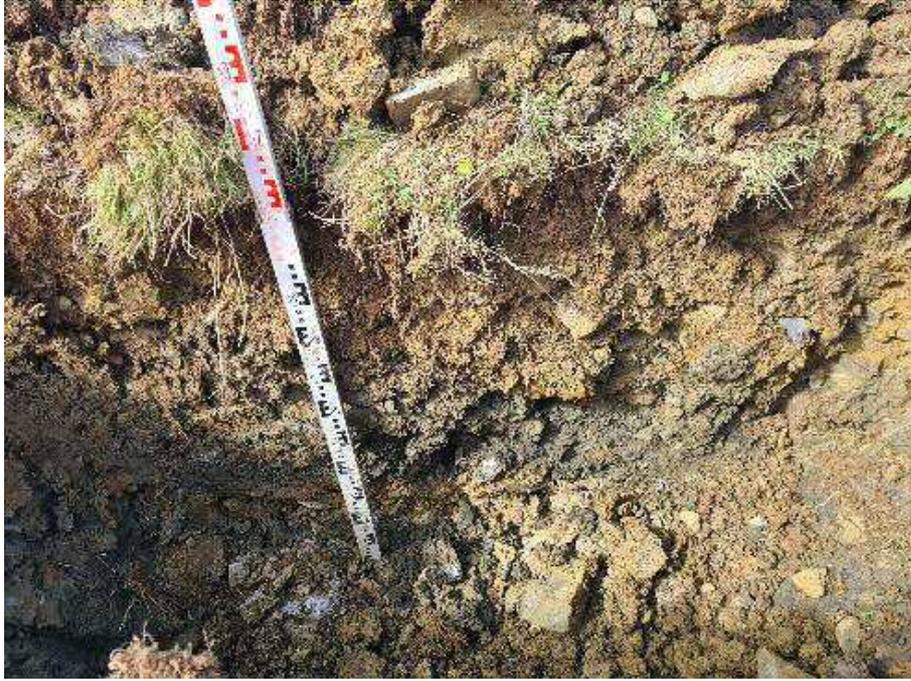
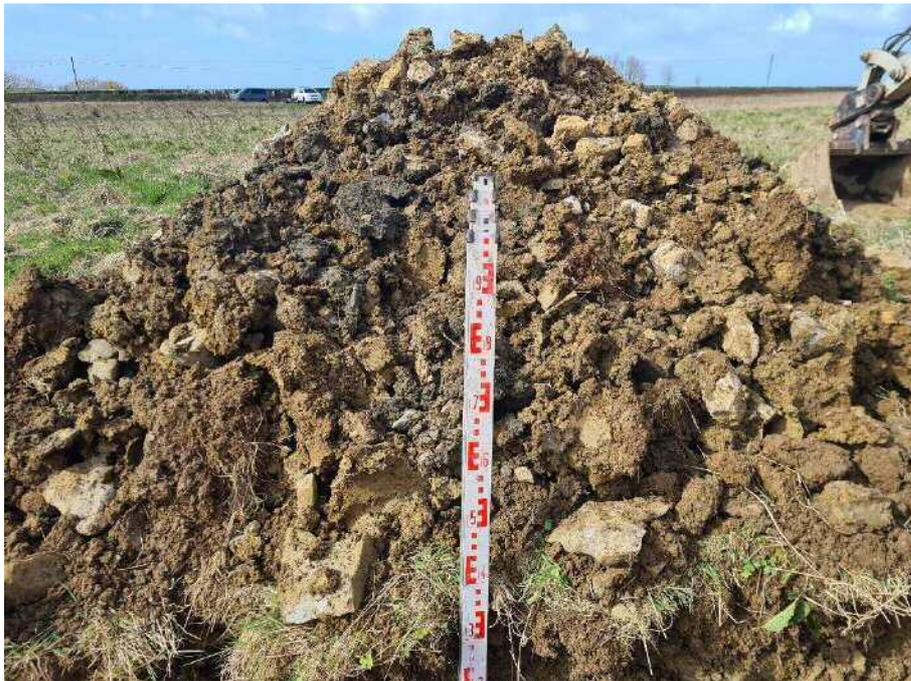
**Figure 16: Trial Pit 4**

- 5.5.1 Trial Pit 4 was excavated at equal distances away from the centre of the site and the edge of the site, the pit was excavated to a depth of 1.2m. The top 0.3 meters of the trial pit was light to dark brown top soil. This was underlain by 0.4m of light brown coloured sandy loam with infrequent small sections of sandstone rock. Below this was 0.6m dark brown clay loam subsoil with approx. 30% angular / sub-angular sandstone cobbles. 0.6m of light brown clay with frequent sandstone. It was not possible to confirm whether materials encountered were indigenous or made ground as all were naturally occurring soils consistent with the area. A sample was taken at a depth of 1.15m and no ground water was identified.

- 7.1.6 The results from the laboratory analysis screened well against the Soil Screening Values (SSV), with only one exceedance noted. The sample taken from TP4 was taken at 1.15m below ground level and has an exceedance for lead against the Residential with Plant Uptake and Allotment SSV. The results was Lead 536.7mg/kg, against an Atkins AtRisk SSV for Residential with Plant Uptake of 200mg/kg and Residential without Plant Uptake of 310mg/kg and a LQM/CIEH Suitable 4 Use Levels for an Allotment End Use SSV of 80mg/kg. This result is an outlier, with the other results being consistent and the next highest reading being 37.3mg/kg. Due to the depth at which the sample was taken, the nature of the soil (clay) and the anomalous nature of the reading, we do not believe that this poses a risk to human health or controlled waters.

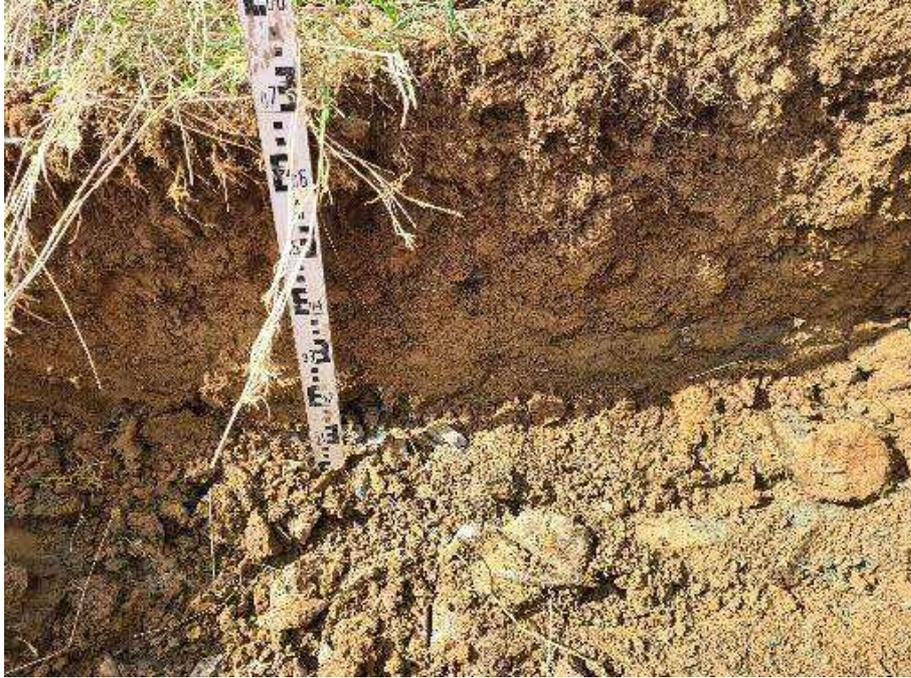
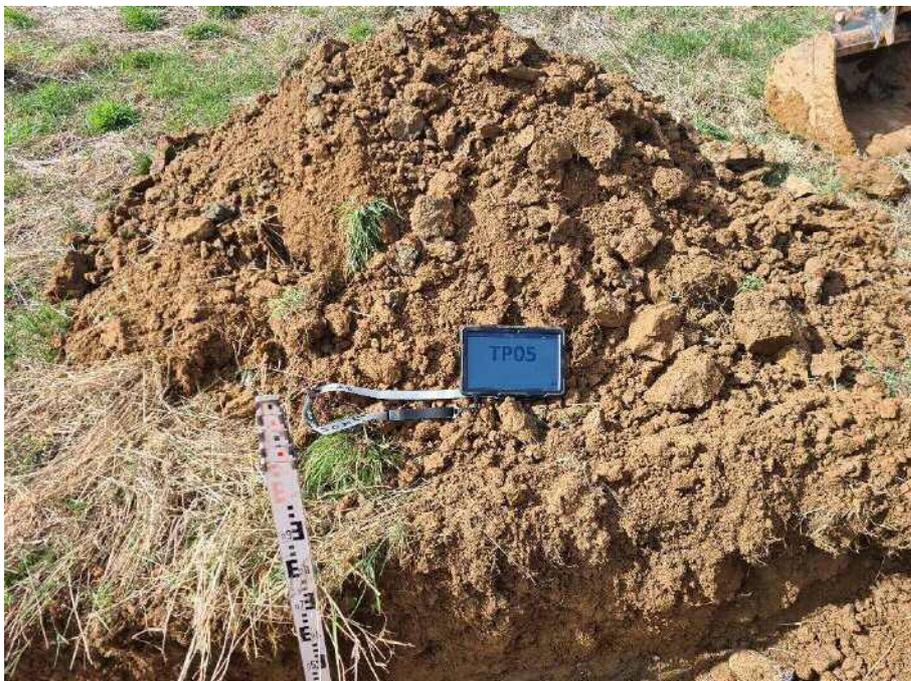
*Figure 18: Trial Pit 5*

- 5.6.1 Trial Pit 5 was excavated to a depth of 0.7m and was located at the edge of where it was anticipated that placed fill would be encountered. The top 0.4m of the pit was made up of light brown clay topsoil with frequent rootlets and occasional sandstone fragments. The lower 0.2m of the pit was Light brown clay soil with frequent (50%) sandstone fragments. The pit was terminated as it was believed that this was indigenous soil. The sample was taken at a depth of 0.5m no groundwater encountered.

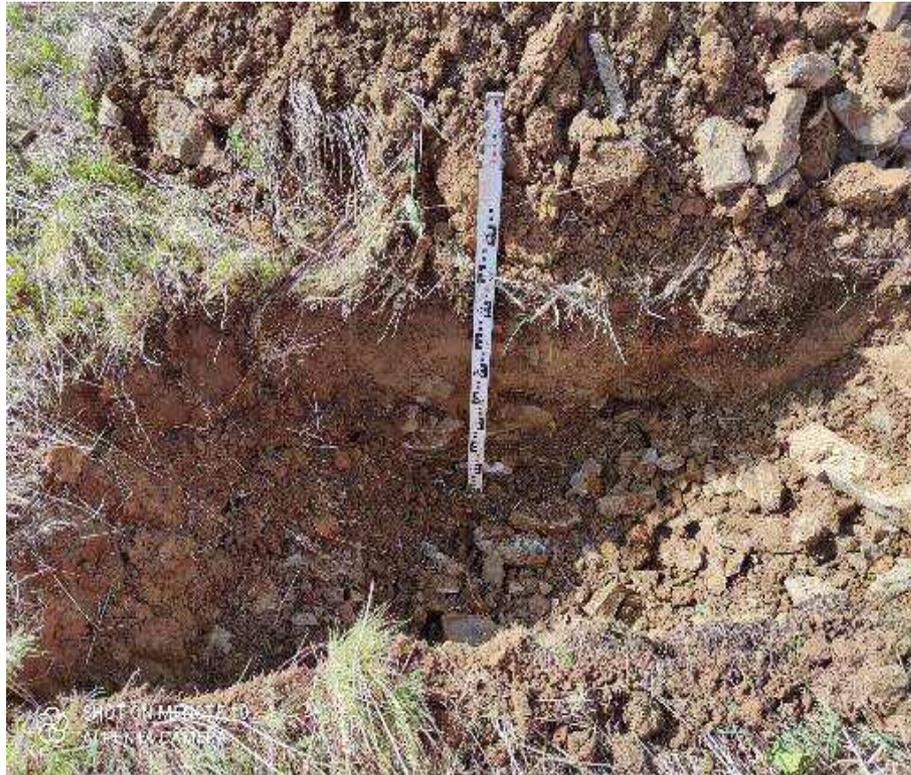
Figure 20: Trial Pit 6

- 5.7.1 Trial pit 6 was excavated near the gate that acts as the entrance and exit of the field and thus may be an area where there is likely to be material remaining from the construction of the site entrance. Small fragments of bituminous bound materials were noted on the surface of the site. The trial pit was excavated to a total depth of 0.8m. The top 0.2m of the trial pit consisted of a thin layer of light brown clay topsoil with frequent rootlets and occasional sandstone fragments. The middle 0.3m of the trial pit was made up of light brown sandy loam type soil. The bottom 0.3m of the trial pit was Light brown clay loam sub-soil with a high density of angular / sub-angular sandstone cobbles.

- 5.7.2 soil mixed with a very high density of sandstone fragments. The broken sandstone is likely naturally occurring but could be materials remaining from the access into the compound. The sample was taken at a depth of 0.6m and there was no ground water.

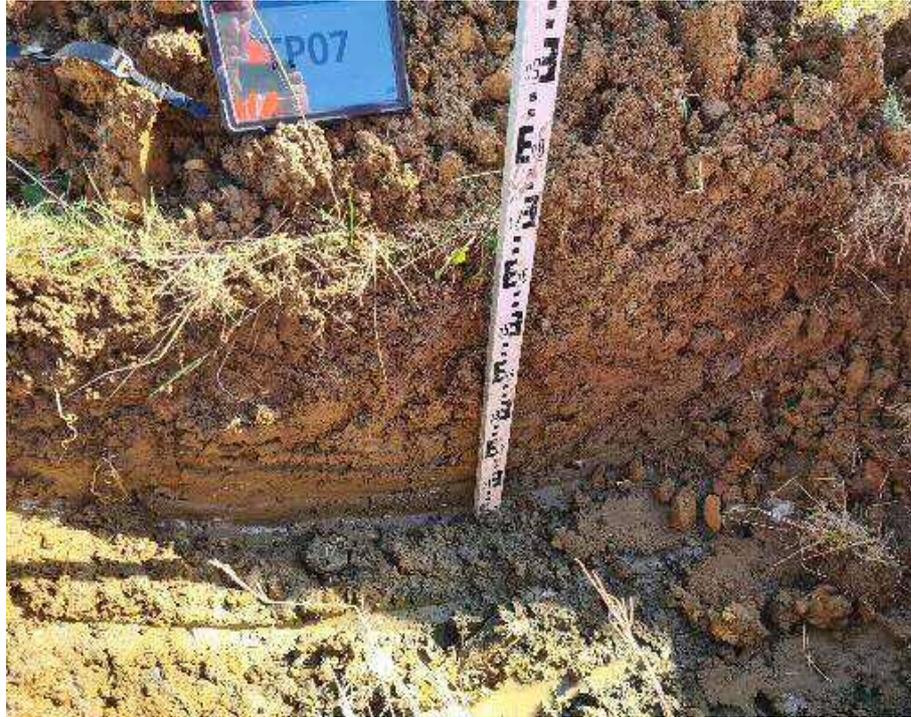
Figure 21: Trial Pit 7

- 5.8.1 Trial pit 7 was dug near to the entrance gate to the field and reached a depth of 0.65m. The top 0.2m of the trial pit was light brown clean top soil. The bottom 0.45m of the trial pit was light brown clay. The sample was taken at a depth of 0.4m and there was a small amount of surface water trickling into the trial pit.

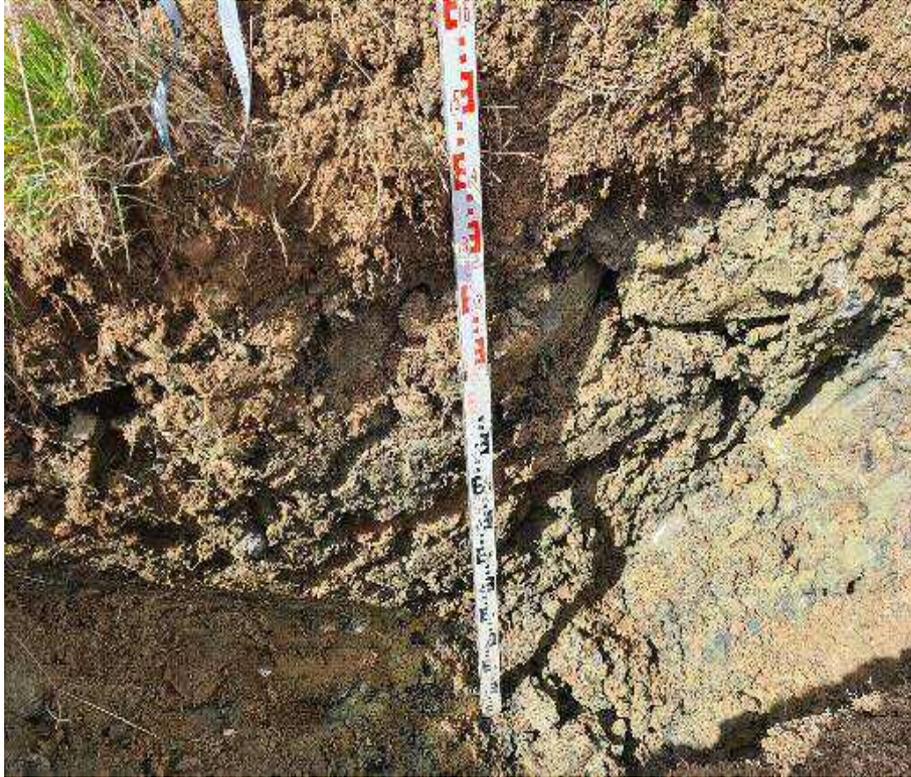
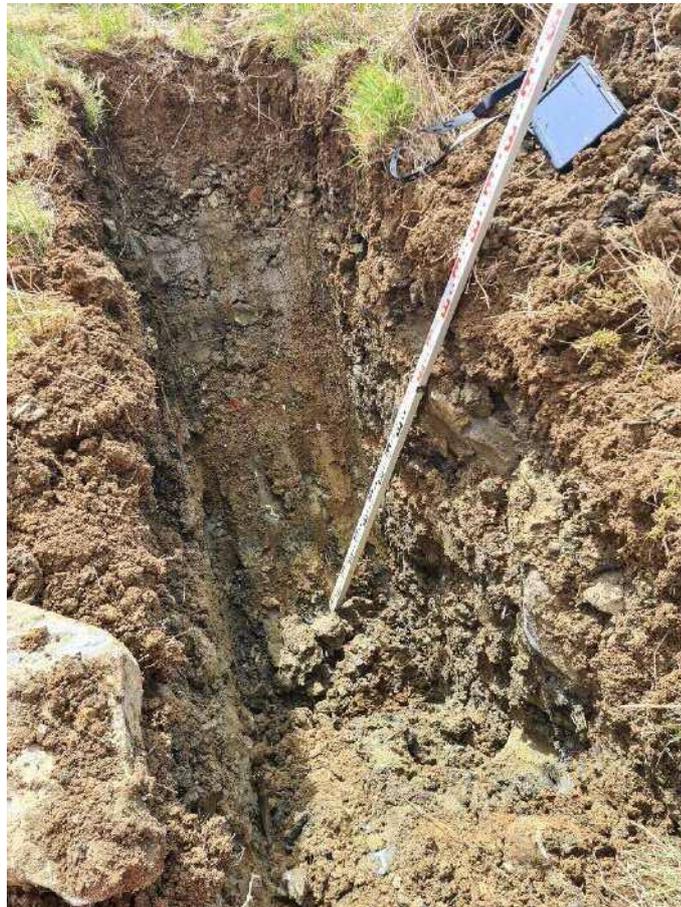
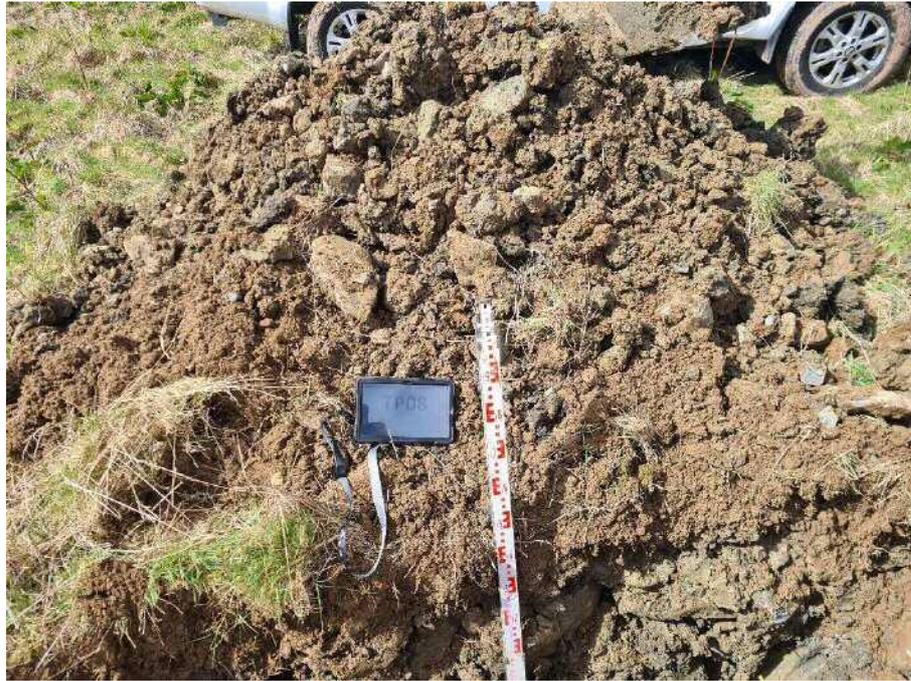
**Figure 22: Trial Pit 8**

- 5.9.1 Trial pit 8 was excavated in the centre of the site to a depth of 1.4m. The trial pit consisted of 0.15m of light brown clay loam topsoil, 0.40m of clay sub-soil with angular / sub-angular sandstone cobbles, 0.60m of light brown clay sub-soil with frequent angular / sub-angular sandstone cobbles, with occasional brick / tile fragments. This was underlain by 0.25m of dark black clay sub-soil. Trial pit terminated at 1.4m. Several pieces of wire were identified within the sub-soil. It is likely that this trial pit contains made ground, from fill placed at the site.

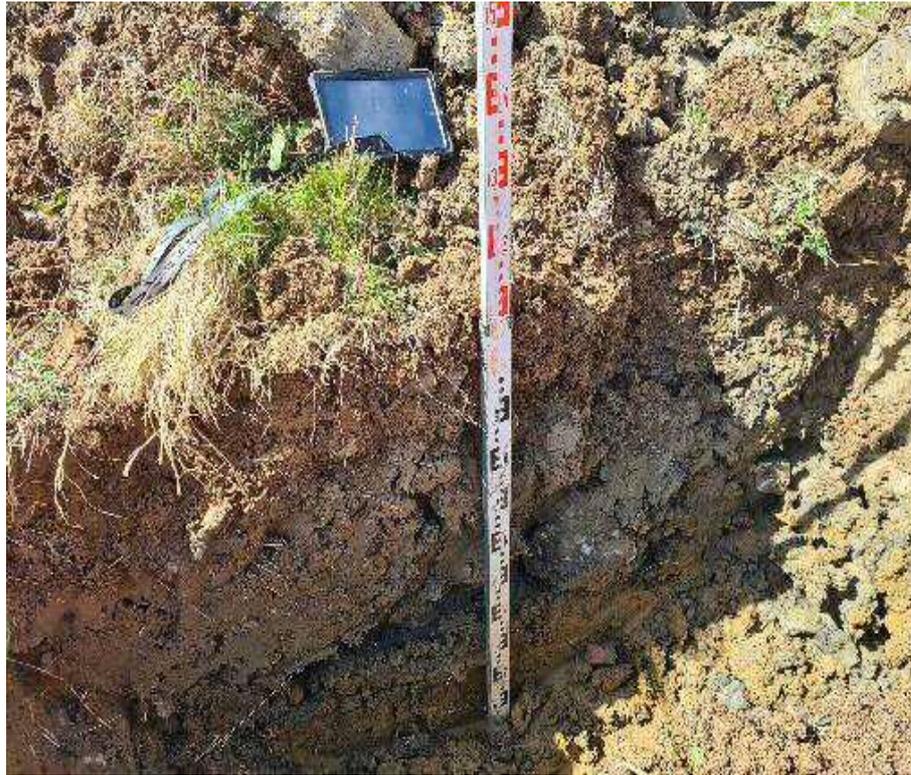
Figure 25: Trial Pit 9

- 5.10.1 Trial pit 9 was excavated close to the eastern boundary of the plot. It was excavated to a depth of 1.00m. Soils within the trial pit were comprised of 0.20m of clay topsoil with frequent rootlets and occasional stone (sandstone), 0.55m of mid brown clay sub-soil with frequent angular / sub-angular sandstone and very occasional brick / tile fragments. Several sub-rounded sandstone boulders. This material appears to be made ground fill. This was underlain by clay sub-soil, which appears to be natural ground. Trial pit terminated at 1m, no groundwater encountered.
- 5.10.2 The 0.55m thick layer of clay sub-soil with sandstone cobbles and boulders appears to be placed material, although has probably been sourced locally to the site as was of same composition as indigenous materials.

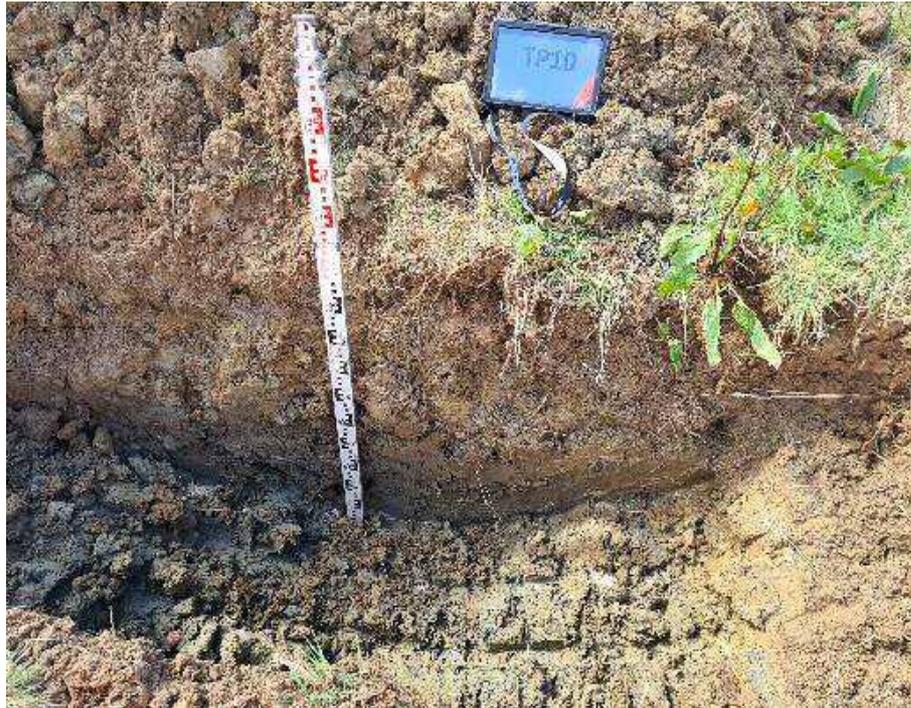
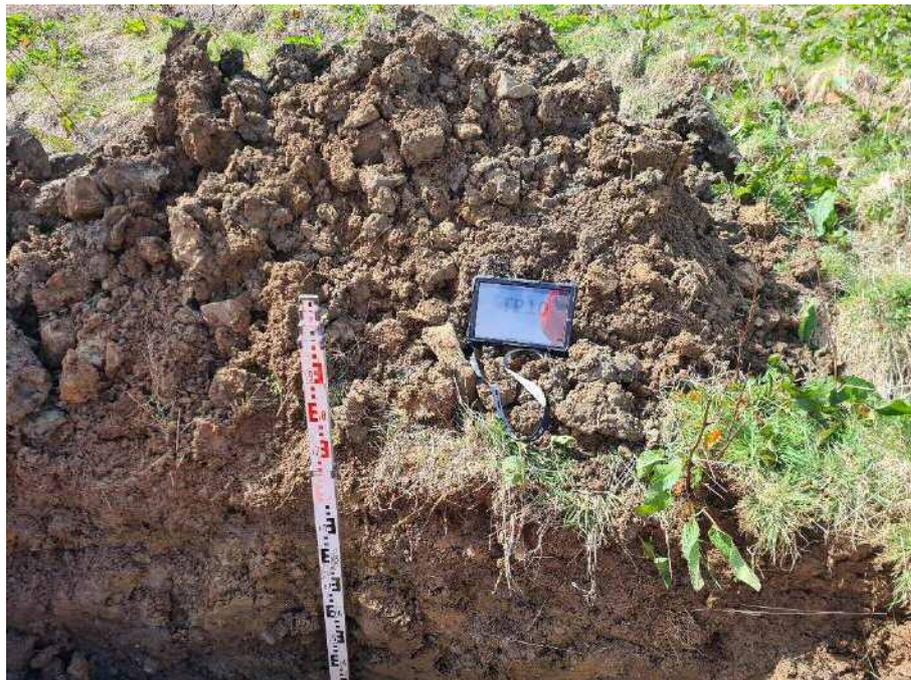
**Figure 26: Trial Pit 10**

5.11.1 Trial pit 10 was excavated on the eastern boundary of the site, in the area, which it is assumed will be the deepest section of placed material (made ground). The trial pit consisted of the following soils, 0.20m of Clay loam topsoil with frequent rootlets and occasional sandstone, 0.40 of Sandy loam sub-soil with angular / sub-angular sandstone cobbles. No anthropogenic material notes, 0.40 of Mid brown clay sub-soil with angular / sub-angular sandstone cobbles and very occasional brick / tile fragments.

5.11.2 Soils appeared to be indigenous, with only indication that this may be made ground, being occasional brick / tile fragments. No ground water was encountered and the sample was taken at a depth of 0.7m

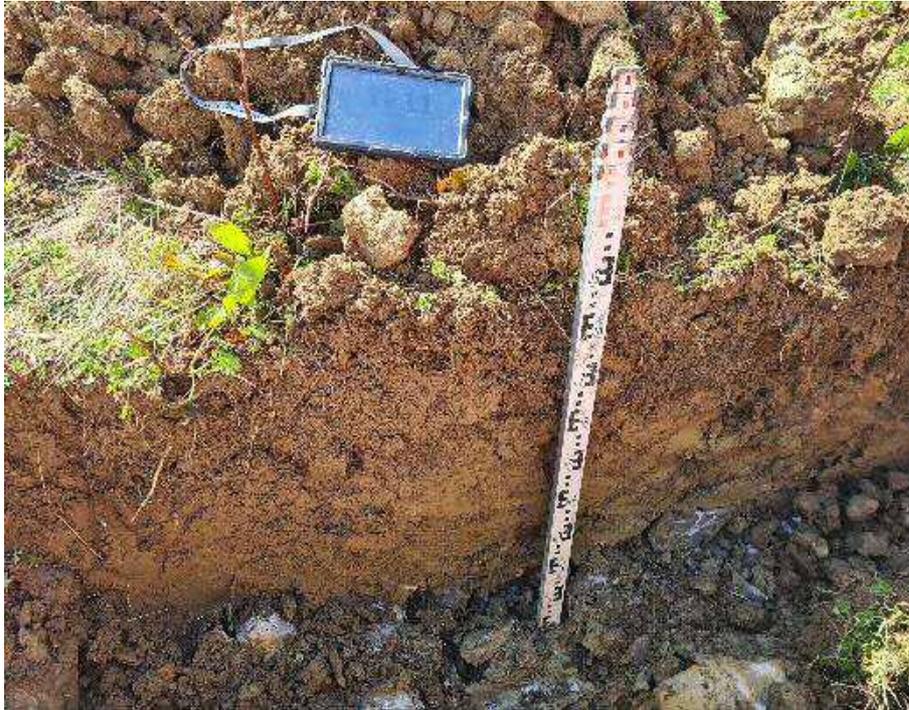
Figure 28: Trial pit 11

- 5.12.1 Trial pit 11 was excavated in the centre of the plot to a depth of 0.8m. The soils within the trial pit consisted of 0.15m Clay loam topsoil, with frequent rootlets and stones, 0.55m of the trial pit consisted of uninterrupted natural looking clay sub-soil, 0.1m of clay with size range of angular / sub-angular sandstone. No anthropogenic materials encountered.

5.12.2 There was no water found in the trial hole and the soil sample was taken at a depth of 0.6m. Except for one brick / tile / tile fragment found, soils appeared to be indigenous.

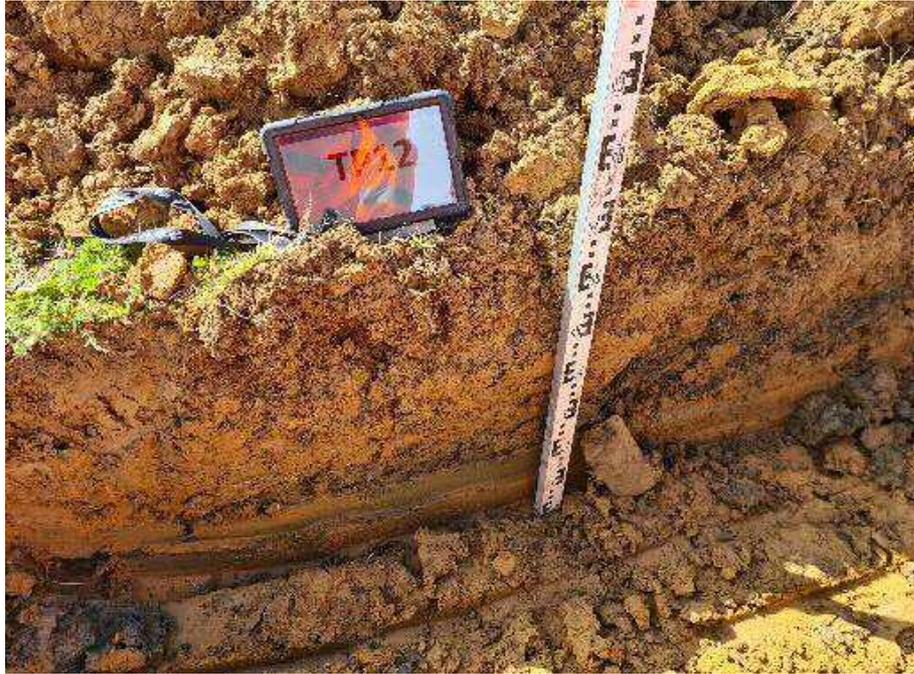
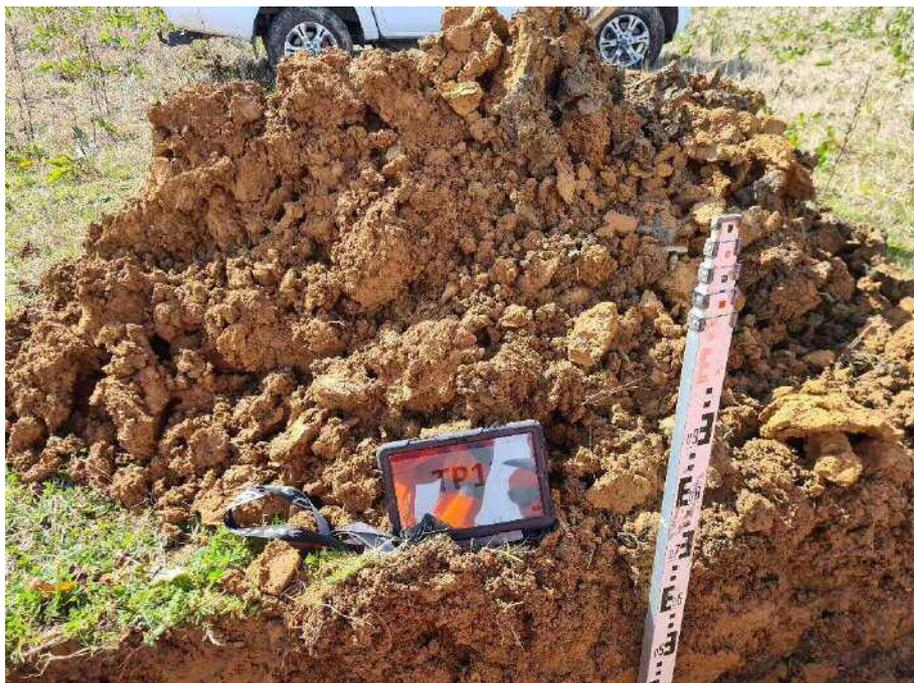
Figure 29: Trial pit 12

5.13.1 Trial Pit 12 was excavated approximately 30m from the western boundary. The intention being to try and identify the extent of placed fill within the plot. The trial pit was terminated at 0.65m. Soils in the trial pit comprised the following, 0.10m of light brown clay loam topsoil, with frequent rootlets, 0.55m of Light brown clay sub-soil with angular / sub-angular sandstone cobbles. Thin bands of a black coloured clay material were encountered. No odours were noted.

5.13.2 Soils appear to be naturally occurring and indigenous to the site. No ground water was encountered. A soil sample was taken at a depth of 0.4m where there was a band of black material running through the clay.

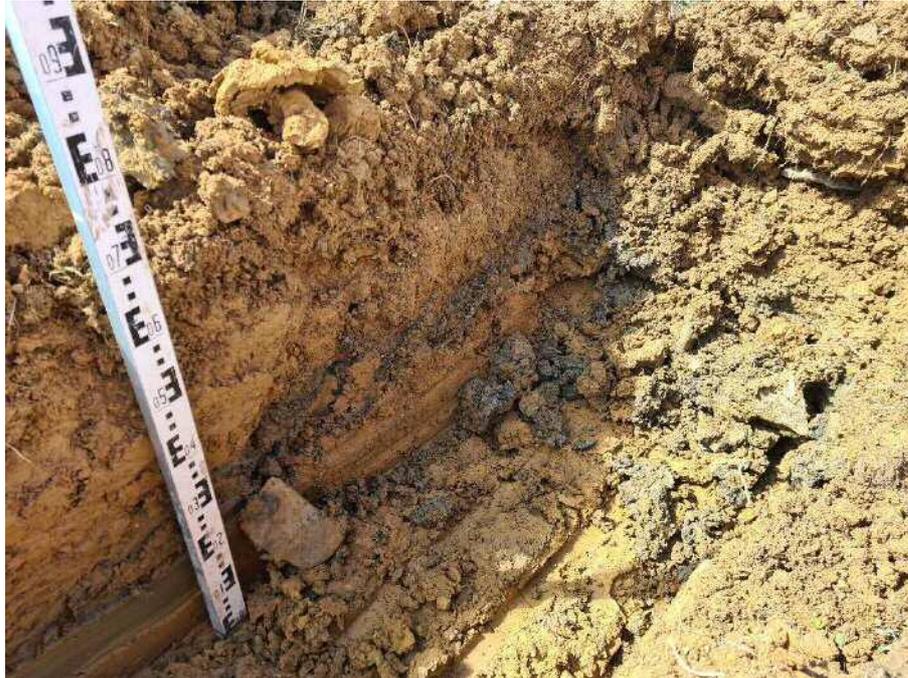
Figure 31: Trial pit 12, illustrating dark band of material.

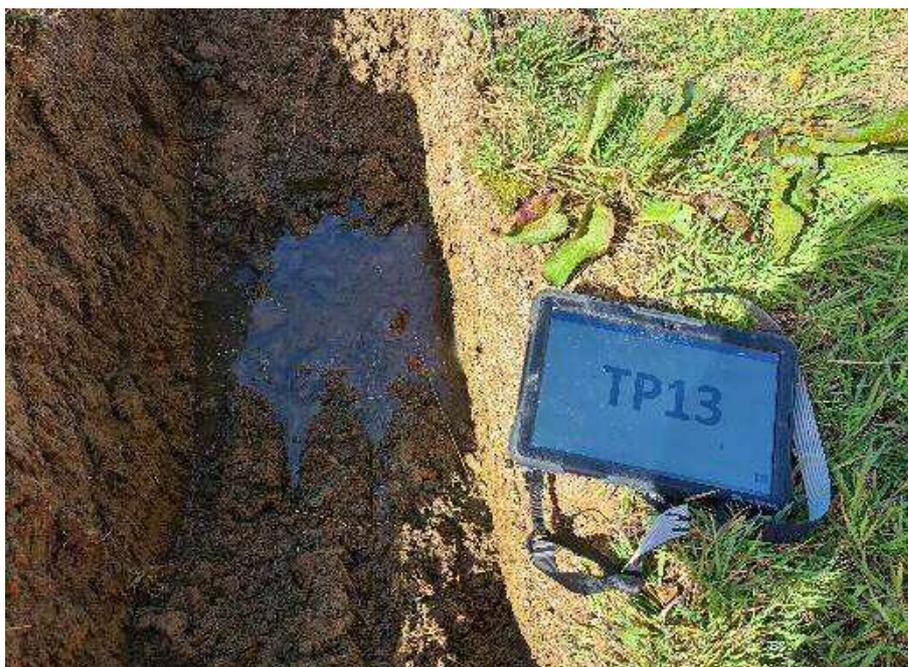
Figure 32: Trial pit 13

5.14.1 Trial pit 13 was excavated on the western side of the site, south of the gas main, to a depth of 0.85m. Soils within the trial pit consisted of 0.20m of Sandy loam crumbly topsoil, with frequent rootlets, 0.65m of Light brown clay soil with small areas of black clay soil. Groundwater encountered at 0.8m bgl. Slow seepage rising to 0.8m bgl after 30 minutes. A soil sample was taken at 0.60m bgl.

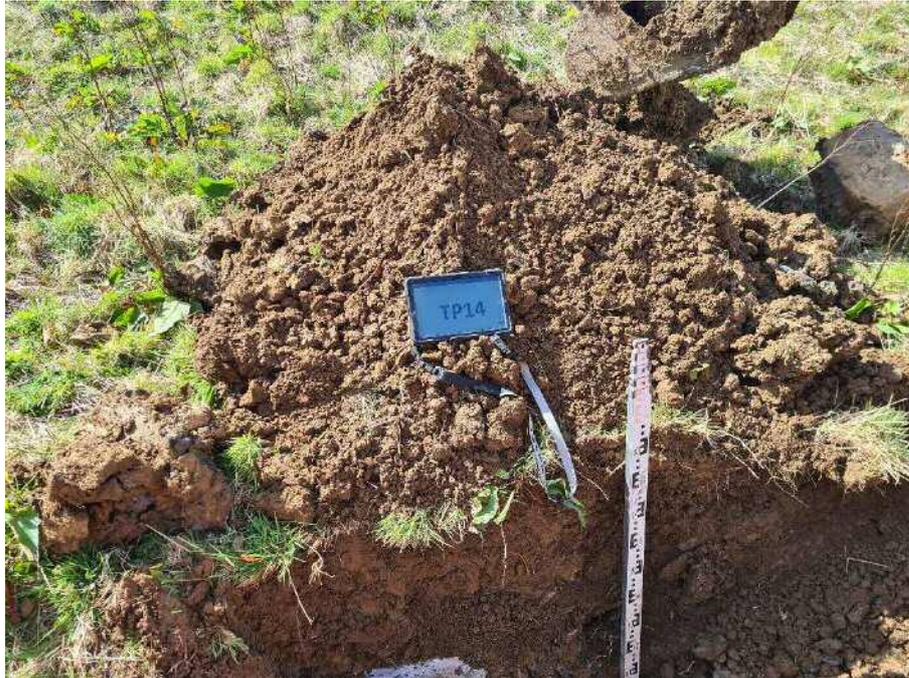
Figure 33: *Trial pit 14*

5.15.1 Trial pit 14 was excavated near the eastern boundary, south of the gas main, to a depth of 0.90m. Soils in the trial pit consisted of 0.15m of sandy, clay, loam topsoil with frequent rootlets, 0.75m of Sandy clay sub-soil with angular / sub-angular sandstone cobbles and boulders. Materials appear to be indigenous except for one small piece of plastic encountered at approximately 0.40m.

5.15.2 No groundwater was encountered and a soil sample was taken at a depth of 0.60m.

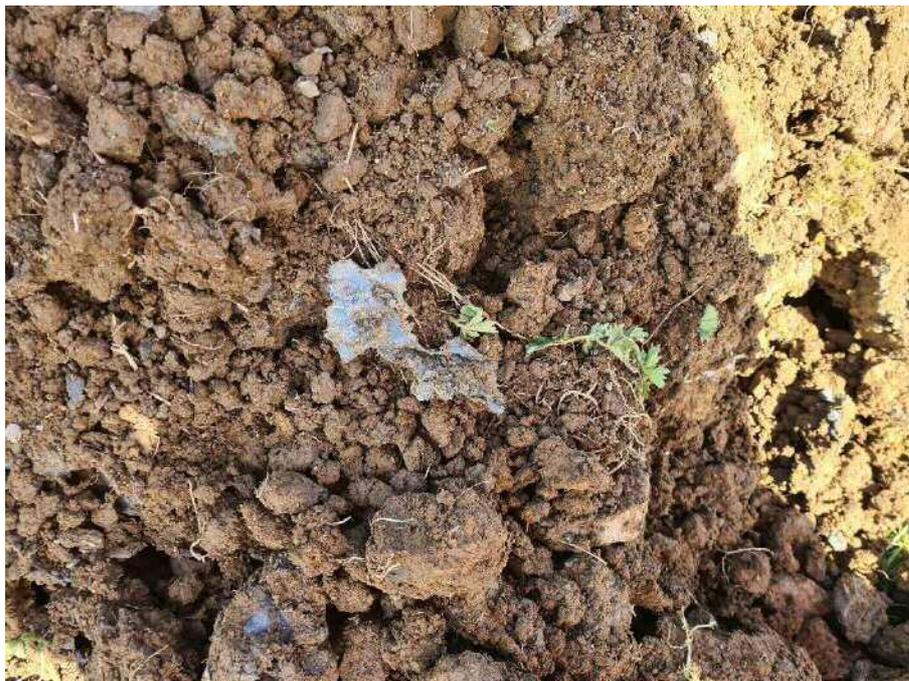
Figure 35: Trial pit 14 – plastic fragment.

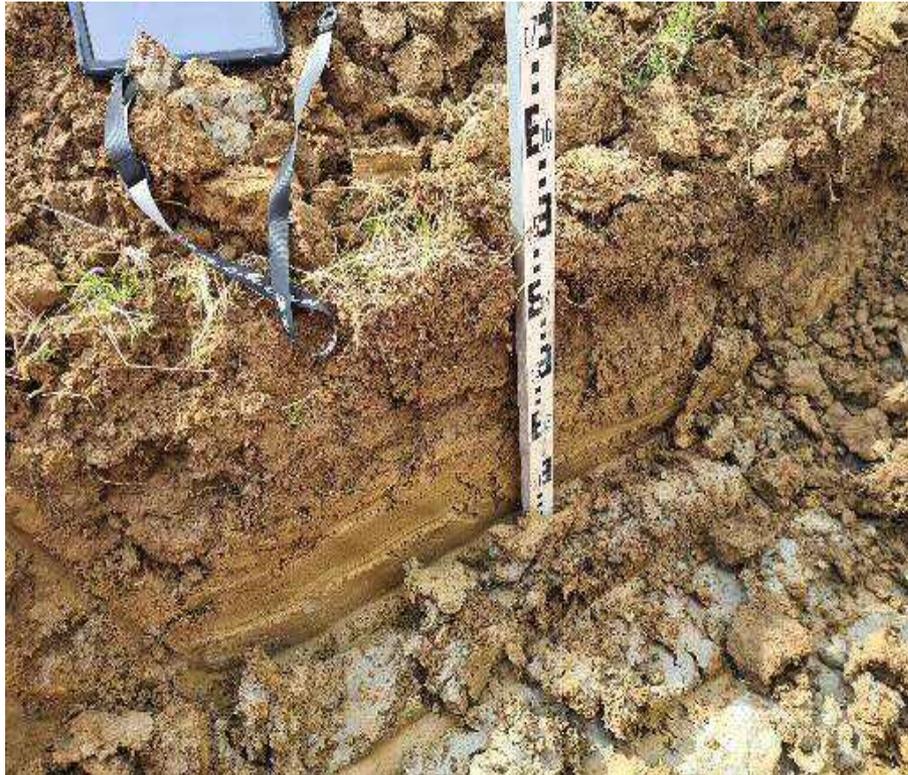
Figure 36: Trial pit 15

- 5.16.1 Trial Pit 15 was excavated on the northern side of the gas main. From anecdotal information, it was unlikely that fill was placed within this area. The trial pit was terminated at 0.50mbgl.

5.16.2 dug on the other side of a gas main to the entrance of the field. The total depth of the trial hole was 0.50m. The top 0.25m of the trial hole was undisturbed light brown top soil. The bottom 0.25m of the trial hole was brown grey clay soil. The area looks natural which is likely due to the trial holes proximity to the gas main. No water was found and the soil sample was taken at a depth of 0.40m.

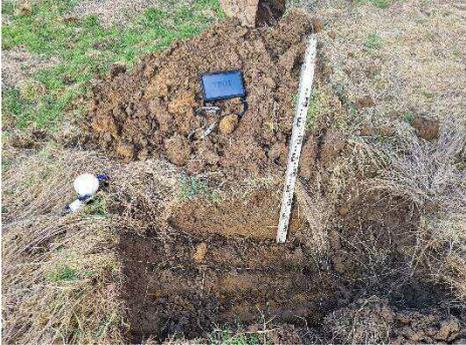
Contract: <b>Cardiff – 5 Mile Lane Investigation of Reinstated Agricultural Land</b>				Client: <b>Griffiths Construction</b>		Trial pit: <b>TP 1</b>	
Contract Ref: <b>J000878</b>		Date: <b>07/04/2022</b>		Ground Level (m):		National Grid Co-ordinate: <b>ST 07829 71612</b>

Sheet: <b>1 of 1</b>							
Samples and In-situ Tests				Water	Backfill	Description of Strata	Depth (Thickness) (m)
Depth (m)	No	Type	Results				
Total depth of the trial pit 0.46m  Soil samples taken at 0.4	1	Soil	Refer to lab results	No	Yes	Clean brown topsoil	0.30
						Light coloured sandy loam soil with occasional angular / sub-angular sandstone cobbles.	0.16
<b>Plan (Not to scale)</b>				<b>General Remarks</b>

This trial pit is at the bottom of the field, close to the boundary so there is unlikely to be fill materials here. Materials encountered are likely to be indigenous soils.			
				All dimensions in metres <b>0.8 by 1.2</b>			
Method Used: <b>Machine Dug</b>		Plant Used: <b>Excavator</b>		Logged By: <b>Callum Hole</b>		Checked by:

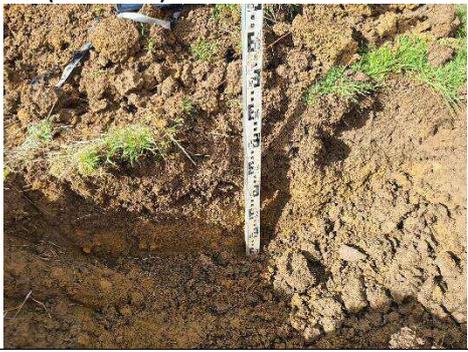
Contract: <b>Cardiff – 5 Mile Lane Investigation of Reinstated Agricultural Land</b>				Client: <b>Griffiths Construction</b>		Trial pit: <b>TP 2</b>	
Contract Ref: <b>J000878</b>		Date: <b>07/04/2022</b>		Ground Level (m):		National Grid Co-ordinate: <b>ST 07863 71644</b>

Sheet: <b>1 of 1</b>							
Samples and In-situ Tests				Water	Backfill	Description of Strata	Depth (Thickness) (m)
Depth (m)	No	Type	Results				
Trial Pit terminated: 0.52m  Soil samples taken at a depth of: 0.45m	1	Soil	Refer to lab results	No	Yes	Light brown clay topsoil, with frequent rootlets and occasional stone.	0.18
						Light brown coloured sandy loam sub-soil, with angular / sub-angular sandstone cobbles.	0.34
<b>Plan (Not to scale)</b>				<b>General Remarks</b>

This trial pit is on the fringe of the sight so is expected to contain no fill material. Soils encountered appear to be indigenous.			
				All dimensions in metres: <b>0.85 by 1.65</b>			
Method Used: <b>Machine Dug</b>				Plant Used: <b>Excavator</b>		Logged By: <b>Callum Hole</b>	
				Checked by: <b>J Gregory</b>

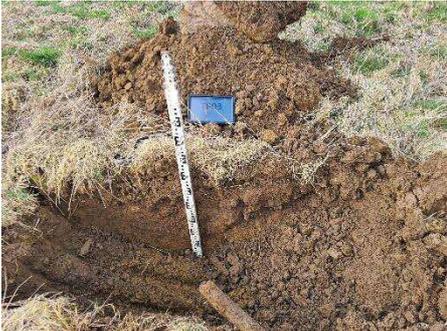
This trial pit was near the southern boundary of the plot. This area is unlikely to have received fill materials and hence soils noted are likely indigenous.

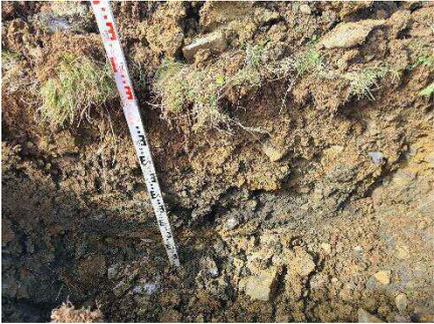
Contract: <b>Cardiff – 5 Mile Lane Investigation of Reinstated Agricultural Land</b>				Client: <b>Griffiths Construction</b>		Trial pit: <b>TP 4</b>	
Contract Ref: <b>J000878</b>		Date: <b>07/04/2022</b>		Ground Level (m):		National Grid Co-ordinate: <b>ST 07871 71728</b>

Sheet: <b>1 of 1</b>							
Samples and In-situ Tests				Water	Backfill	Description of Strata	Depth (Thickness) (m)
Depth (m)	No	Type	Results				
Trial pit terminated at 1.20m  The depth at which the soil samples were taken was 1.15	1	Soil	Refer to lab results	no	yes	Light brown clay loam topsoil, frequent rootlets.	0.3
						Light brown coloured sandy loam with infrequent small sections of sandstone rock.	0.3
						Dark brown clay loam subsoil with approx. 30% angular / sub-angular sandstone cobbles.	0.4
						Clay with high proportion of broken angular sandstone.	0.2
<b>Plan (Not to scale)</b>

<b>General Remarks</b> It is unknown whether the layer of broken sand stone at the base of the trial pit is natural or remains of the old compound.			
All dimensions in metres: <b>0.85 by 2.80</b>				Scale:			
Method Used: <b>Machine Dug</b>		Plant Used: <b>Excavator</b>		Logged By: <b>Callum Hole</b>		Checked by: <b>J Gregory</b>

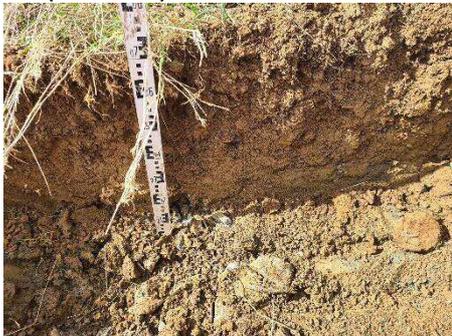
Contract: <b>Cardiff – 5 Mile Lane Investigation of Reinstated Agricultural Land</b>				Client: <b>Griffiths Construction</b>		Trial pit: <b>TP 5</b>	
Contract Ref: <b>J000878</b>		Date: <b>07/04/2022</b>		Ground Level (m):		National Grid Co-ordinate: <b>ST 07831 71704</b>

Sheet: <b>1 of 1</b>							
Samples and In-situ Tests				Water	Backfill	Description of Strata	Depth (Thickness) (m)
Depth (m)	No	Type	Results				
Trial pit terminated at 0.70m  The depth at which the samples were taken was 0.50m	1	Soil	Refer to lab results	no	yes	Light brown clay topsoil with frequent rootlets and occasional sandstone fragments.	0.40
						Light brown clay soil with sandstone fragments.	0.30
<b>Plan (Not to scale)</b>

<b>General Remarks</b> The soil was good looking with no abnormalities of sight or smell.			
All dimensions in metres: <b>0.65 by 2.60</b>				Scale:			
Method Used: <b>Machine Dug</b>		Plant Used: <b>Excavator</b>		Logged By: <b>Callum Hole</b>		Checked by: <b>J Gregory</b>

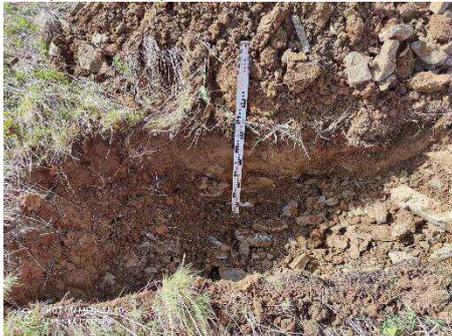
The rocks and stones in the bottom layer of the soil are not likely to be fill as they are rounded instead of crushed.

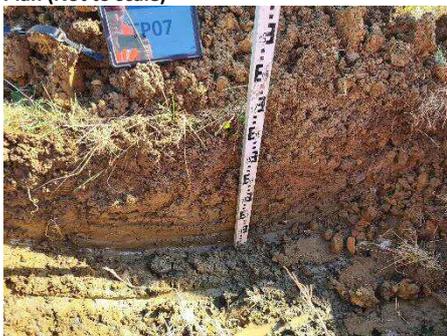
<b>Plan (Not to scale)</b>

Samples and In-situ Tests				Water	Backfill	Description of Strata	Depth (Thickness) (m)
Depth (m)	No	Type	Results				
Trial pit terminated at 0.65m  The depth at which the samples were taken was 0.40m	1	Soil	Refer to lab results	Yes	Yes	Light brown topsoil with frequent rootlets and occasional sandstone fragments.	0.20
						Light brown clay loam sub-soil, with occasional stone.	0.45
						No groundwater encountered.

<b>General Remarks</b>	
	Trial pit terminated at 0.65m as believed to be indigenous soils. No groundwater encountered.	
All dimensions in metres: <b>0.9 by 2.4</b>		Scale:

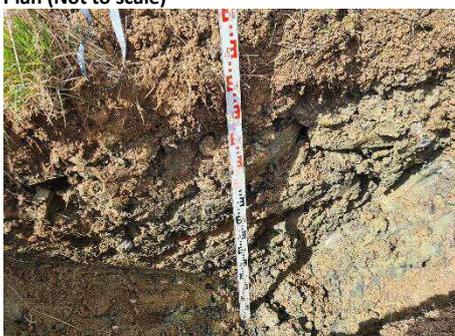
<b>Plan (Not to scale)</b>	<b>General Remarks</b>

Samples and In-situ Tests				Water	Backfill	Description of Strata	Depth (Thickness) (m)
Depth (m)	No	Type	Results				
Trial pit terminated at 1.4m  The depth at which the samples were taken was 0.9m	1	Soil	Refer to lab results	No	Yes	Light brown clay loam topsoil	0.15
						Clay sub-soil with angular / sub-angular sandstone cobbles	0.40
						Clay soil with angular / sub-angular sandstone cobbles and very occasional brick fragments.	0.60
						A layer of dark black clay soil	0.25

<p>There was a high density of angular / sub-angular sandstone with very occasional anthropogenic materials including several fragments of wire and brick. No odours or other evidence of contamination was identified.</p>
	<p>All dimensions in metres: <b>0.7 by 3.00</b></p> <p>Scale:</p>

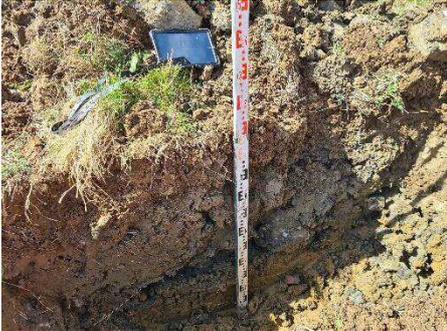
The 0.55m thick layer of clay sub-soil with sandstone cobbles and boulders appears to be placed material, although has probably been sourced locally to the site as was of same composition as indigenous materials.

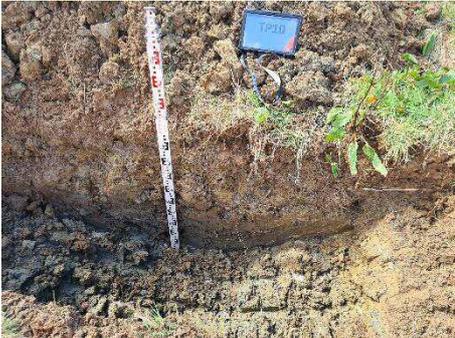
Soils appeared to be indigenous, with only indication that this may be made ground, being occasional brick fragments.

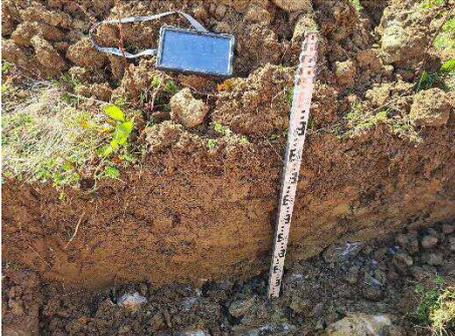
Apart from one fragment of brick found within the clay soil, no anthropogenic materials were encountered. It was not possible to determine whether soils were indigenous or made ground.

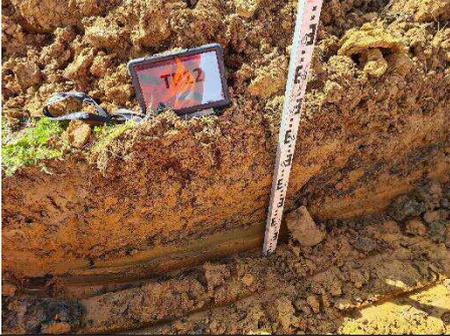
Contract: <b>Cardiff – 5 Mile Lane Investigation of Reinstated Agricultural Land</b>				Client: <b>Alun Griffiths Construction</b>		Trial pit: <b>TP 12</b>	
Contract Ref: <b>J000878</b>		Date: <b>07/04/2022</b>		Ground Level (m):		National Grid Co-ordinate: <b>ST 07716 71814</b>

Sheet: <b>1 of 1</b>							
Samples and In-situ Tests				Wate	Backfi	Description of Strata	Depth (Thickness) (m)
Depth (m)	No	Type	Results				
Trial pit terminated at 0.65m	1	Soil	Refer to lab results	No	Yes	Light brown clay loam topsoil, with frequent rootlets.	0.10
Sample taken at 0.40m (where there is a black streak in the clay soil)						Light brown clay sub-soil with angular / sub-angular sandstone cobbles. Thin bands of a black coloured clay material were encountered. No odours were noted.	0.55
<b>Plan (Not to scale)</b>				<b>General Remarks</b>

Looks entirely natural.			
				All dimensions in metres: <b>0.8 by 2.4</b>			Scale:
Method Used: <b>Machine Dug</b>		Plant Used: <b>Excavator</b>		Logged By: <b>Callum Hole</b>		Checked by: <b>J Gregory</b>

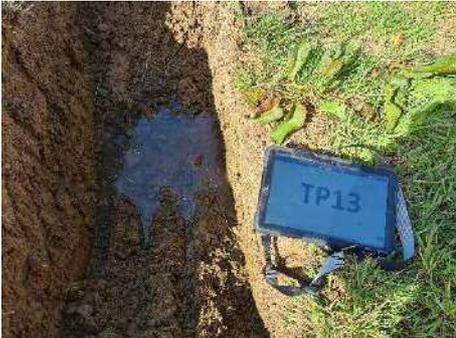
There was a small amount ground water seepage rising to 5cm deep, seeping through the base of the trial pit. No anthropogenic materials encountered.
