**Five Mile Lane – Former Griffiths  
Compound / Materials Storage Area  
(Land south of Amelia Trust Farm)**

**Investigation into Depth and  
Quality of Placed Fill.**

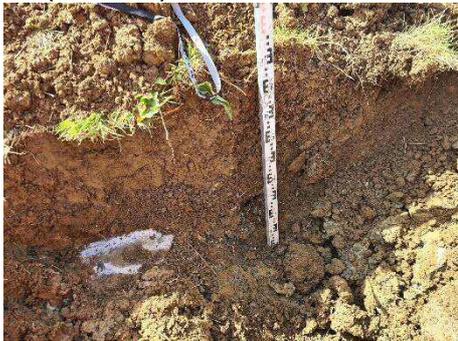
<b>Plan (Not to scale)</b>

Samples and In-situ Tests				Wate	Backfi	Description of Strata	Depth (Thickness) (m)
Depth (m)	No	Type	Results				
Trial pit terminated at 0.90m  Sample taken at 0.60	1	Soil	Refer to lab results	No	Yes	Sandy, clay, loam topsoil with frequent rootlets.	0.15
						Sandy clay sub-soil with angular / sub-angular sandstone cobbles and boulders	0.75

<b>General Remarks</b>	
	Materials appear to be indigenous except for one small piece of plastic encountered at approximately 0.40m.
