**Land at Upper  
Cosmeston Farm,  
Lavernock Road,  
Penarth**

**Archaeological  
and Heritage  
Assessment**

Prepared by:  
**The Environmental  
Dimension  
Partnership Ltd**

August 2020  
Report Reference:  
**edp5187\_r003e**

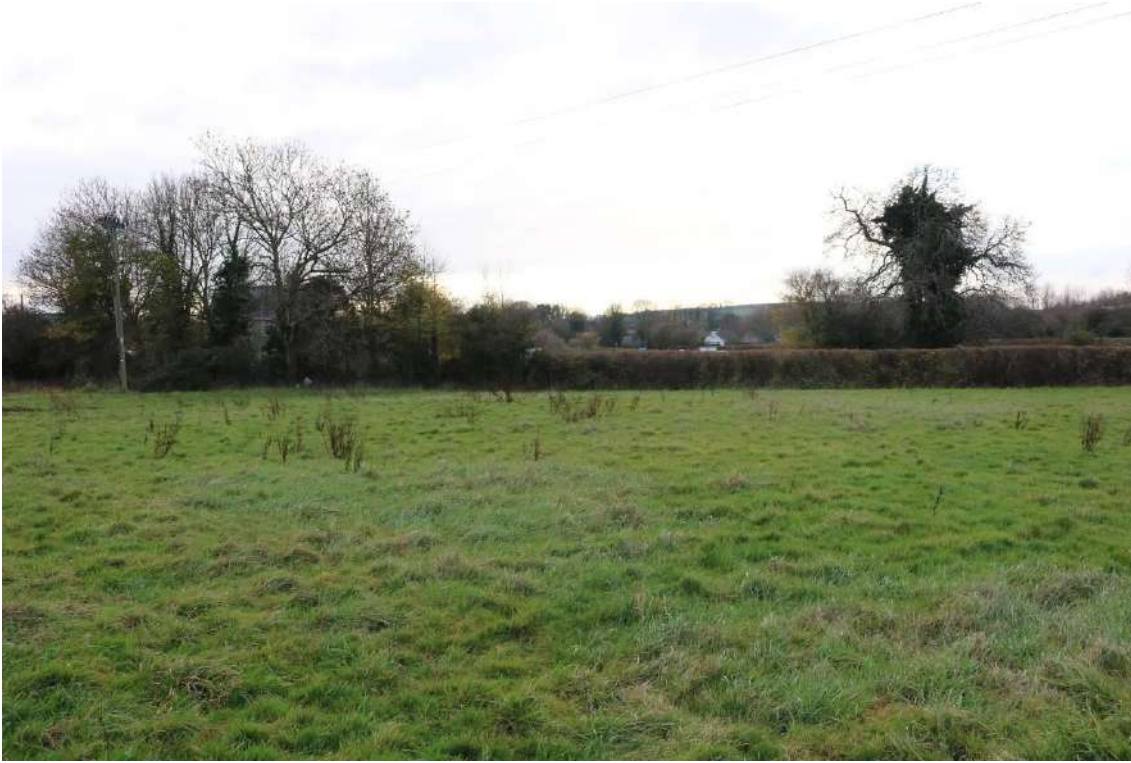
**Image EDP 1:** View from the western edge of the site towards the Cosmeston medieval village and county treasure cottage. Glimpses of the roofs of the buildings can be seen in the distance.

- 4.26 Glimpsed views of this locally noted cottage are still possible from the western edge of the site (**Image EDP 1**) although, as noted above, the site has no historic connection to the cottage, and this experience is of the cottage within the entirely modern setting of

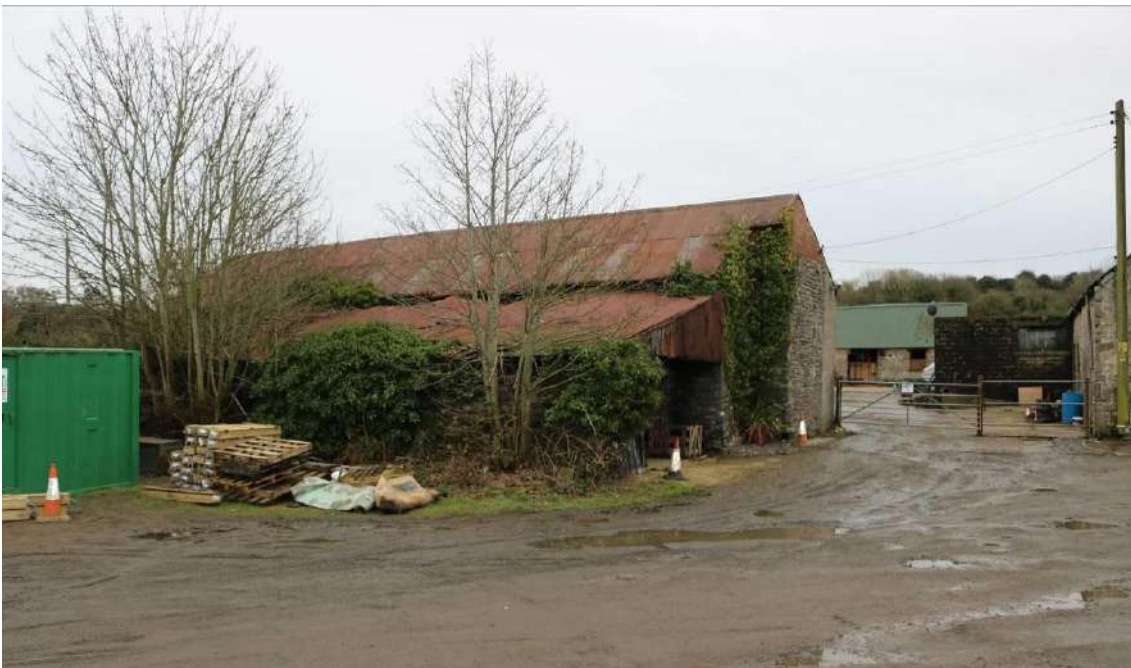
**Image EDP 2:** View of Structure A looking south-east from the old course of Lavernock Road and showing the projecting chimney stack at the western end.

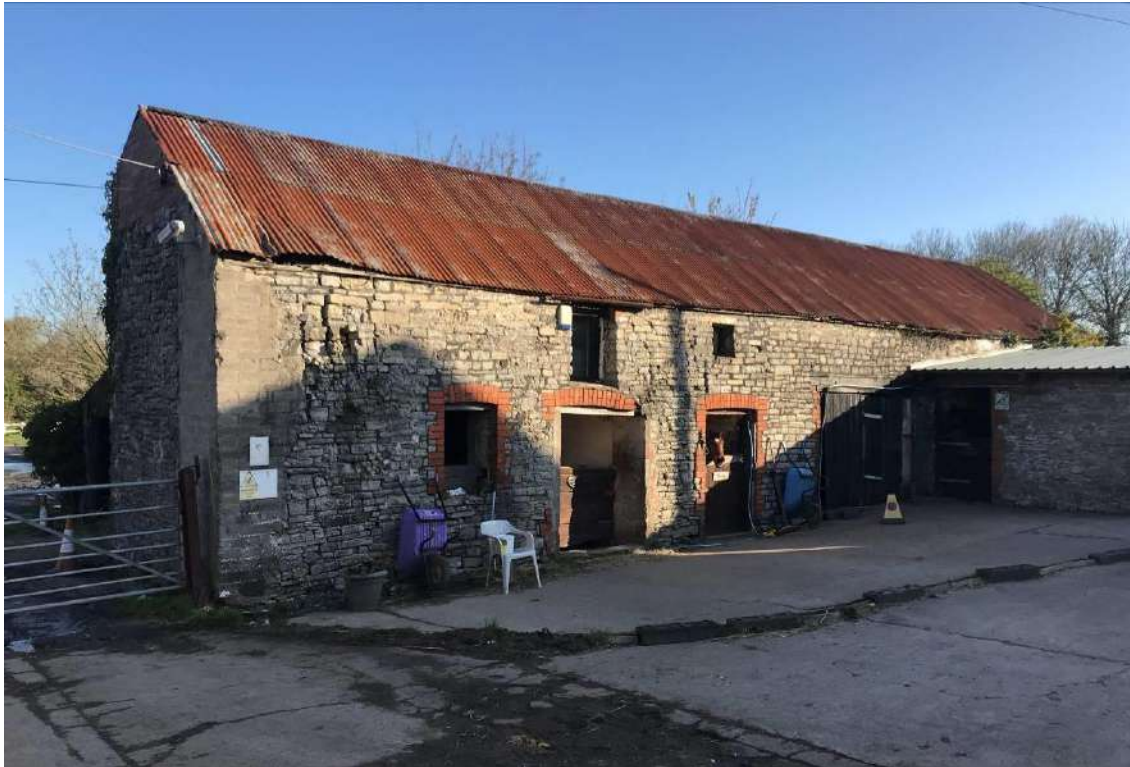
**Image EDP 3:** View of Structure A looking north-east from within the farmyard and illustrating the extent of adaptation associated with the house's conversion to a stable block.

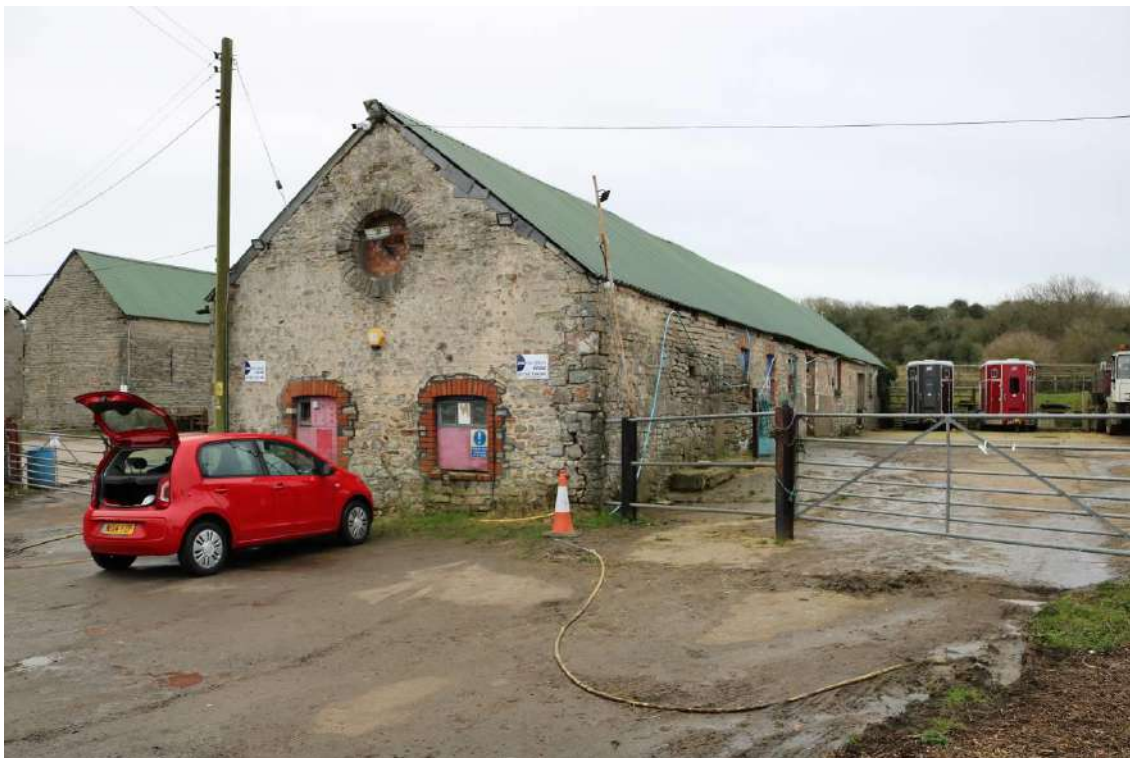
**Image EDP 4:** View of Structure C looking south from the old course of Lavernock Road and showing the similarity in the form of the window openings with Structure A further east.

- 4.104 This 18<sup>th</sup> or early 19<sup>th</sup> century building exhibits a comparable amount of modification and alteration to the other ranges within the farmyard, diminishing its historic character in the process. The changes include the replacement of the roof covering throughout with pale green corrugated aluminium sheets, damage to a number of the doors and windows and some insertion of new openings in the later 19<sup>th</sup> century identified through the use of red brick for the relieving arches (see **Image EDP 4**).

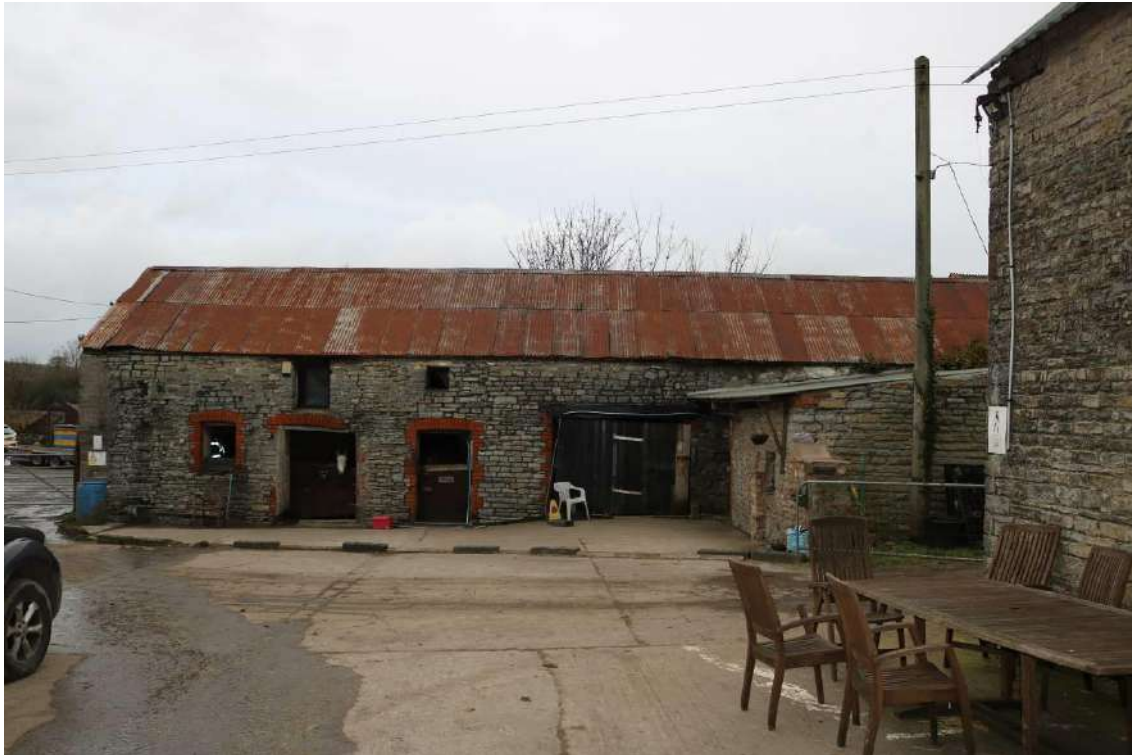
**Image EDP 5:** View of the south-facing elevation of Structure A from within the farmyard and here showing the stratigraphic relationship between the two early phases. The earliest element of the building can be discerned where the double doors are visible.

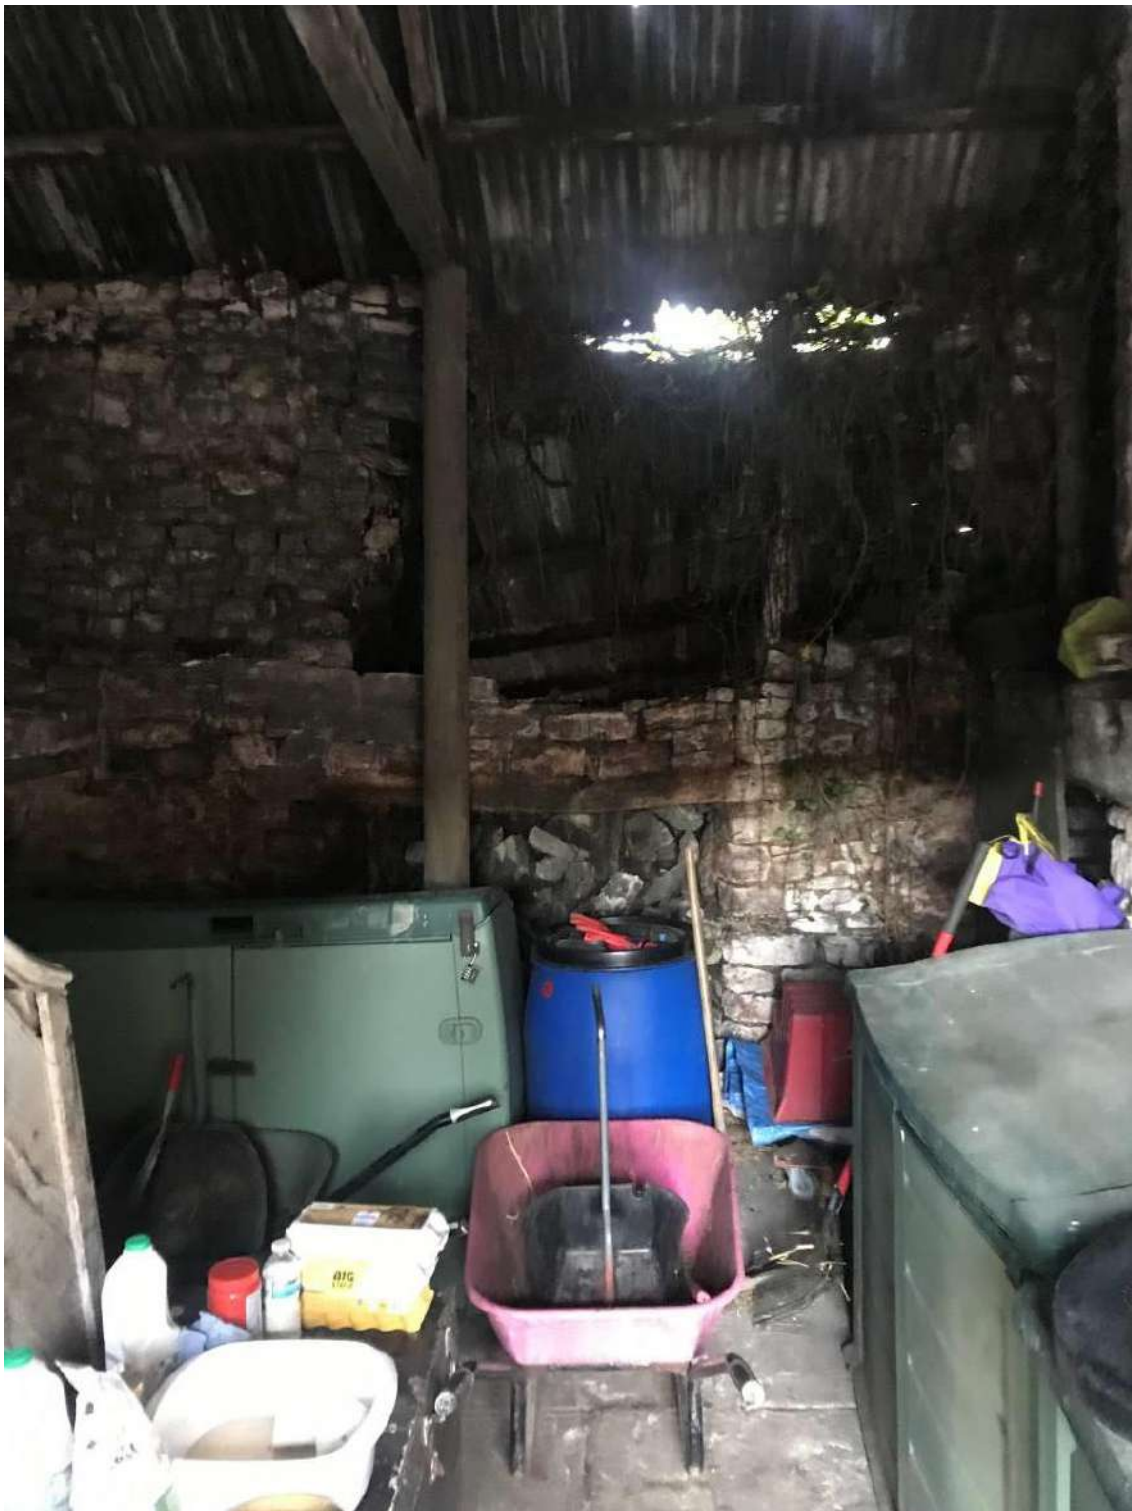
**Image EDP 6:** View of the north-facing elevation of Structure A, here highlighting the condition of the stonework within the earliest phase of the house.

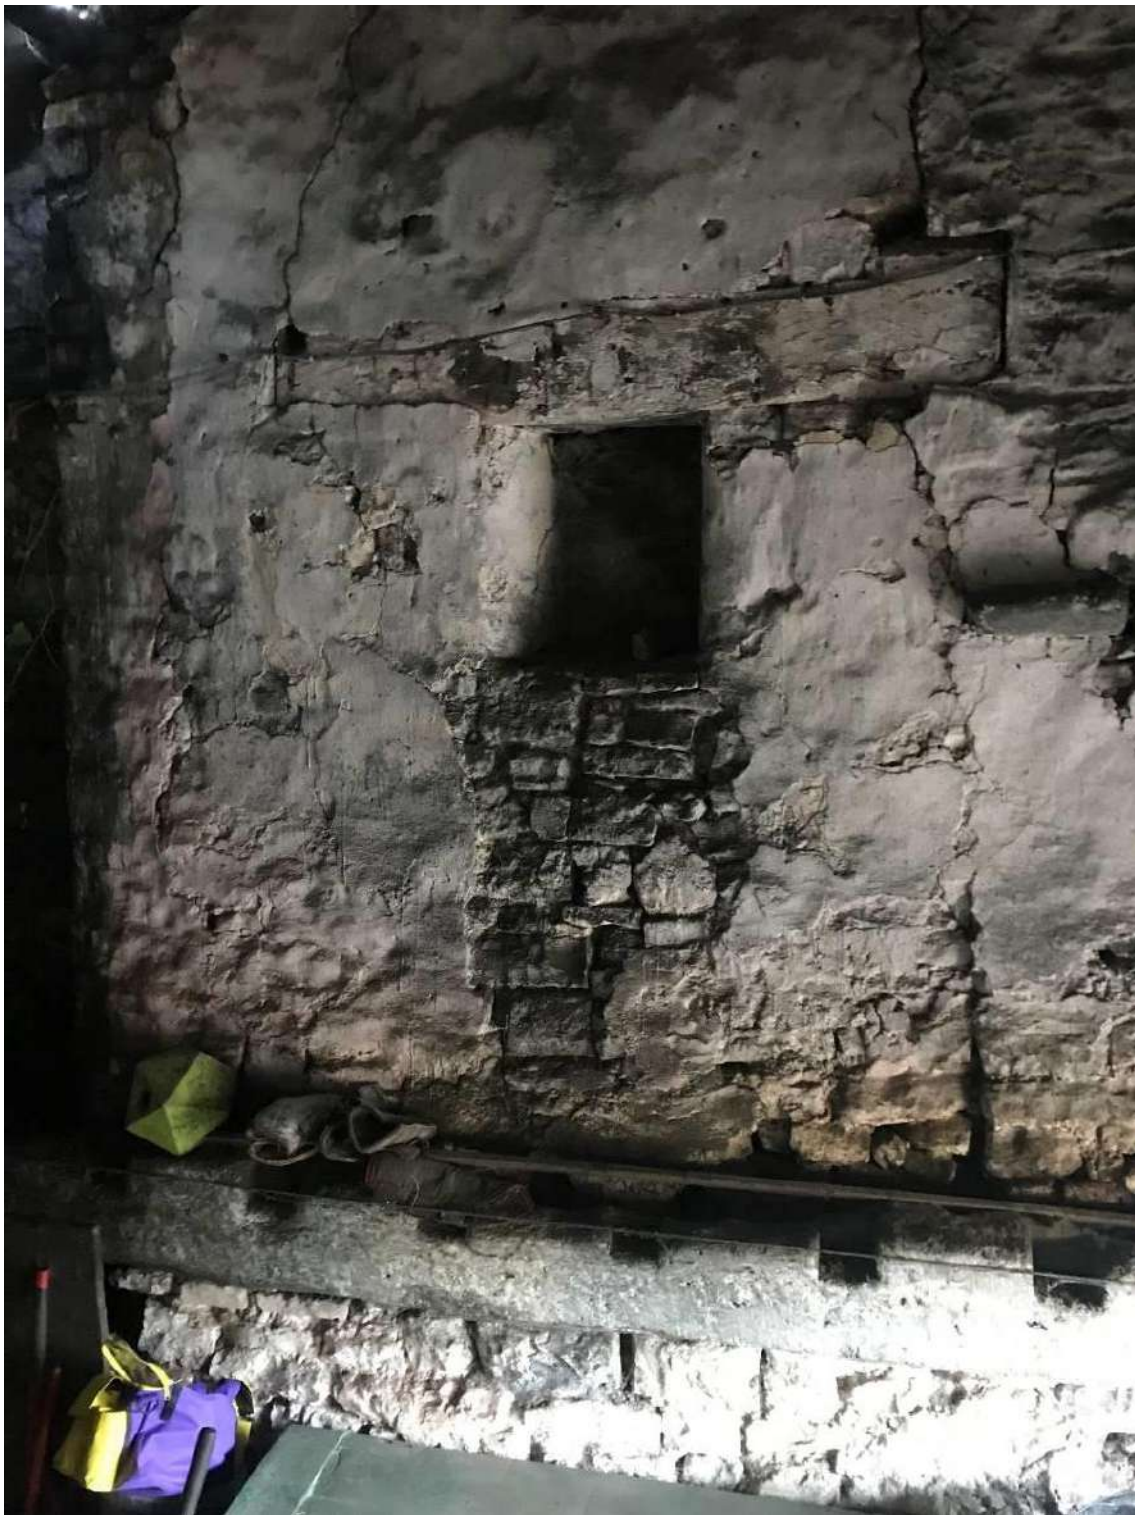
**Image EDP 7:** View of the east-facing gable of the earliest phase of Structure A, here illustrating the infilled window opening and the timber beam.

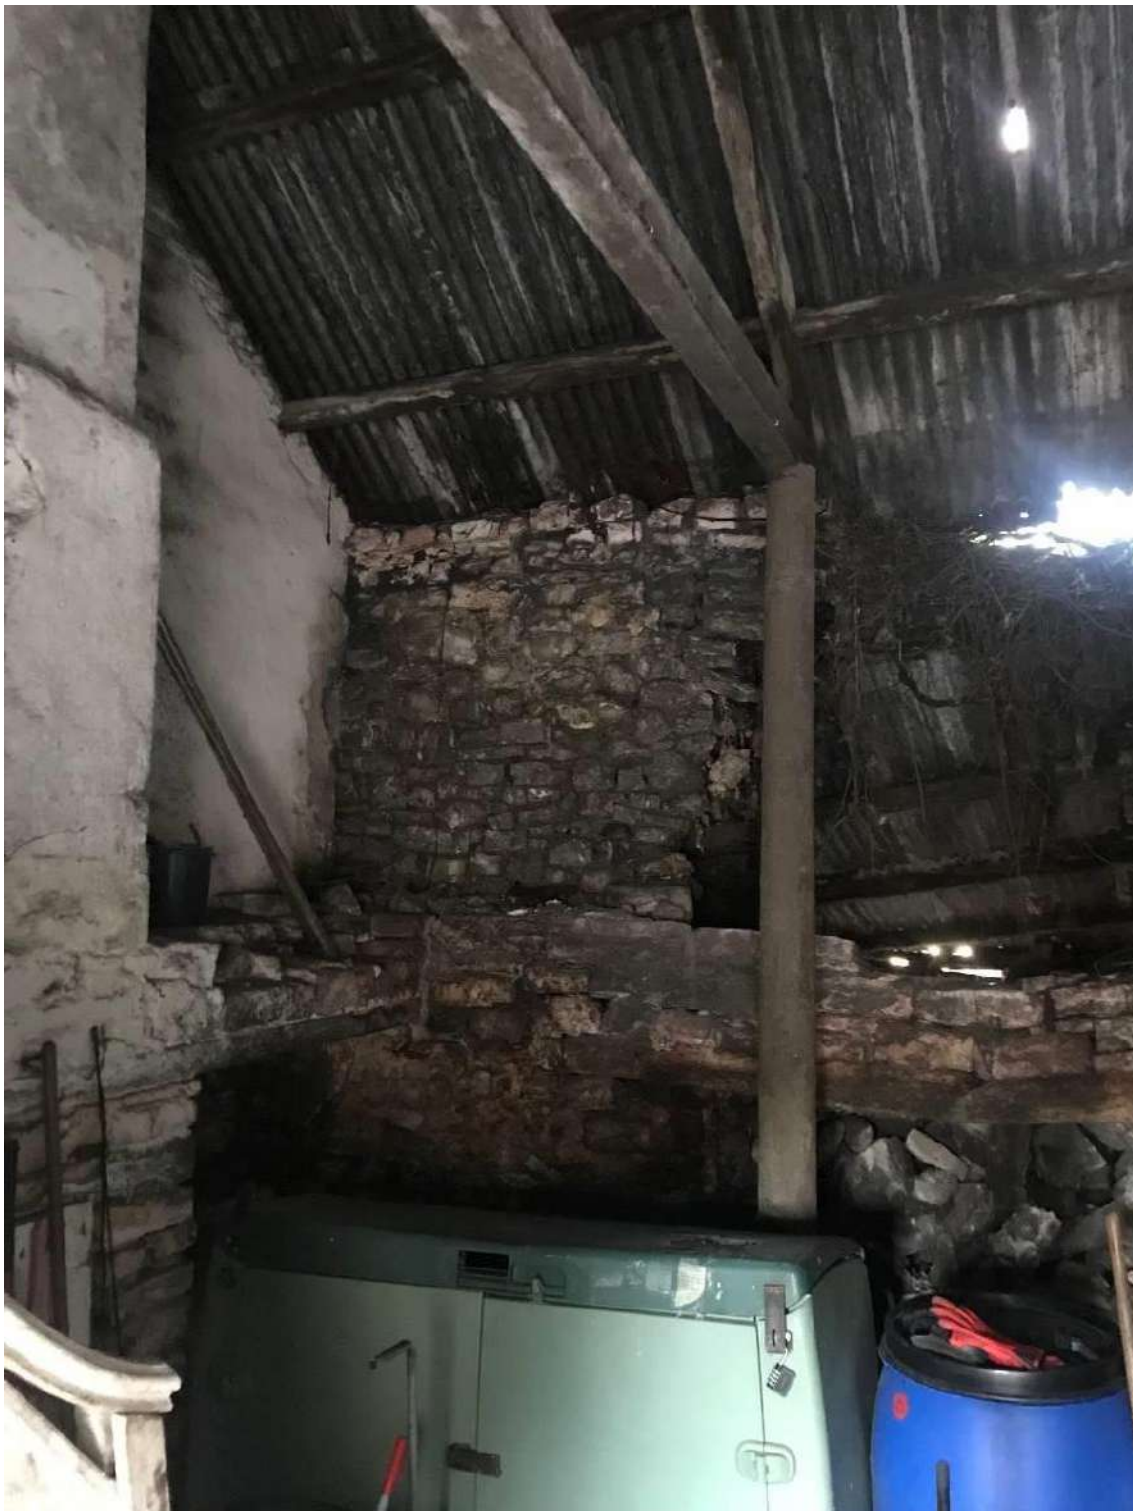
**Image EDP 8:** View of the internal space within the earliest element of Structure A, here looking north-west to the door opening on the opposite side of the chimney stack.

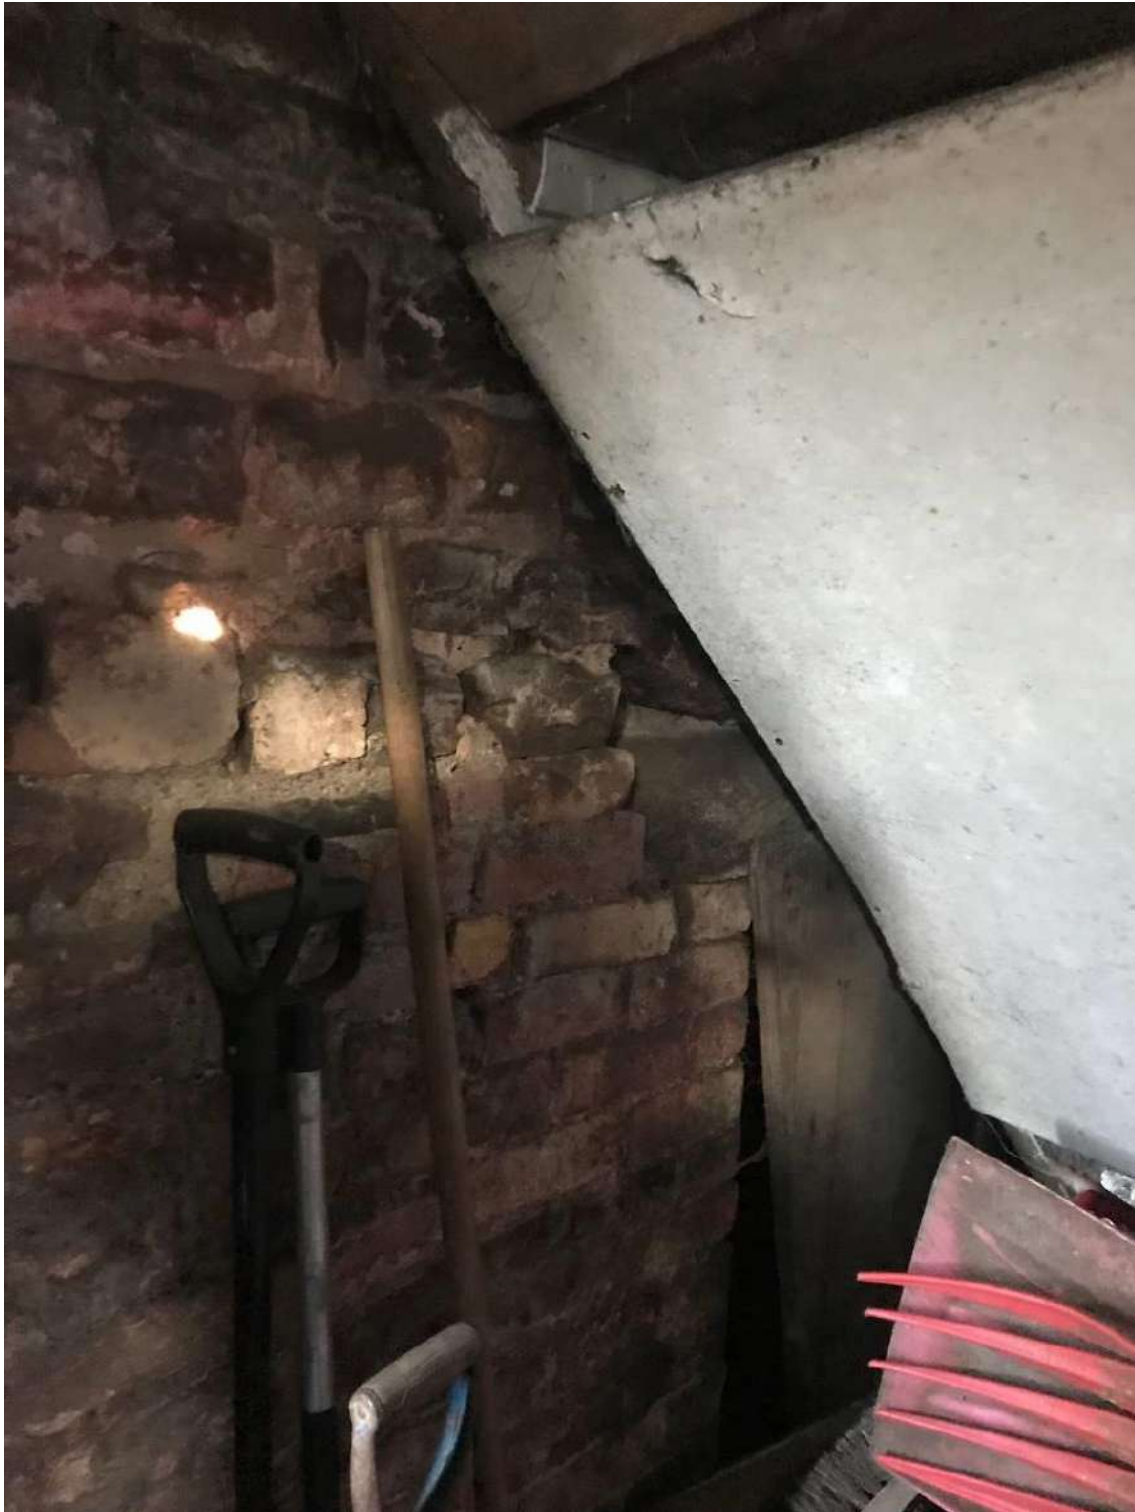
**Image EDP 9:** View of the fireplace concealed by the modern timber staircase on the west side of the earliest section of Structure A.

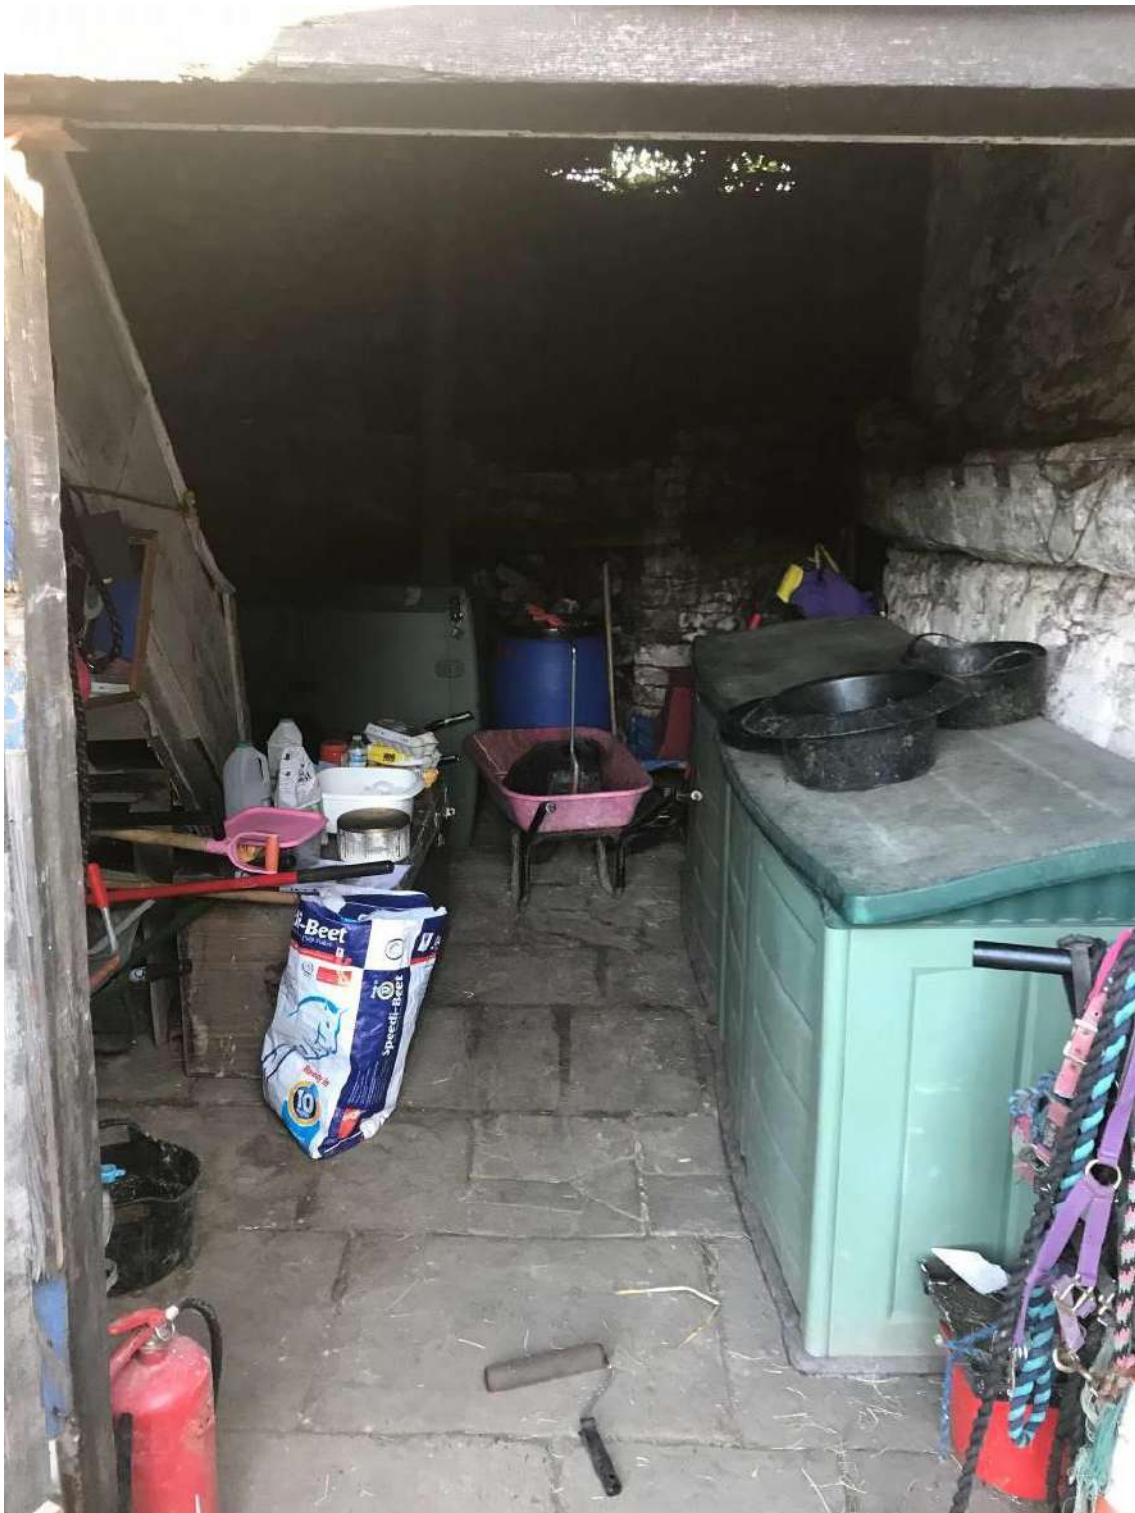
**Image EDP 10:** View of the interior of the earliest phase of Structure A, here showing the flagstone floor and the inserted door opening.

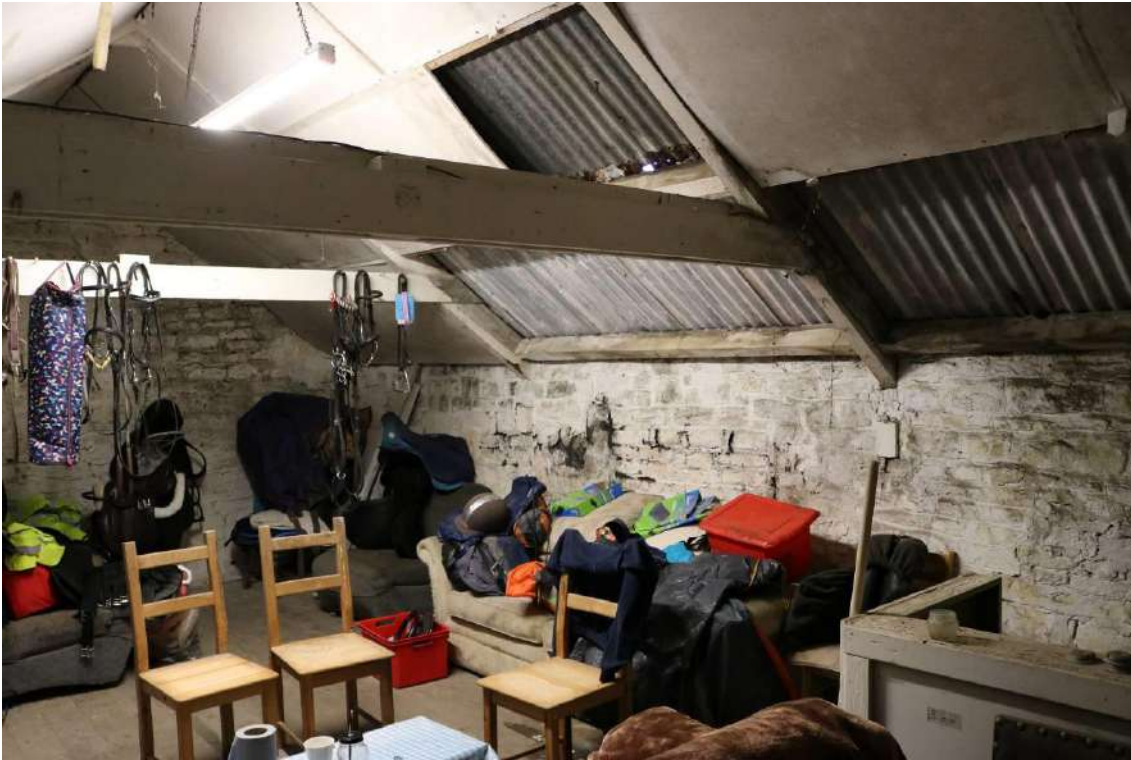
- 4.91 The staircase provides access to the inserted timber floor above, where it is quite evident that the historic roof structure has been entirely replaced in the relatively recent past, the covering now made from sheets of corrugated iron (see **Image EDP 11**).

**Image EDP 11:** View of the first floor space at the west end of Structure A.

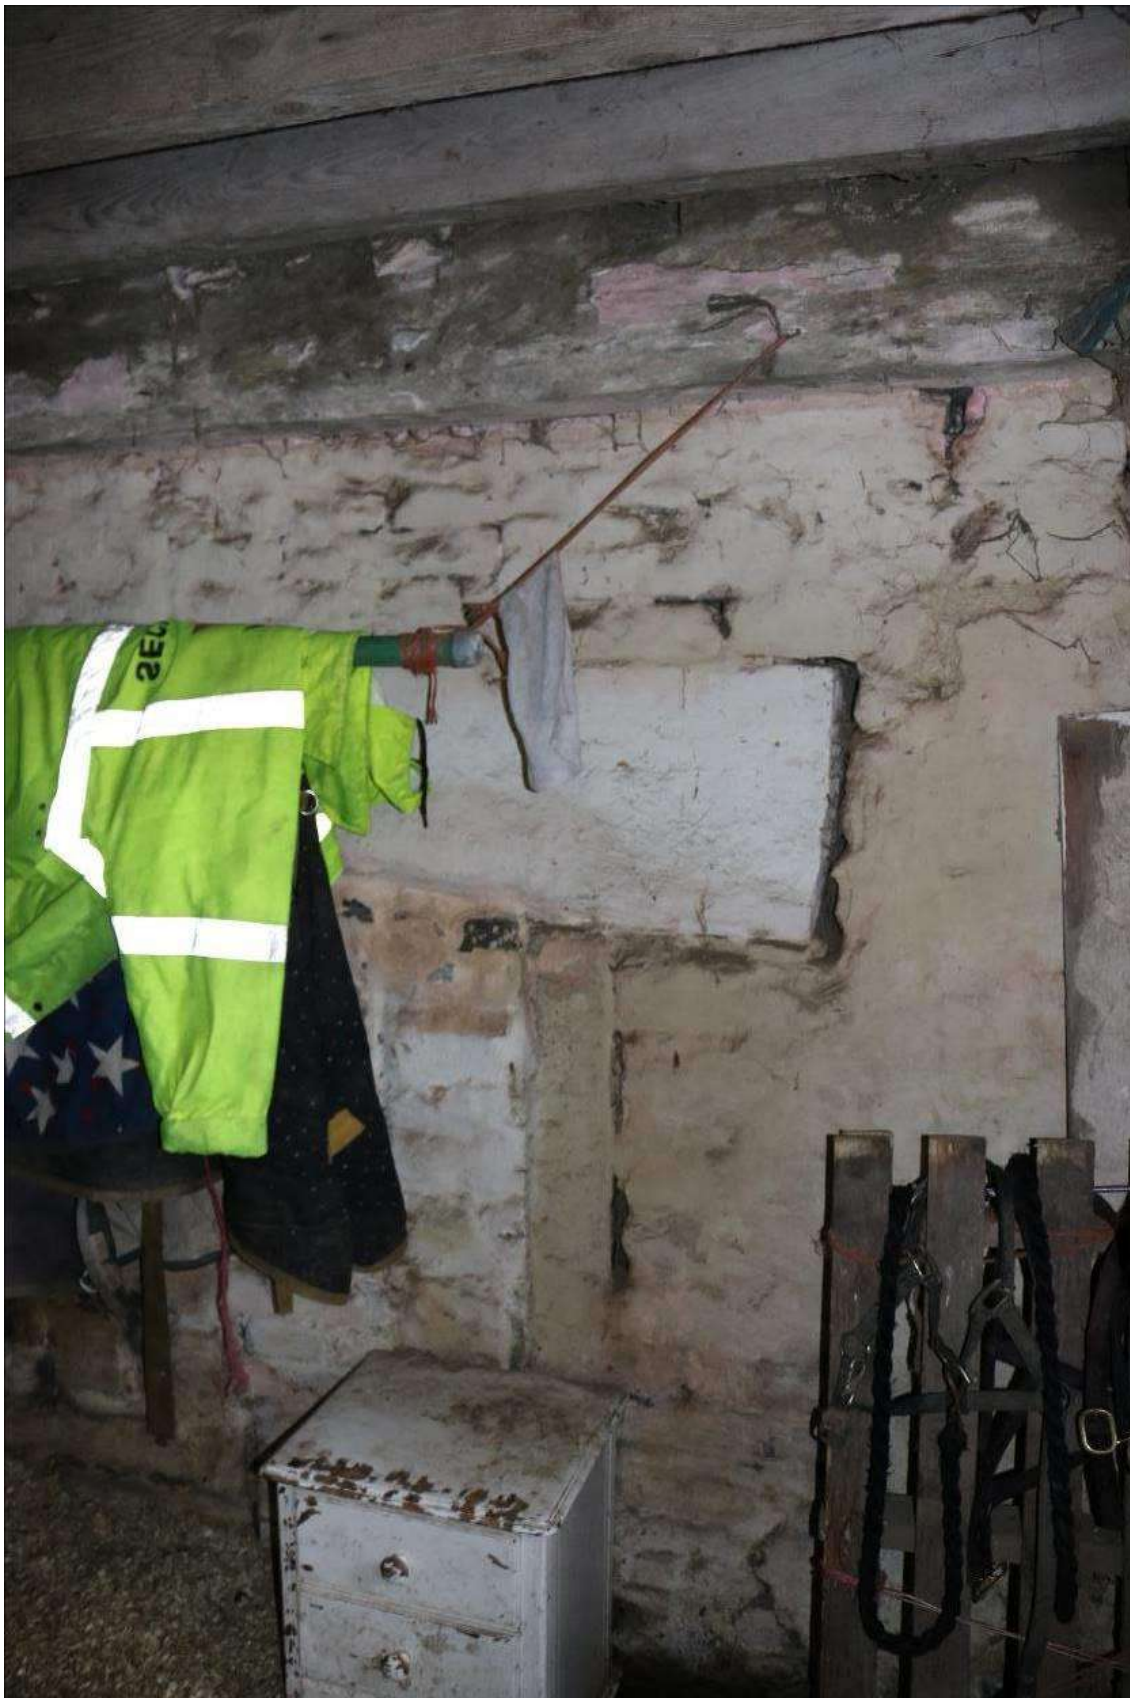
**Image EDP 12:** View of the fireplace at the west end of Structure A, where the staircase winds up to the left-hand side (outside the photograph).

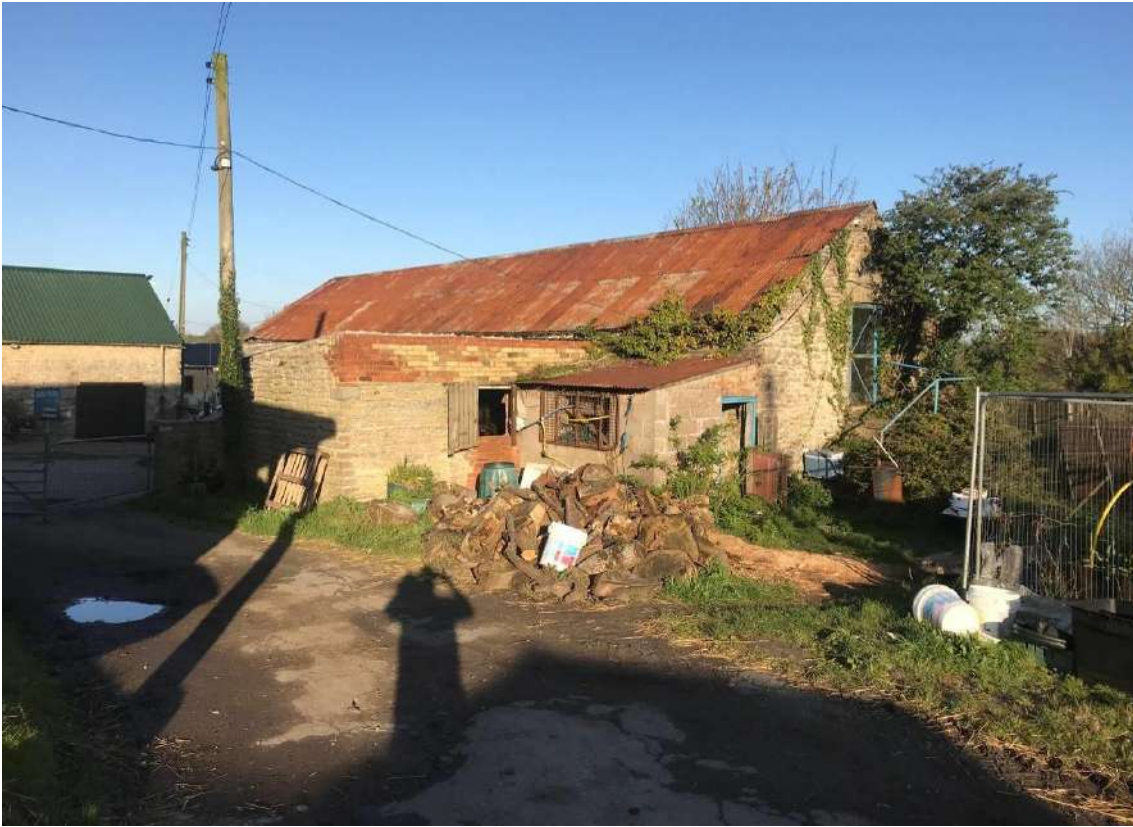
**Image EDP 13:** View of the east end of Structure A, here looking north-west.

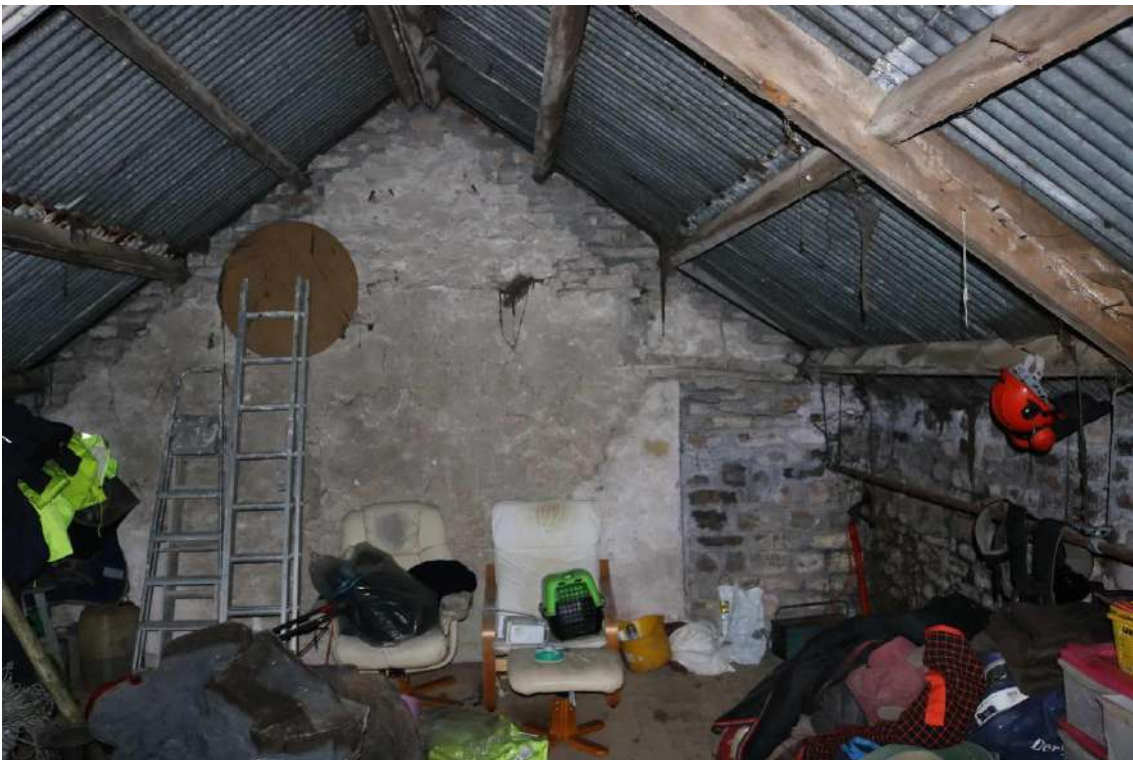
**Image EDP 14:** View of the first floor within the eastern extension to Structure A, here showing the form of the modern replacement roof structure.

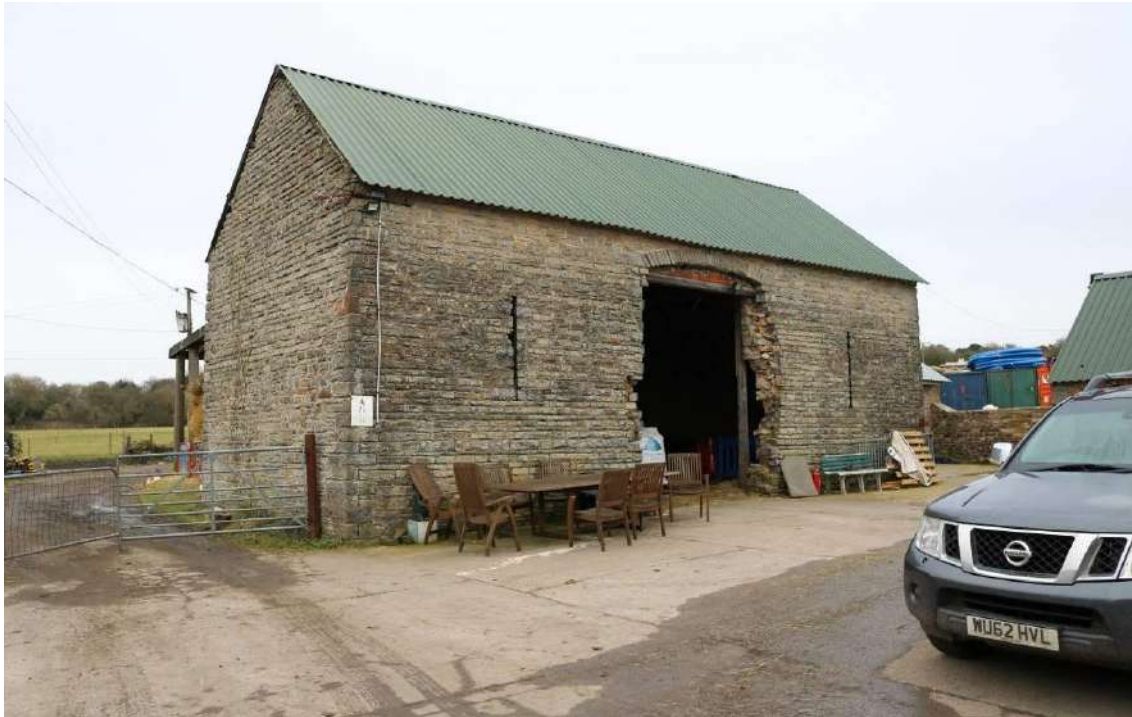
corrugated aluminium roof, the damaged stonework around the western cart opening and the use of red brick for the reinforcement of the stone arch over (**Images EDP 15 to 17**).

**Image EDP 15:** Viewing of threshing barn [Structure B] looking south-east from within the farmyard and illustrating the form of this characteristic building.

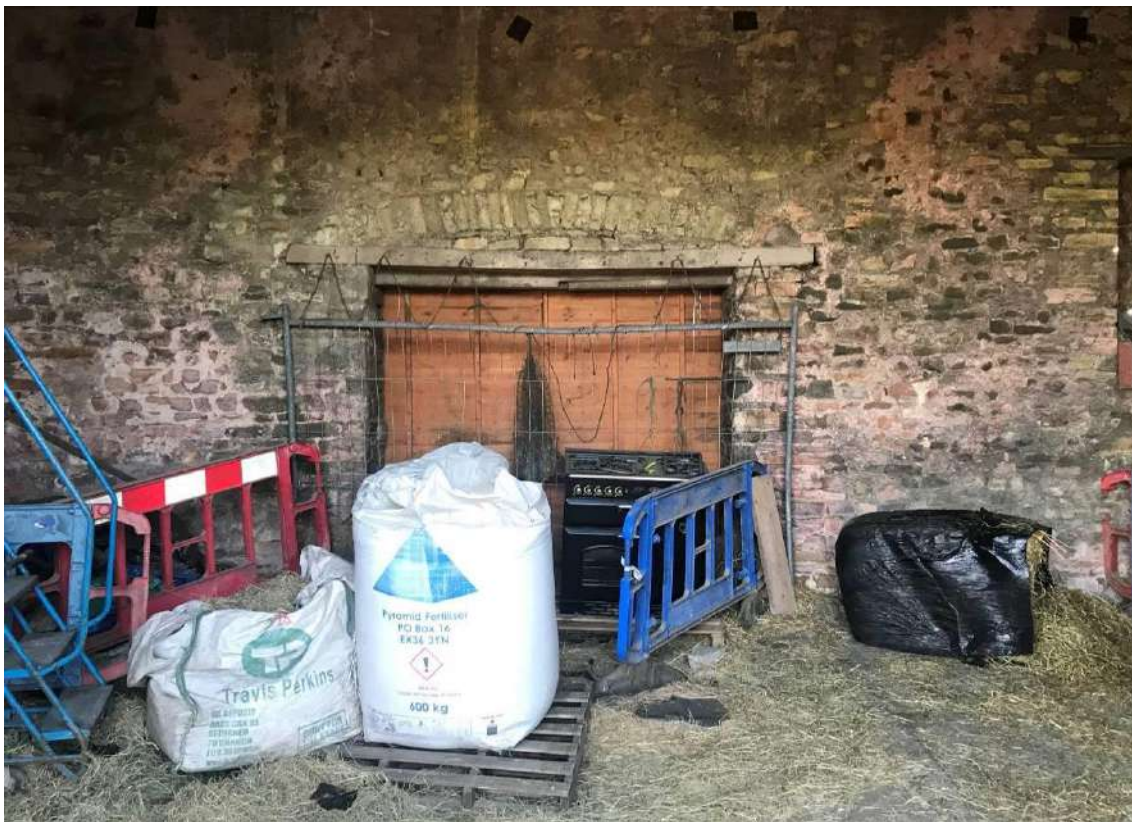
**Image EDP 16:** Close-up of the eastern cart opening from within the building, showing the form of the relieving arch in particular.

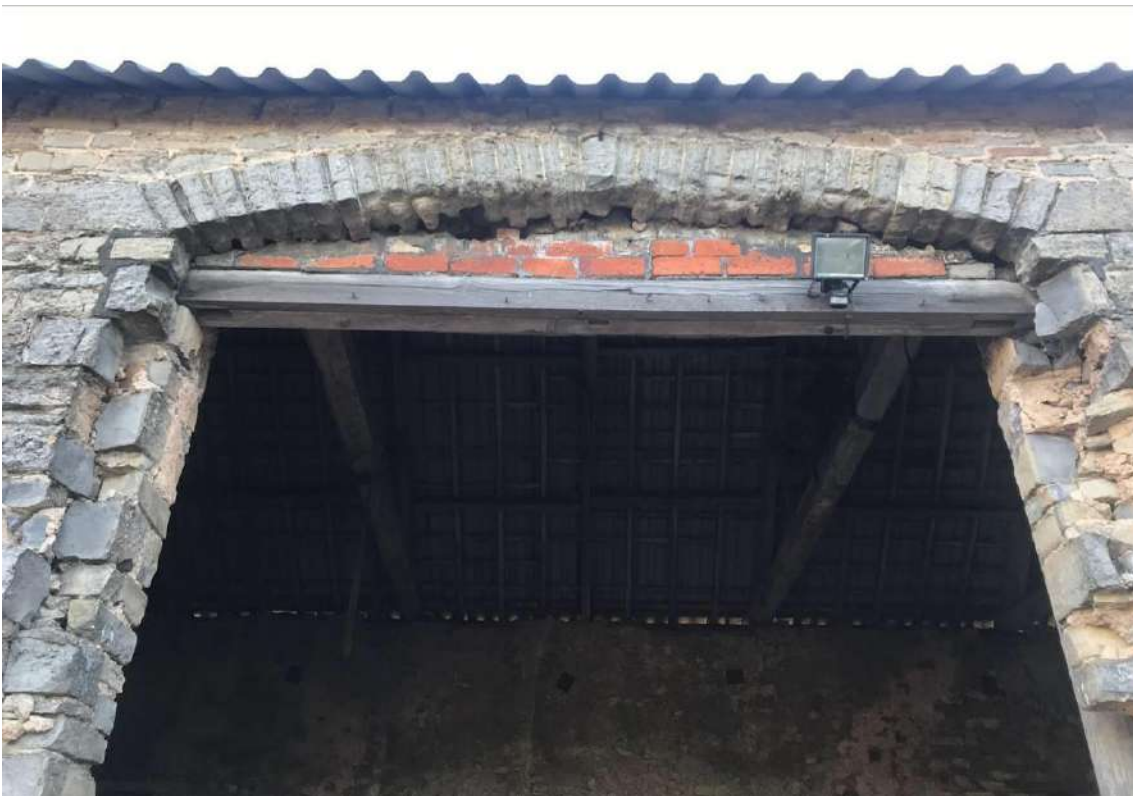
**Image EDP 17:** Close-up of the eastern cart opening to Structure B, looking east from within the farmyard and showing the impact of secondary alteration.

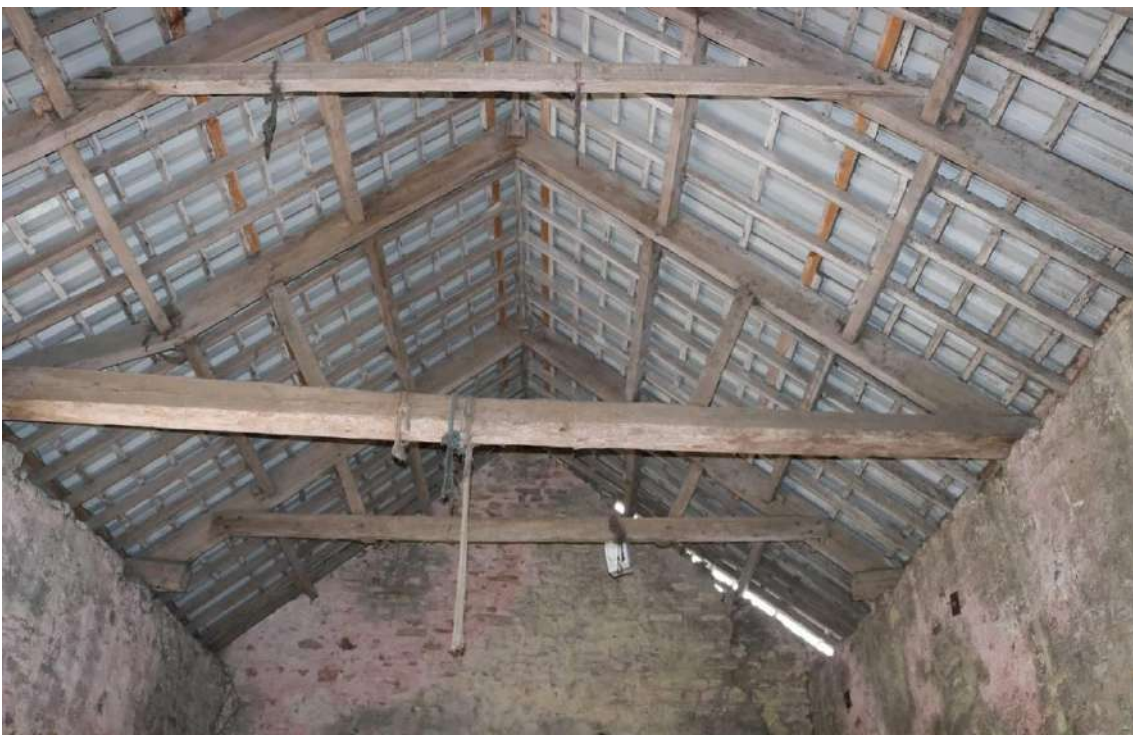
**Image EDP 18:** View of the interior of Structure B, here looking north towards Lavernock Road and highlighting the currently variable condition of the original roof structure.

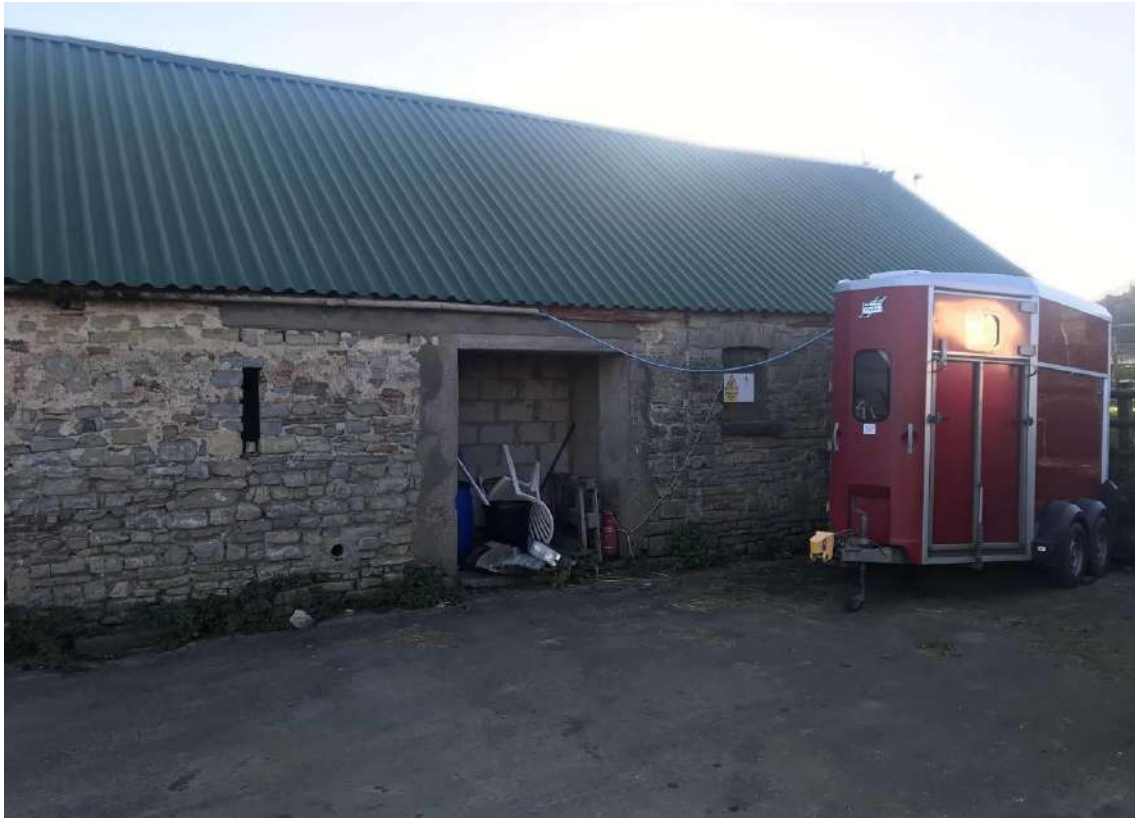
**Image EDP 19:** View of the east-facing elevation of Structure C, here highlighting the extent and character of the later northern extension.
