**Land at Upper  
Cosmeston Farm,  
Lavernock Road,  
Penarth**

**Archaeological  
and Heritage  
Assessment**

Prepared by:  
**The Environmental  
Dimension  
Partnership Ltd**

August 2020  
Report Reference:  
**edp5187\_r003e**

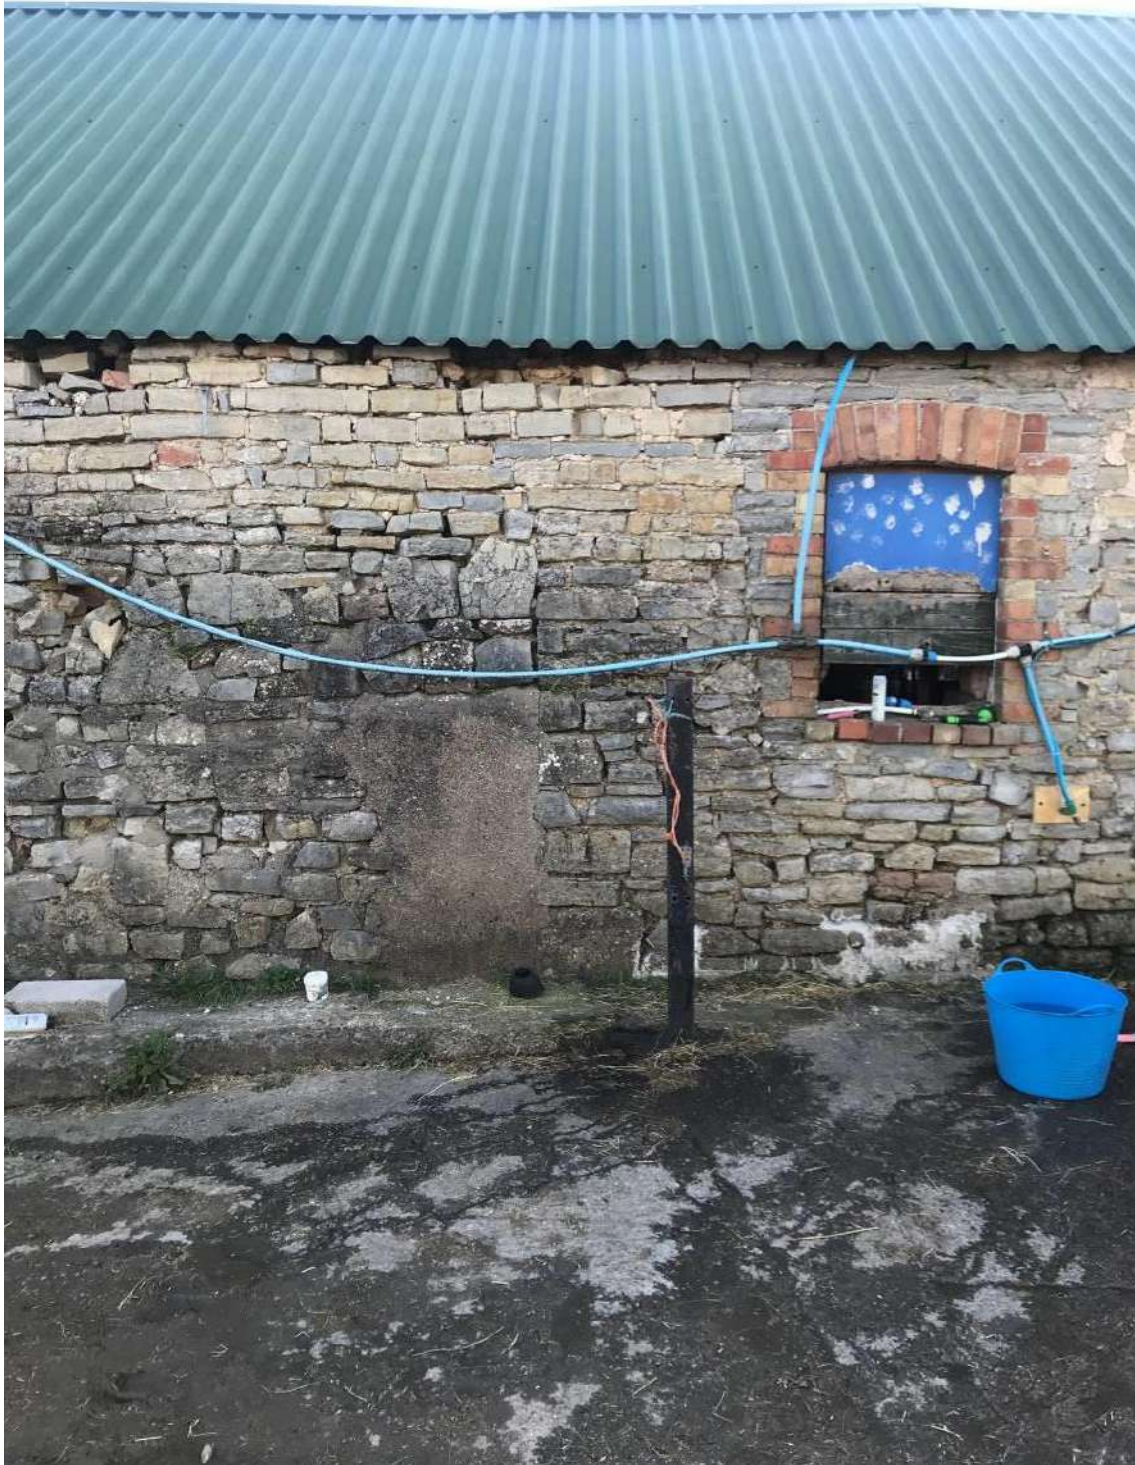
**Image EDP 20:** View of the east-facing elevation of Structure C, here highlighting the extent and character of the later southern extension.

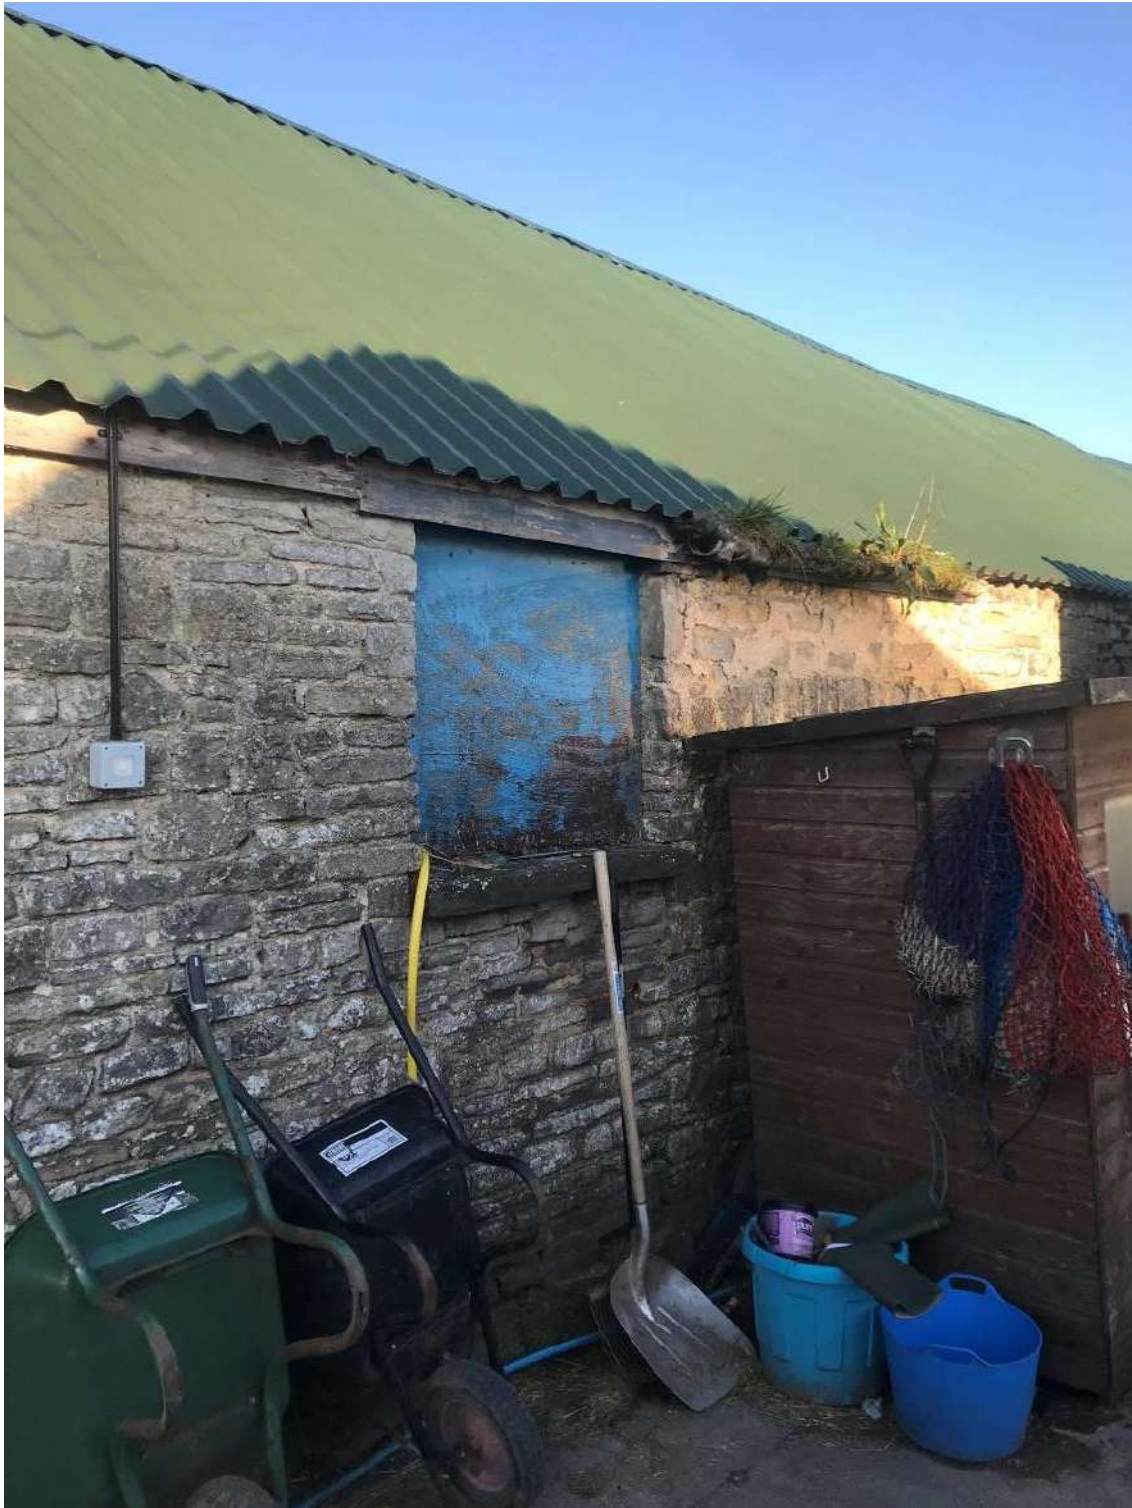
**Image EDP 21:** Close-up of the northern extension to Structure C, here highlighting that this element of the building has two principal elevations.

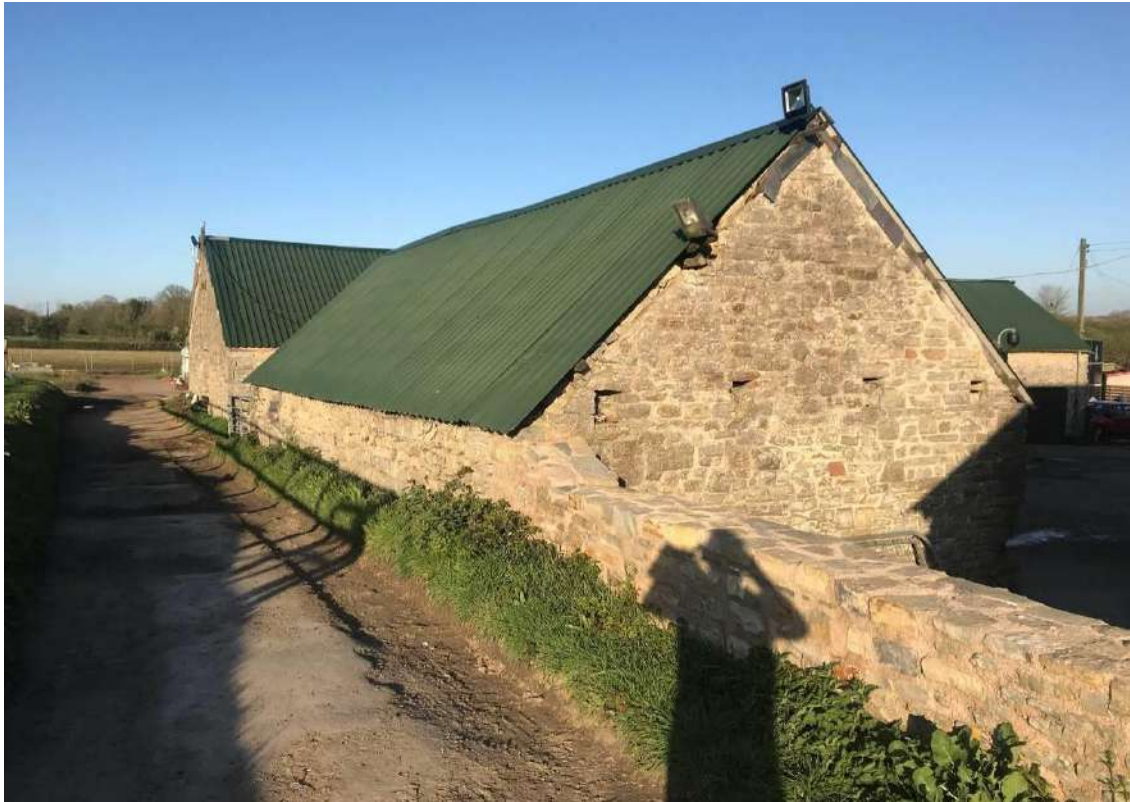
- 4.107 This is the characteristic appearance of a stable block, where here the flanking windows have stone sills and timber lintels. This arrangement is illustrated in **Image EDP 22**.
- 4.108 In common with the other buildings around the farmyard, this structure has experienced significant modification and alteration. This most clearly includes the replacement of the roof covering with sheets of corrugated aluminium and also damage to the relieving arch over the principal door opening in the north-facing elevation (see **Image EDP 23**).
- 4.109 The interior of this small stable block is also unremarkable, even if it does continue to be used for stabling horses.

**Image EDP 22:** View of Structure D from the east and showing the form of this building and the nature of its relationship with the wider fieldscape.

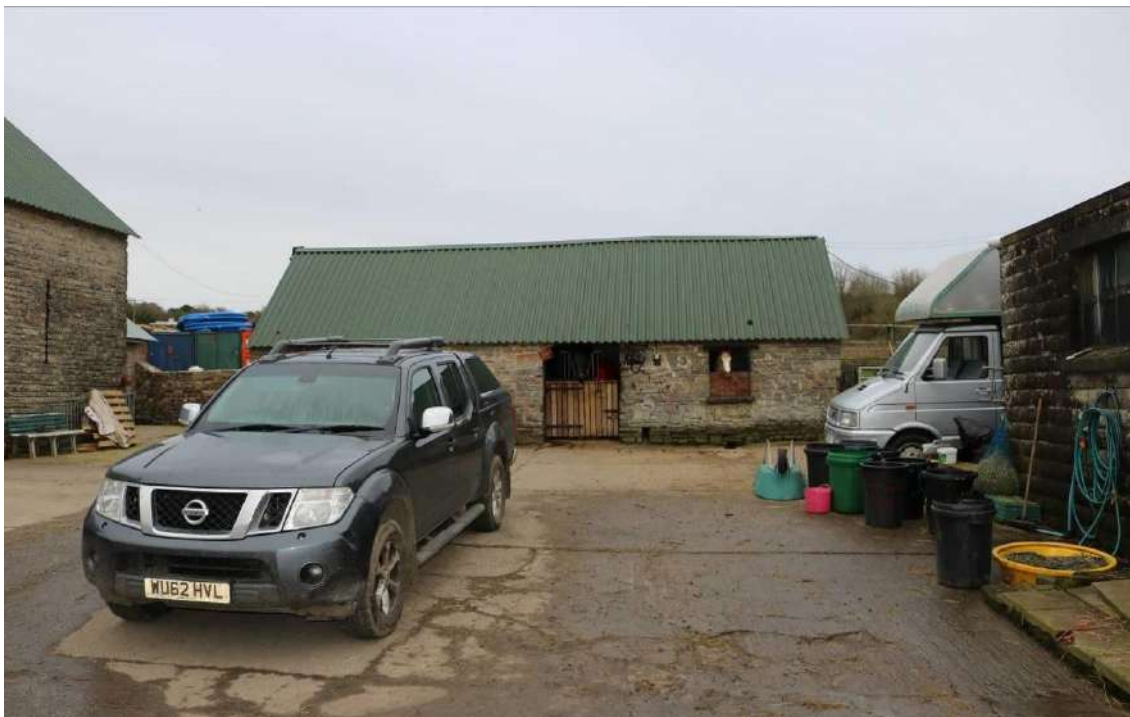
**Image EDP 23:** View of Structure D from within the farmyard, here looking south and showing the appearance and condition of the three openings in the north-facing elevation.

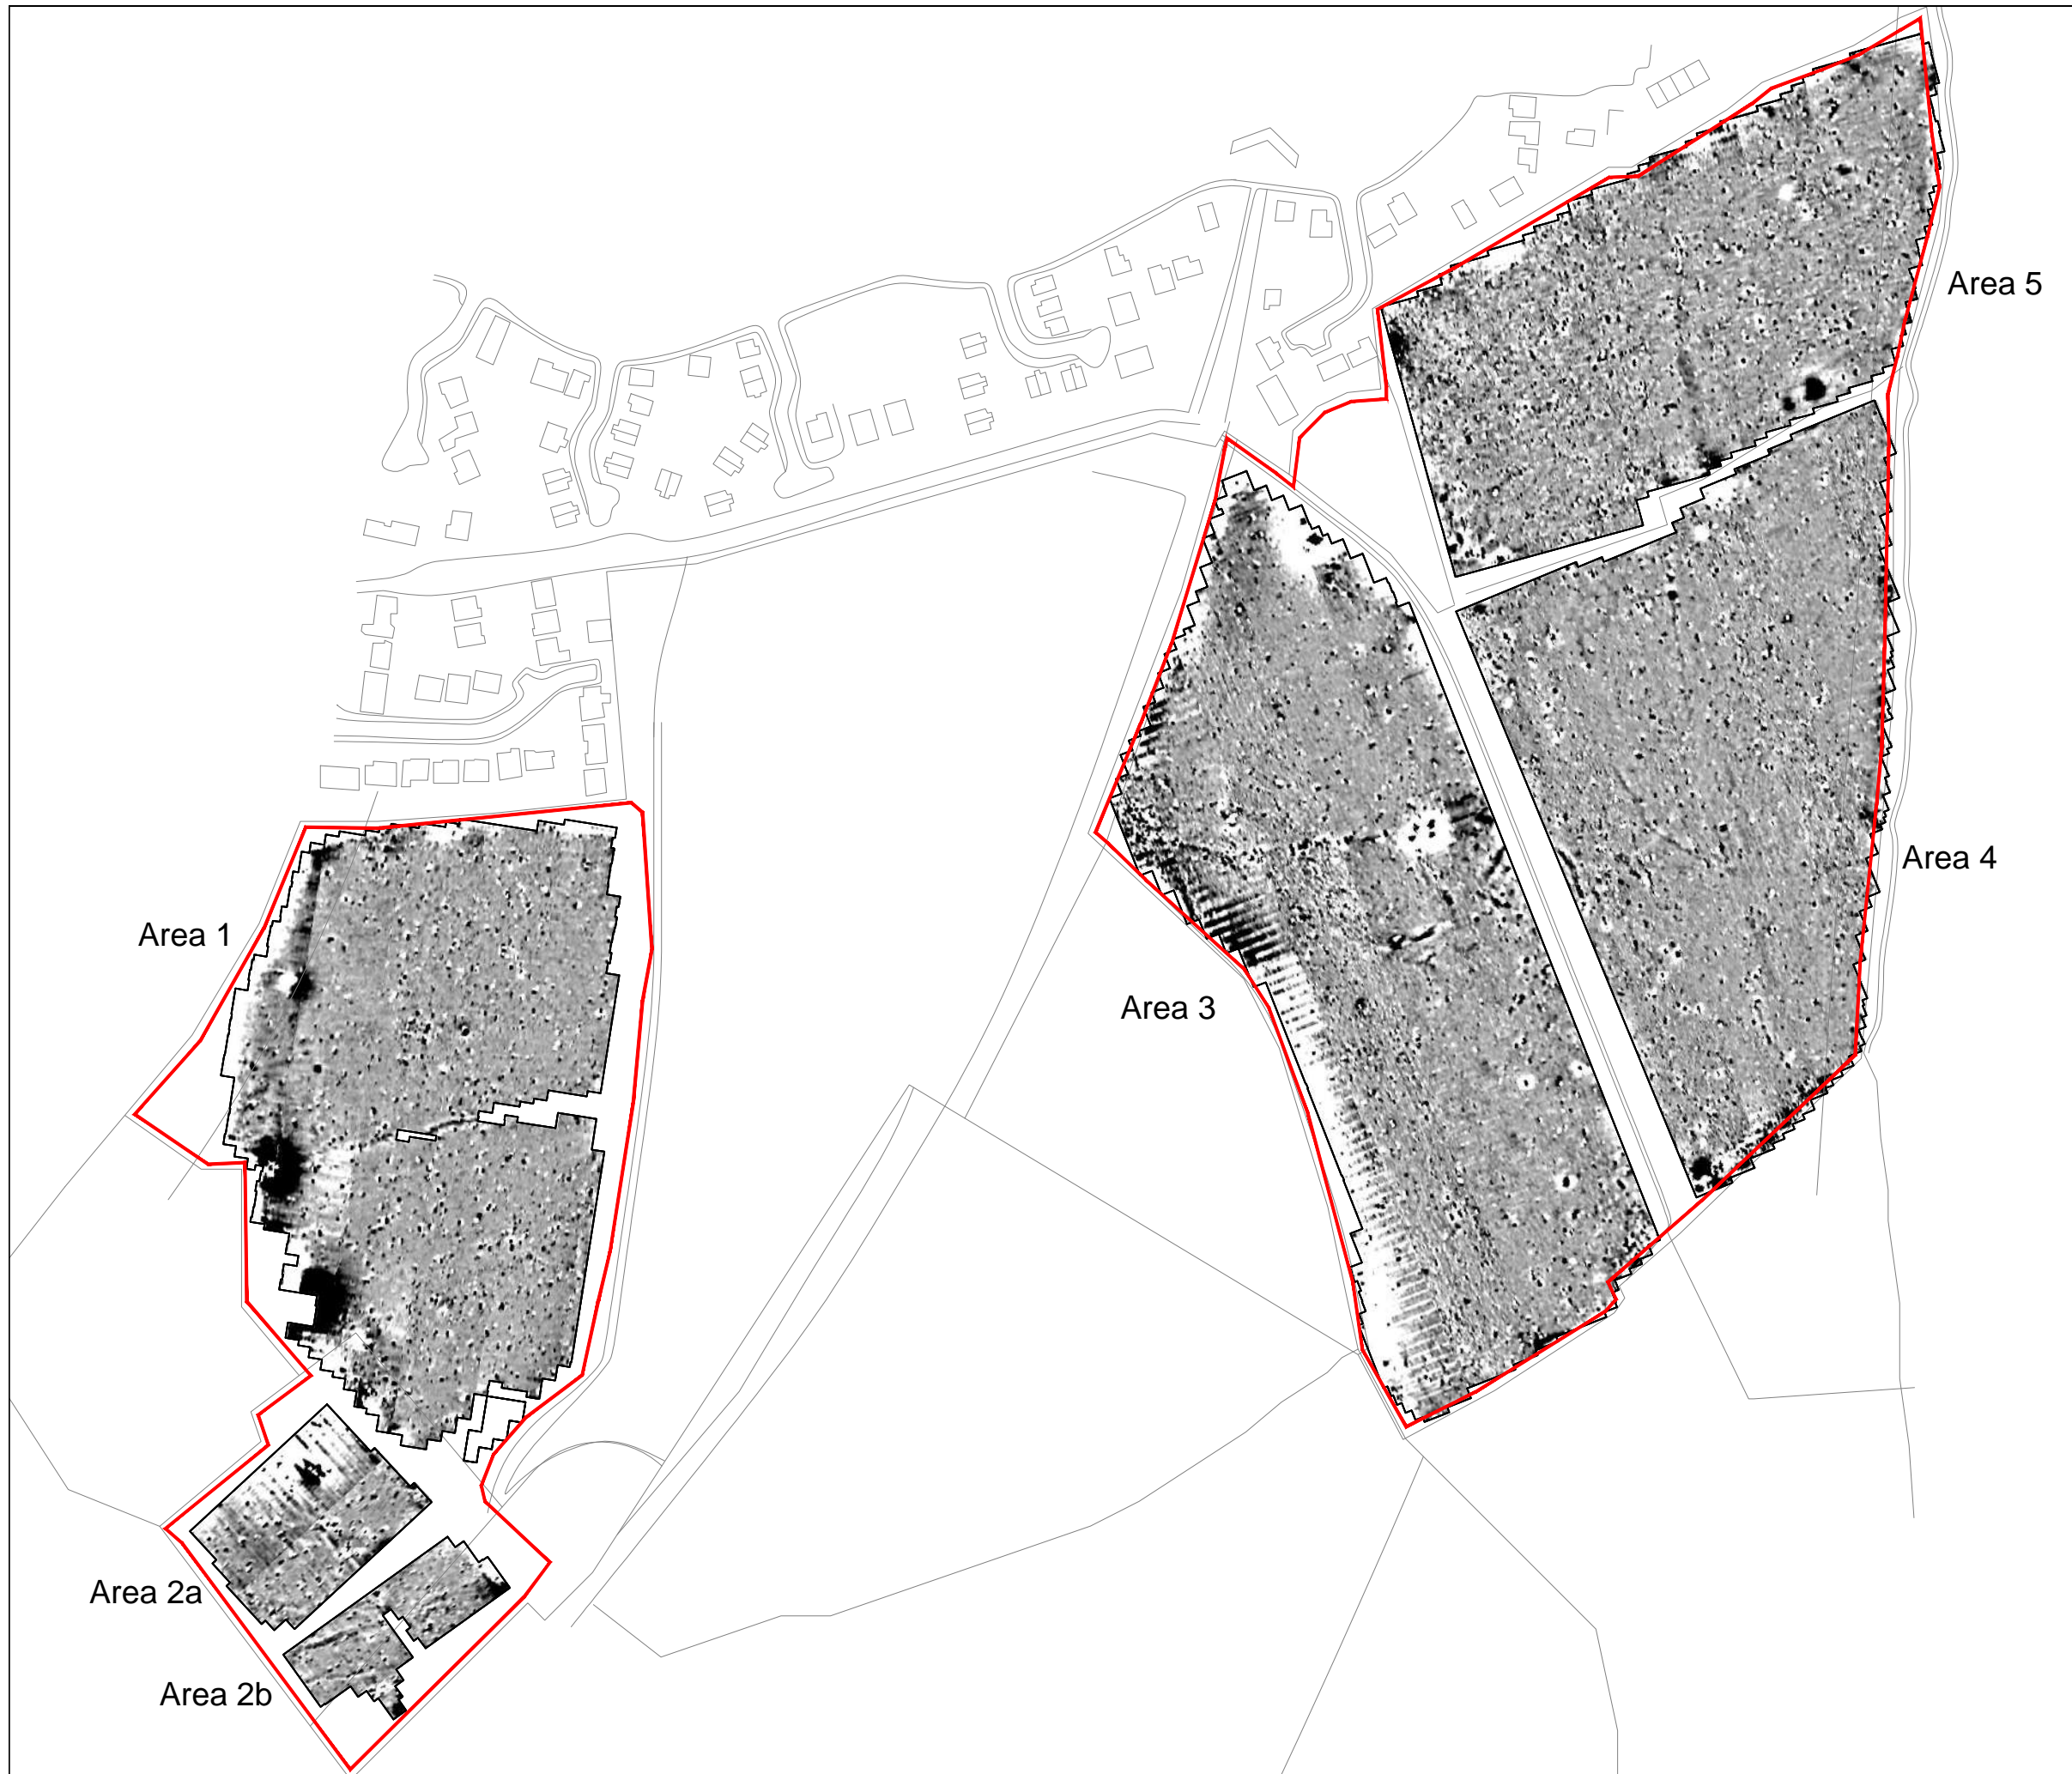
Scale: 0 metres 125  
1:2500 @ A3 Fig No: 03

Title: Magnetometer Survey  
Greyscale Plots

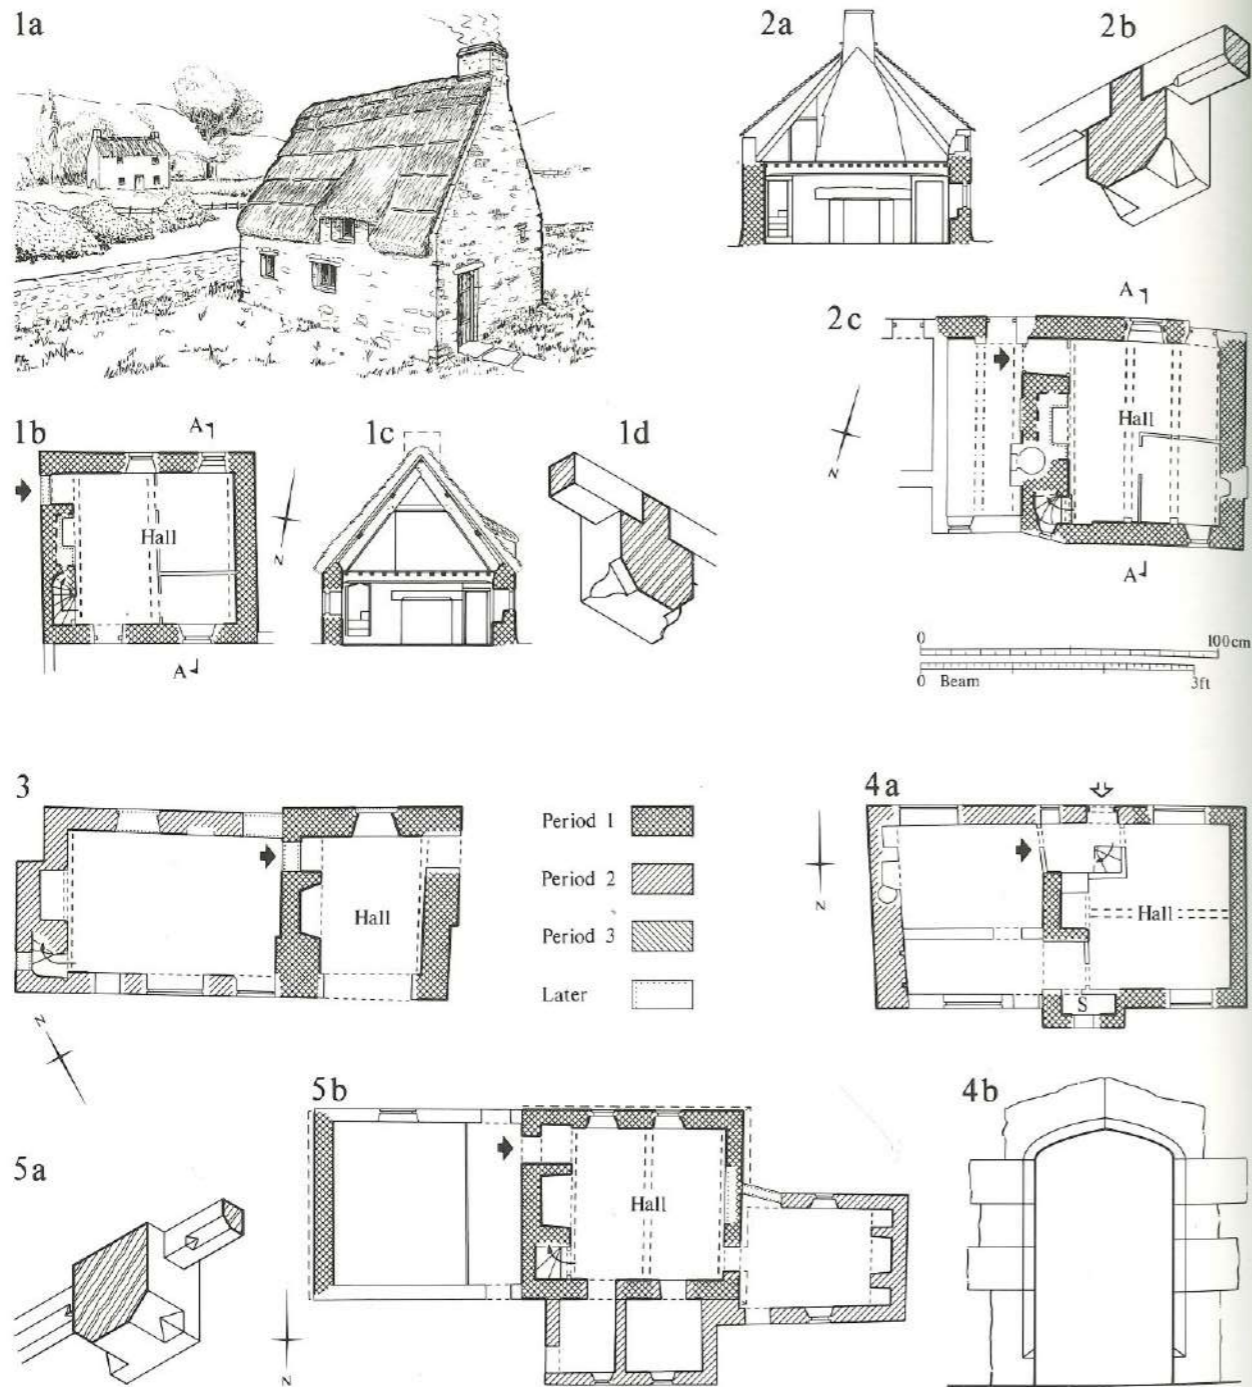
B11) Single-unit, end-entry houses – East Glamorgan.  
 1 Rose Cottage (887), Penarth, late 17th cent.: a restored view from S.E., b ground floor, c section A-A, d hall ceiling.  
 2 Pontprennau (836), Llanedern, 17th cent.: a section A-A, b hall ceiling, c ground floor.  
 3 Lower Cosmeston (620), Lavernock, 17th cent., ground floor.  
 4 Holly Cottage (507), Pen-marc, late 16th cent.: a ground floor, b re-used hall doorway.  
 5 Old Vicarage, Rumney (725), Cardiff, 17th cent.: a hall ceiling, b ground floor.  
 Rose Cottage remained little altered until its demolition, except for the change in doorway position, a common occurrence. Note that evidence pointed to the existence of an outer room at Pontprennau and Old Vicarage.

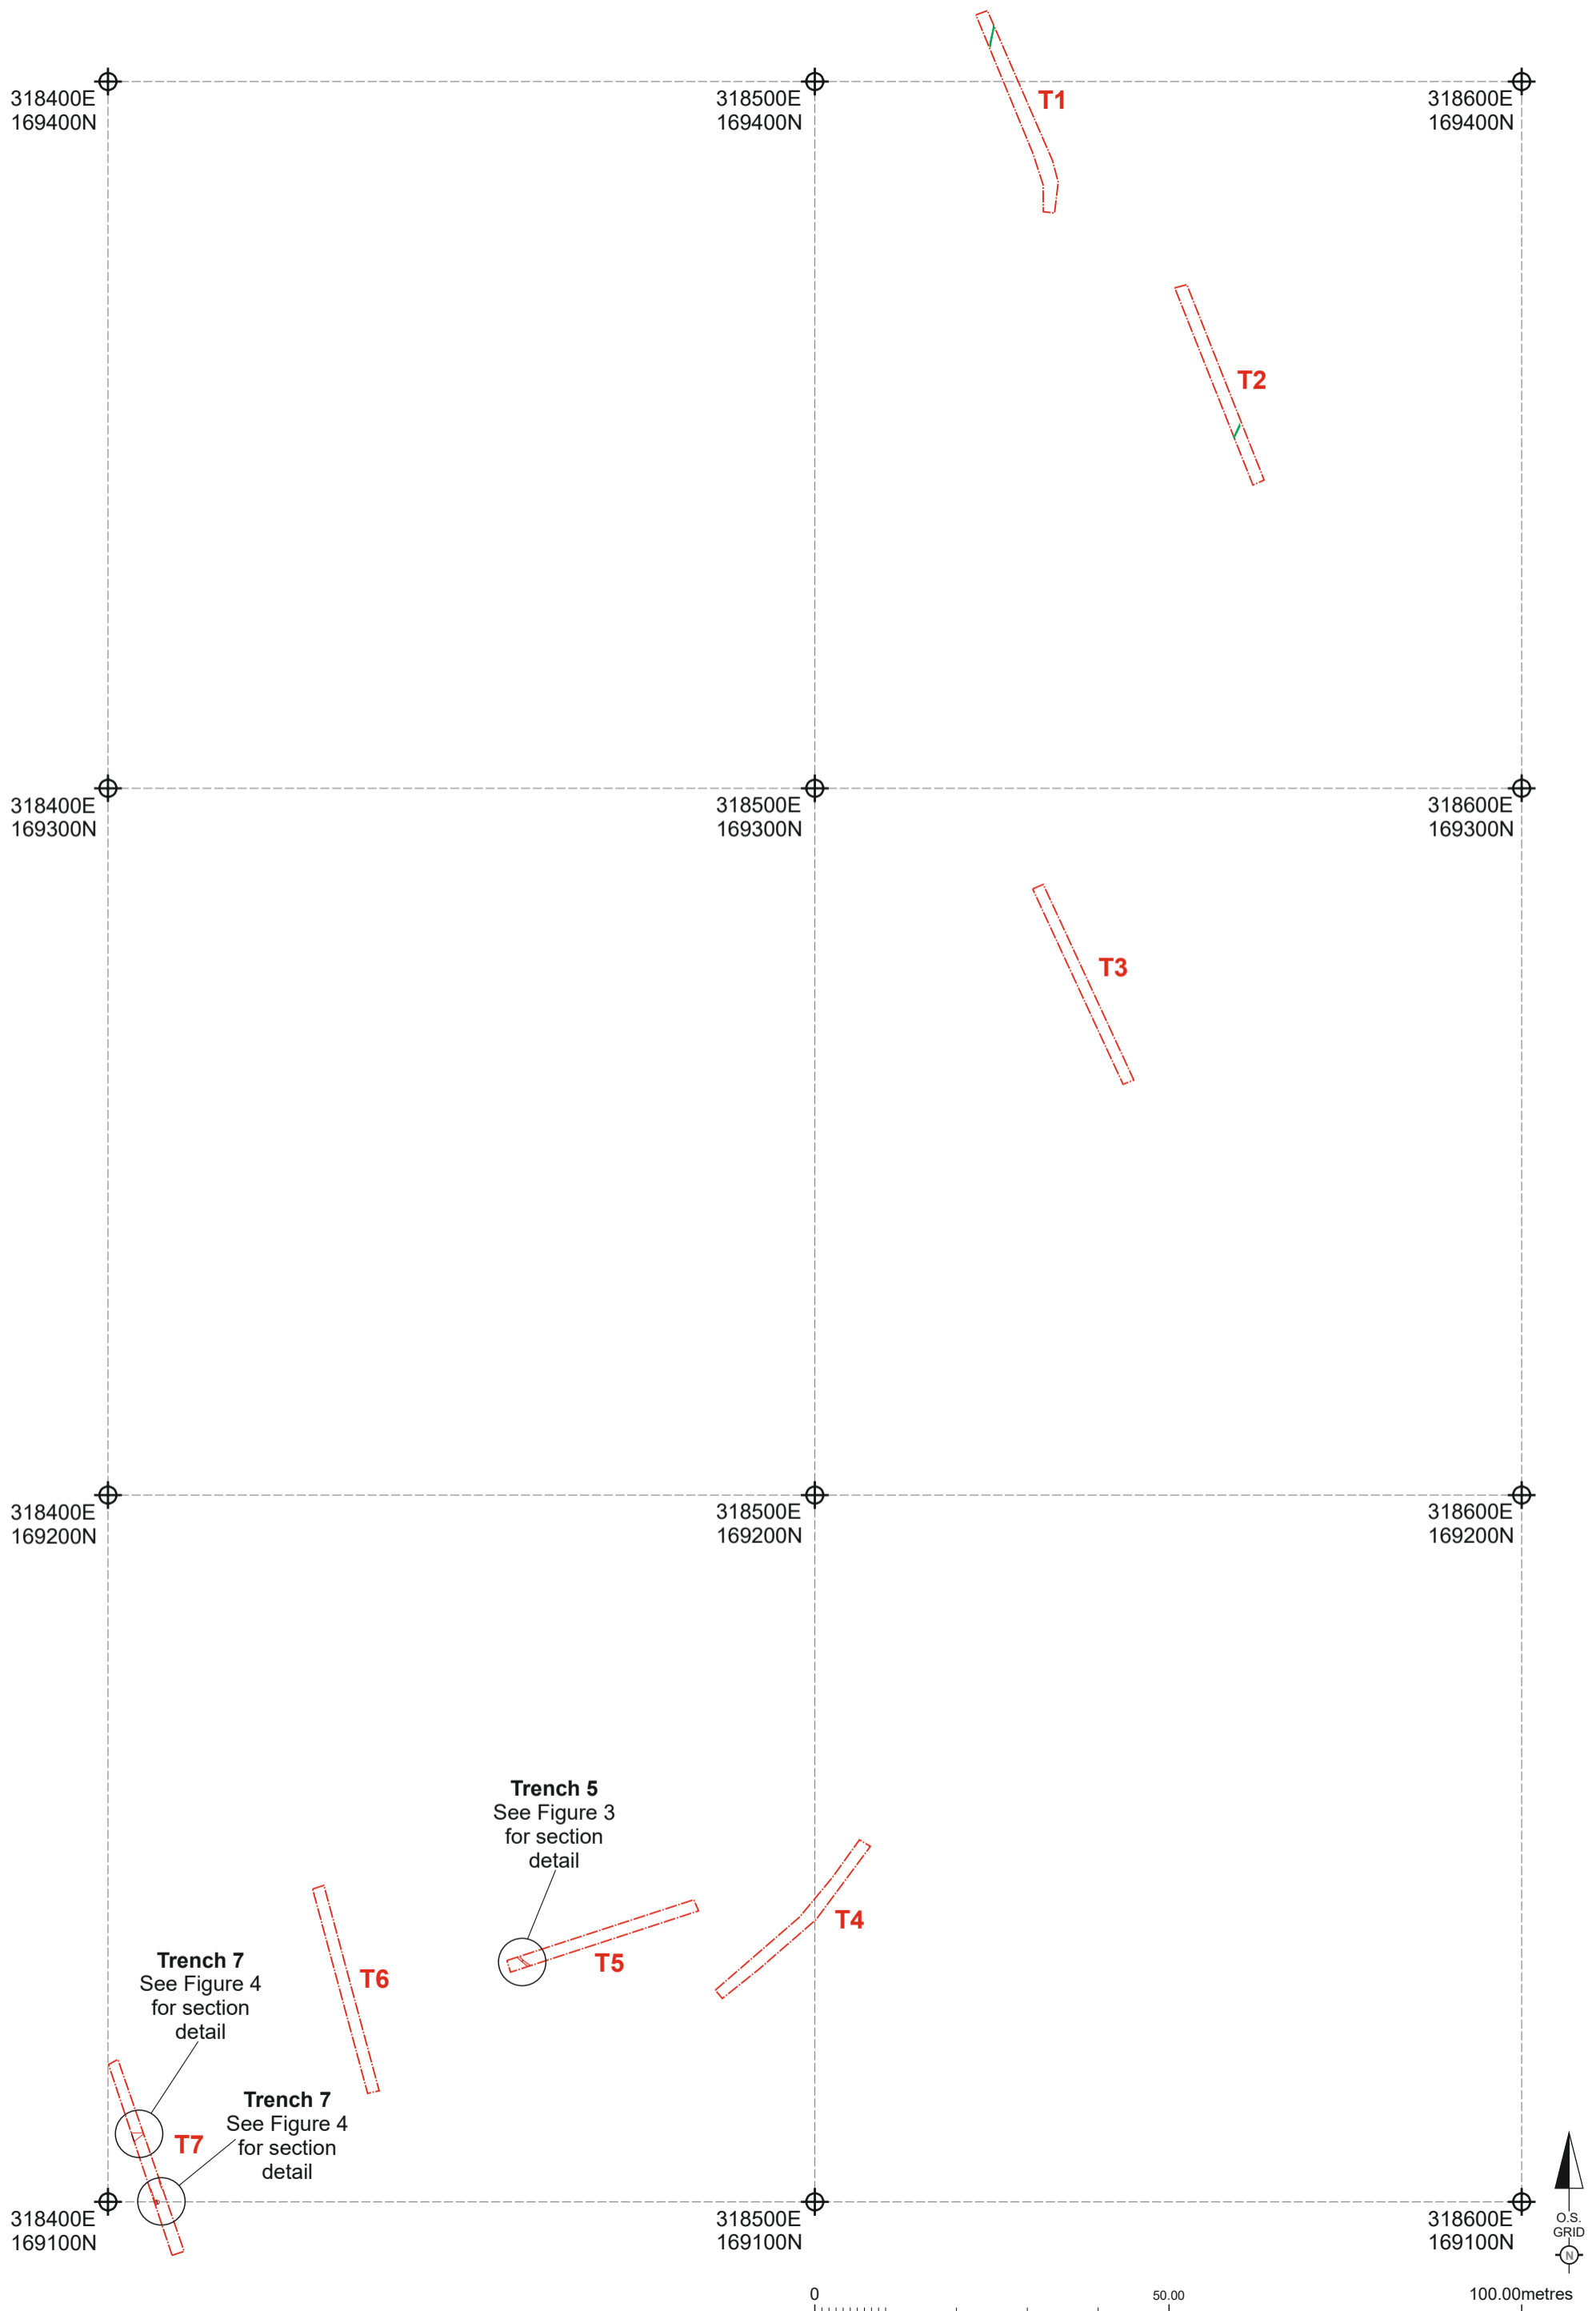
Figure 2. Trenches 1 - 7 showing detailed recorded data within each trench

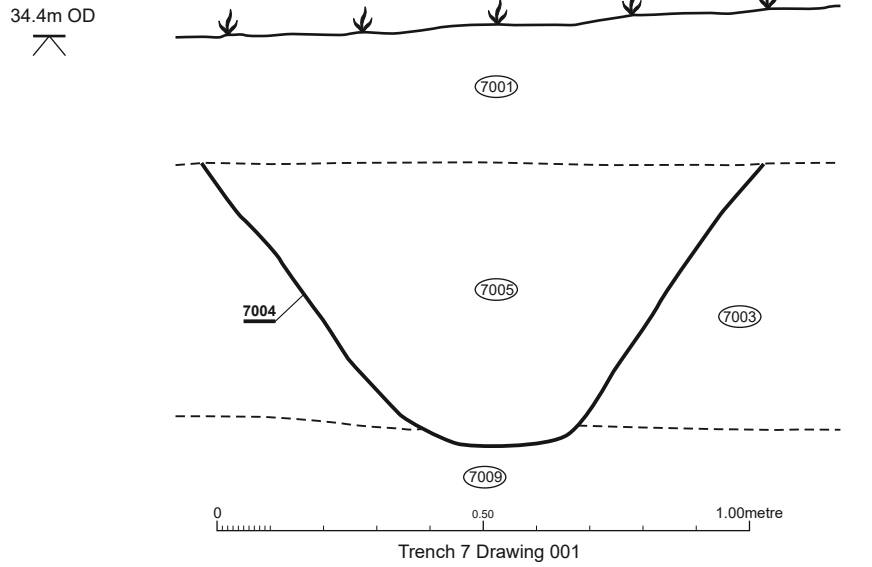
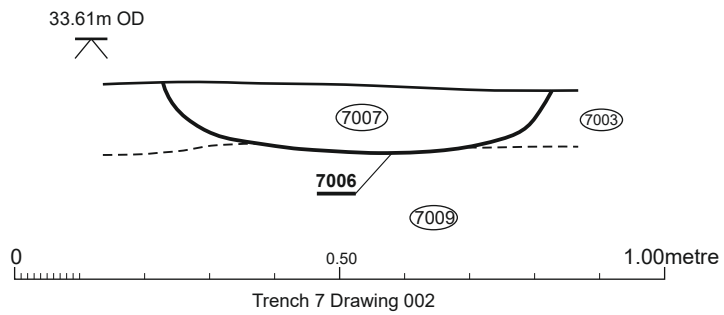
Figure 4. Trench 7 plan and section drawings (001 and 002) (scales as shown)

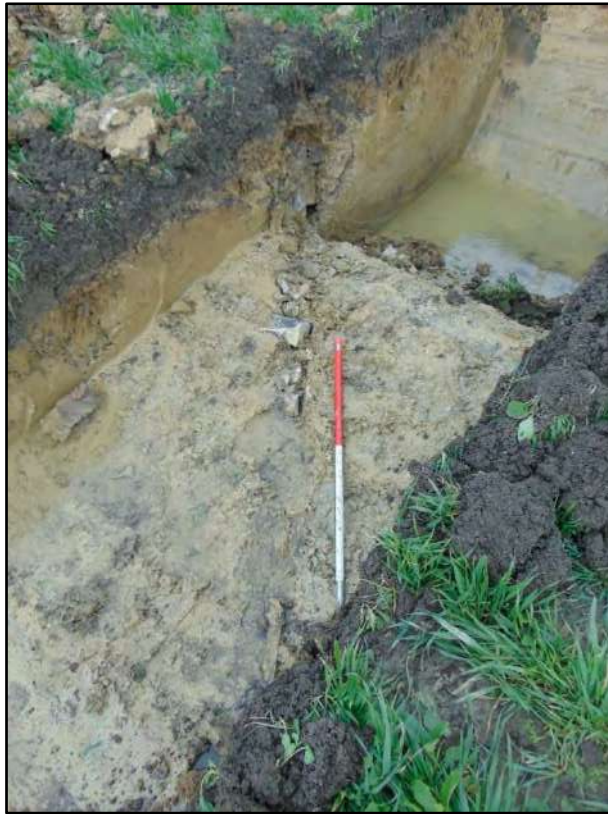
**Plate 1. Trench 1 field drain 1003. Scale divisions 0.5m.**

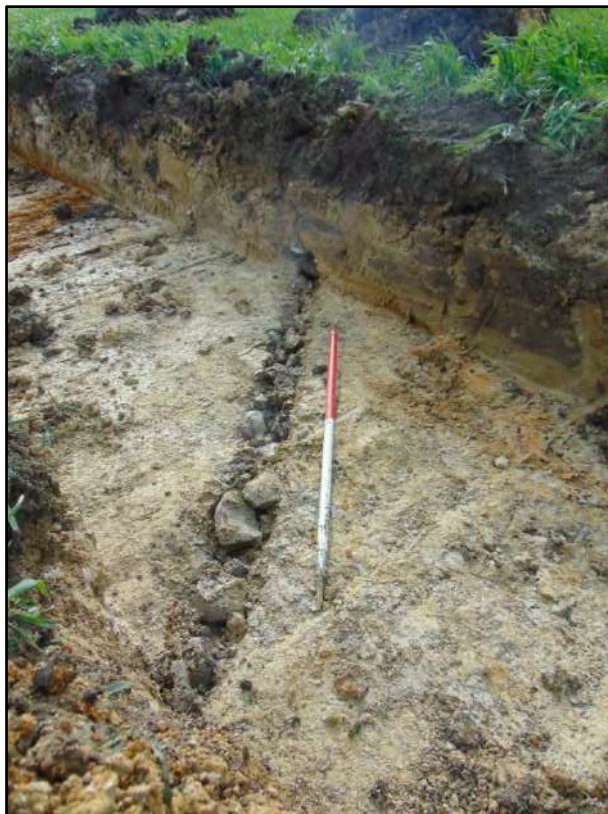
**Plate 2. Trench 2 field drain 2003. Scale divisions 0.5m.**

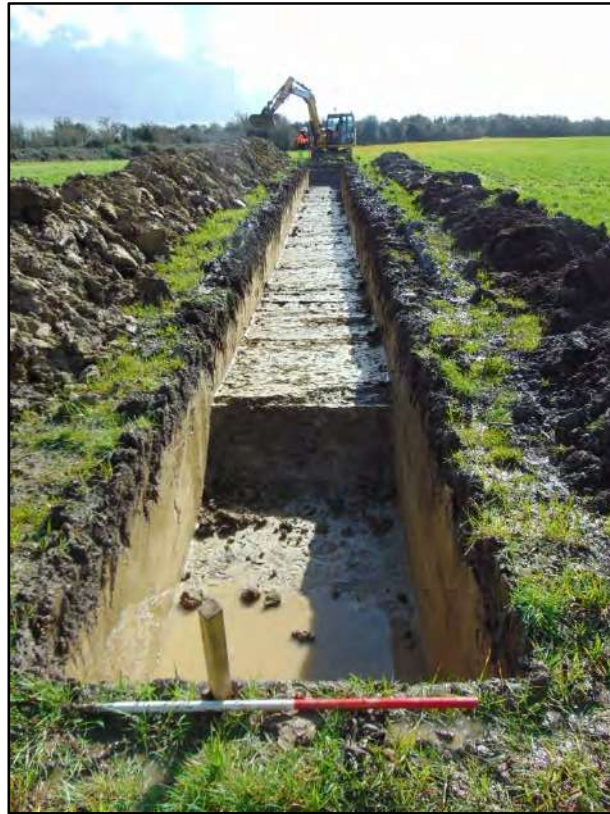
**Plate 3. Trench 3 general shot towards Southeast. Scale divisions 0.5m.**

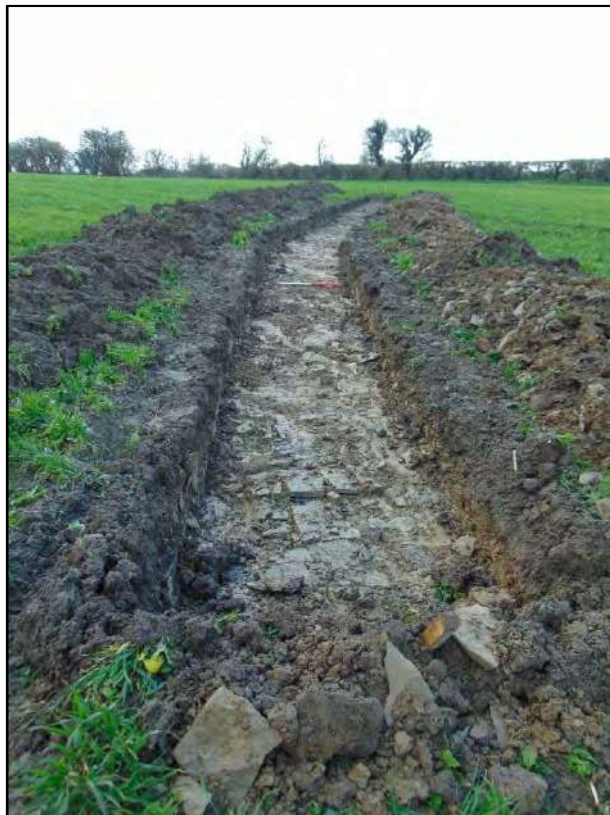
**Plate 4. Trench 4 general shot towards Northeast. Scale divisions 0.5m.**

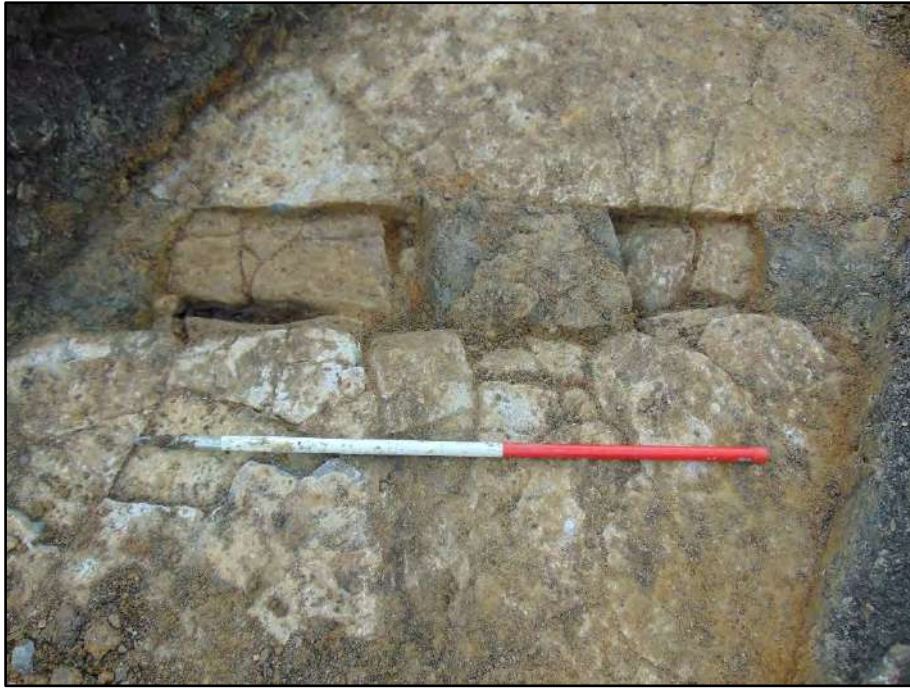
**Plate 5. Trench 5 linear bedrock (possible feature) Scale divisions 0.5m.**

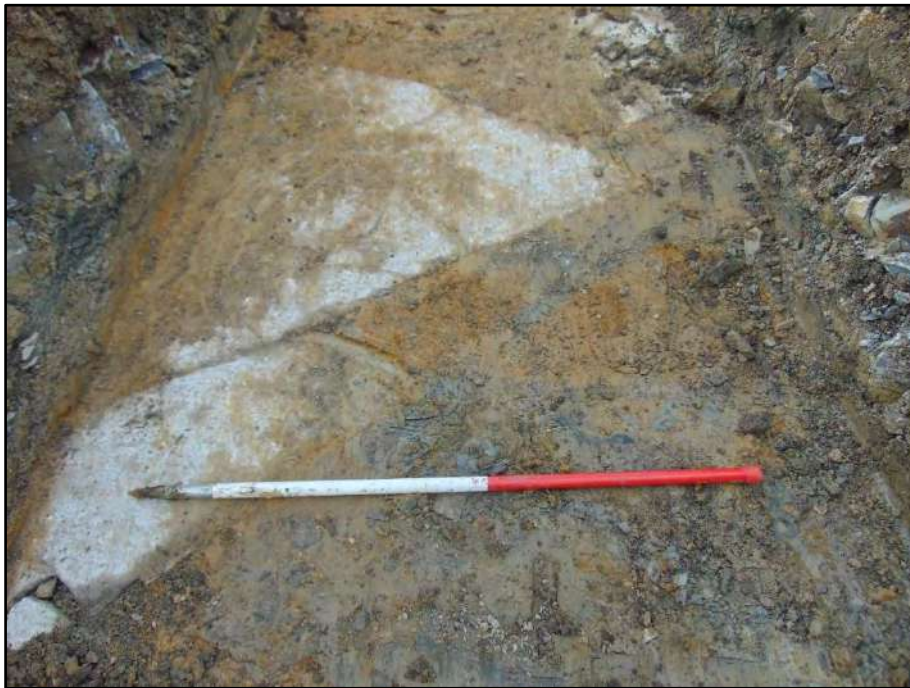
**Plate 6. Trench 5 example of linear bedrock. Scale divisions 0.5m.**

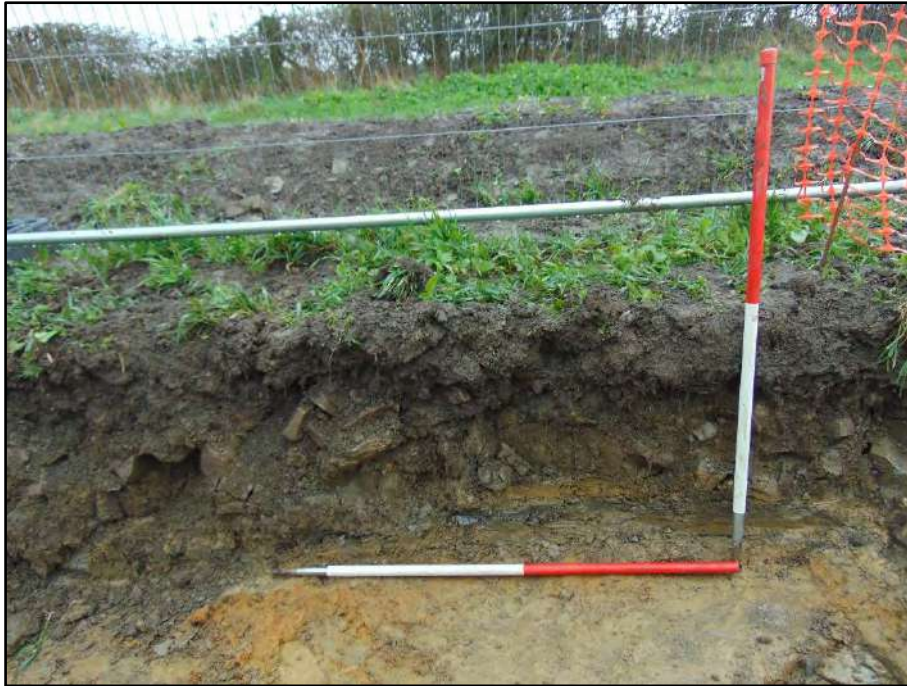
**Plate 7. Trench 6 showing natural bedrock. Scale divisions 0.5m.**

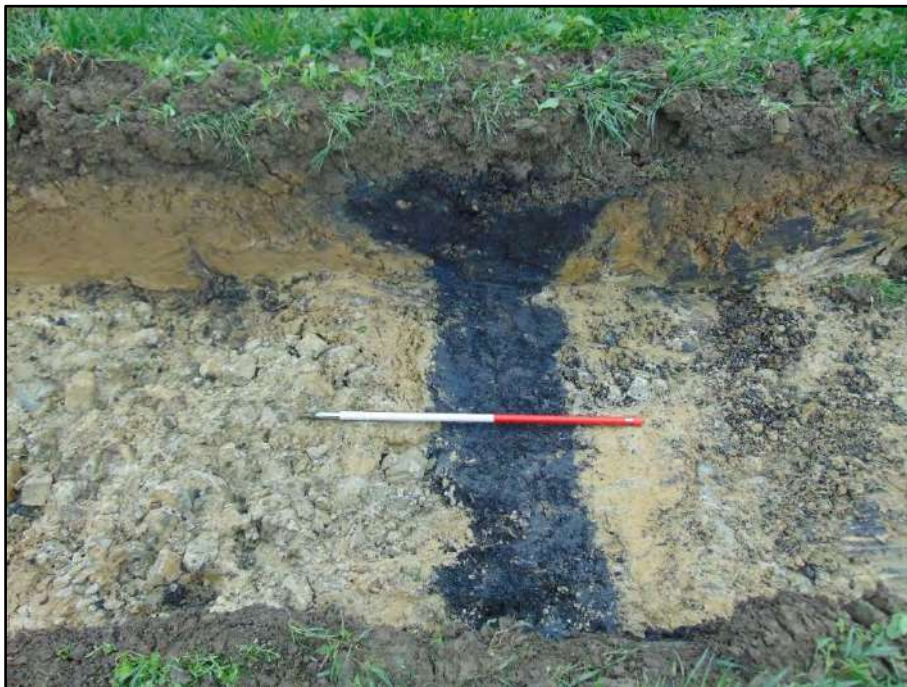
**Plate 8. Trench 7 feature 7006. Scale divisions 0.5m.**

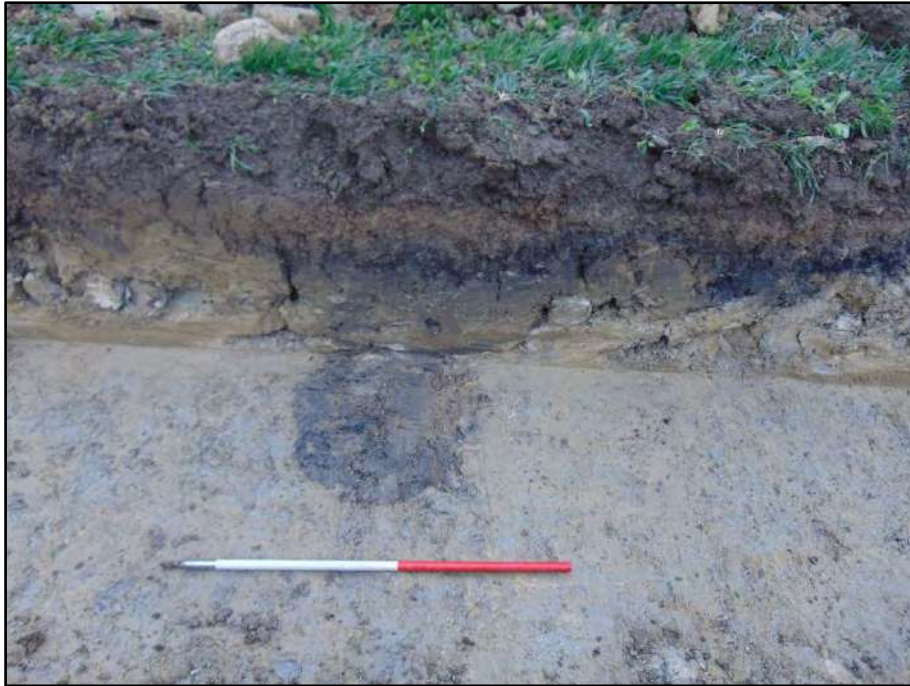
**Plate 9. Trench 7 pit or post hole 7006. Scale divisions 0.5m.**

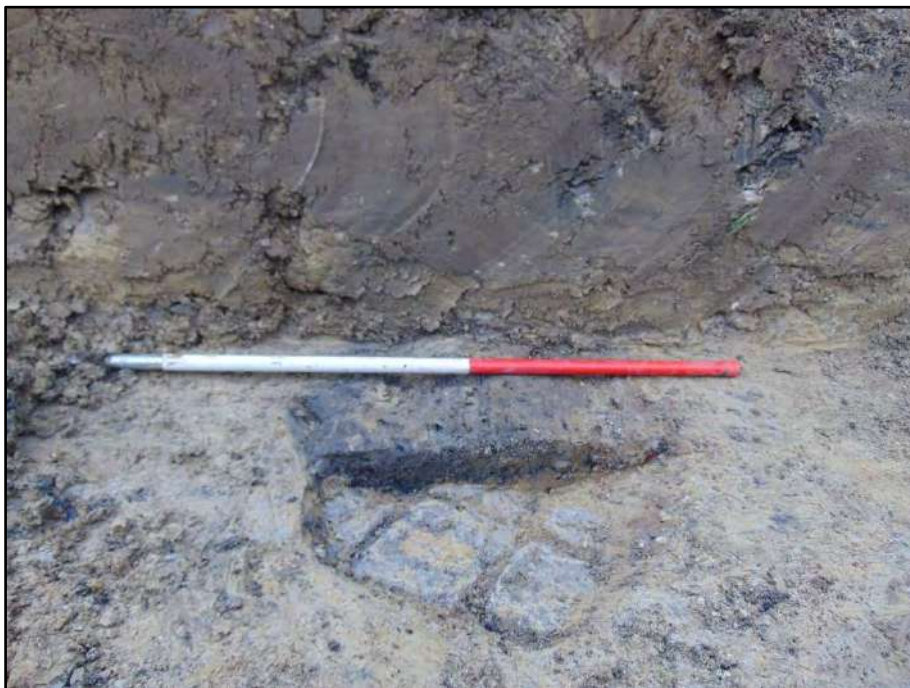
**Plate 10. Trench 7 pit or post hole 7006. Scale divisions 0.5m.**
