PHASE II GEO-ENVIRONMENTAL ASSESSMENT REPORT

Cardiff and Vale College

Cardiff and Vale College Site, Cardiff Airport Business Park

Phase II Geo-Environmental Assessment Report

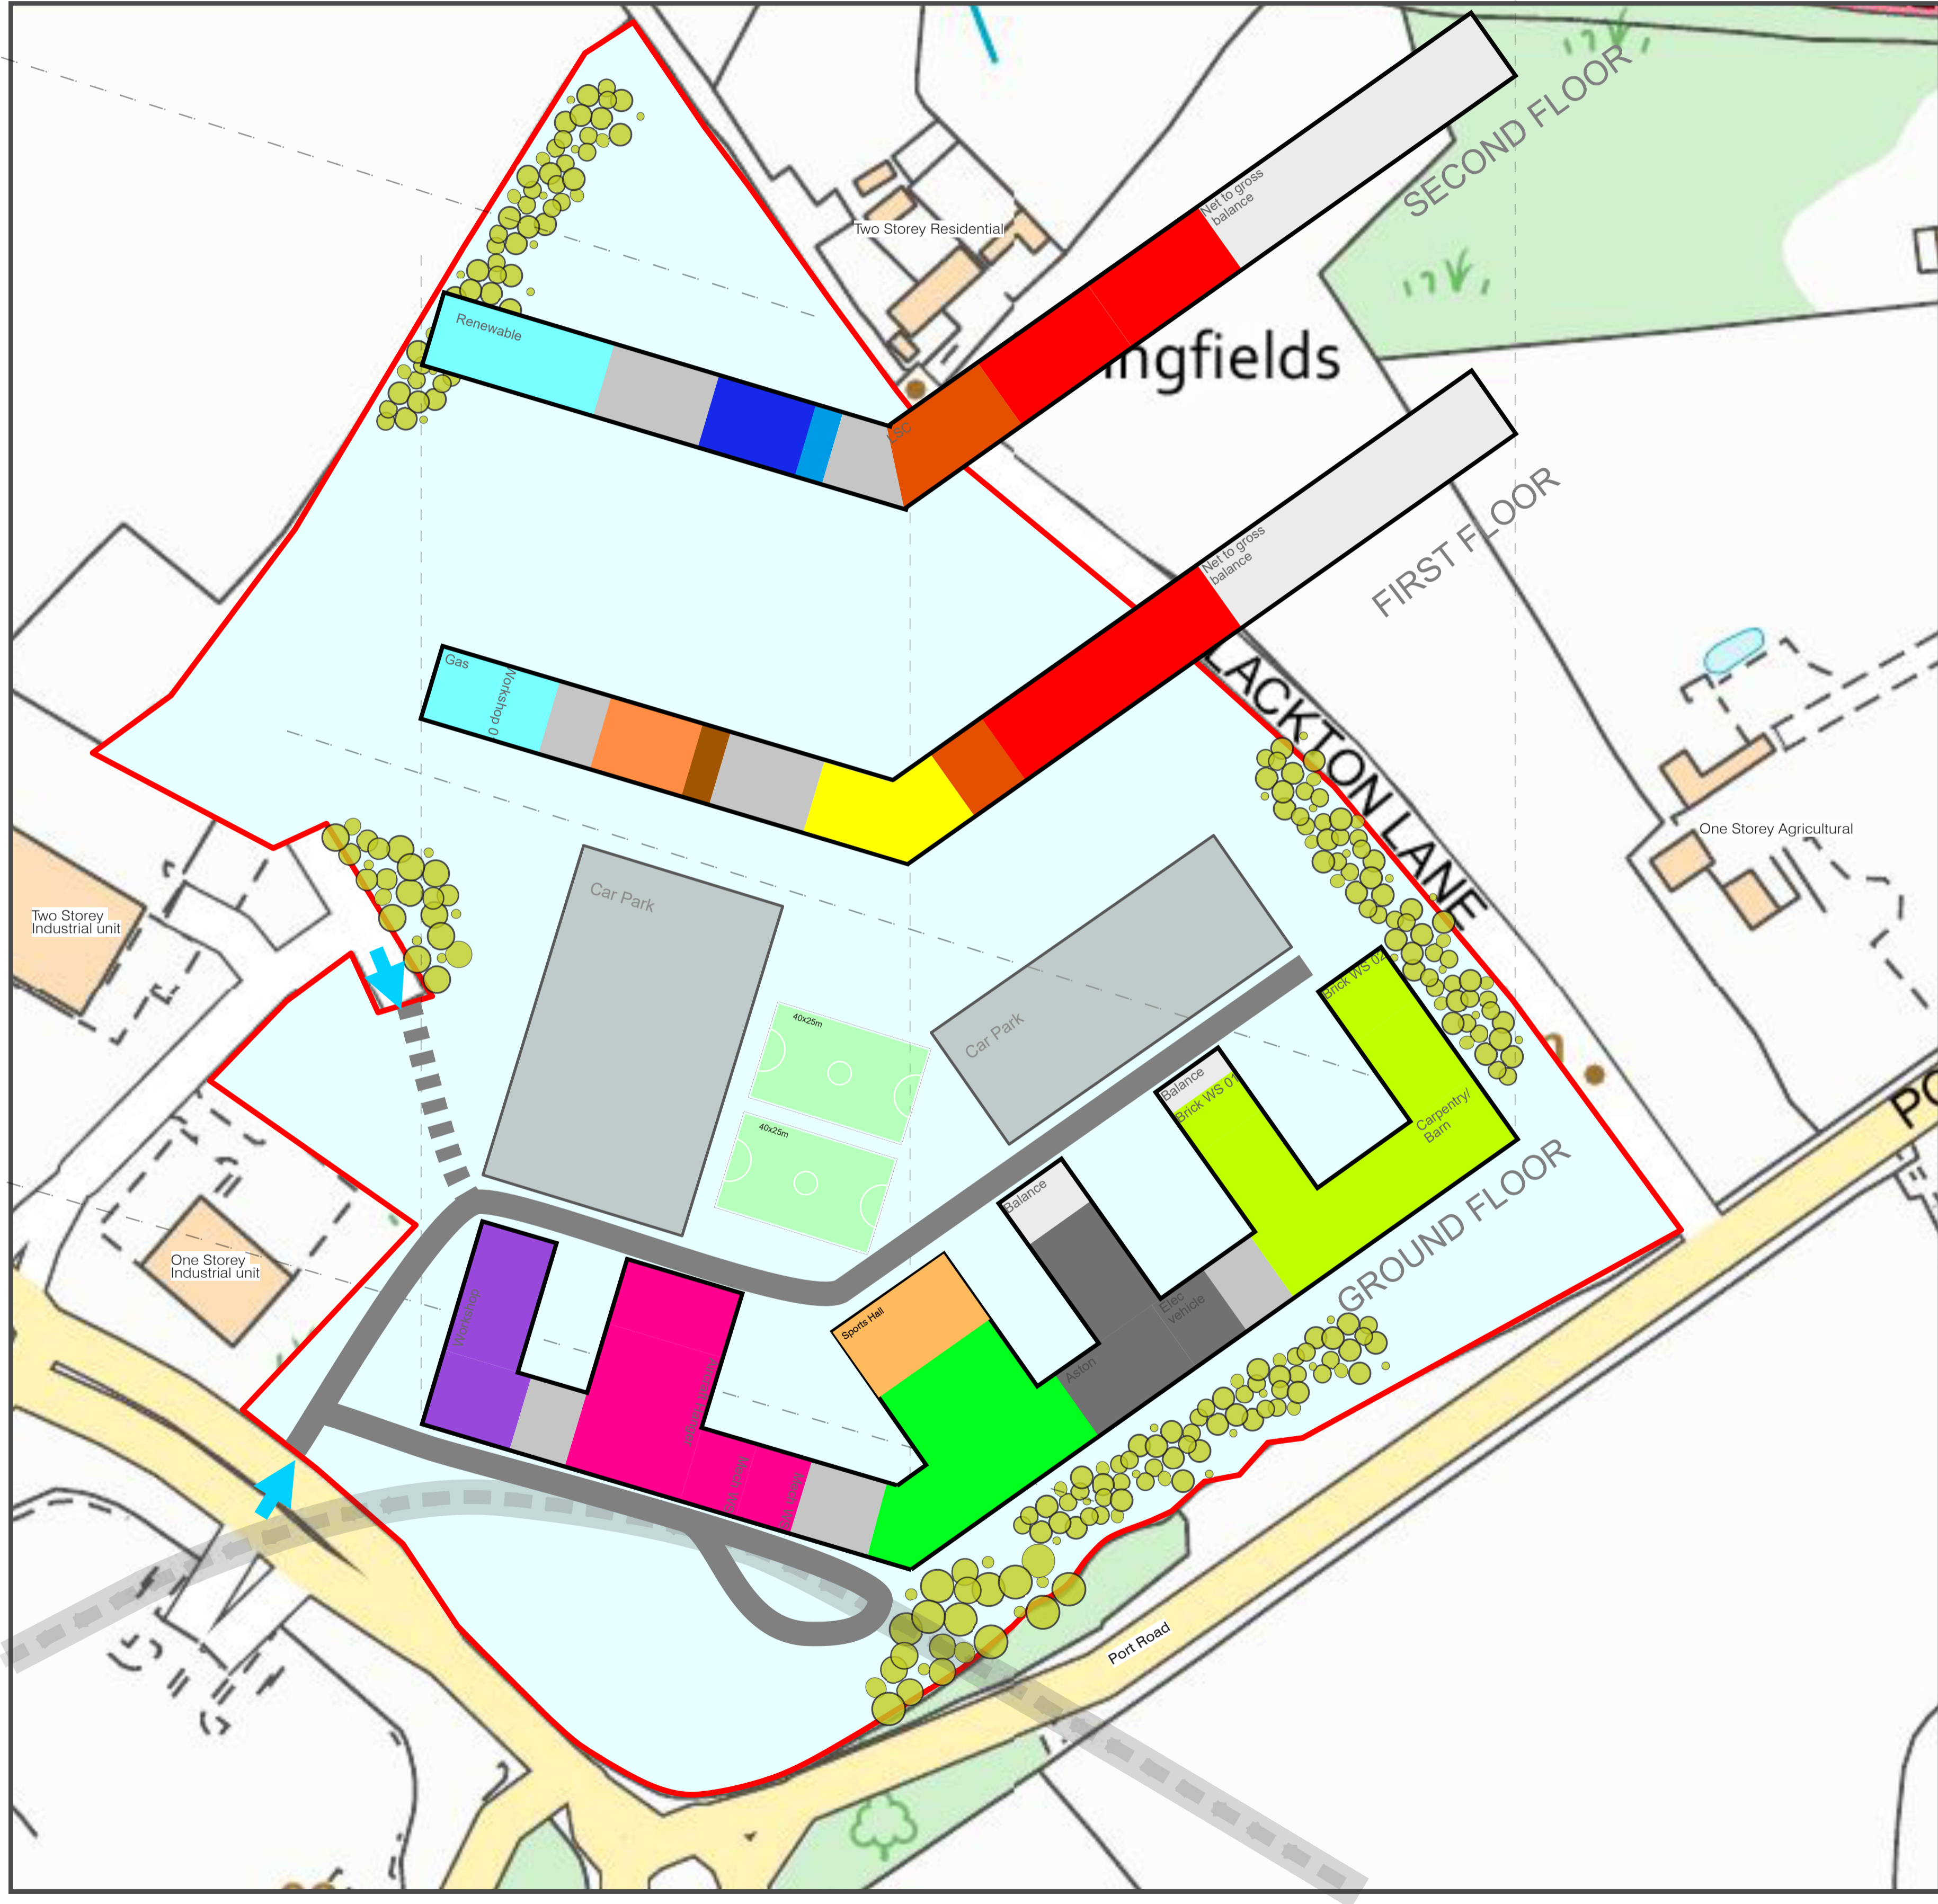
Appendix II

CAVC Rhoose Advanced Technology Centre	
College Specifics:	
No. of pupils	TBC
FTE staff	TBC
Total Building Area / m2	
General teaching	1,633
IT & CAD teaching	330
HE Business	562
Non-Curriculum	1,068
Student Services	95
Engineering	757
Motor vehicle	933
Building Services	991
Construction	1,901
Aerospace Engineering	1,319
Cabin crew	95
Math & labs	341
LSC	608
Sports Hall	594
Net Total	11,227
Circulation	2,000
Net to Gross Balance	2,519
Gross Total	15,996
External Spaces	
Spaces	TBC
Parking	
No. of Spaces	TBC

- Points of Note.**
- Adjacencies to be developed with CAVC - test to fit is indicative.
 - 50% of building programme is required to be on ground floor. Some spaces may need to be multi-story.

At the time of writing, an indicative test to fit plan was made available, this can be found within Appendix II. The plan proposes the construction of a three-storey educational facility on the site with associated car parking, sports areas and soft landscaping.
