Leckwith Quay, Cardiff and Vale of Glamorgan

Archaeological desk-based assessment

August 2019

A report for Gareth Davies Project Services By Sophie Lewis-Jones BA ACIfA GGAT report no. 2019/041 Project no. P2020 National Grid Reference: ST 15894 75207

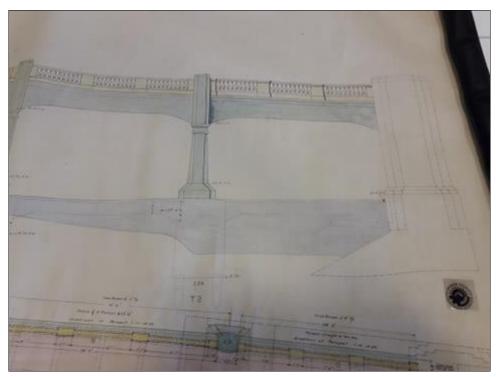
Plate 2. Extract from 1930s plans for the new bridge at Leckwith

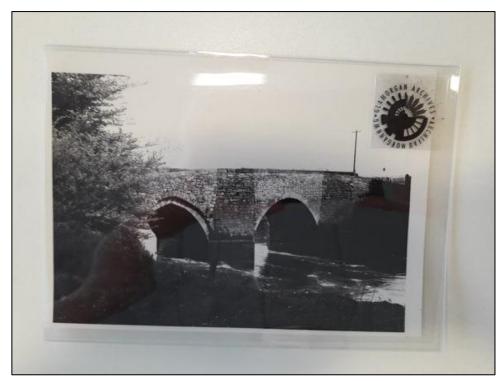
Plate 3. Photograph of Leckwith Bridge (00134S/GM014/LB13748/LB26487/24126) to the west (1952-1973)

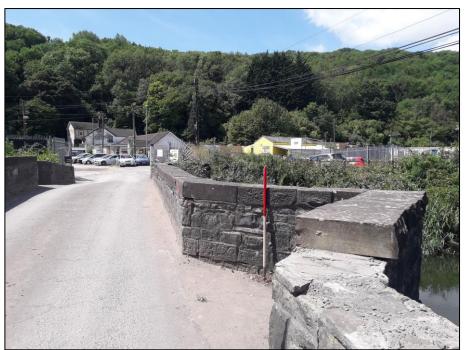
Plate 6. Eastern end of Leckwith Bridge 00134s/GM014/LB13748/LB26487/24126 (Scale: 0.5m divisions)

ID 00134s **Name** Leckwith Bridge **Type** Medieval, Bridge, Rank: 1 **NGR** ST15907524 **Description** Leckwith Bridge has three arches, two being pointed with double arch-rings built in two orders, but the middle arch has been rebuilt. **Condition** Restored Year: 1977 **Status** Scheduled Monument GM014, listed building 13748 II* **Rarity** rarity **Group** Association g_ass Historical Association h_ass **Confidence** con **Value** value **Effect** effect

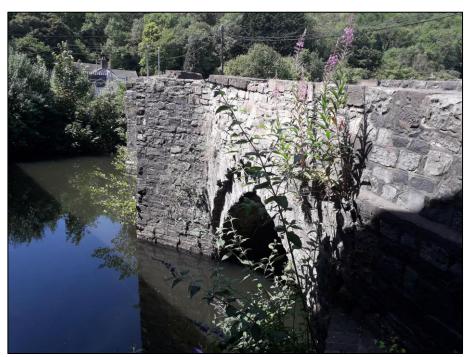
Plate 7. View of Leckwith Bridge 00134s/GM014/LB13748/LB26487/24126 from 307689 towards the north

An effect of 'Considerable' was assigned to the site of Leckwith Bridge (00134s/ GM014/ LB13748/ LB26487/ 24126), due to the relatively flat nature of the development area, and the close proximity of the bridge to the proposed developments. However, it must also be noted that previous development has occurred immediately surrounding the bridge, most notably in the form of the Leckwith New Bridge and Viaduct (307689), forming the road, so the setting of the bridge has been previously compromised.

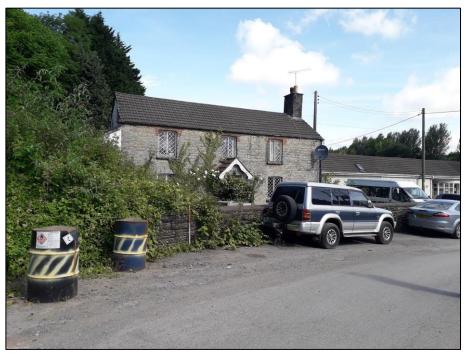
Plate 9. View to south of north facing elevation of Leckwith Bridge House (LQ001) (Scale: 0.5m divisions)

In addition to the recommended archaeological watching brief mitigation, it is considered that Leckwith Bridge House (LQ001) should be mitigated by means of a Level 3 building survey and Leckwith New Bridge and Viaduct (307689) and Drain cover (LQ005) should be mitigated by means of a photographic survey.

HER Field Name	Field Definition
Historic Asset UID/PRN	LQ001
Site Name	Leckwith Bridge House
Summary Welsh	Tŷ wedi'i labeli 'Bridge Farm' ar Fap Ystad 1824.
Summary English	House labelled 'Bridge Farm' on 1824 Estate Map.
Description	House labelled 'Bridge Farm' in 1824. This changed to 'Cardiff Arms Public House' by 1841 Tithe Map, then 'Leckwithbridge' on 1st Edition OS Map (1880). Subsequently as 'Leckwith
1107	Bridge House' from 2 nd Edition OS Map (1901) to 4 th Edition (1941).
NGR	ST1585975203
Easting	
Northing	
NGR Qualifier	
NGR Derivation	
Туре	House
Period	Unknown
Survival Condition	Intact
Condition Rating	
Condition Description	
Broad class	Structure
Evidence	Map Regression
Year	2019
References	-
Record Complied By	Sophie Lewis-Jones
Record Complied On	13/08/2019
Copyright Holder	GGAT Ltd.

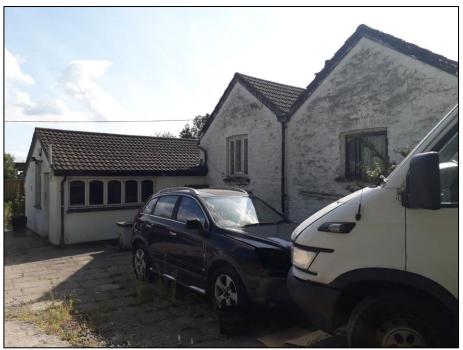
Plate 10. View to south facing elevation of Leckwith Bridge House (LQ001)

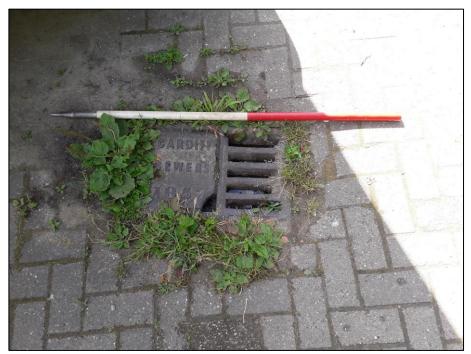
Plate 11. Drain cover (LQ005) towards the east (Scale: 0.5m divisions)

HER Field Name	Field Definition
Historic Asset UID/PRN	LQ005
Site Name	Drain cover
Summary Welsh	Gorchudd draen, Carthffosydd Caerdydd (1857)
Summary English	Drain cover, Cardiff Sewers (1857)
Description	Identified during site visit. Drain cover, Cardiff Sewers (1857)
NGR	ST1584075267
Easting	
Northing	
NGR Qualifier	
NGR Derivation	
Туре	Drain cover
Period	Post-medieval
Survival Condition	Intact
Condition Rating	
Condition Description	
Broad class	Drain
Evidence	Map Regression
Year	2019
References	-
Record Complied By	Sophie Lewis-Jones
Record Complied On	10/05/2019
Copyright Holder	GGAT Ltd.

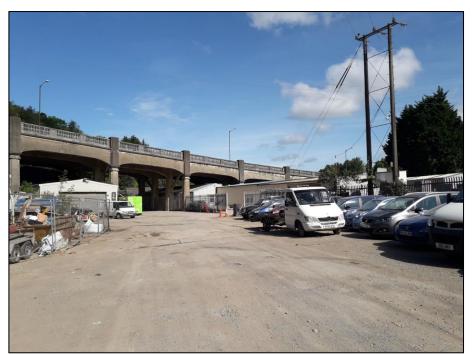
Plate 12. Leckwith New Bridge and Viaduct (307689) from south eastern end of development area to the northwest

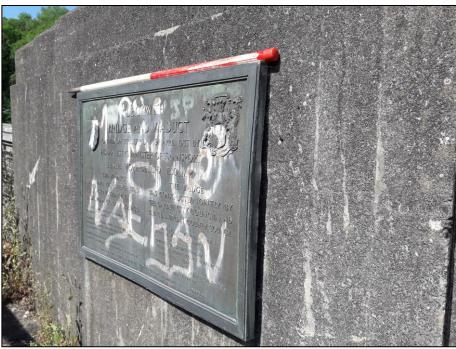
Plate 13. Plaque seen on Leckwith New Bridge and Viaduct (307689), view to north west (Scale: 0.5m divisions)

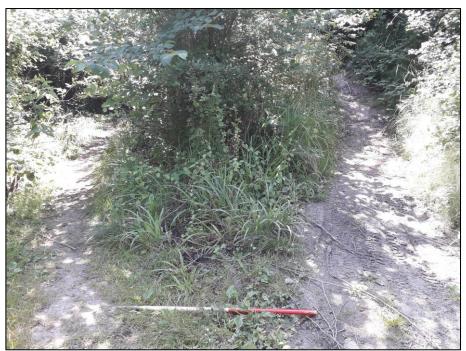
Plate 14. Location of features (04122s), (04120s) and (LQ002) to the west (Scale: 0.5m divisions)

ID 04120s **Name** Lime Kiln **Type** Post-Medieval, lime kiln, Rank: - NGR ST1585875115 **Description** 'Old Limekiln' recorded on 1st edition OS map 1880. **Condition** Not known Year: 2010 **Status** None recorded **Rarity** rarity **Group Association** g_ass **Historical Association** h_ass **Confidence** con **Value** value **Effect** effect

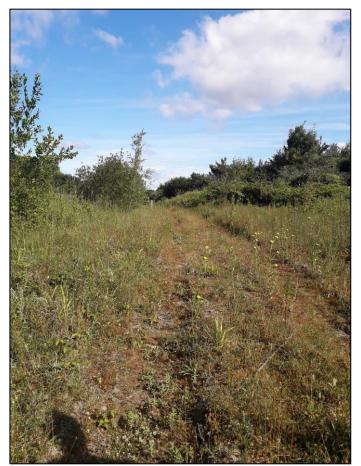
Plate 15. Location of Milestone (LQ004)

HER Field Name	Field Definition
Historic Asset UID/PRN	LQ004
Site Name	Milestone
Summary Welsh	'Carreg Filltir' wedi'i nodi ar Argraffiad Cyntaf Map 1880.
Summary English	'Milestone' noted on 1880 1st Edition Mapping.
Description	'Milestone' noted on 1880 1st Edition Mapping, onwards, labelled as 'Ely Station, Cardiff and
	Leckwith'
NGR	ST1595675280
Easting	
Northing	
NGR Qualifier	
NGR Derivation	
Туре	Milestone
Period	Post medieval
Survival Condition	Unknown
Condition Rating	
Condition Description	
Broad class	Milestone
Evidence	Map Regression
Year	2019
References	-
Record Complied By	Sophie Lewis-Jones
Record Complied On	10/05/2019
Copyright Holder	GGAT Ltd.

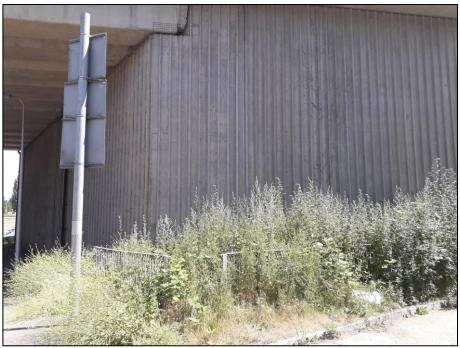
Plate 16. Former location of cottage LQ003, view to the east

HER Field Name	Field Definition
Historic Asset UID/PRN	LQ003
Site Name	Cottage
Summary Welsh	Adeiledd (bwthyn) wedi'i gofnodi ar Fap Degwm (1841).
Summary English	Structure (cottage) depicted on Tithe Map (1841)
Description	Rectangular structure seen on Landough, Cogan and Leckwith Parish Tithe Map (1841). Parcel
_	325, apportionment name- cottage and garden.
NGR	ST1595675280
Easting	
Northing	
NGR Qualifier	
NGR Derivation	
Туре	Structures
Period	Unknown
Survival Condition	Near Destroyed
Condition Rating	
Condition Description	
Broad class	Structure
Evidence	Map Regression
Year	2019
References	-
Record Complied By	Sophie Lewis-Jones
Record Complied On	13/08/2019
Copyright Holder	GGAT Ltd.

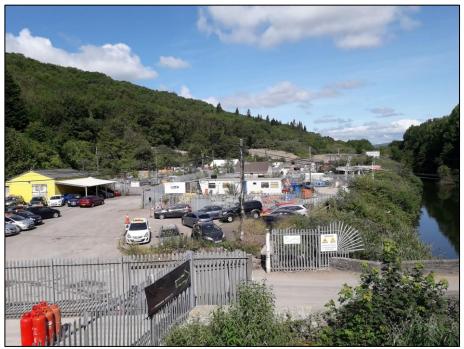
Plate 17. View to the northwest and location of Old Weir LQ002

HER Field Name	Field Definition
Historic Asset UID/PRN	LQ002
Site Name	Old Weir
Summary Welsh	'Hen Gored' wedi'i nodi ar Argraffiad Cyntaf Map 1880.
Summary English	'Old Weir' noted on 1880 1st Edition Mapping.
Description	'Old Weir' noted on 1880 1st Edition Mapping.
NGR	ST1582375267
Easting	
Northing	
NGR Qualifier	
NGR Derivation	
Туре	Weir
Period	Post-medieval
Survival Condition	Near Destroyed
Condition Rating	
Condition Description	
Broad class	Industrial
Evidence	Map Regression
Year	2019
References	-
Record Complied By	Sophie Lewis-Jones
Record Complied On	13/08/2019
Copyright Holder	GGAT Ltd.
