**PROPOSED HIGHWAYS WORKS,  
FORT ROAD, PENARTH**

**STAGE 1 - ROAD SAFETY AUDIT  
MARCH 2022**

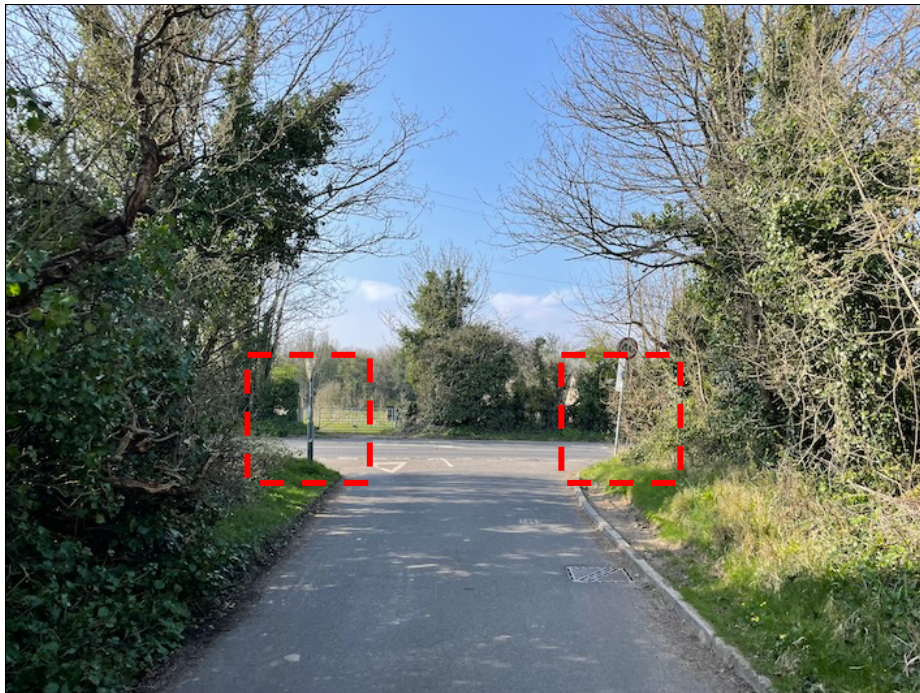
**Photograph 1:** Restricted intervisibility at the crossing point.

- 2.1 The intervisibility splays at the Fort Road/ Lavernock Road junction is considered to be insufficient between vehicles approaching the junction from Fort Road and the shared use crossing point (Ref: **Photograph 1**). Restricted intervisibility at the crossing points could result in an increased risk of vehicle collisions with pedestrians/cyclists.

- 2.2 It is recommended that sufficient intervisibility splays be provided at the crossing point.
