**HILLSIDE COTTAGE,
LECKWITH**

PLANNING STATEMENT

TO REGULARISE THE IMPORTATION OF SOILS AND INERT WASTE FOR USE IN GROUND
STABILISATION AND TREE PLANTING WORKS AT: HILLSIDE COTTAGE, LECKWITH, Cardiff

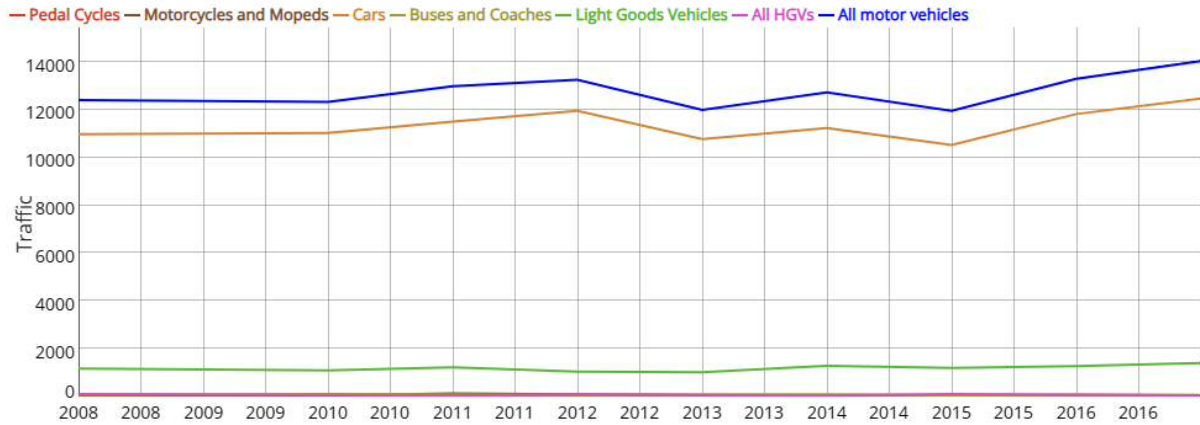
6.5 Figure 1 below indicates the volume of traffic on Leckwith Hill (figures only available to 2016)

Traffic by Year

Street Name: Leckwith Road, Road Number: B4267, Road Type: Class B Road, OS Grid: ST157738, Location: Cardiff, Census Point ID: 951340, Census Point Coverage: B4267, Leckwith Road

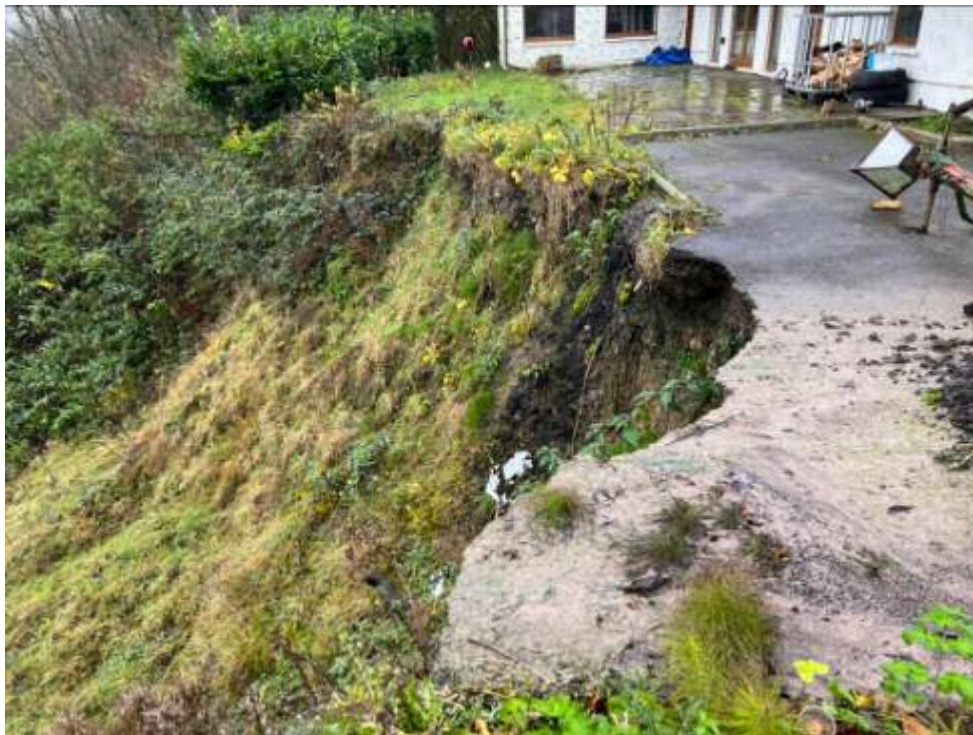
Photograph 1

to the application site resulted in storm damage and erosion to the applicant's property, which has resulted in severe erosion and the structural instability of Hillside Cottage. The flood waters running through the application site, which undermined the foundations of the applicant's property is captured on video footage and clearly illustrates the physical damage caused. The professional advice proffered to the applicants by structural engineers was unequivocal - 'Unless something is undertaken urgently to support the dwelling and the driveway, they will be washed away and would fall into the adjacent void created by the flood water from the public highway'.'

The circumstances illustrated above are particularly pertinent to the current planning application and to the '*counter-proposal*' which advocates the removal of the tipped material. Whilst the consequences damage to the applicant's land is potentially a civil matter between the applicant and Local Highway Authority, there is no doubt that the public highway drainage infrastructure adjacent to the application site is not fit for purpose and contributed significantly to damage to the applicant's property. The flood damage, subsidence and land/mud-slippage has severely compromised the applicant's property by flood damage resulting in structural instability.

4.2 Prior to the development taking place the most significant physical hazard to Hillside Cottage was the void which lay adjacent area occupied by Hillside Cottage and its curtilage (**See Photograph 1**). Within this area the unrestored ground levels fell to by some 25m. Accordingly 'doing nothing' to address this was not considered as a feasible option and an appropriate engineering solution was required both to remove the hazard and ensure the long term stability of Hillside Cottage.
