Cardiff and Vale College - Advanced Technology Centre (ATC)

Ground Investigation Report

Reference: VG0101-ARP-ZZ-ZZ-RP-G-00001

Version 02 | 25 March 2024

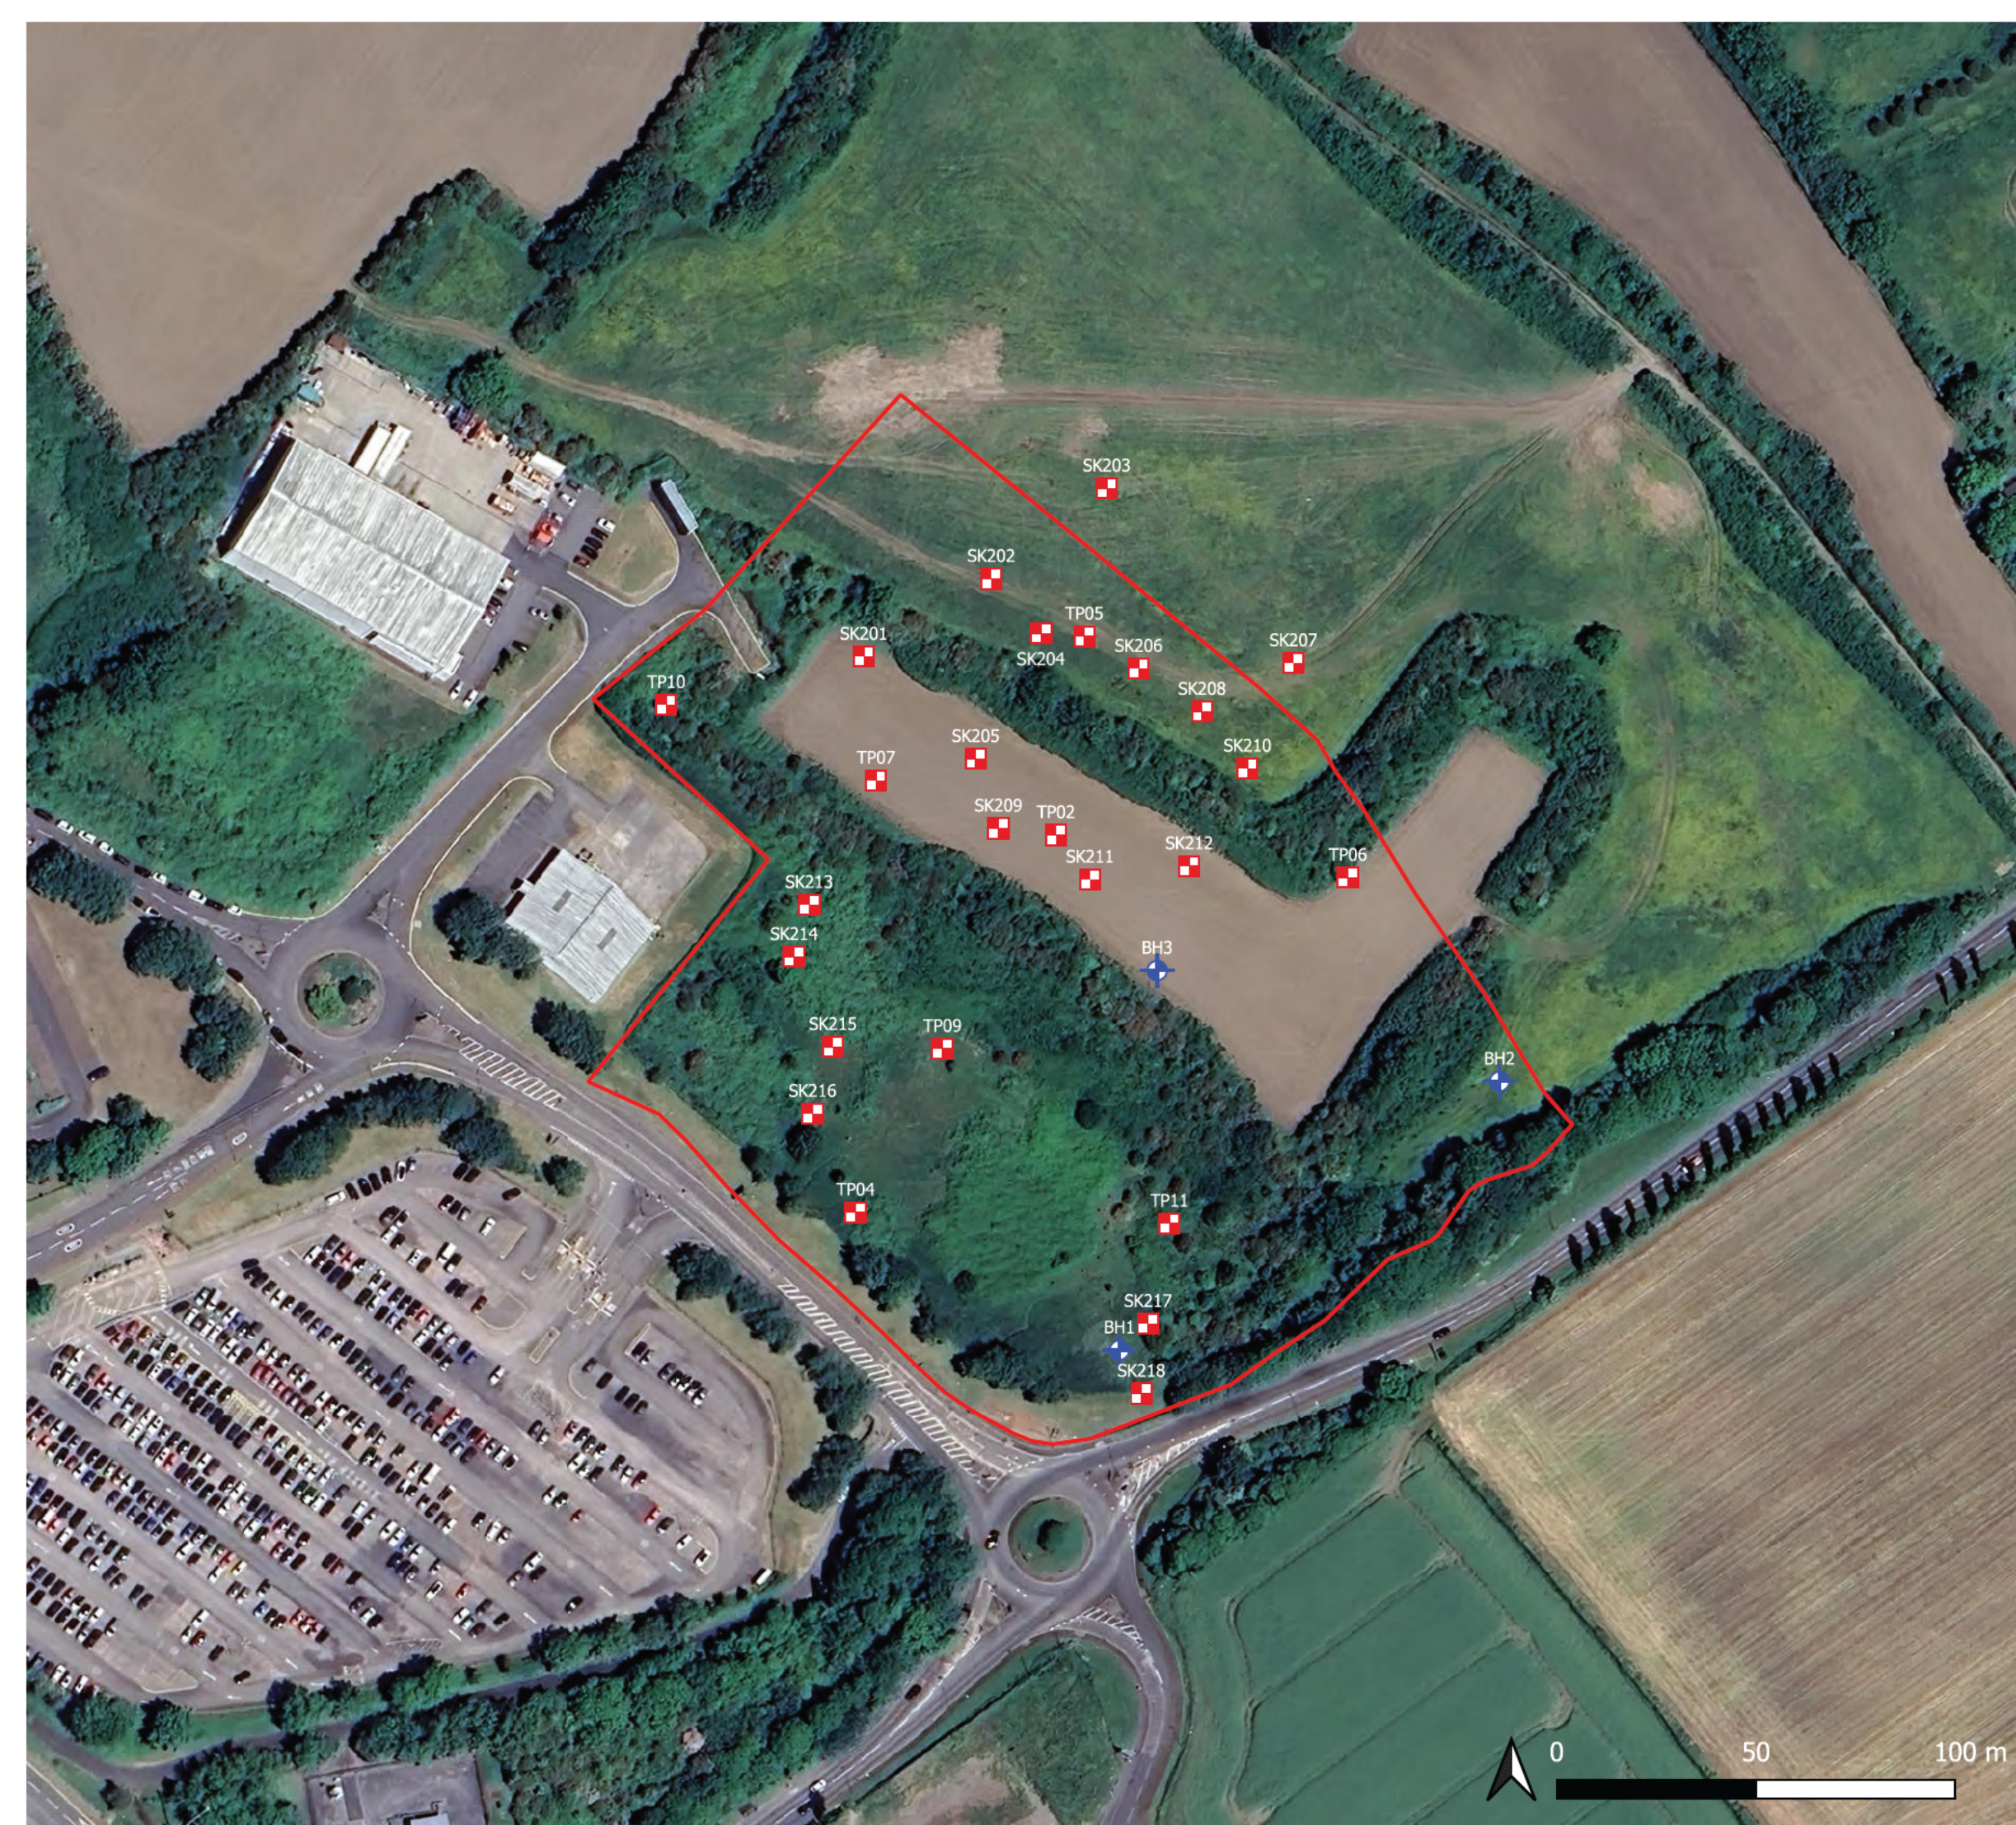
Drawing 2 – Exploratory hole location plan

- Site boundary
- Exploratory holes (GI 2023):
 - + Rotary borehole
 - Trial pit

- 26No. machine excavated trial pits across the site to a maximum of 2.0mbgl to confirm the ground conditions and groundwater level, and collect soil samples for laboratory analysis;
 - soakaway infiltration testing within 21No. of the above-mentioned trial pit locations;
 - plate load tests undertaking within four of the above-mentioned trial pit locations;
- Three rotary open hole boreholes conducted to a maximum depth of 2.0mbgl with rotary core drilling follow-on to a maximum depth of 7.0mbgl distributed across the site;
 - standard penetration tests carried out within the exploratory holes to 5.0mbgl;
 - falling head tests carried out in the competent limestone encountered within the exploratory holes.
- Soil and rock sampling and associated laboratory testing for geotechnical and chemical purposes.

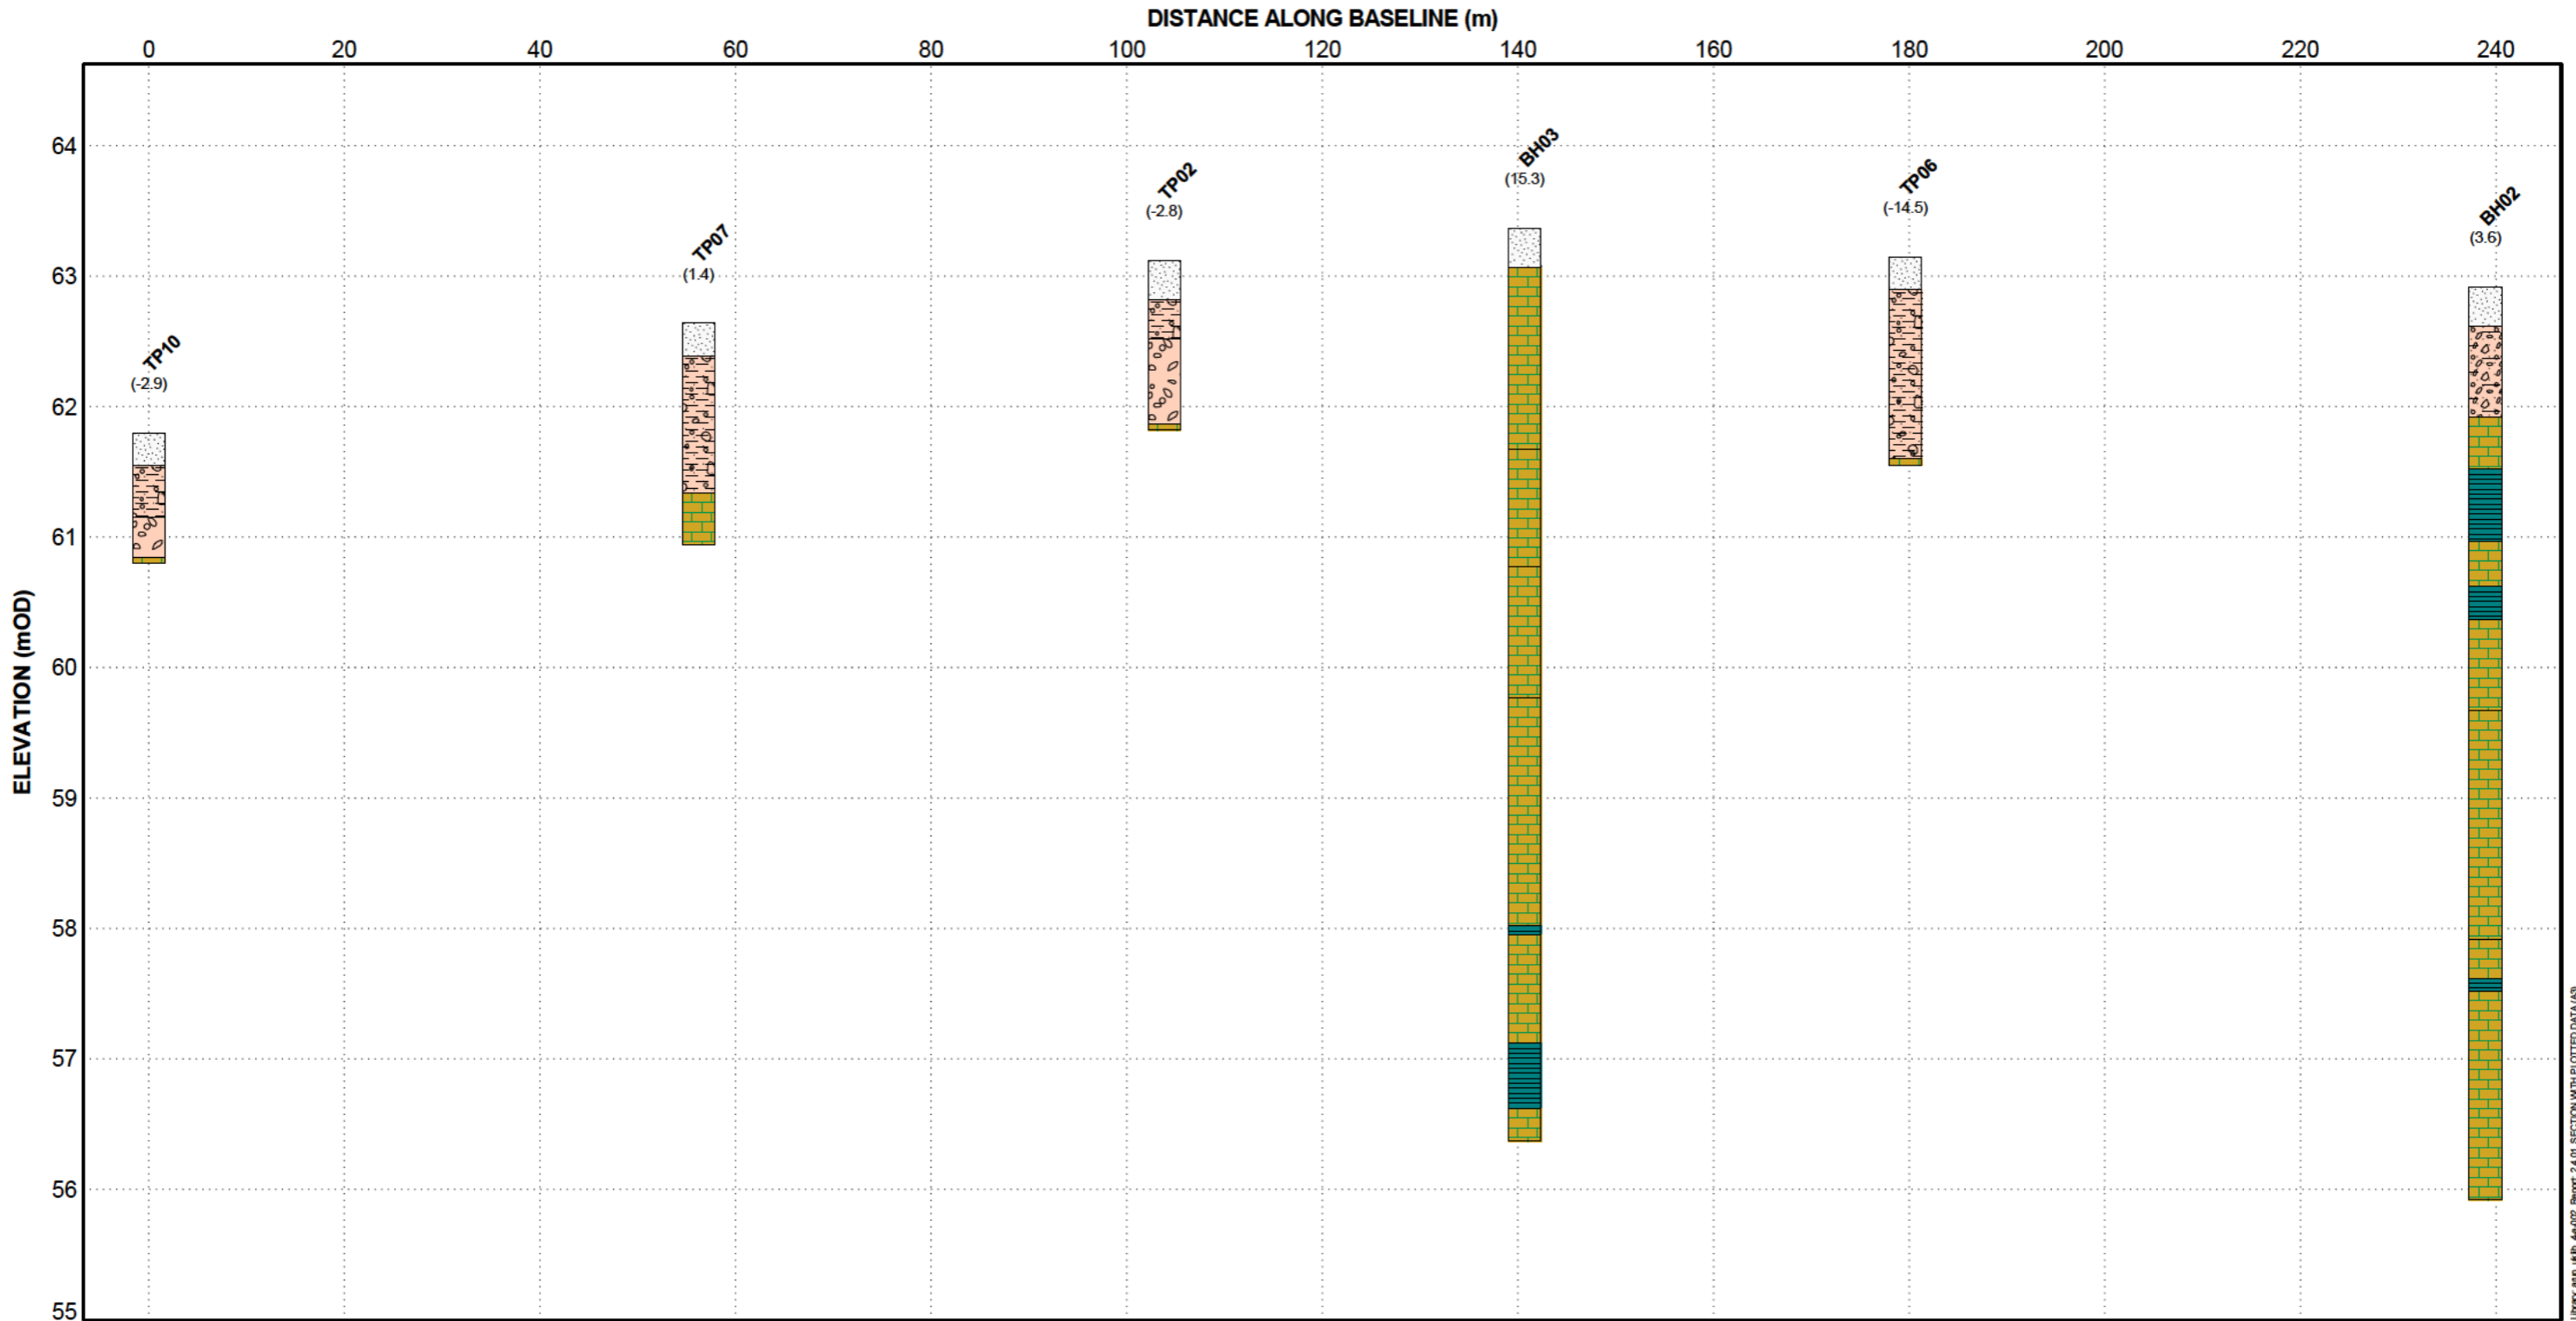
Drawing 4 – Stratigraphic cross section NW-SE

- Topsoil [TOP]
- Mudstone [Mud]
- Head Deposits [HDD]
- Limestone [Lst]

The characteristic levels listed in the table represent a generalised sitewide stratigraphy. However, it should be noted that there is variation in strata levels encountered across the site.

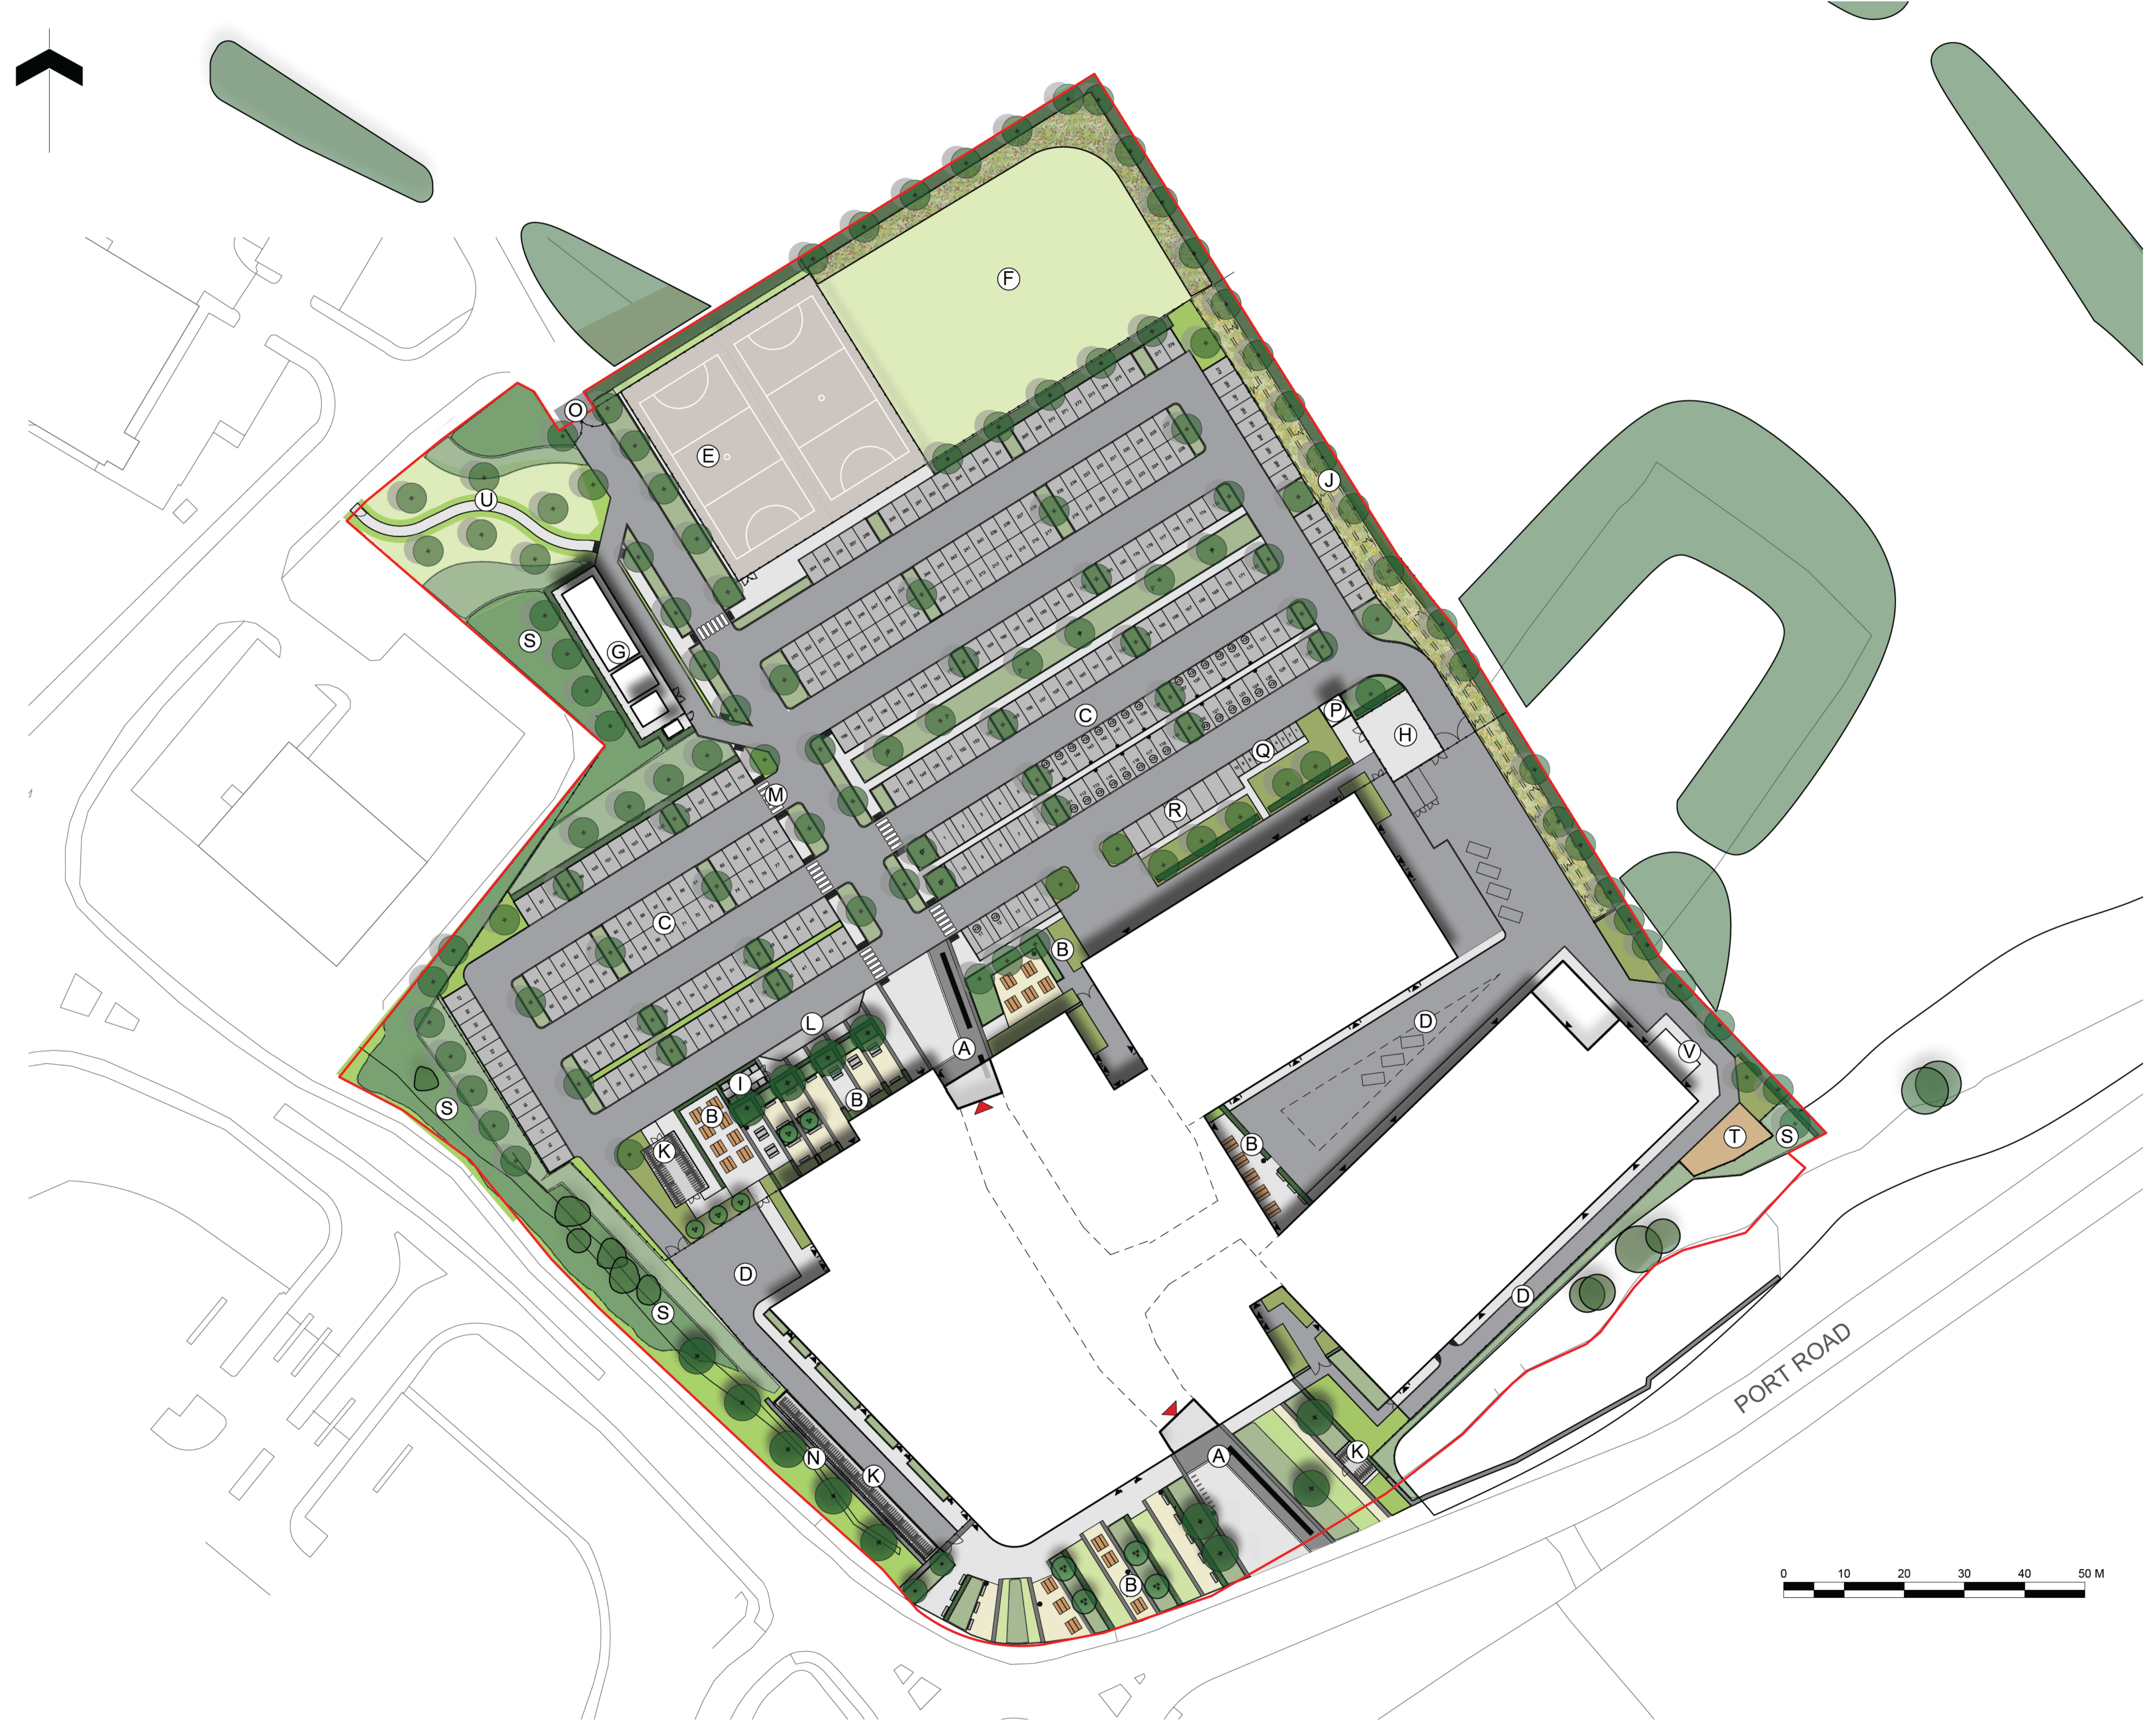
Appendix II

- KEY**
- (A) Entrance Plaza to Building
 - (B) Social Space
 - (C) Car Park
- 294 standard parking spaces (inc. 32no. as EVCPs and 14 Accessible Parking Spaces)
 - (D) Service area for workshop students
 - (E) 2 Court MUGA
 - (F) Meadow Planting and Habitat Area
 - (G) Sprinkler Tank System
 - (H) Air Source Heat Pump
 - (I) Bin Store
 - (J) Swale with Hedgerow and tree planting
 - (K) Cycle Parking (Double Stacked)
- Total 284 long stay bicycle spaces
 - (L) Pick up / Drop off / Delivery bay
 - (M) Access through car park to MUGA
 - (N) Retaining Wall
 - (O) Access controlled vehicular entrance
 - (P) External HV Unit
 - (Q) Motorcycle parking
10 spaces
 - (R) Motor Vehicle Workshop parking spaces
8 spaces
 - (S) New native buffer planting
 - (T) External digging area
 - (U) Cherry Tree Walk
Pedestrian access route
 - (V) Dust extractor

- Development of a multi-use College building with facilities for lecturing, teaching and dining. Building is likely to have shallow foundations.
- Hardstanding in the form of car parking covering the majority of the northern site area, which includes permeable surfacing and raingardens.
- Soft landscaping on the fringes of the site.
