**COWBRIDGE COMPREHENSIVE, ABERTHIN ROAD,  
COWBRIDGE, VALE OF GLAMORGAN**

**SURVEY FOR BATS AND REPTILES**

**September 2017**

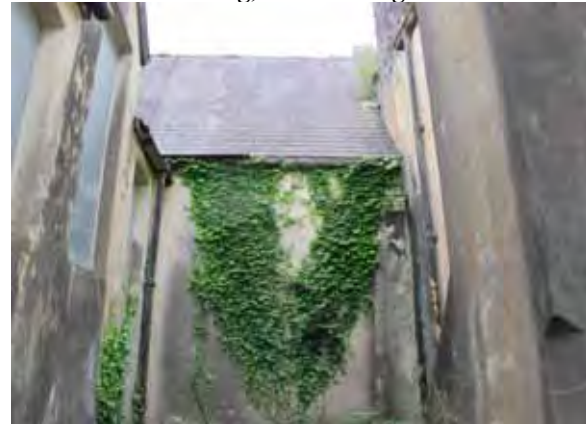
Main building, rear courtyard, site of high bat activity

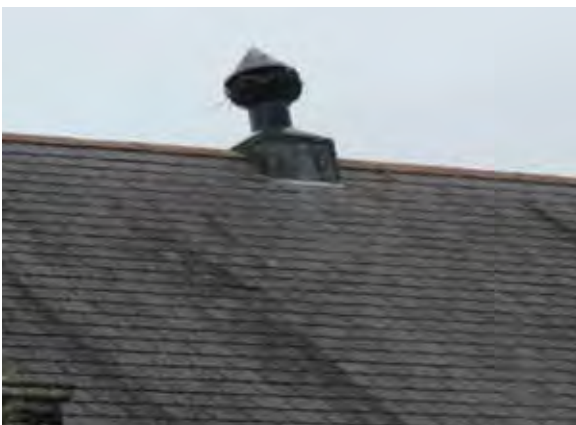
Roof vent with evident nesting bird material

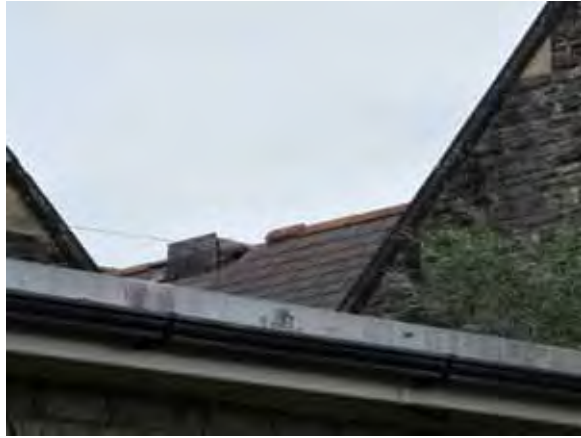
**Missing ridge tiles providing potential roost feature**

bats were recorded flying around the roof of the main school building shortly before dawn. One bat was seen to return to roost at the front of the main school building and another under a missing ridge tile towards the rear. Observations from surveyors suggest that it is highly likely that bats are roosting within other parts of the building although it was not possible to locate the exact re-entry points.

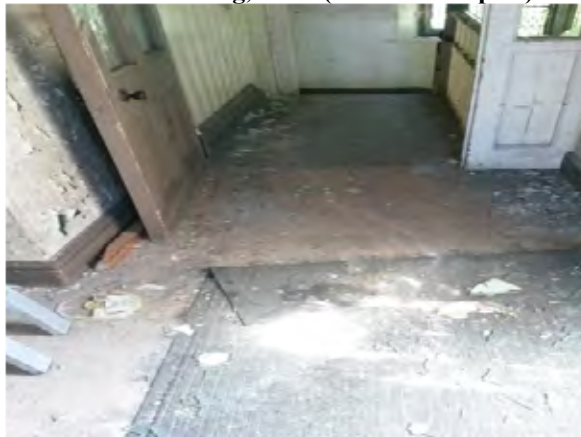
**Lesser horseshoe droppings within main school**

- 3.1.7 Main school building: No droppings, evidence of bats or bats themselves were recorded during the internal inspection on 16<sup>th</sup> August. However, when the static detectors were collected after the second placement on 31<sup>st</sup> August, fresh droppings characteristic of a lesser horseshoe bat, were found at three locations at floor level on the first floor of the main school building. The locations where droppings were found are shown on Plan 2. A large amount of bird nesting material was also noted within the fireplace in an upstairs room in the main school building.

- 4.1.1 The site is constrained in respect of bats. There is evidence indicating that bats occupy roosts in attic voids in several locations in the main school building and also use at least two rooms on the first floor of the building. Lesser horseshoe bat(s) were detected on static detectors within the roof spaces and droppings were found on the floor at three locations on the first floor of the main school building. Common pipistrelle were also recorded returning to roost within the main school building during the flight surveys and this species was also recorded on a static detector within the roof space.
