HAFOD HOUSING ASSOCIATION

COWBRIDGE SCHOOL, ABERTHIN ROAD, VALE OF GLAMORGAN

HIBERNATION SURVEY - ADDENDUM REPORT

DOCUMENT REF: E1884501/Doc 02. 12 NOVEMBER 2019

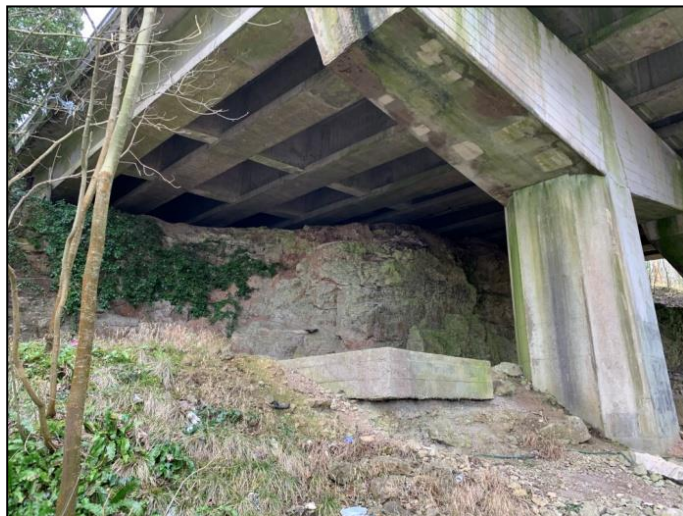
Plate 1 – Roost under A48 flyover

3.9 Following consultation with the ecologist suggested to us by the local authority ecologist, the location of the previously identified hibernation roost was discovered and is shown in Appendix IV and on Plate 1. It lies approximately 50m northeast of the site. Inspection of this roost found that works have been undertaken to repair and fill gaps (Plate 2). A scattering of droppings, including some old ones were seen and feeding remains were present. It is considered that this roost is no longer used for hibernation purposes but is still active as a night roost and feeding perch.

- 4.3 No bats were seen during the inspections of the A48 flyover. Works have been undertaken to the bridge structure that reduces its suitability for hibernation and it is considered unlikely that this structure is currently used for hibernation purposes. It is considered that it may still be used as a night roost or feeding perch. The proposal will not have any detrimental impact on this roost due to its status and physical separation from the proposed development site.

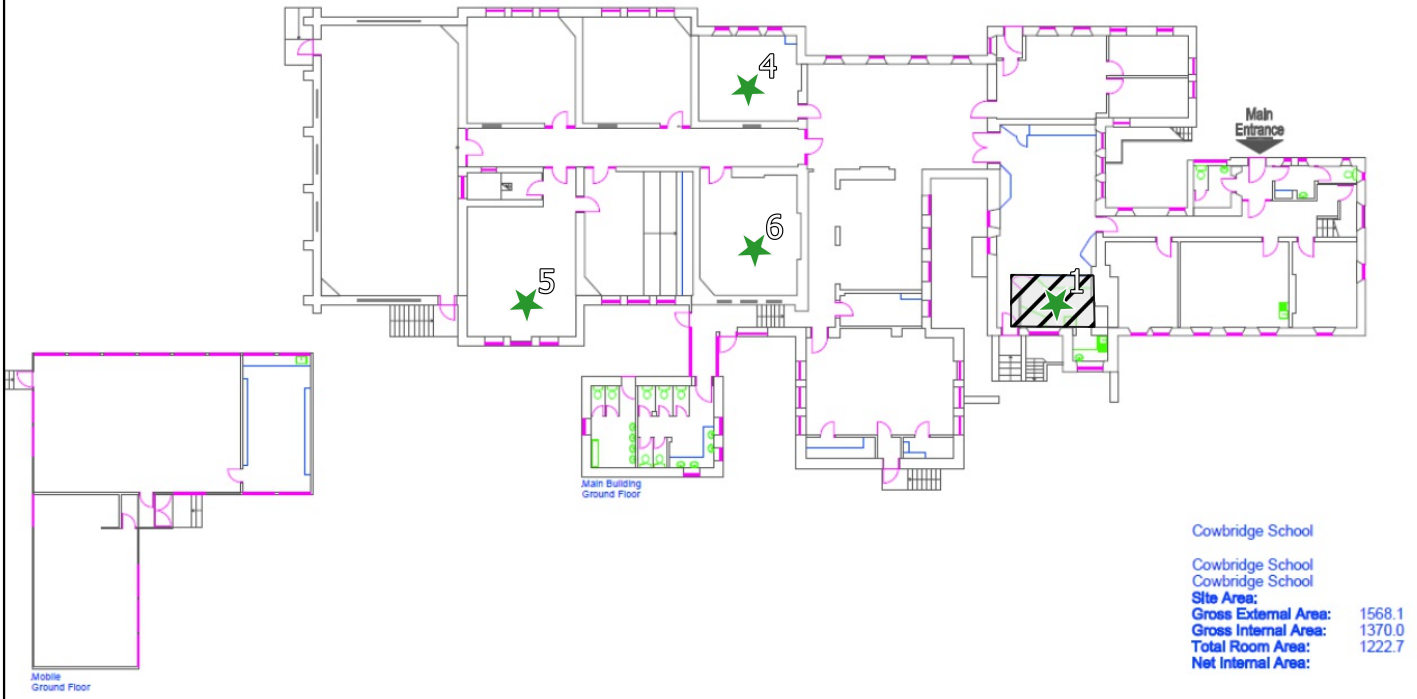
APPENDIX I BAT DETECTOR LOCATION PLAN

- 2.1 The bat hibernation surveys were undertaken from December 2018 – February 2019 (inclusive) by a suitably experienced and licenced ecologist.² Static bat detectors were placed within the basement, ground-floor and first-floor lofts of the former school building (Appendix I). A combination of Anabat Express units, Anabat SD2 units and Peersonic unit were used see Appendix II for full details. The detectors were left *in situ* for a two-week duration each month, with batteries replaced at the one-week interval. Recordings were later analysed via desktop bat analysis software.

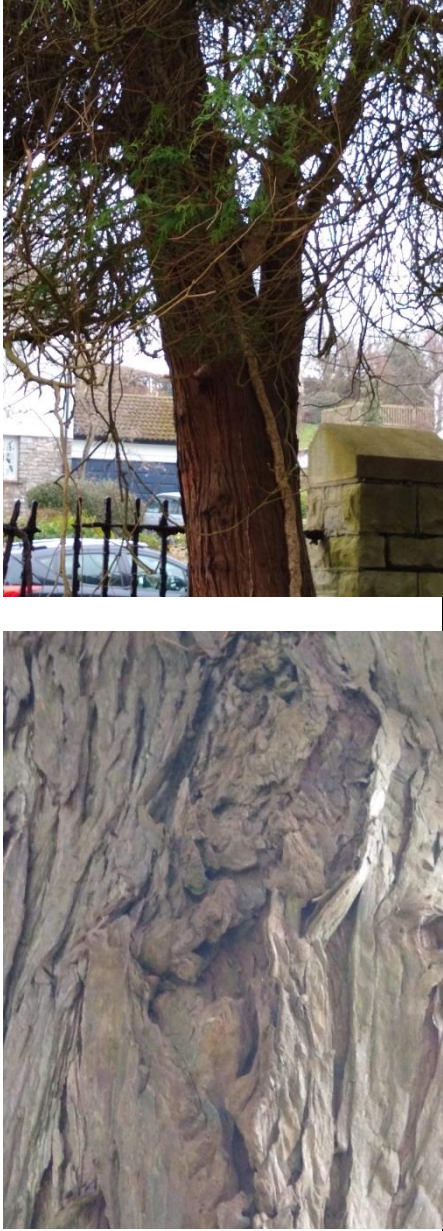
Map ID	Tree Species	DBH (m)	Details of features	Grade (H, M, L)	Picture
T1	Conifer sp.	0.75	Very shallow cracks in the trunk where the bark peels. Male sparrow being very vocal in this tree.	Negligible

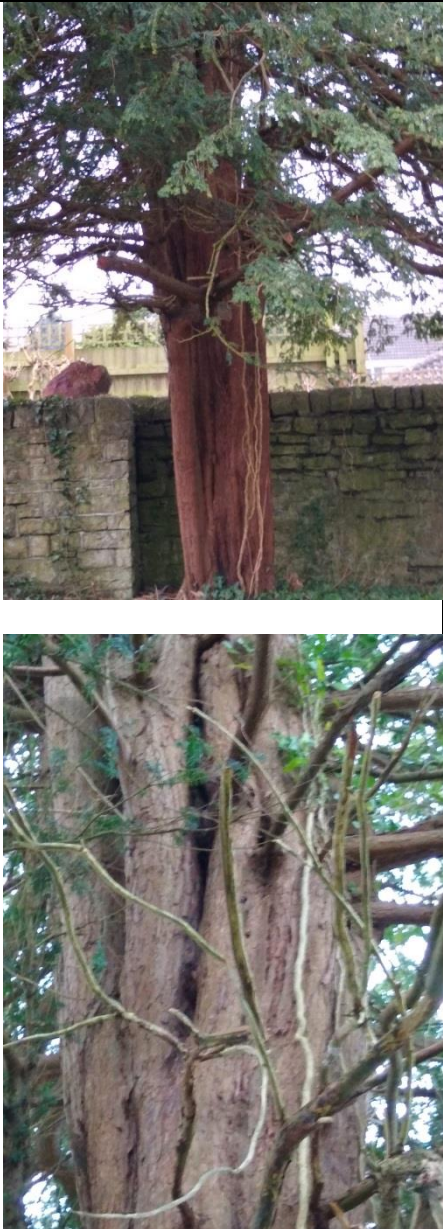
Map ID	Tree Species	DBH (m)	Details of features	Grade (H, M, L)	Picture
T2	Yew	2.5-3	<p>Small (5x10cm) hole in trunk about 0.5m from the ground, <10cm deep.</p> <p>Approx. 4m up main trunk, similar hole as described above but very shallow, doesn't go anywhere.</p>	Negligible

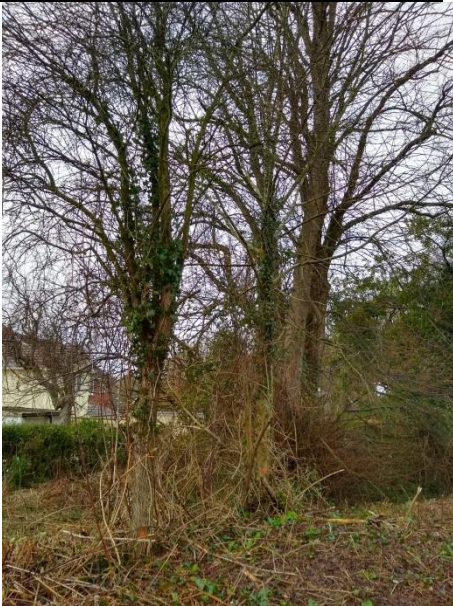
Map ID	Tree Species	DBH (m)	Details of features	Grade (H, M, L)	Picture
T3 & T4	Hawthorn & Ash	<0.5	None	Negligible

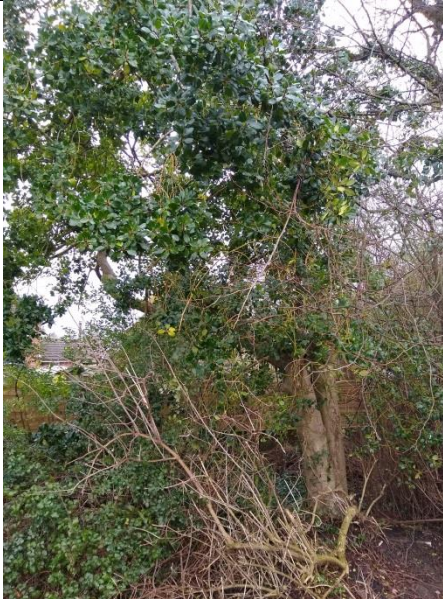
3.7 A single Holly Highclere *Ilex x altaclerensis* located within the ditch at the southern boundary of the site was initially considered to have a low potential to support roosting bats. The tree contained potential bat roosting features including some pruning wounds and thick ivy cover. A deeper hole was located along the main limb which extends over the site boundary into a residential garden. After closer inspection (via ladder) it was discovered that this hole narrows and terminated at about 10cm depth. It showed no evidence of use by bats. Other trees on site were assessed to have negligible potential to support roosting bats (Appendix III).

T5	Highclere Holly	2 Double trunk	Some broken branch or pruning wounds – mostly shallow but one on the main limb (which goes across the site boundary into the residential garden) has a deeper hole. Closer inspection confirmed it is approx. 10cm deep and there are no signs of use by bats. A split limb with a large panel of bark lifted. A single thick ivy trunk up one site.	Initially L, but no further survey considered necessary

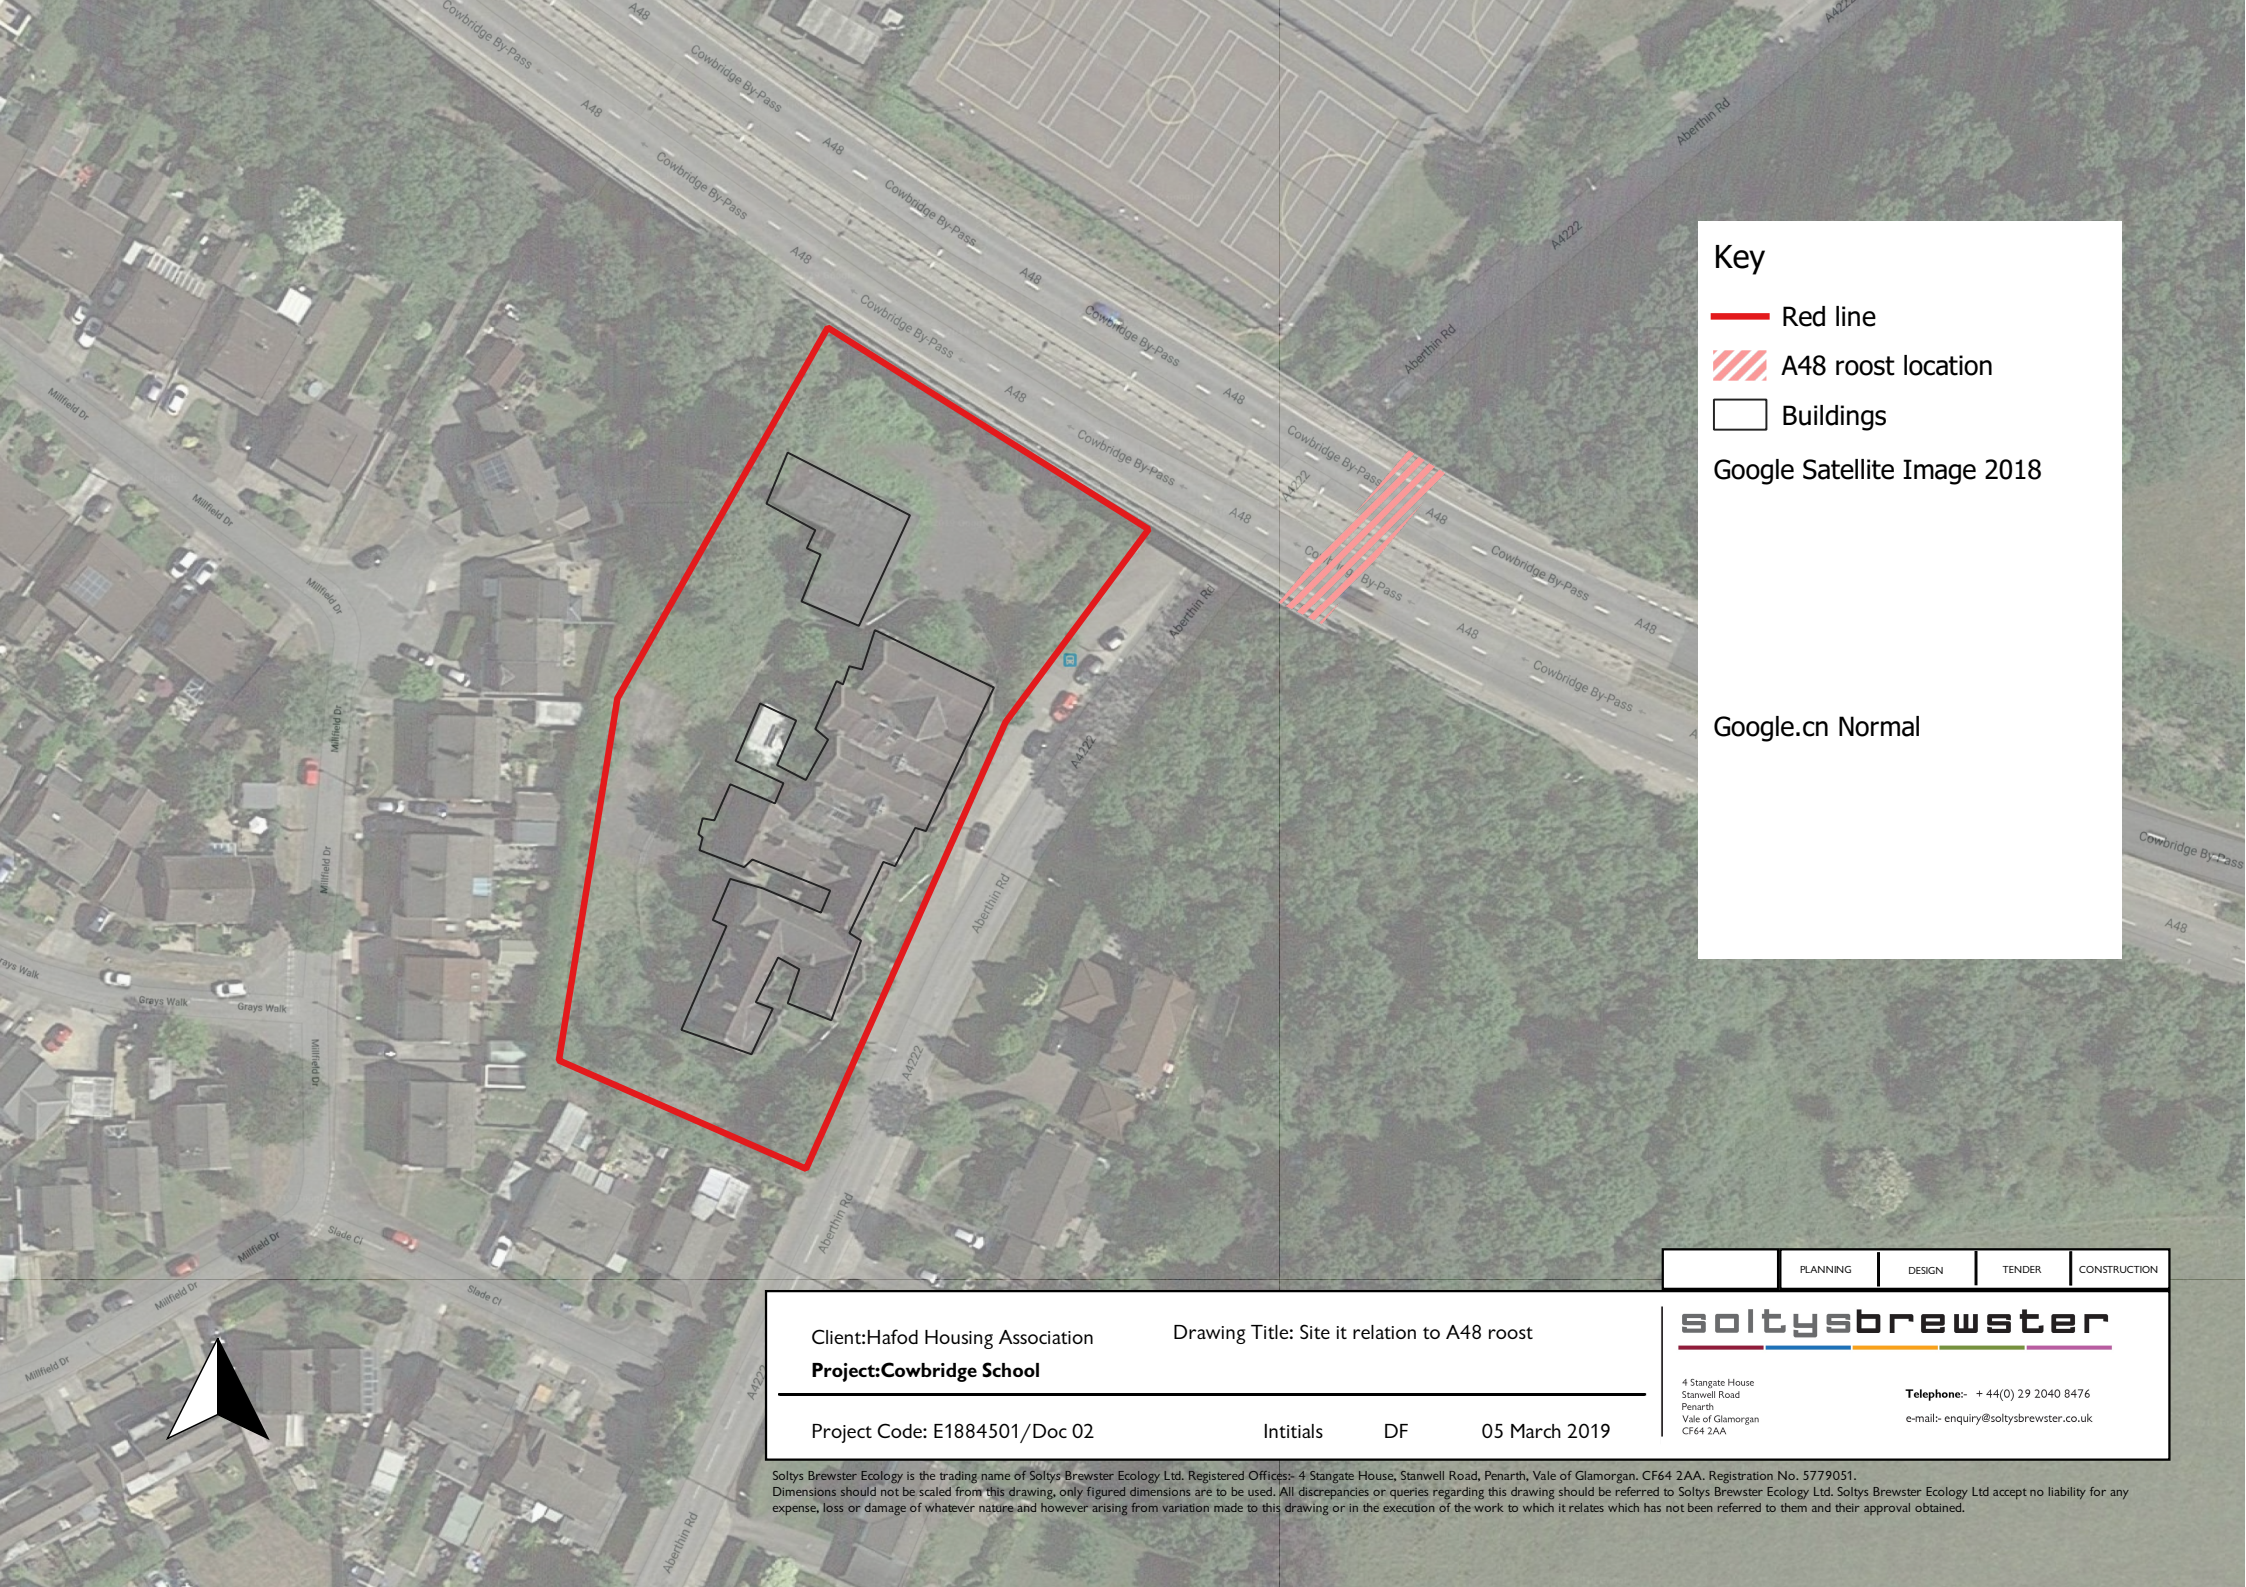
APPENDIX IV A48 FLYOVER ROOST LOCATION

A48 roost location

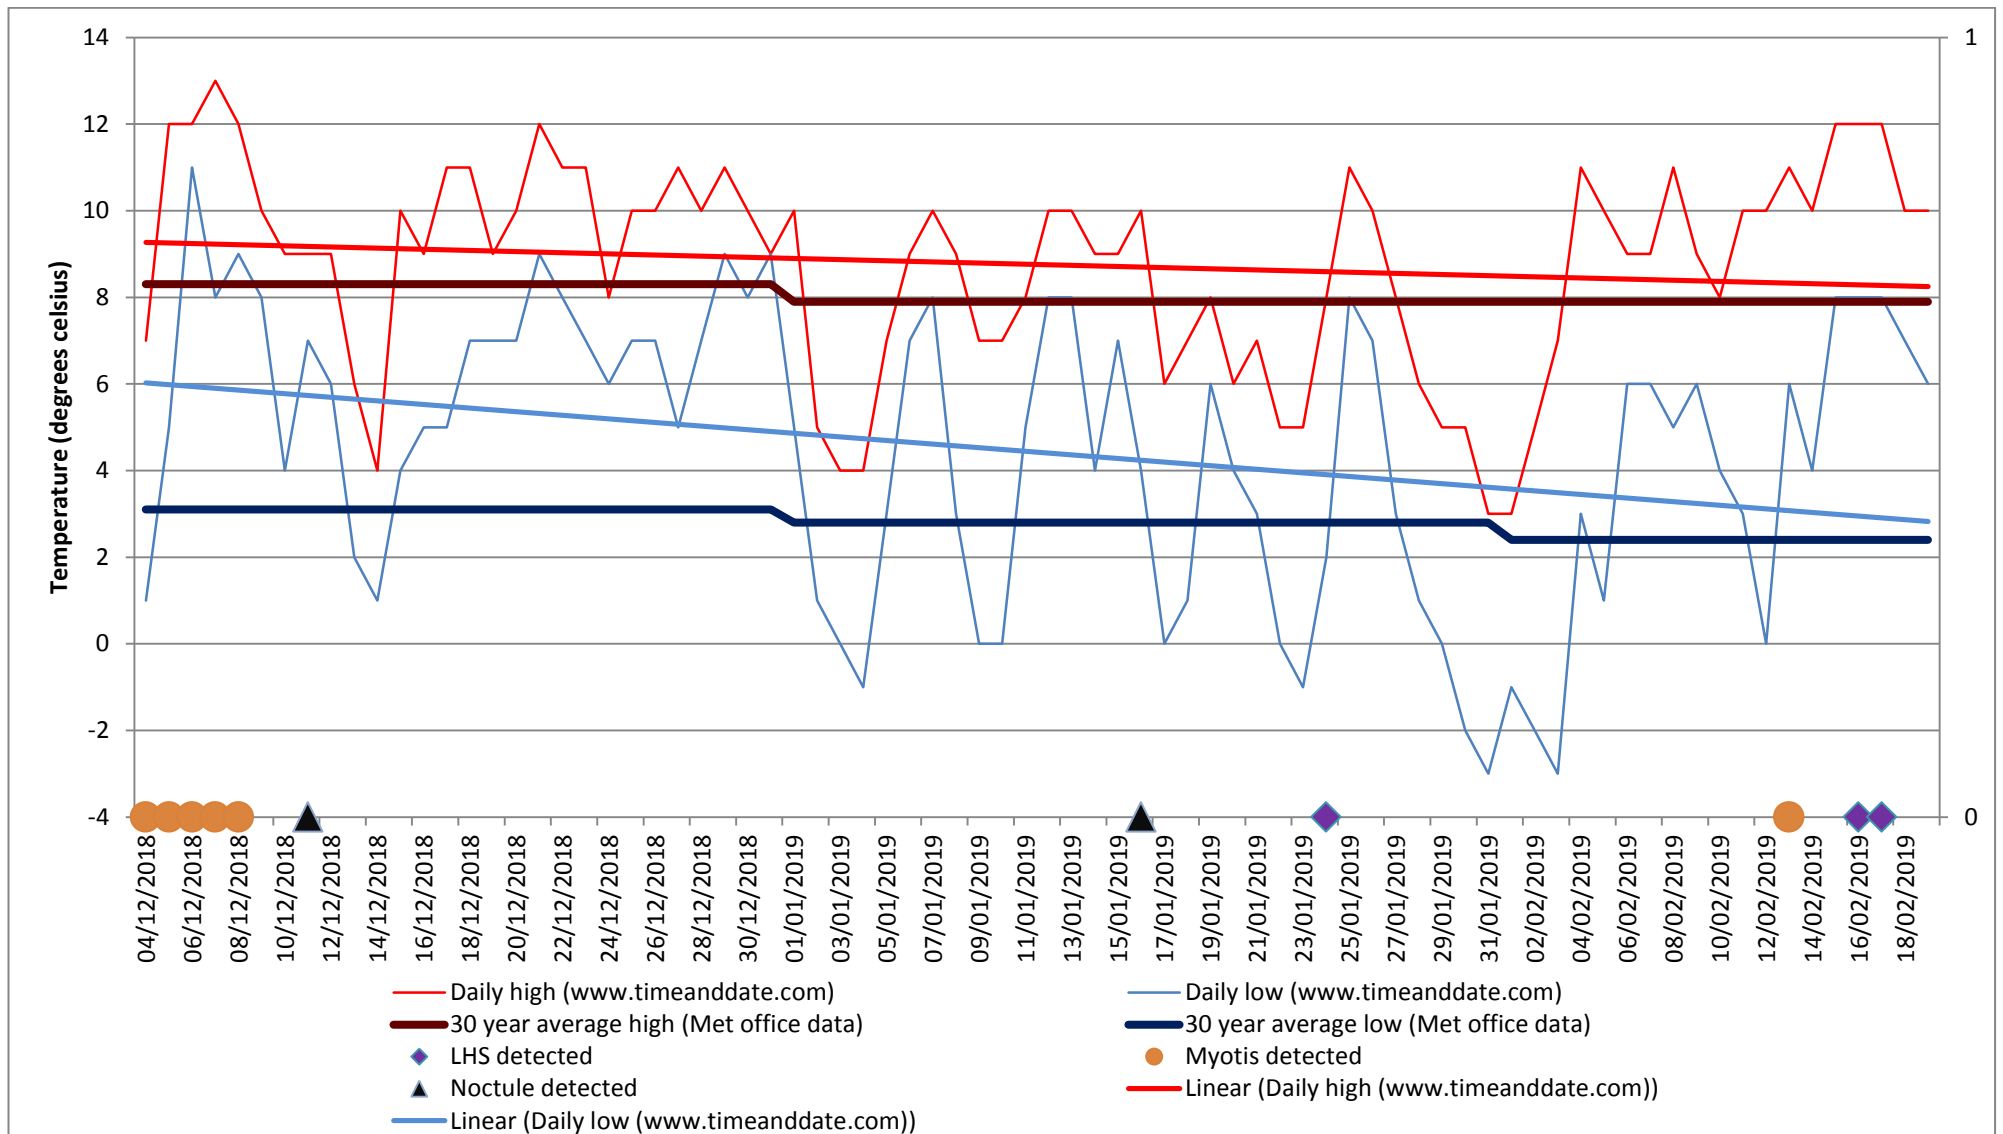
APPENDIX V TEMPERATURE GRAPH

- 4.1 It should be noted that the winter of 2018/19 has been relatively mild with average daily temperatures remaining above the 30 year average (Appendix V). February concluded what has been a relatively warm, dry and sunny winter season (December to February) for the country as a whole. Late January into early February experienced the most significant cold spell of the season. Overall it was the 7th warmest, 6th sunniest, and 23rd driest winter in series from 1910 (Met office, 2019). It will go in the record books as the first winter in which the Met Office have officially recorded a daily maximum temperature above 20 C (Met office, 2019).

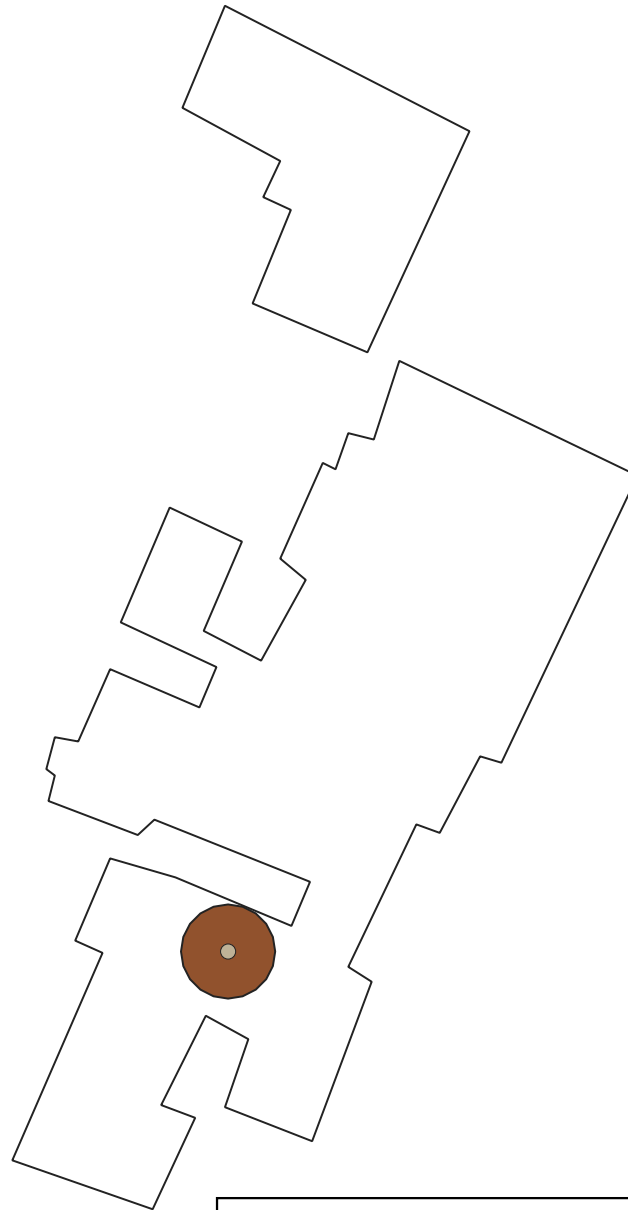
APPENDIX VI BAT RECORDING LOCATIONS AND DETECTION BUFFERS

- 4.6 Noctule bats produce very loud calls and can be detected up to 100m away (Anabat training, 2014). Accordingly 100m buffer has been put on the detection locations (Appendix VI). The calls were detected on 11th December and 16th January when it was still relatively mild and just before temperatures fell for a short cold snap (Appendix V). The recordings were of partial calls and it is considered likely that if the call came from within the building a clearer recording would have been made. In addition, Noctule do not typically roost within buildings, although there are occasional examples. On this basis it is considered most likely that the bat recorded was outside the building and the structure is not a winter roost for this species.

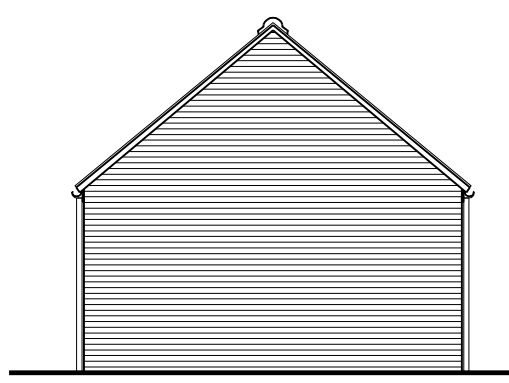
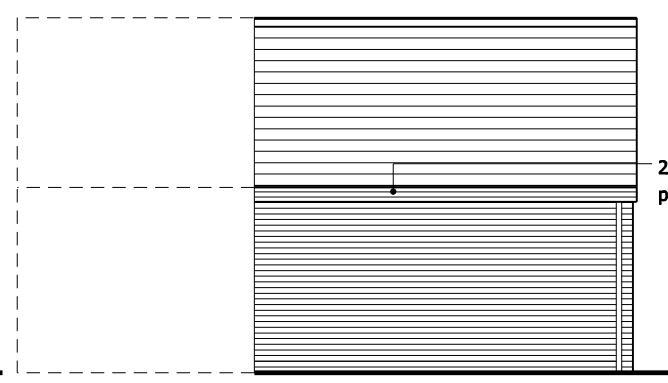
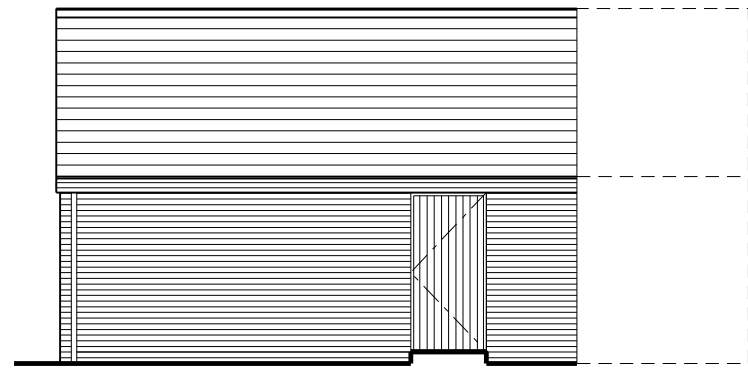
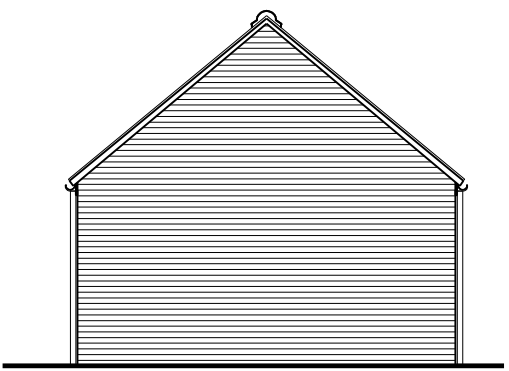
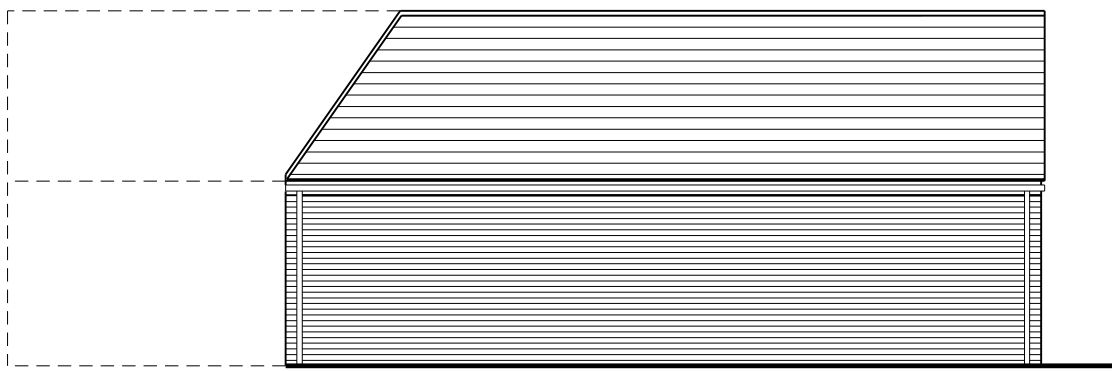
APPENDIX VII BAT HOUSE DETAILS

20-30mm gap between fascia & wall to permit bat access

20-30mm gap between fascia & wall to permit bat access
Bat Access
500 x 500mm with horizontal metal grill

- 4.8 The proposal will result in the loss of a winter roost for small numbers of Lesser horseshoe, Myotis and probably pipistrelle as well. It is recommended that the bat house previously described (SBE, 2018 and Appendix VII) remain unaltered i.e. the cool room element of the house will be required to mitigate for the loss of this roost.

- 4.13 The proposed bat house (Appendix VII) has been designed to provide suitable conditions for the range of species and roost types identified at the site. The location of the bat house within the site has been carefully considered in conjunction with a range of constraints that apply to the site including significant root protection

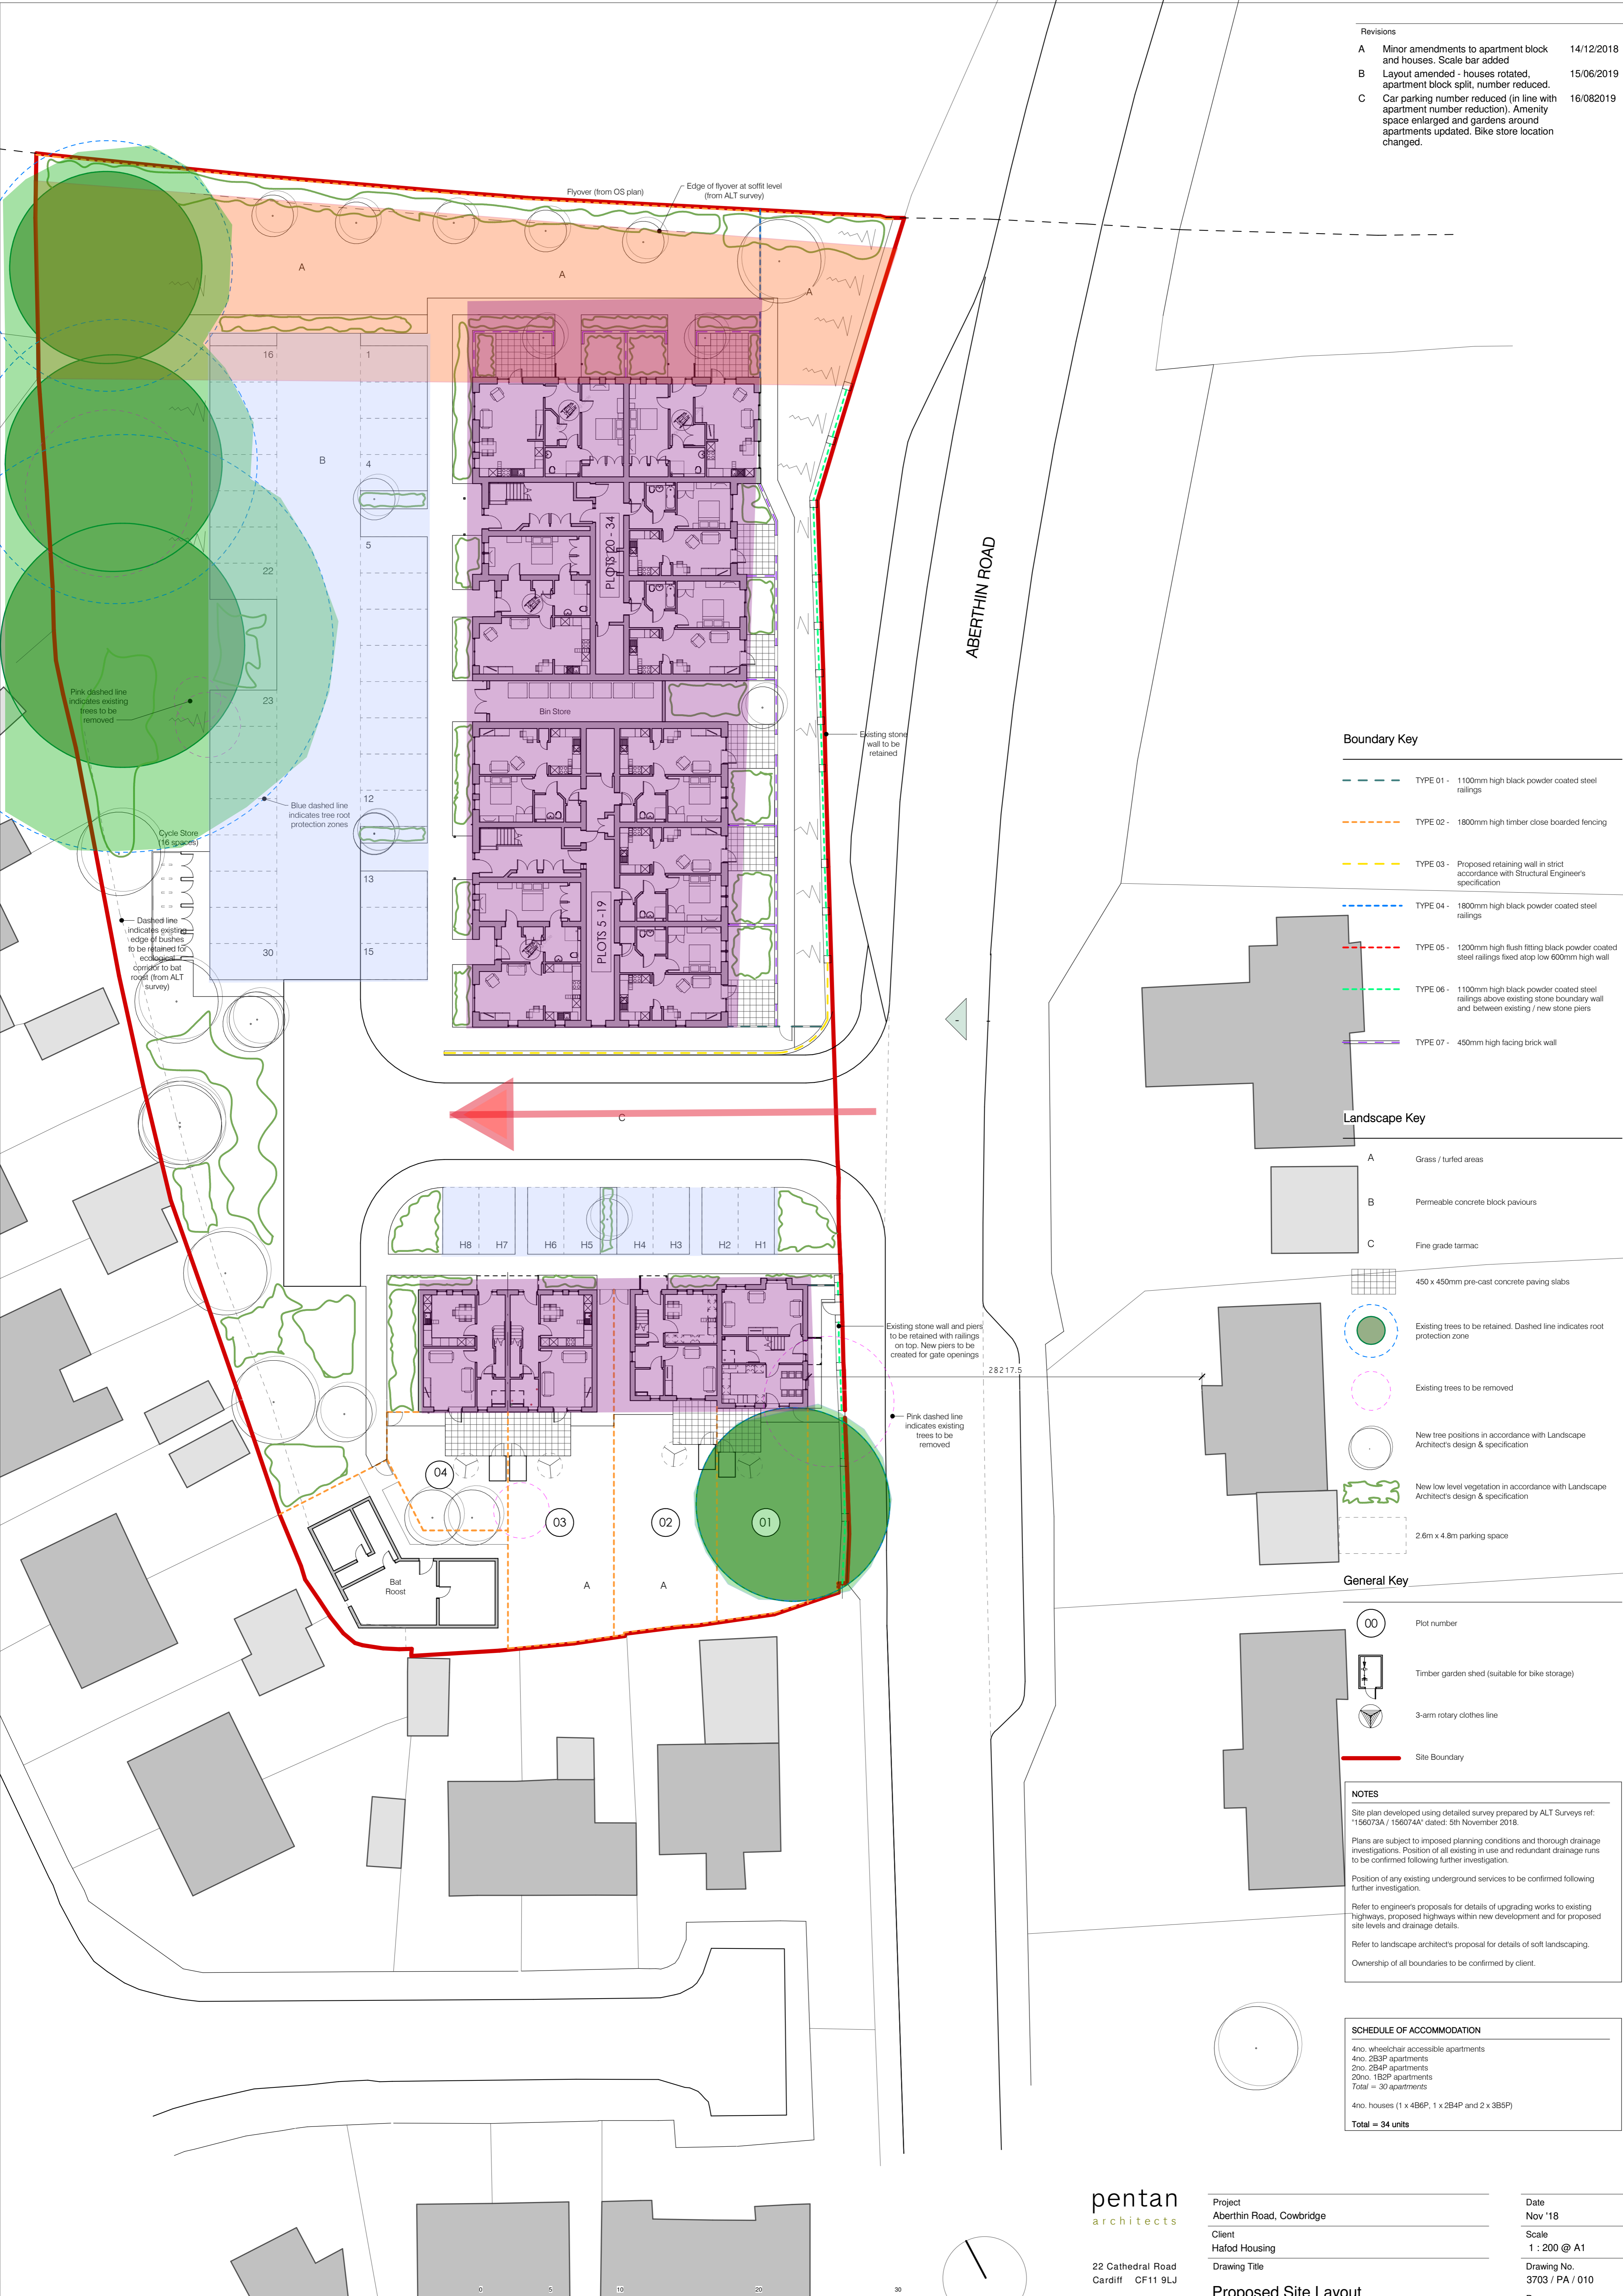
- Green areas are protected trees and tree protection areas.
- Orange is the easement zone away from the flyover.
- Purple is the location of the buildings – the Planning Authority would expect us to address the main road, so they must be sited in these locations.
- Light blue is the parking areas – car parking must be sited adjacent to the dwellings they serve, but in effect, by this stage, the only logical location for the bat house is the south of the site where it is away from trees; flyover easement; and buildings, as well as being secluded.

zones and the flyover easement zone which must be kept clear for maintenance. These constraints are illustrated in Appendix VIII.

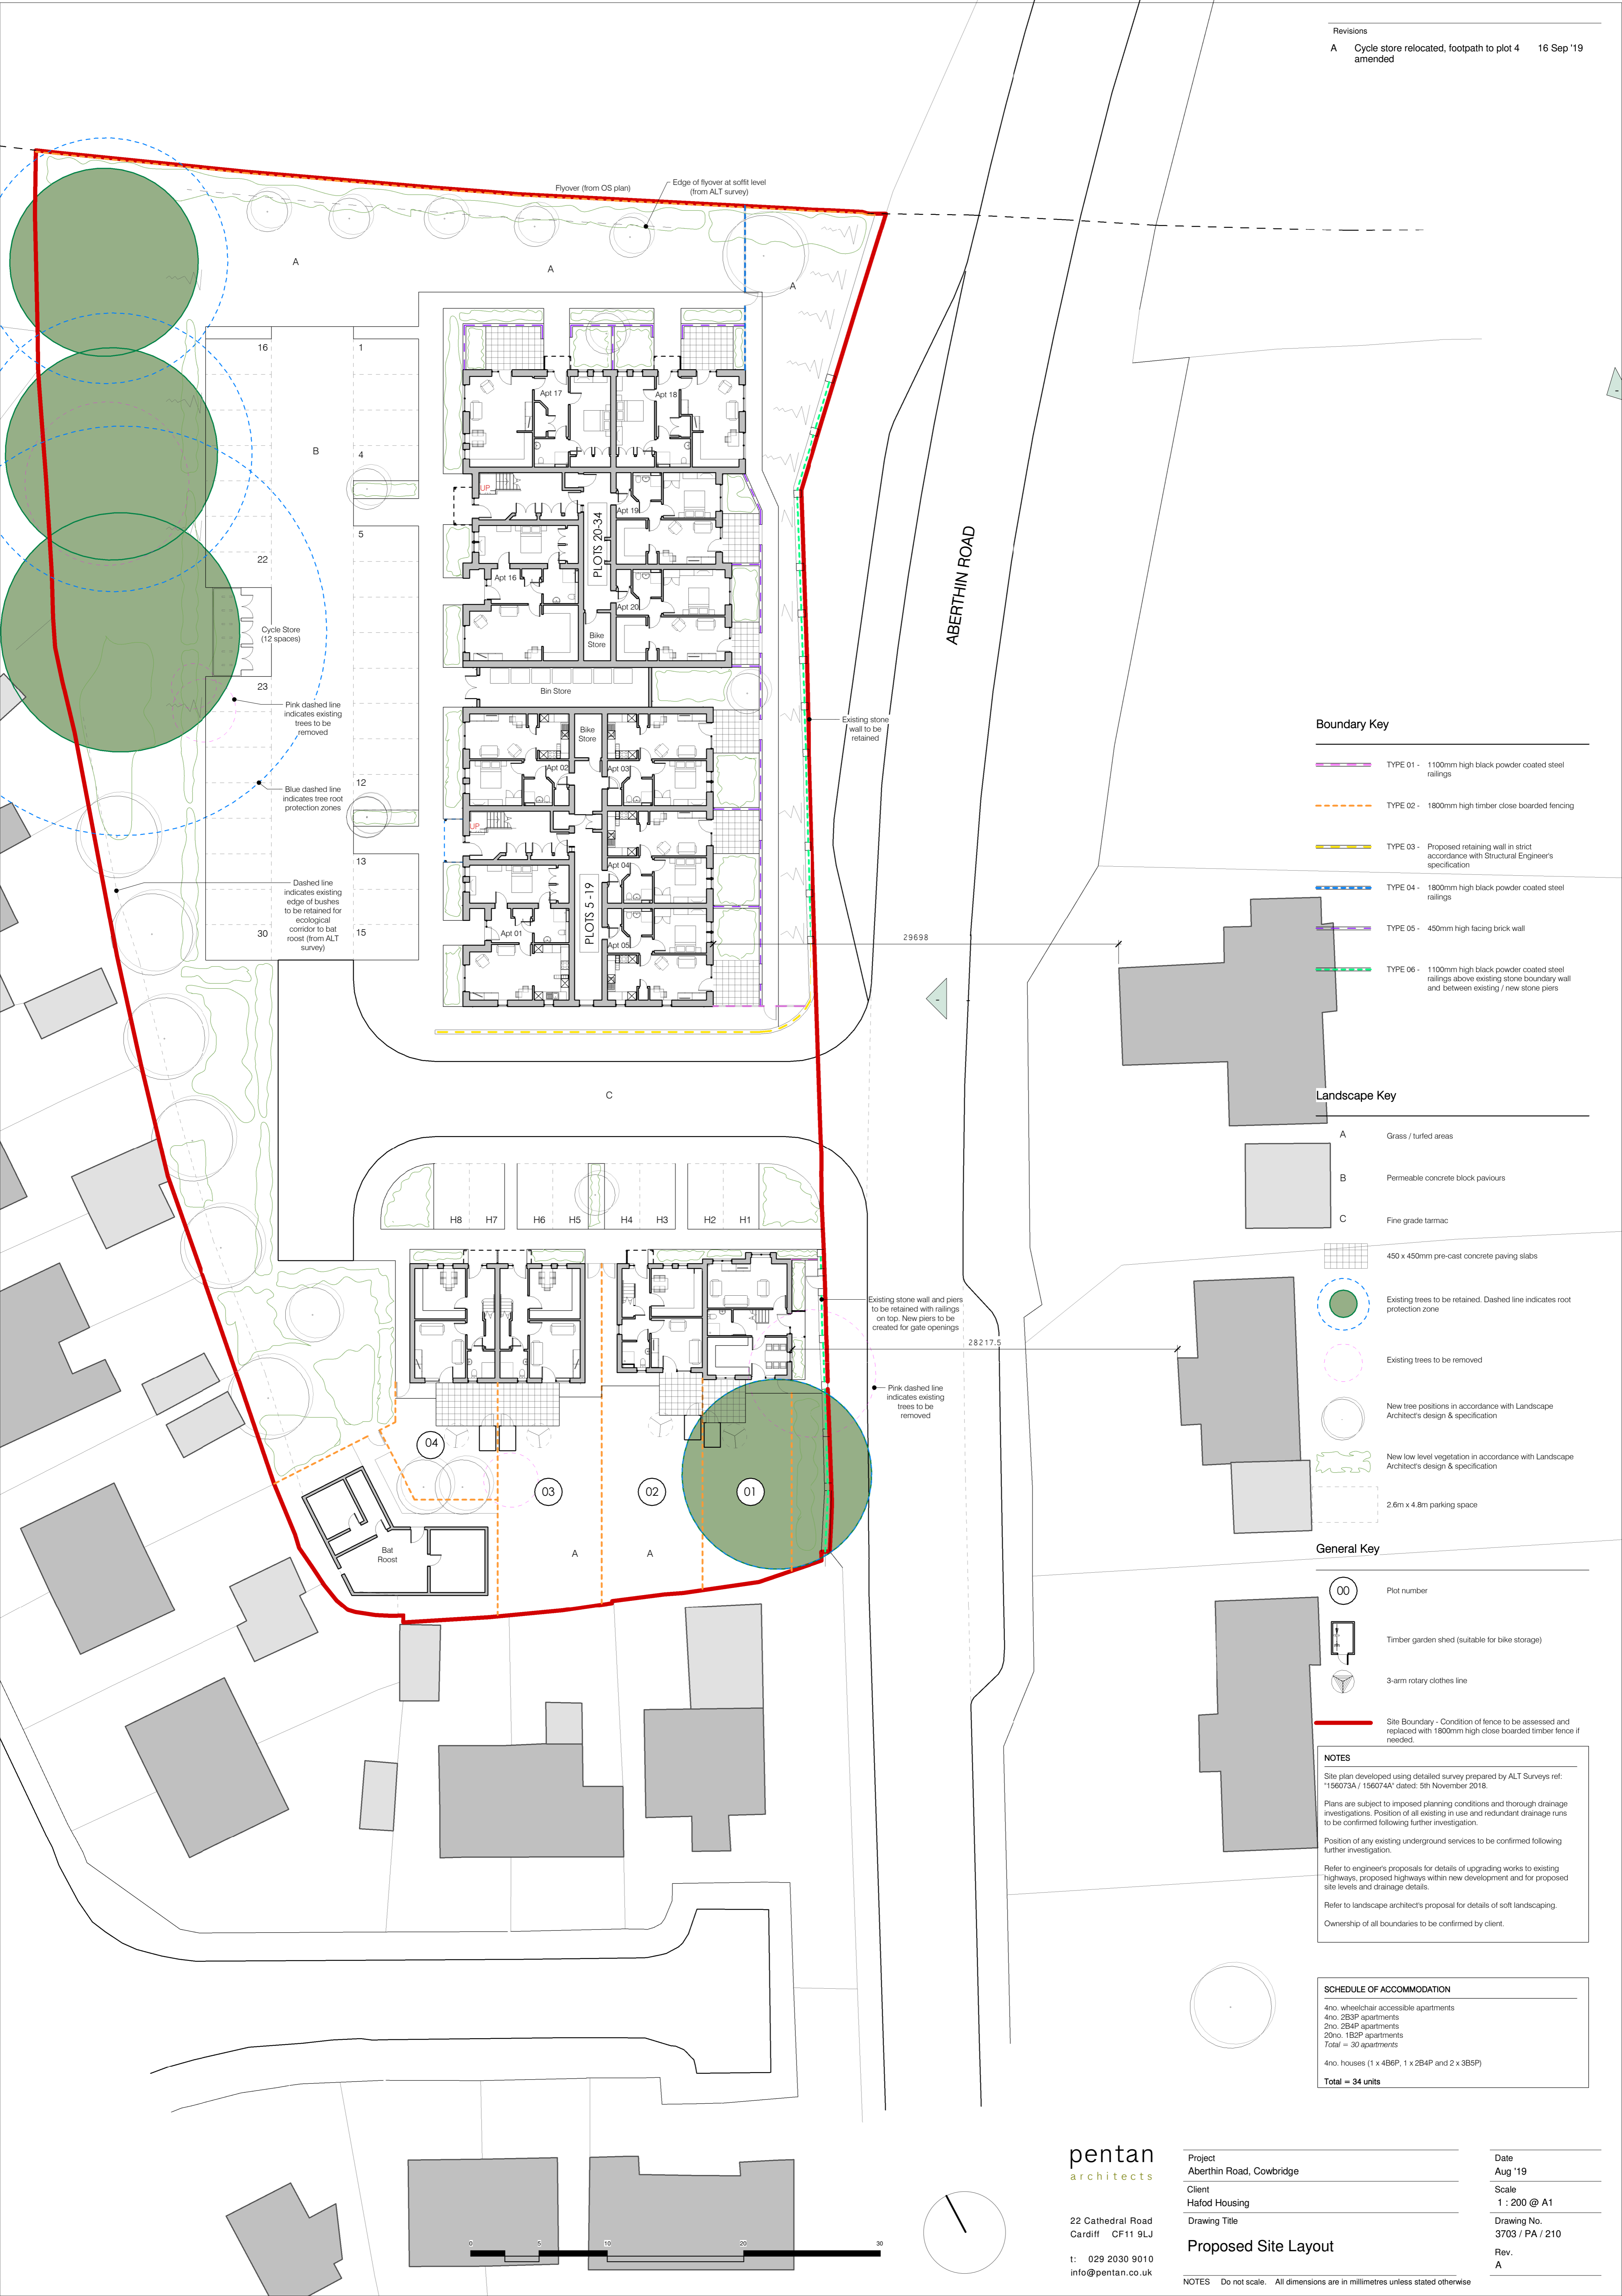
APPENDIX IX PROPOSED SITE LAYOUT AND PLANTING PLAN

- 4.14 Connectivity from the bat house to the wider landscape has been carefully incorporated into the site design maintaining a vegetated corridor (Appendix IX) along the western boundary and a sensitive lighting plan (Appendix X). The external lights are all fixed in a downward direction and fitted with motion sensors and set to remain on for a maximum of one minute. The bollards at the western edge of the carpark are floor mounted and allow the vegetative corridor along this boundary to achieve a less than 0.5 lux (Appendix X) which is considered acceptable for continued use by the sensitive species present on this site.

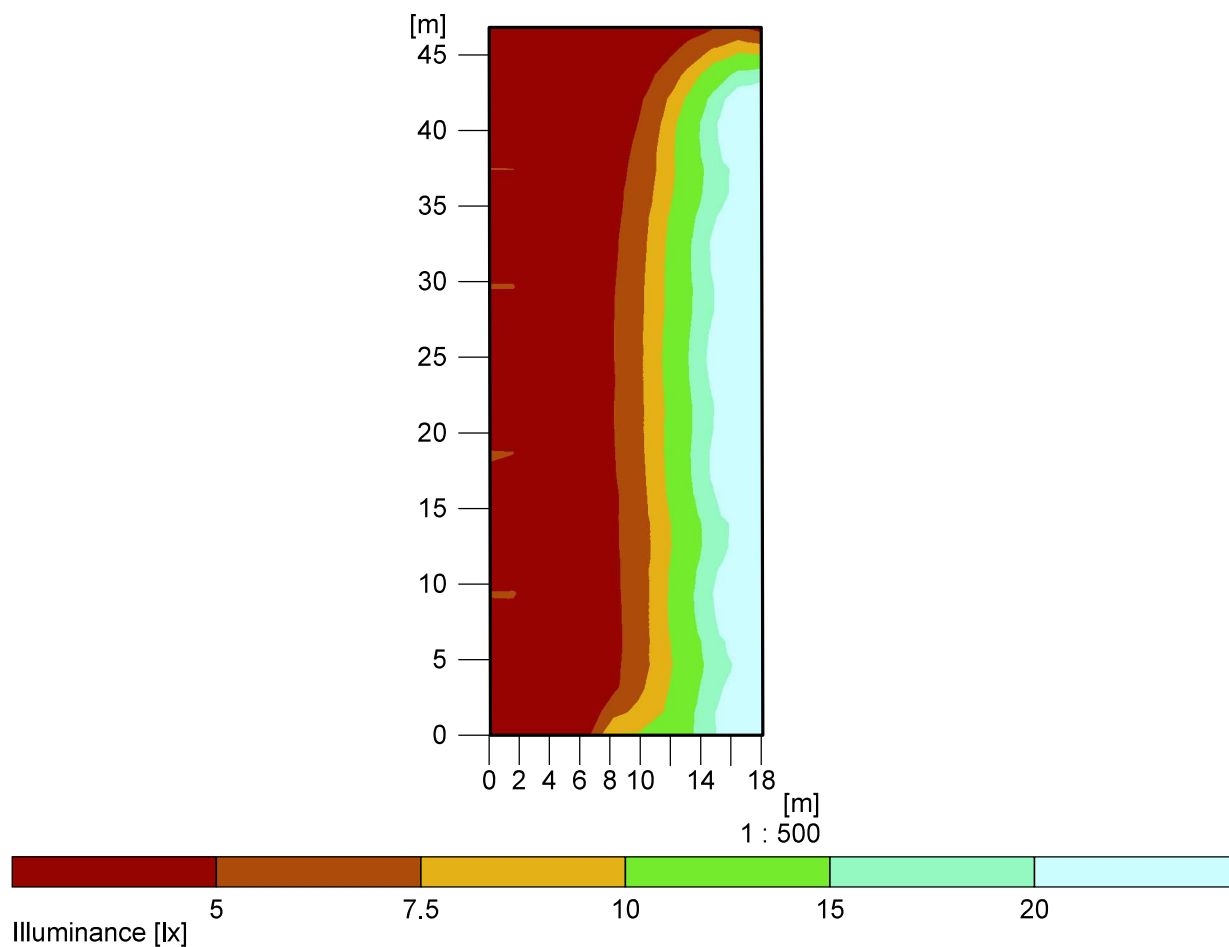
1.3.7 Pseudo colours, REF PLANE - CAR PARK (E)

: 0.00 m
Average illuminance	Eav	: 8.6 lx
Minimum illuminance	Emin	: 1.1 lx
Maximum illuminance	Emax	: 32.8 lx
Uniformity Uo	Emin/Eav	: 1 : 7.57 (0.13)
Diversity Ud	Emin/Emax	: 1 : 28.88 (0.03)
