FORMER SITE OF COWBRIDGE SCHOOL, COWBRIDGE

ARCHAEOLOGICAL EVALUATION

2018/01417/FUL

commissioned by EDP
on behalf of Hafod Housing Association

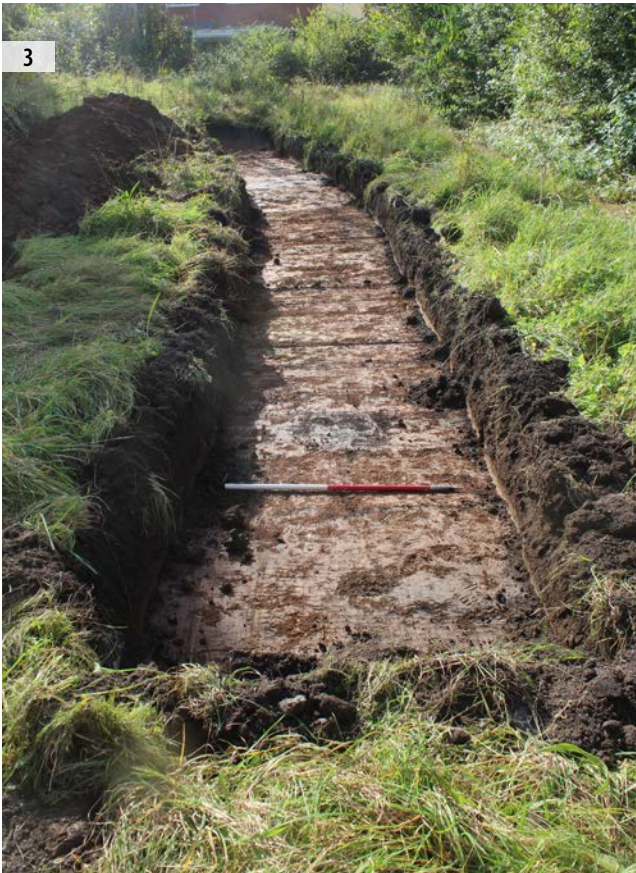
ILLUS 3 View of Trench 1, looking south **ILLUS 4** General view of shrub bowl [1004], looking north

The geological substrate was exposed 0.44m bgl, sealed by buried soil horizon (1002) and overlain by asphalt footpath and modern overgrowth (Illus 3).

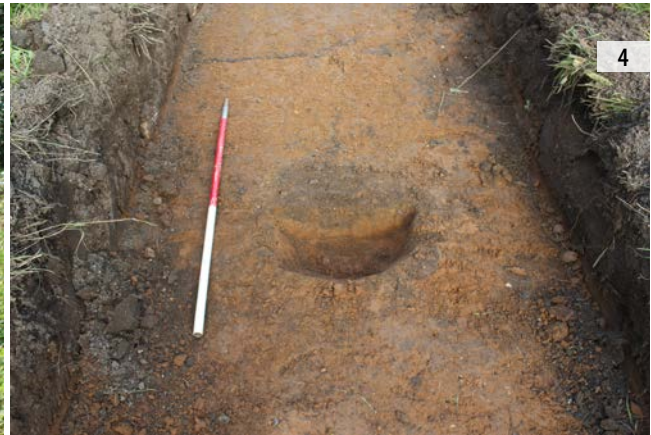
A single sub-rectangular feature [1004] was located in the northern part of the trench. This feature measured 0.47m long, 0.54m wide and at a depth of 0.10m. It contained a humic dark grey brown sandy loam deposit (1005) with fragments of slate. It is likely that this was the basal remains of a removed shrub or tree bowl (Illus. 4).

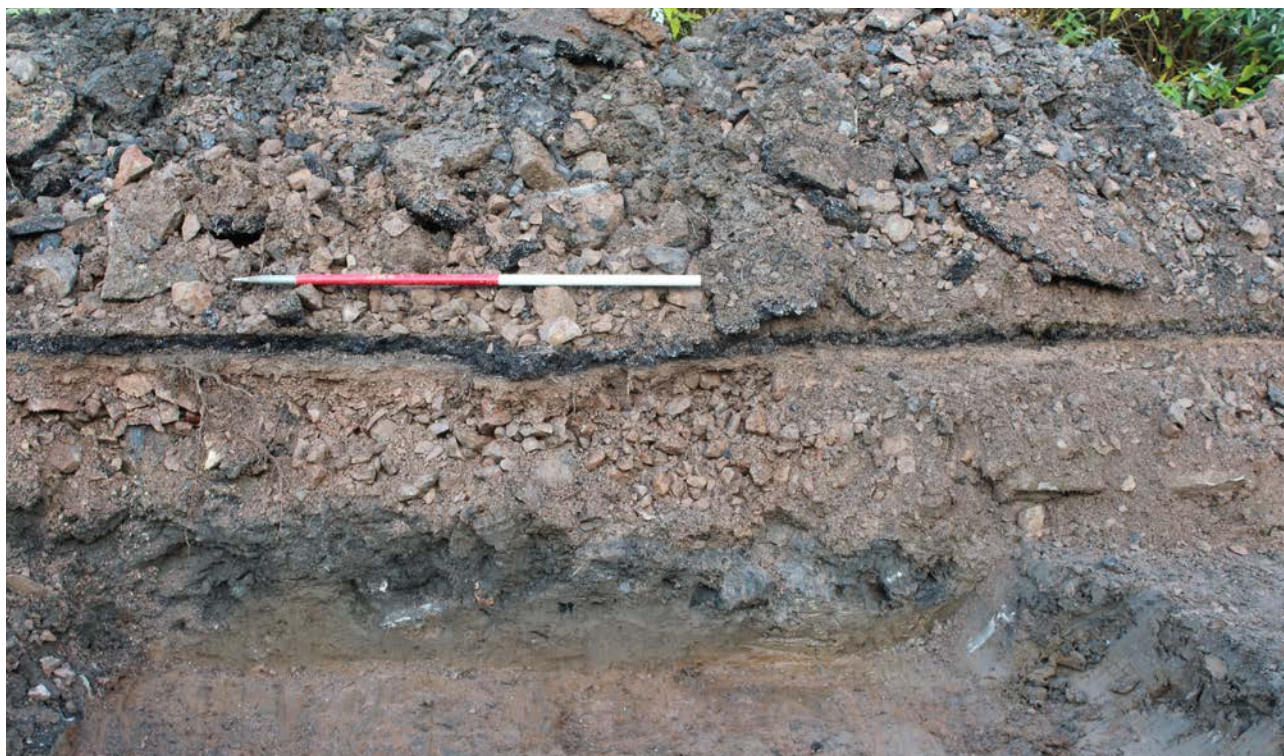
ILLUS 5 Representative section of Trench 2, looking west

These trenches contained the remains of a sewer system, comprising concrete housing and bricked inspection chamber (manhole) with ceramic drains.

The geological substrate was exposed between 0.33m and 0.79m bgl, sealed by made ground deposits and garden soil/asphalt (Illus 5).

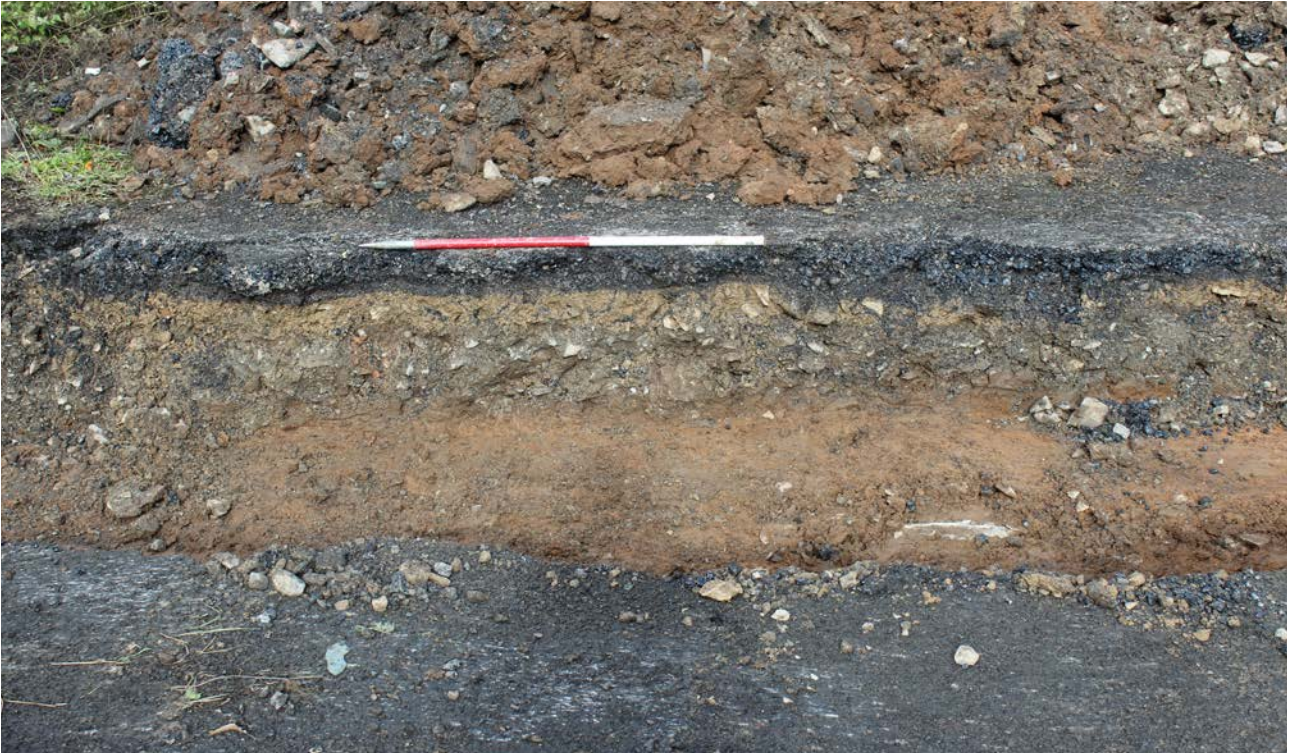
ILLUS 6 Representative section of Trench 5, looking north-west

The geological substrate was exposed between 0.18m and 0.40 bgl, sealed by made ground deposits (5002) and asphalt/bedding 'type 1' deposit associated with the construction of the former playground (Illus 6).

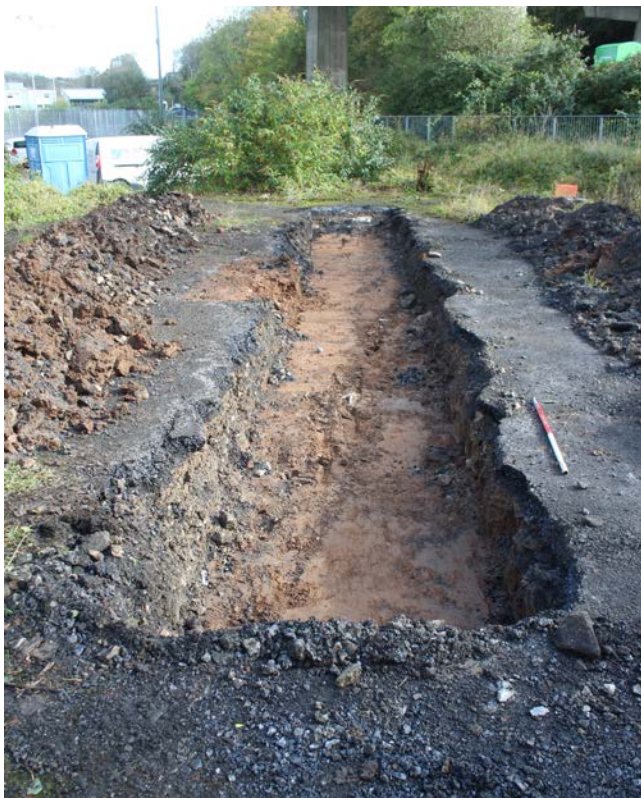
ILLUS 7 View of Trench 5, looking north

Trench 5 exposed probable plough scarring indicative of previous agricultural land use predating the initial development of the site c 1896 (Illus 7).

Trench 5 contained linear striations, tentatively interpreted as possible plough scarring. The absence of any buried agricultural soils or subsoil suggests the likelihood of any potential buried archaeological features is highly unlikely.
