**INNOVATION QUARTER, HOOD ROAD,
BARRY WATERFRONT, BARRY**

Site Investigation Report

11539/RB/15

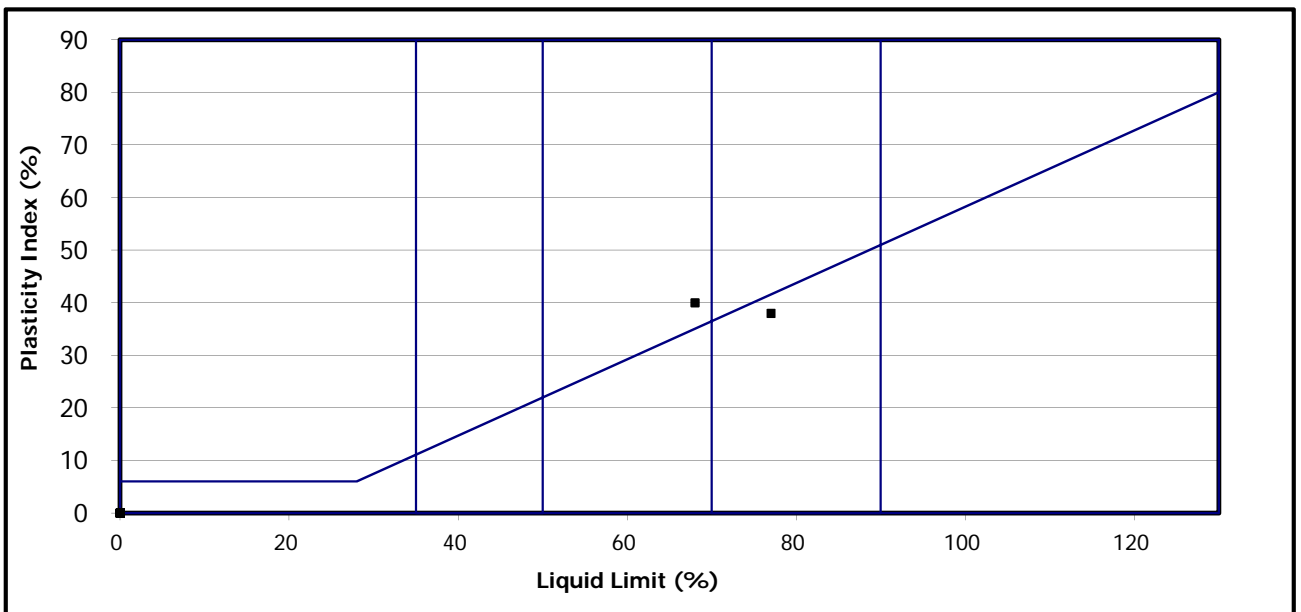
Hole/ Sample Number	Sample Type	Depth m	Moisture Content % Cl. 3.2	Liquid Limit % Cl. 4.3/4.4	Plastic Limit % Cl. 5.	Plasticity Index % Cl. 6.	% Passing .425mm	Remarks
BH1	U	5.00 - 5.45	49	77	39	38	100	MV Very High Plasticity
BH1	U	8.00 - 8.45	36	68	28	40	95	CH High Plasticity

Symbols: NP : Non Plastic # : Liquid Limit and Plastic Limit Wet Sieved
 PLASTICITY CHART FOR CASAGRANDE CLASSIFICATION.
 BS 5930:1999+A2:2010

The results of Atterberg Limit testing on samples of alluvium indicated that the materials were of high to very high plasticity, with plasticity indices of 38-40%. Moisture contents ranged from 36-49%.

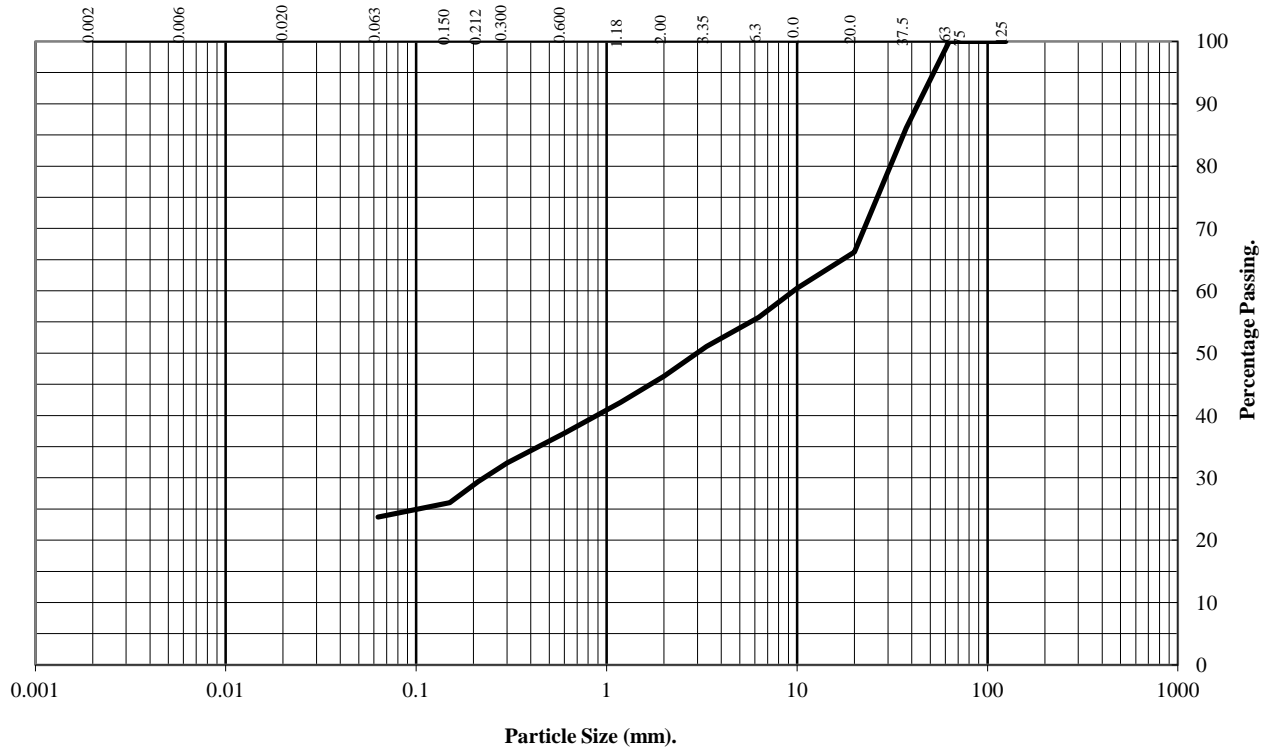
Hole Number: **TP1** Type: **B** Depth (m): **1.00**

Wet Sieve, Clause 9.2

BS Test Sieve	Percentage Passing
125	100
75	100
63	100
37.5	86
20	66
10	60
6.3	56
3.35	51
2.00	46
1.18	42
0.60	37
0.300	32
0.212	29
0.150	26
0.063	24

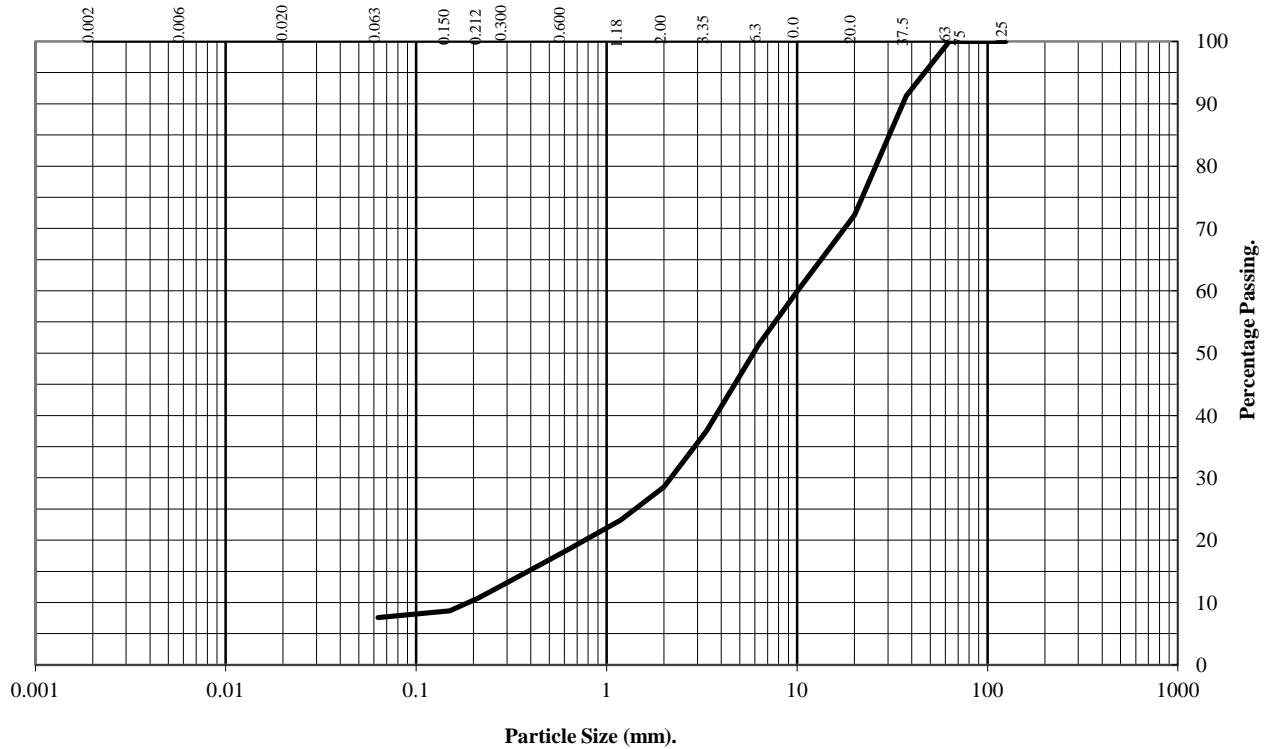
Hole Number: **TP3** Type: **B** Depth (m): **1.60**

Wet Sieve, Clause 9.2

BS Test Sieve	Percentage Passing
125	100
75	100
63	100
37.5	91
20	72
10	60
6.3	51
3.35	38
2.00	29
1.18	23
0.60	18
0.300	13
0.212	11
0.150	9
0.063	8

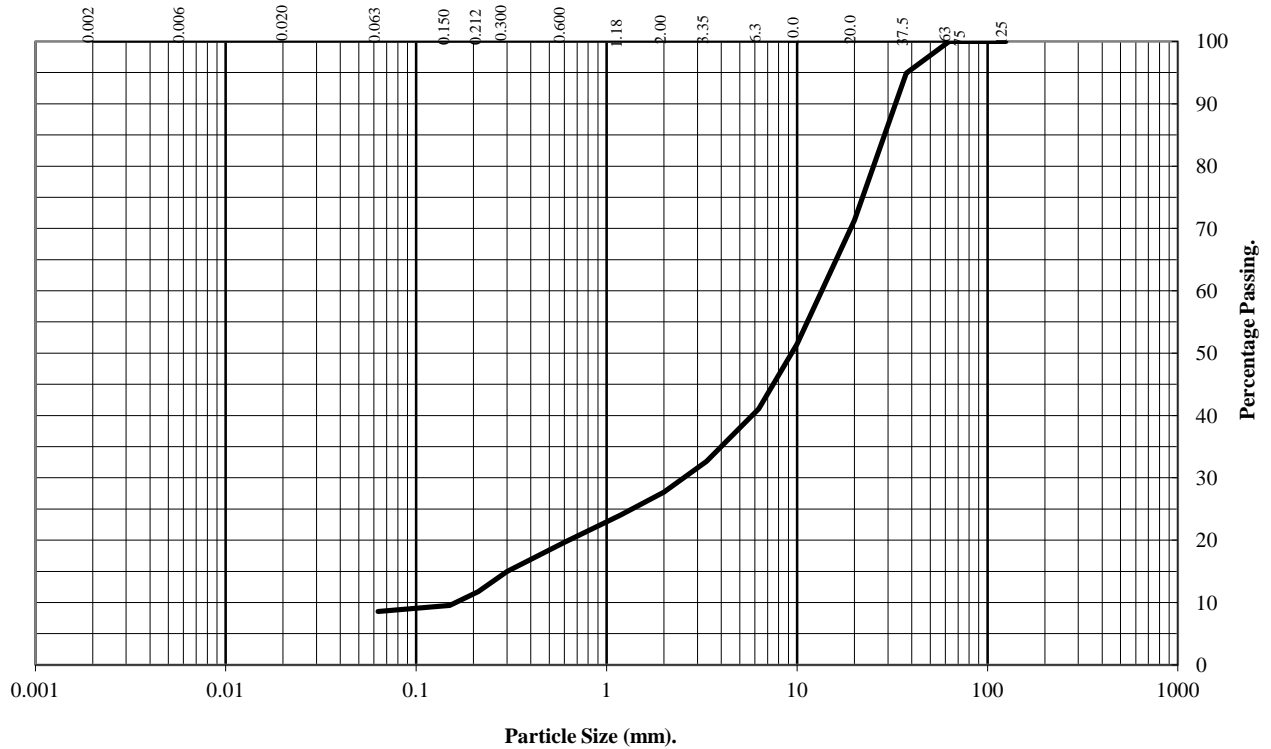
Hole Number: **TP5** Type: **B** Depth (m): **1.00**

Wet Sieve, Clause 9.2

BS Test Sieve	Percentage Passing
125	100
75	100
63	100
37.5	95
20	71
10	51
6.3	41
3.35	33
2.00	28
1.18	24
0.60	20
0.300	15
0.212	12
0.150	10
0.063	9

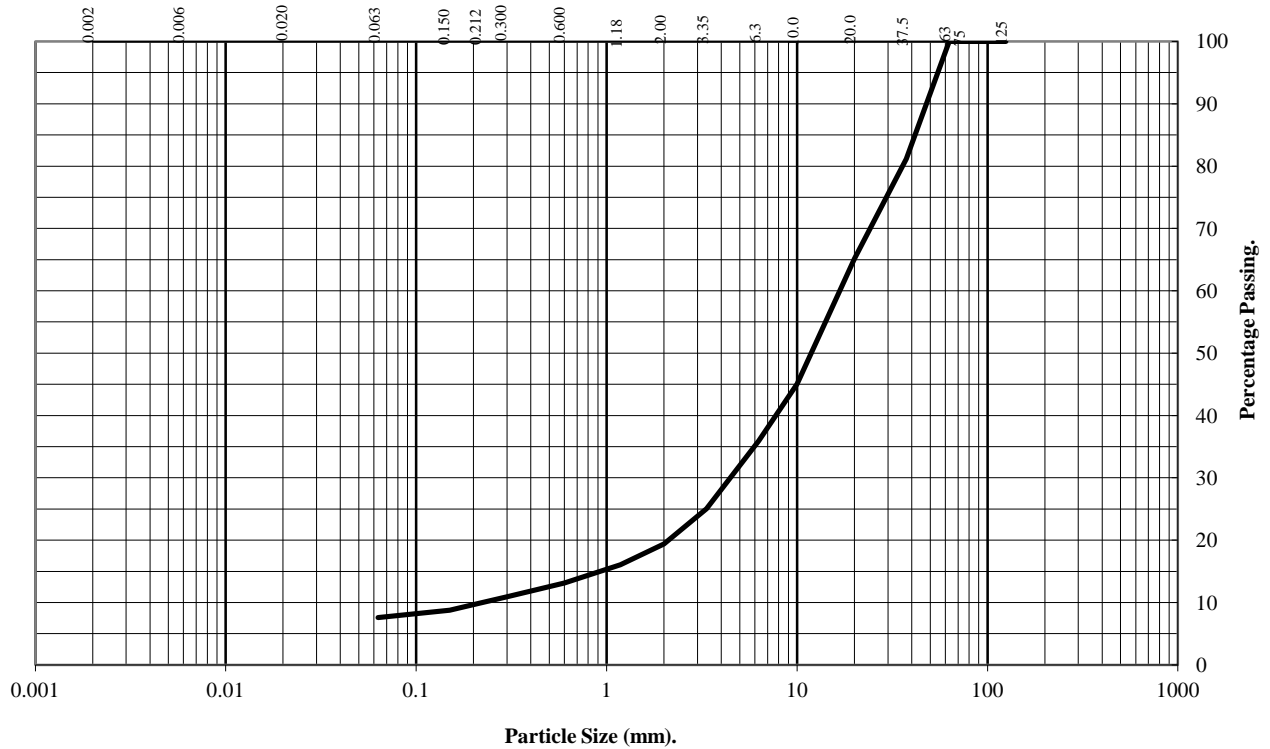
Hole Number: **TP6** Type: **B** Depth (m): **1.50**

Wet Sieve, Clause 9.2

BS Test Sieve	Percentage Passing
125	100
75	100
63	100
37.5	81
20	65
10	45
6.3	36
3.35	25
2.00	19
1.18	16
0.60	13
0.300	11
0.212	10
0.150	9
0.063	8

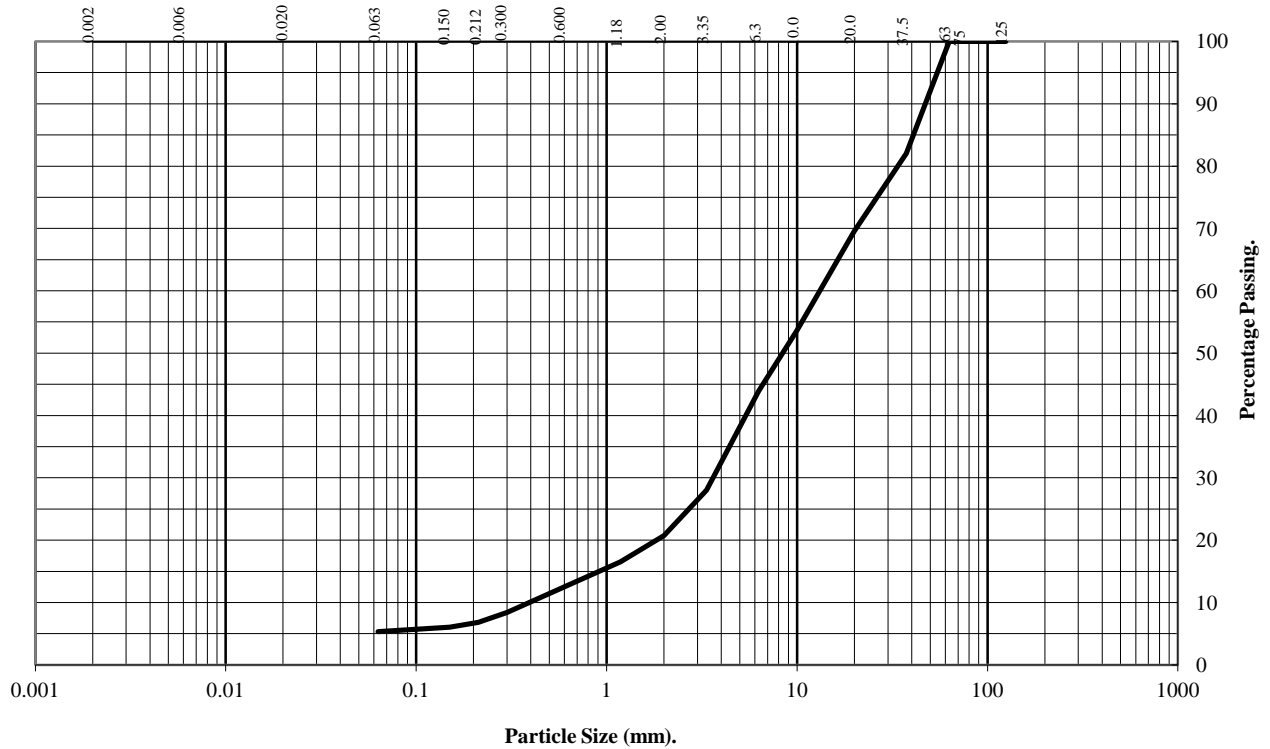
Hole Number: **TP8** Type: **B** Depth (m): **2.00**

Wet Sieve, Clause 9.2

BS Test Sieve	Percentage Passing
125	100
75	100
63	100
37.5	82
20	70
10	54
6.3	44
3.35	28
2.00	21
1.18	17
0.60	12
0.300	8
0.212	7
0.150	6
0.063	5

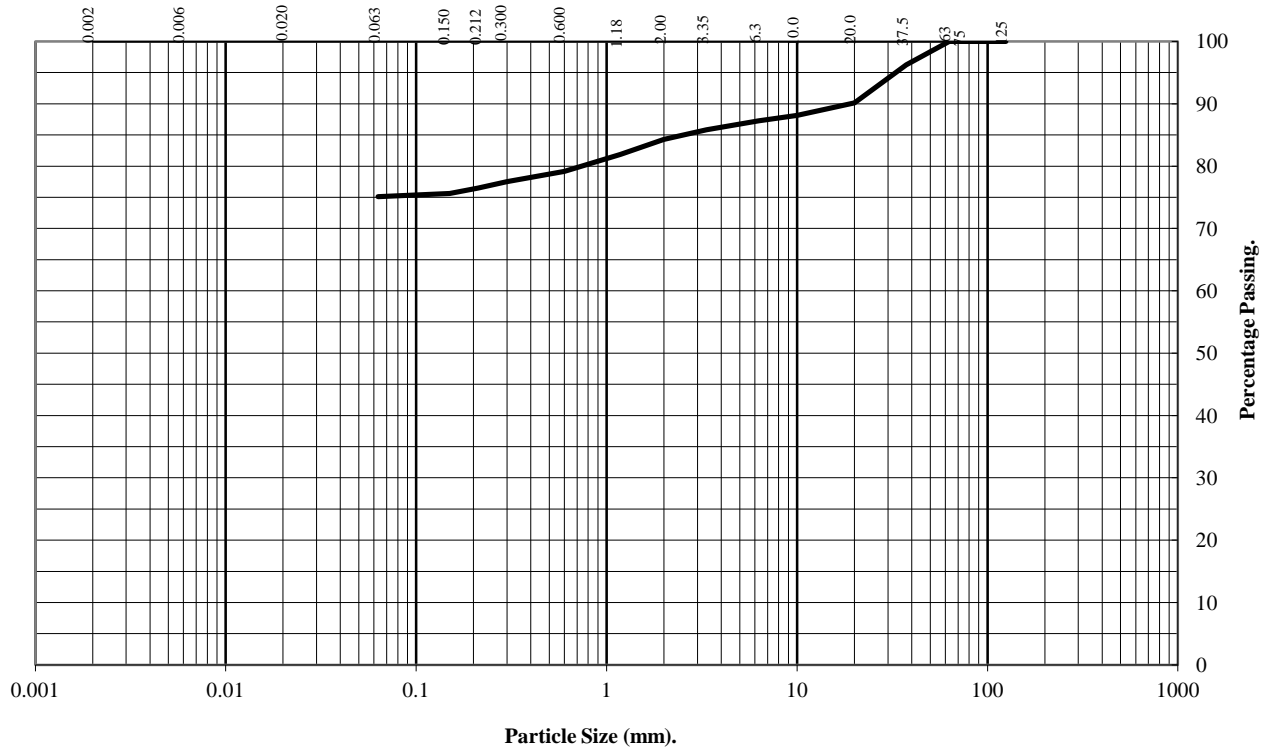
Depth (m): **1.00**

BS Test Sieve	Percentage Passing
125	100
75	100
63	100
37.5	96
20	90
10	88
6.3	87
3.35	86
2.00	84
1.18	82
0.60	79
0.300	77
0.212	76
0.150	76
0.063	75

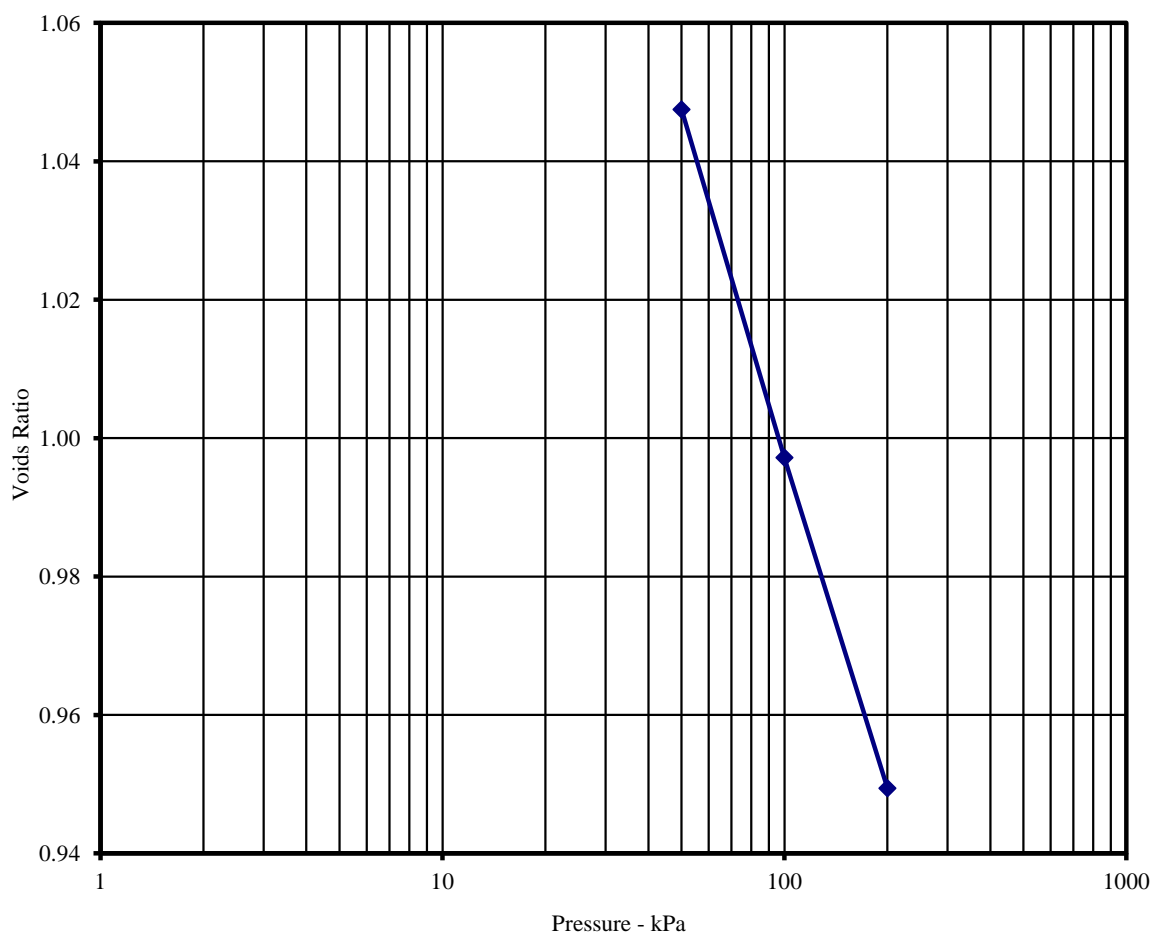
Depth (m): **5.00-5.45**

Initial Conditions		Pressure Range	Mv	Cv	Method of time fitting used
Moisture Content (%):	51	kPa	m2/MN	m2/yr	Cv Calculated using t90
Bulk Density (Mg/m3):	1.91	0 - 50	0.494	10.667	Nominal Laboratory Temperature
Dry Density (Mg/m3):	1.26	50 - 100	0.491	16.398	20°C
Voids Ratio:	1.0994	100 - 200	0.239	16.469	Location of specimen with sample
Degree of saturation:	123.6				Top
Height (mm):	19.95				Remarks:
Diameter (mm)	75.12				
Particle Density (Mg/m3):	2.65				
Assumed

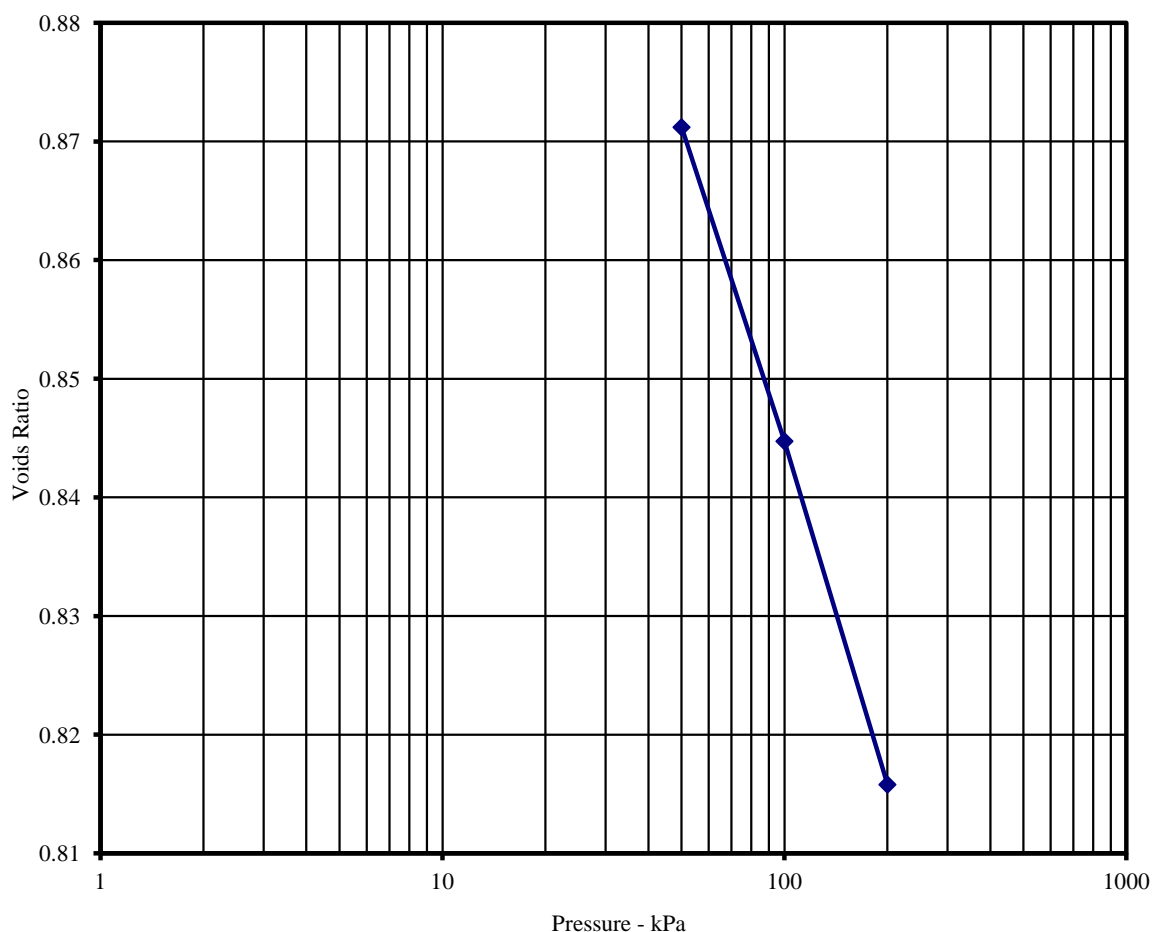
Depth (m): **8.00-8.45**

Initial Conditions		Pressure Range	Mv	Cv	Method of time fitting used
Moisture Content (%):	39	kPa	m2/MN	m2/yr	Cv Calculated using t90
Bulk Density (Mg/m3):	1.93	0 - 50	0.294	10.775	Nominal Laboratory Temperature
Dry Density (Mg/m3):	1.40	50 - 100	0.283	16.914	20°C
Voids Ratio:	0.8991	100 - 200	0.157	17.314	Location of specimen with sample
Degree of saturation:	113.9				Top
Height (mm):	19.95				Remarks:
Diameter (mm)	75.12				
Particle Density (Mg/m3):	2.65				
Assumed

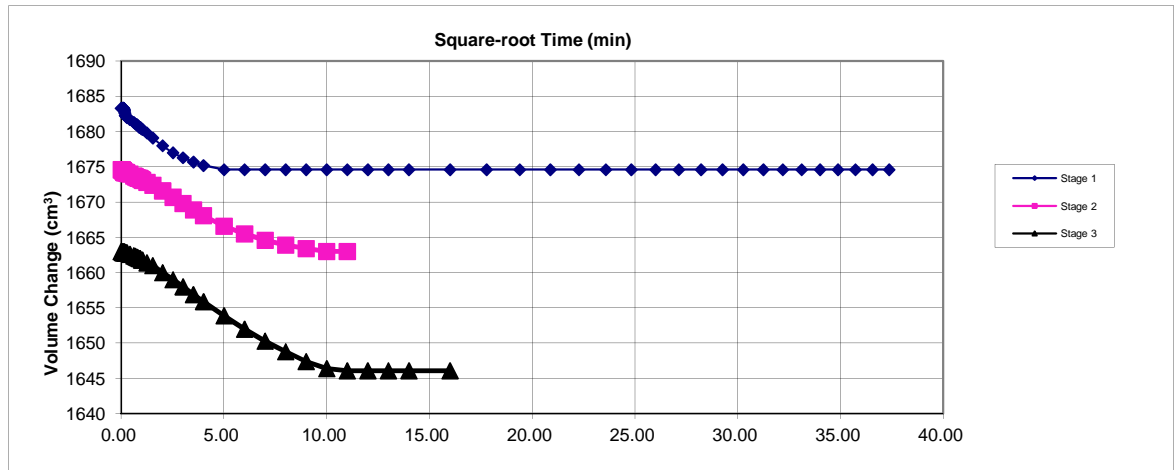
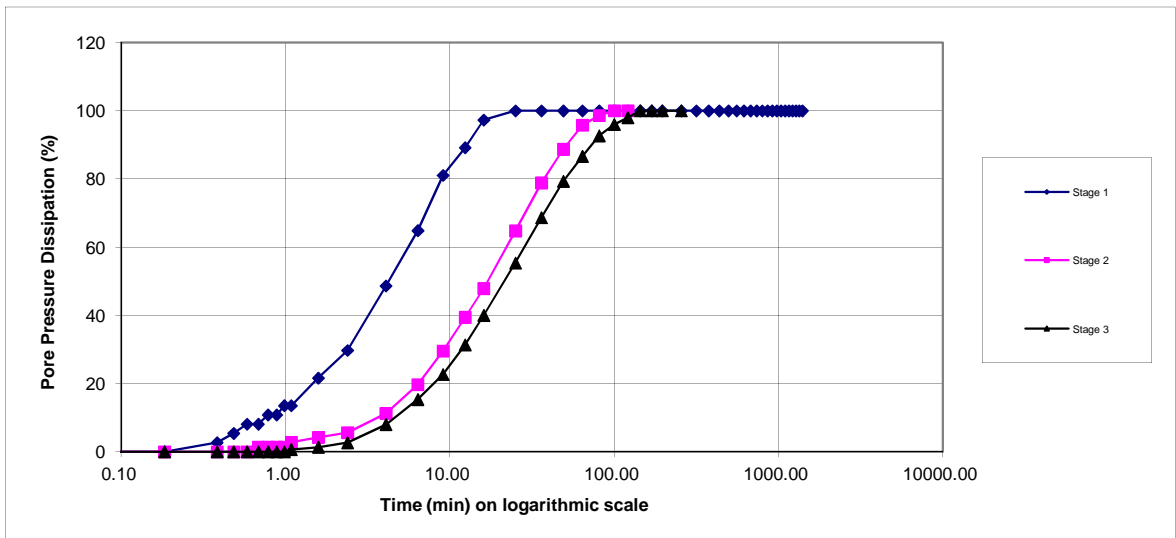
Borehole	BH2
Sample No.	
Depth	m 5.00-5.45
Date	18/04/2012

Consolidation Stage

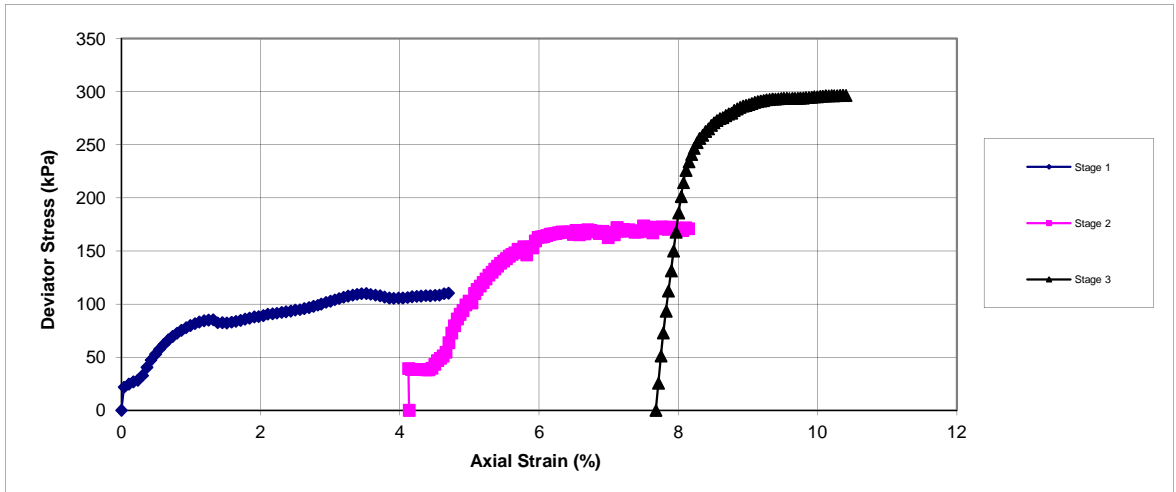
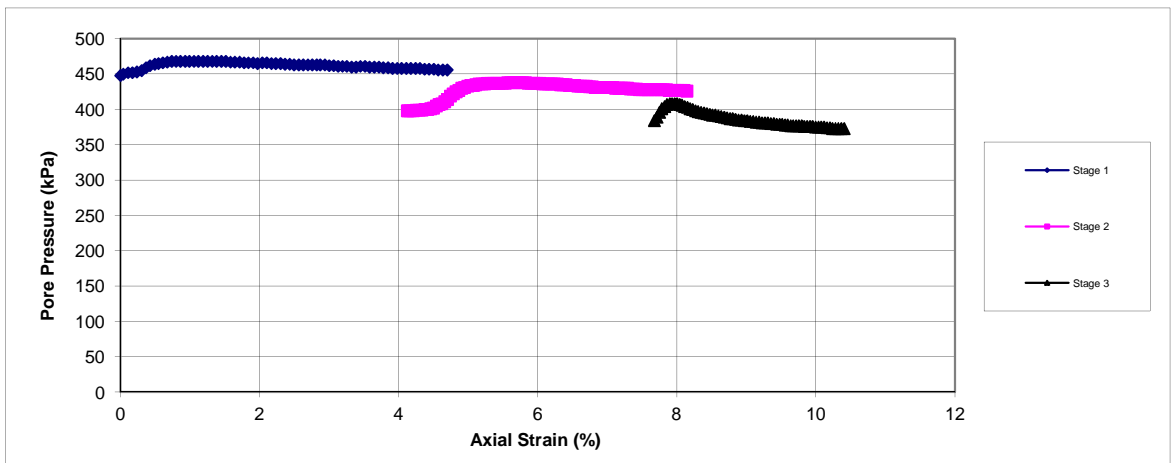
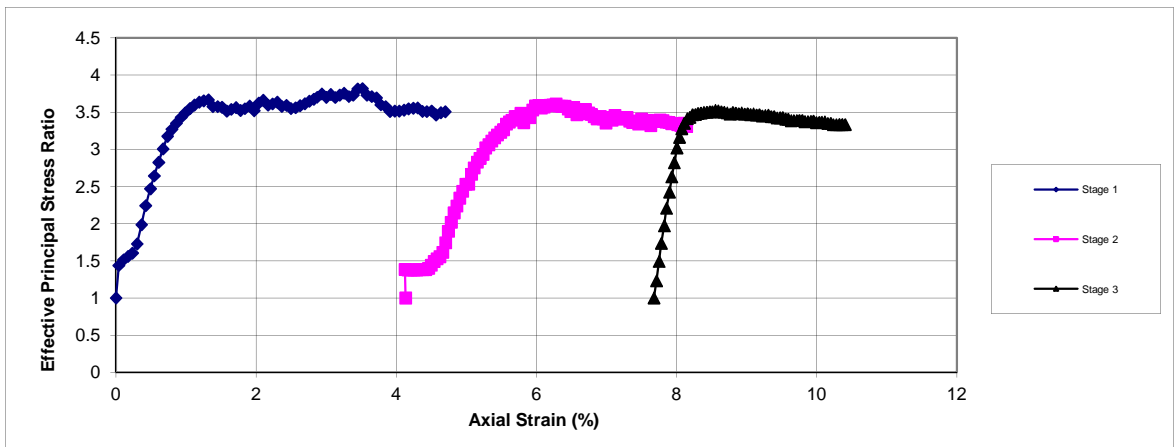
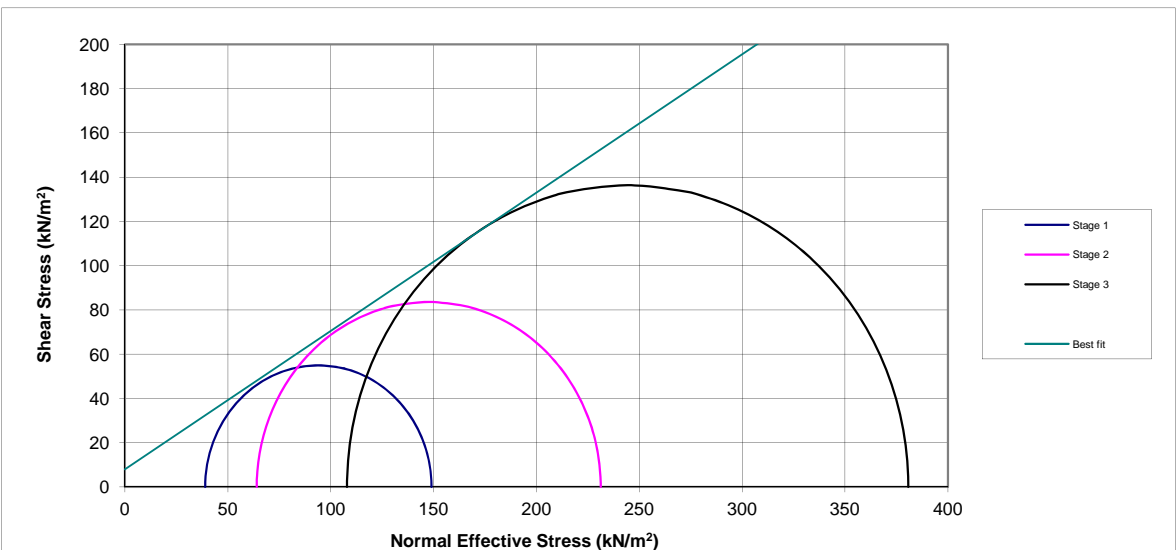
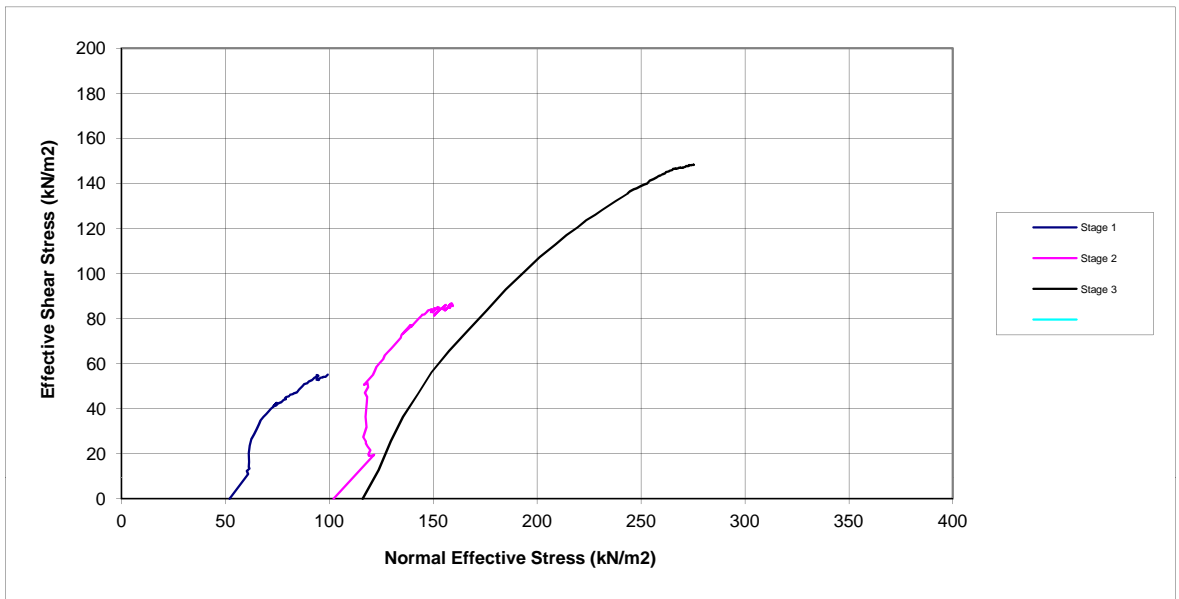
Borehole	BH2
Sample No.	
Depth	5.00-5.45
Date	18/04/2012

Shearing Stage

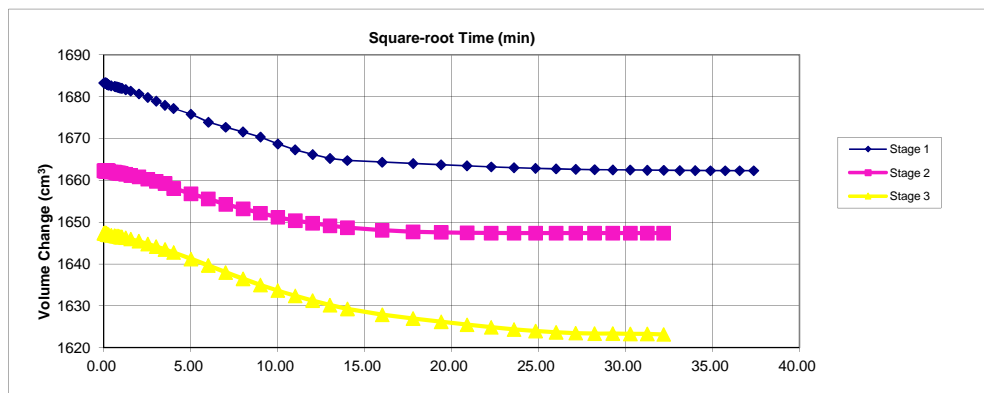
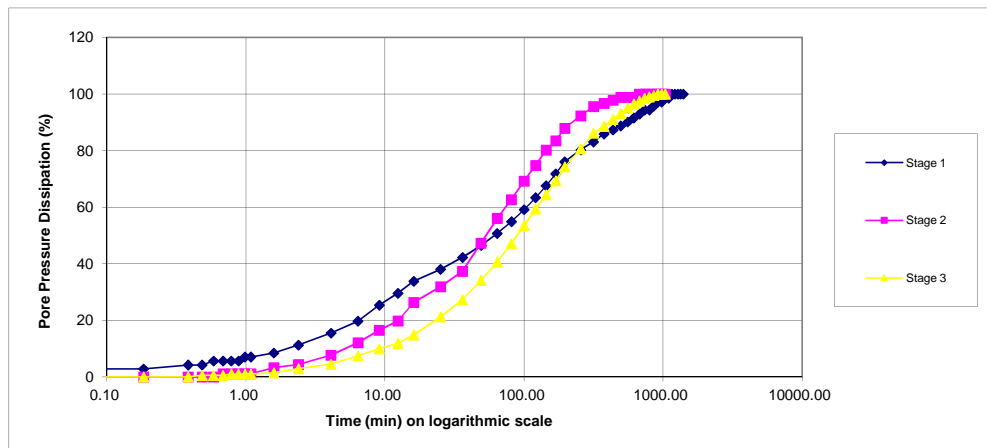
Borehole	BH01
Sample No.	
Depth	m 8.00-8.45
Date	17/04/2012

Consolidation Stage

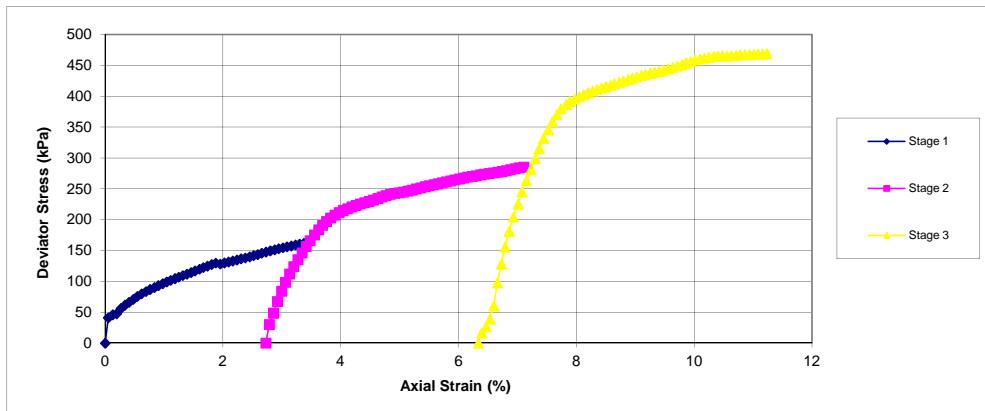
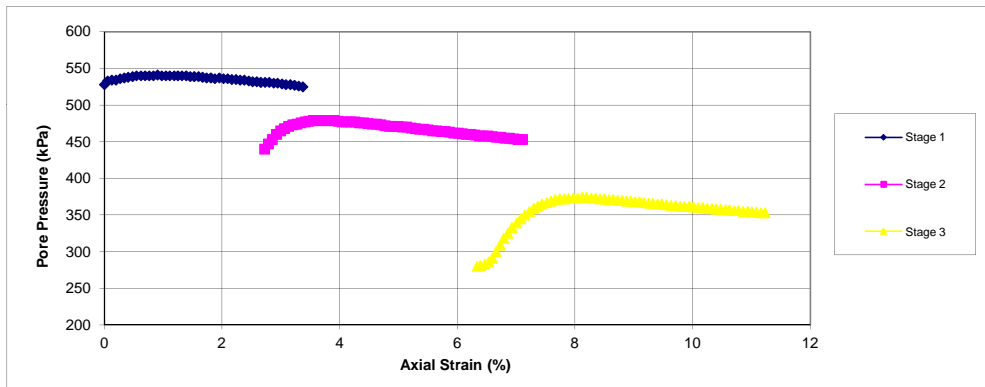
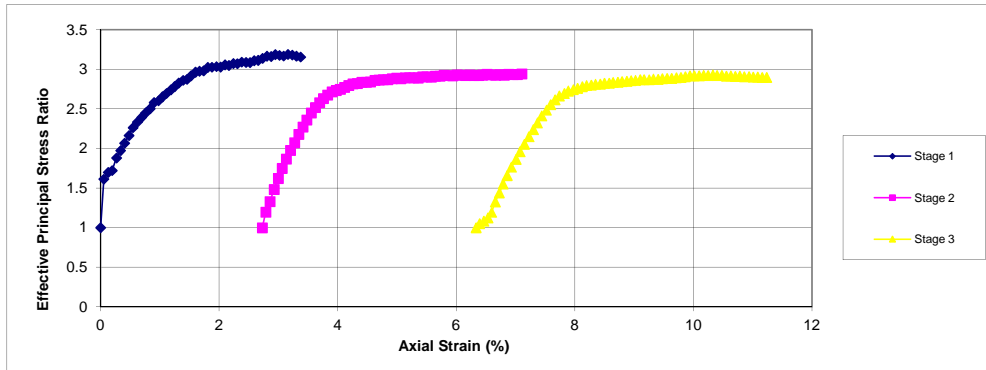
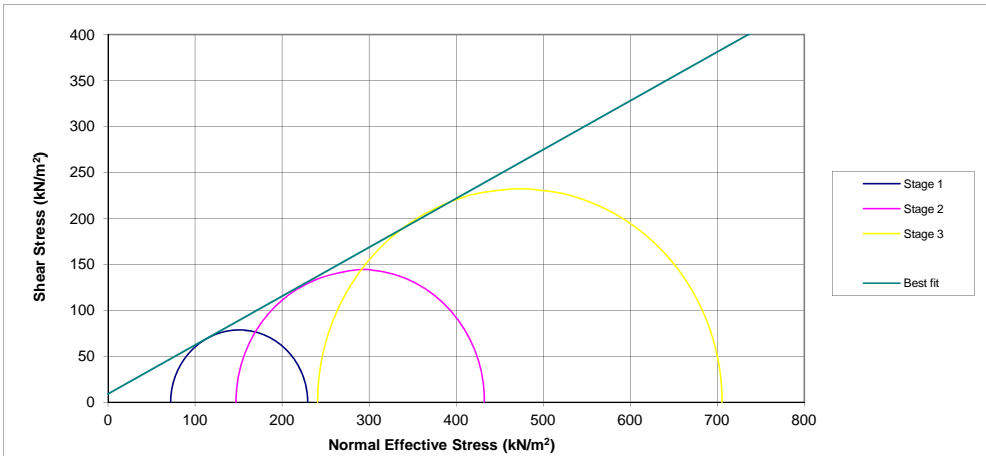
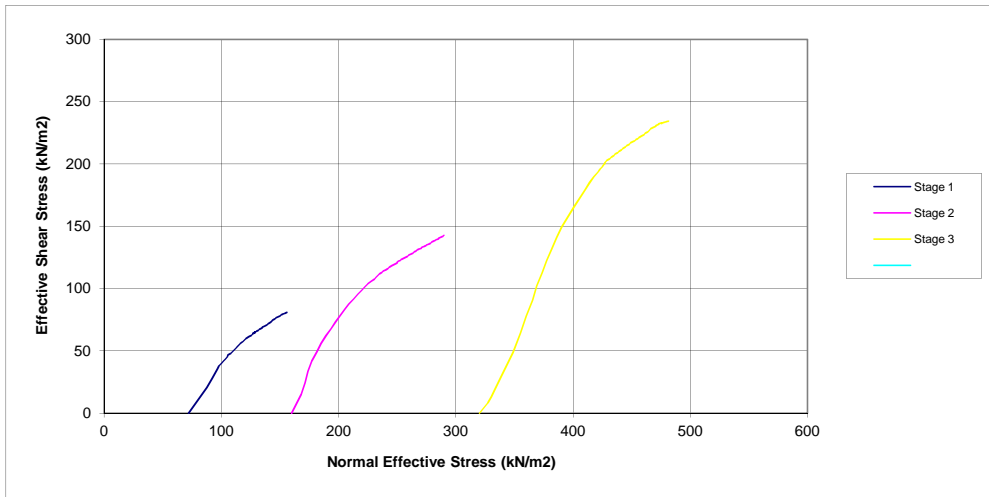
Borehole		BH01
Sample No.		
Depth	m	8.00-8.45
Date		17/04/2012

Shearing Stage

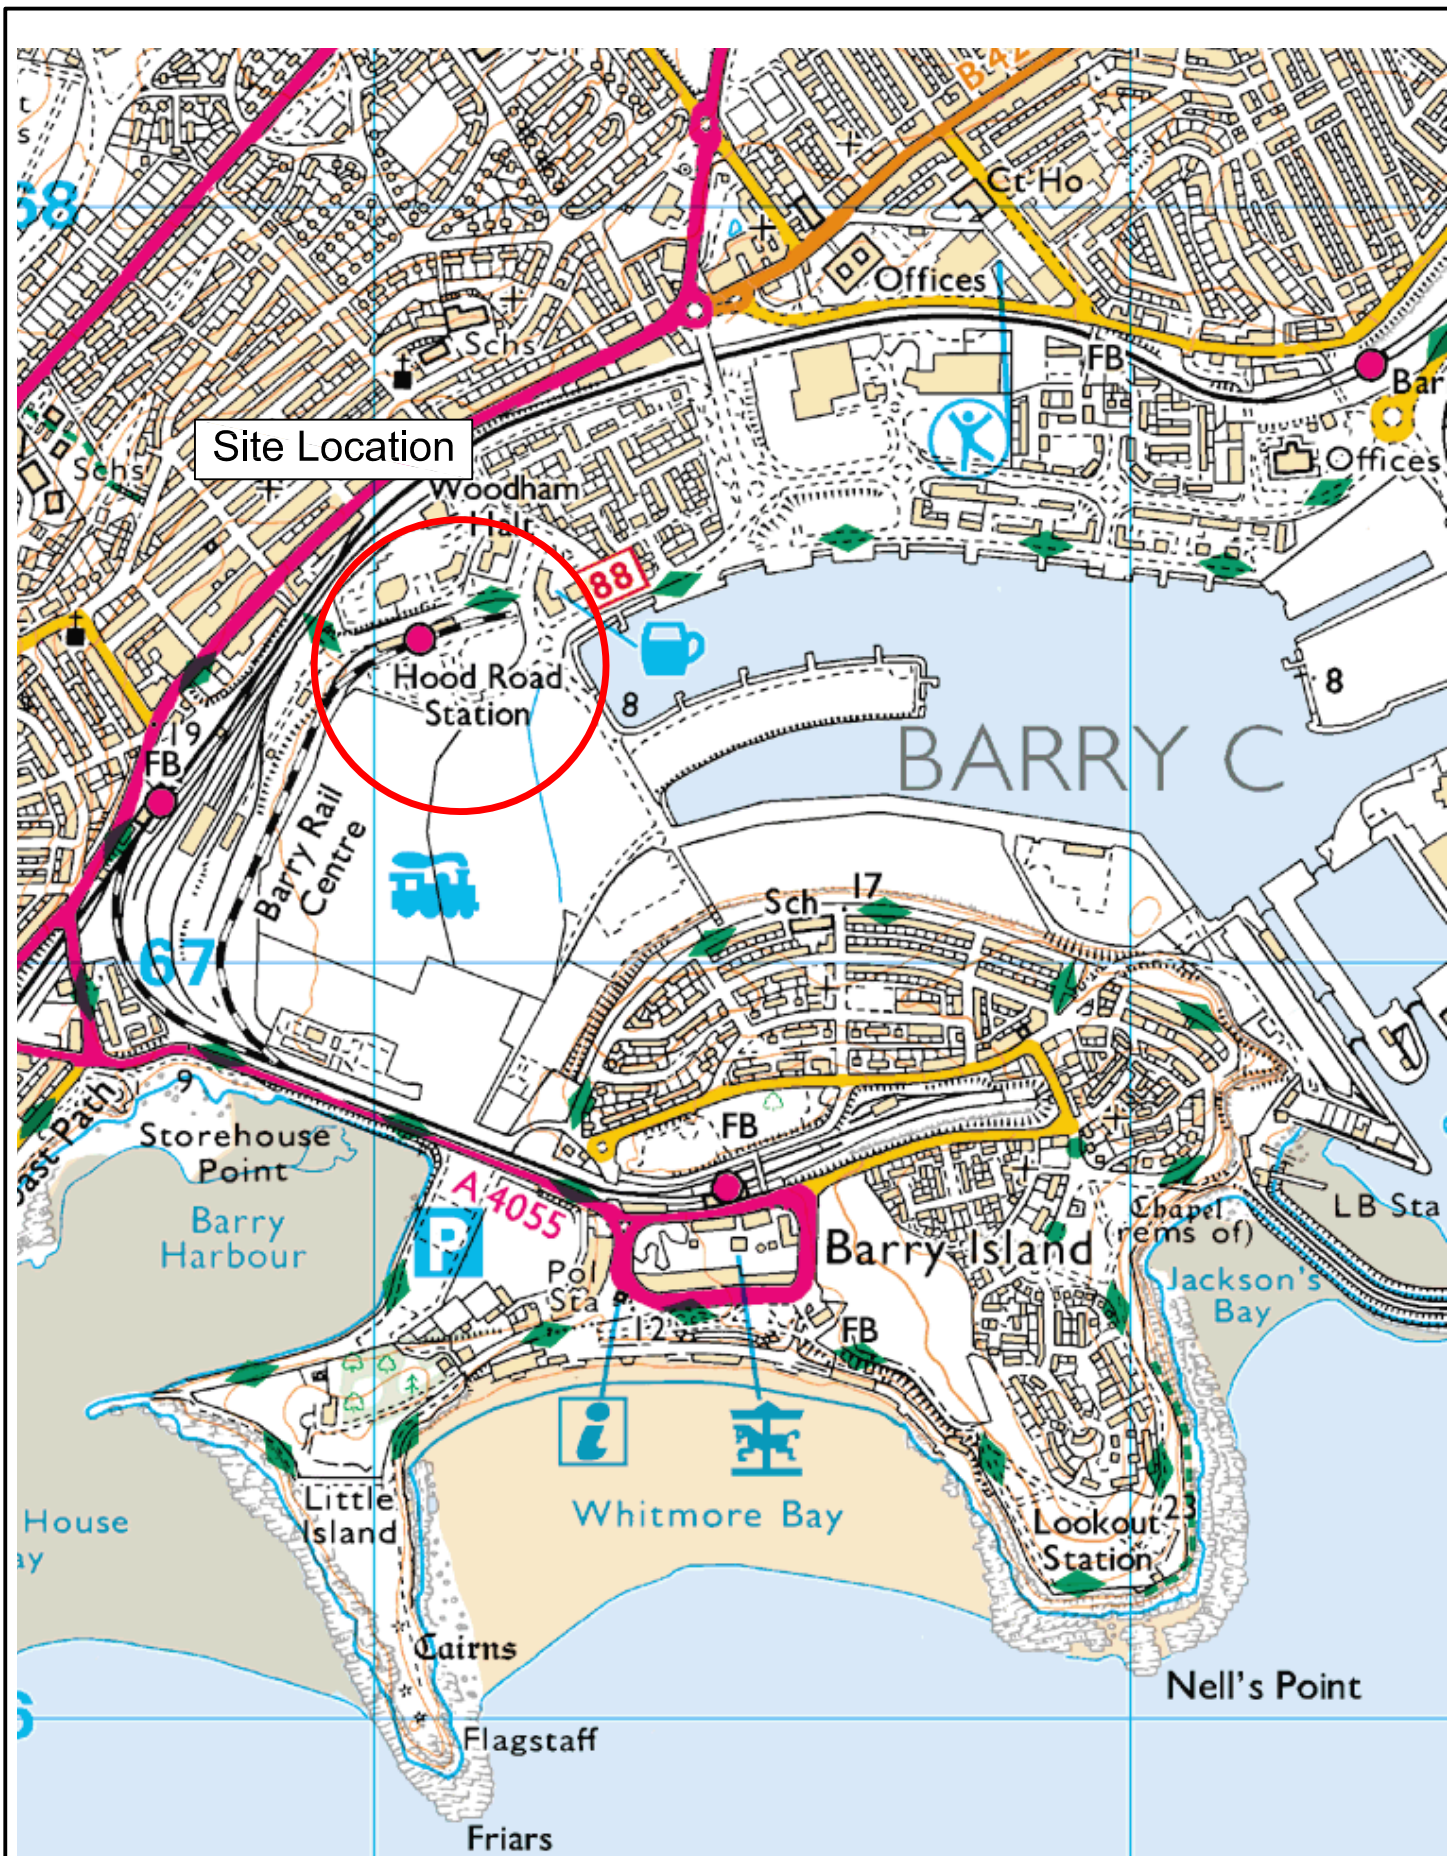
Figure 1: Site Location

The site is located to the west of Barry No. 1 Dock, approximately 1.4km southwest of Barry Town Centre, at a National Grid Reference of 311090, 167390, see Figure 1.
