BAT SURVEY

BOLSTON HOUSE, BONVILSTON, VALE OF GLAMORGAN

OCTOBER 2021

Bat Survey

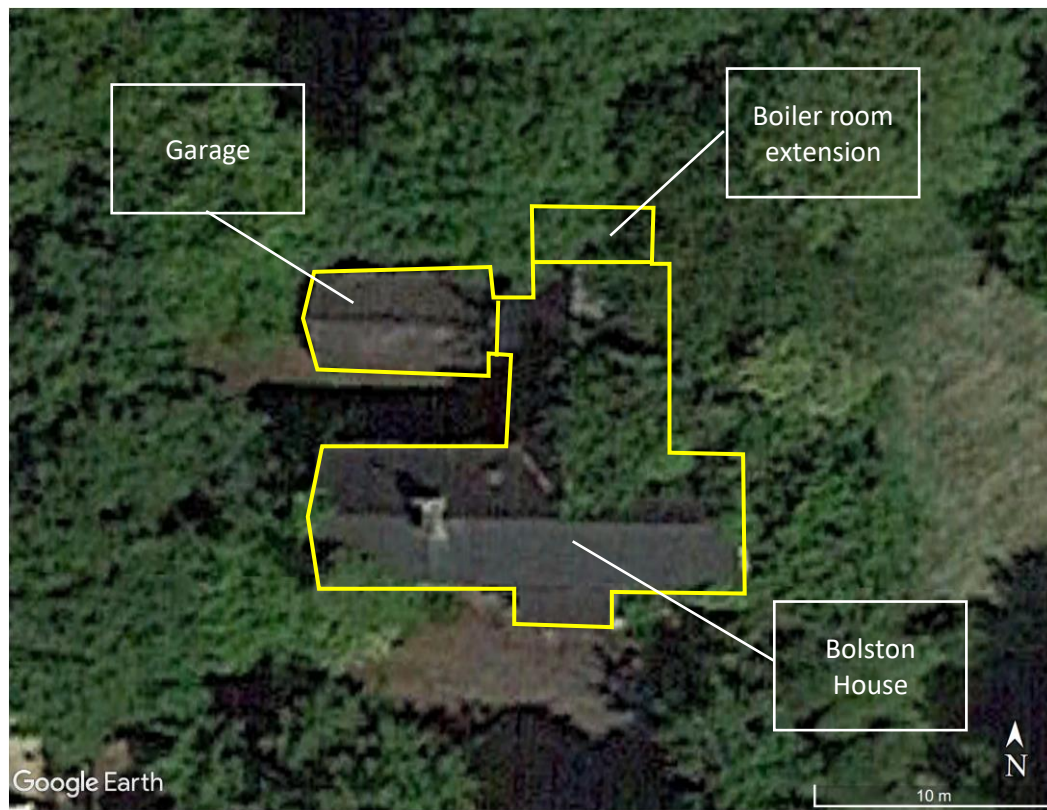
Figure 3 – detail of Bolston House (house and garage outlined yellow)

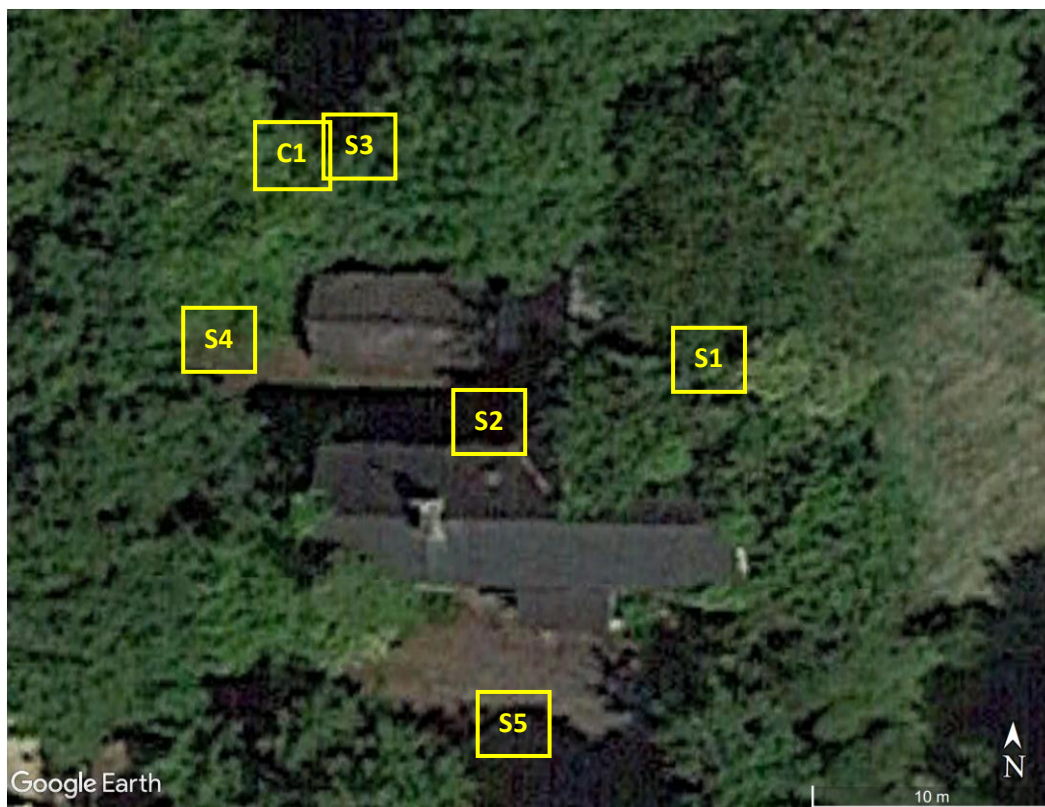
Figure 4 – surveyor locations Bolston House 18.06.2021

A dusk emergence survey was carried out of the building utilising 5(no.) surveyors and an infra-red camera (S1 – S5; C1; locations shown at **Figure 4**) situated so as to be able to view all visible elevations and roof lines of buildings likely to be used by bats at the same time. All surveyors were equipped with Batlogger M or Batlogger M2 and / or Anabat Walkabout full spectrum bat detectors.

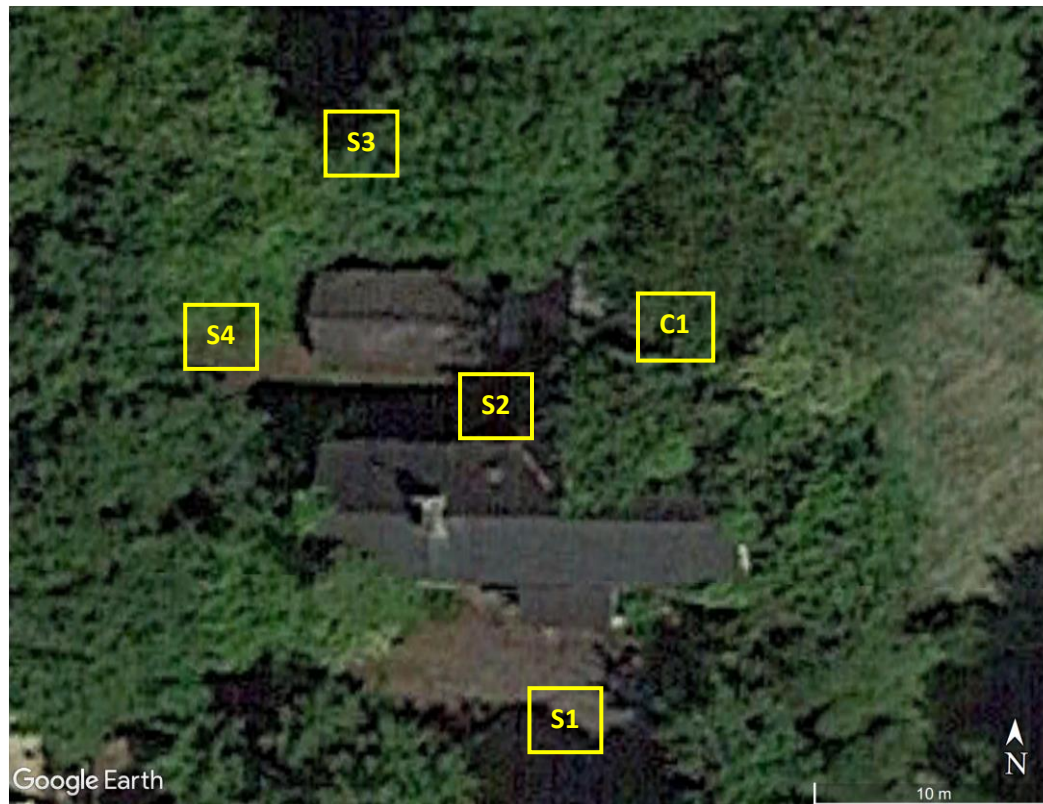
Figure 5 – surveyor location Bolston House (25.07.2021)

A dusk emergence survey was carried out of the building with 4(no.) surveyors and an infra-red camera (S1 – S4; C1) as shown at **Figure 5**. The surveyors were equipped with Batlogger M / Batlogger M2 and / or Anabat Walkabout full spectrum bat detectors.

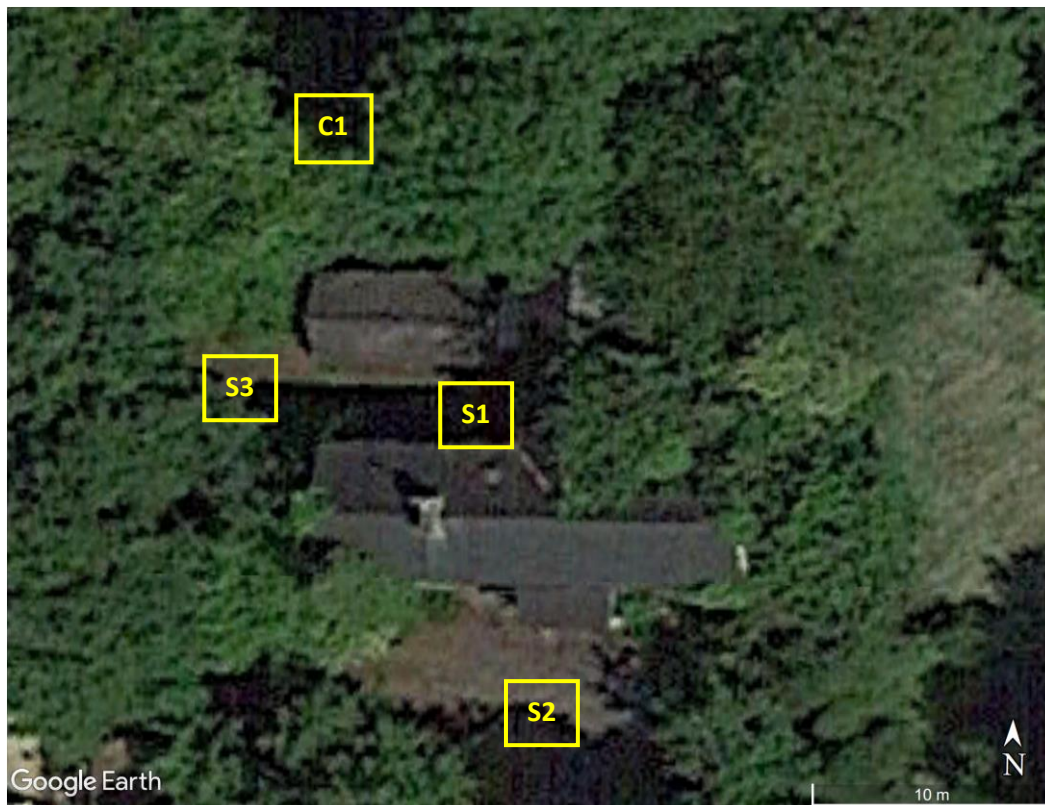
Figure 5 – surveyor location Bolston House (13.08.2021)

A dusk emergence survey was carried out of the building with 3(no.) surveyors and an infra-red camera (S1 – S4; C1) as shown at **Figure 5**. The surveyors were equipped with Batlogger M / Batlogger M2 and /or Anabat Walkabout full spectrum bat detectors.

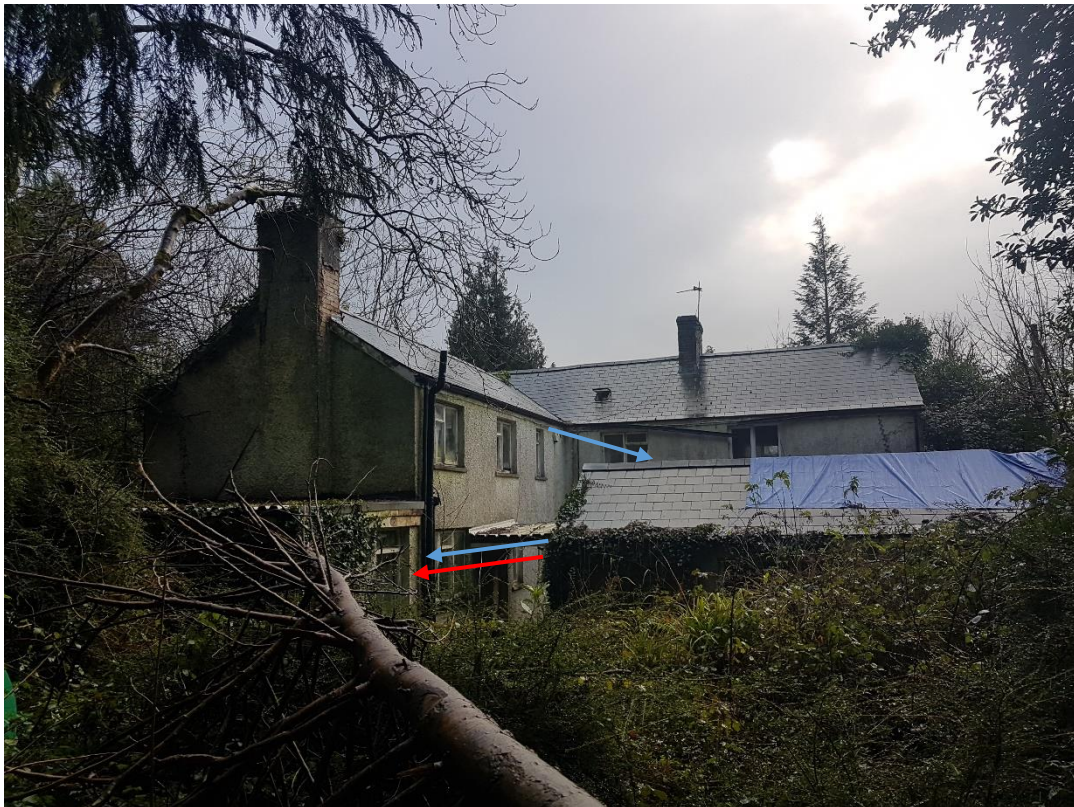
A single soprano pipistrelle bat was seen to emerge from the eastern end of the garage 21:52. 2no. soprano pipistrelle bats were seen to emerge from the roof of the main house at 21:53. 2no. lesser horseshoe bats were heard in the garage at 21:57 with emergence later at approximately 22:15 from the eastern end of the garage building. All emergence points are shown at **Figure 5**.

Figure 5 – emergence points Bolston House 18.06.2021
(Soprano pipistrelle arrowed blue; lesser horseshoe arrowed red)

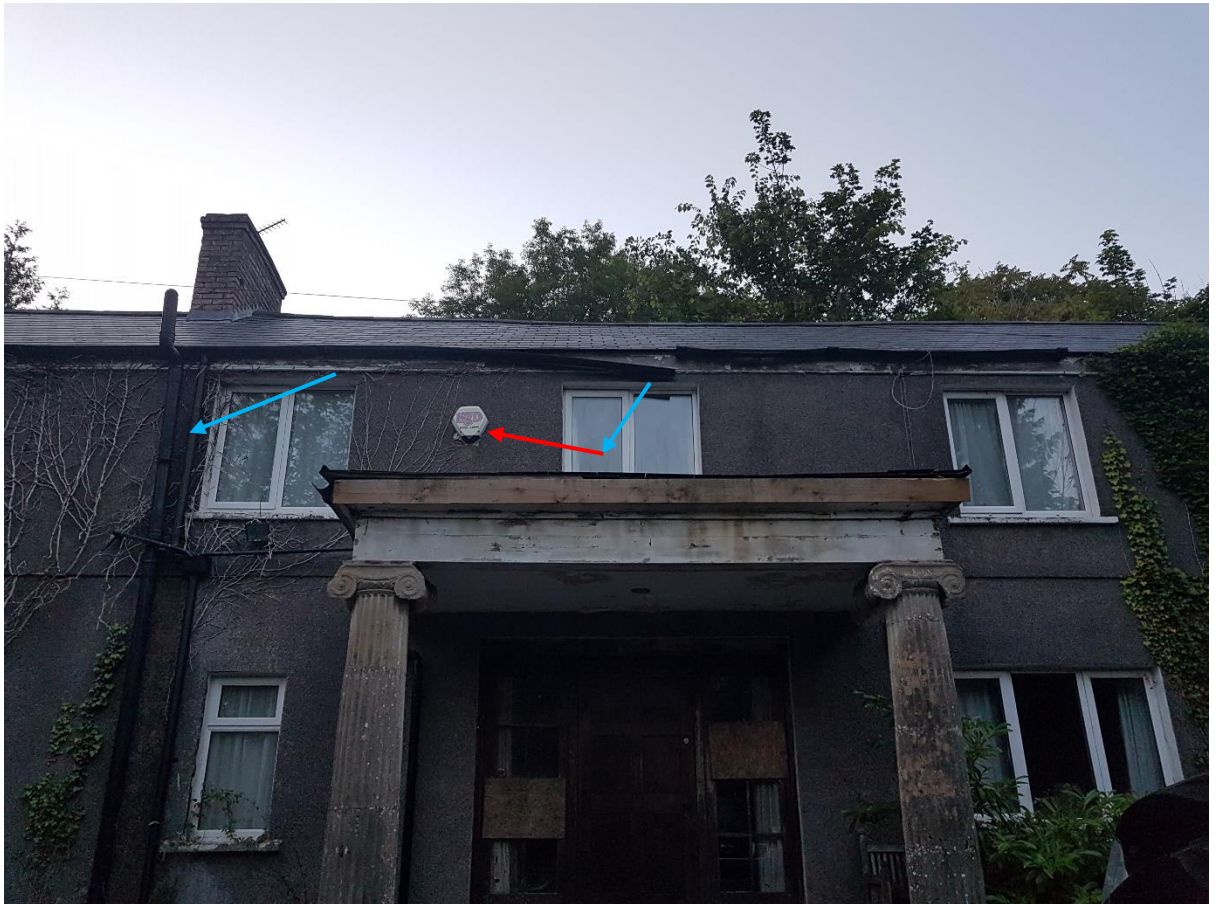
Figure 6 – emergence points Bolston House 09.07.2021
(Soprano pipistrelle emergence arrowed blue. Re-entry arrowed red)

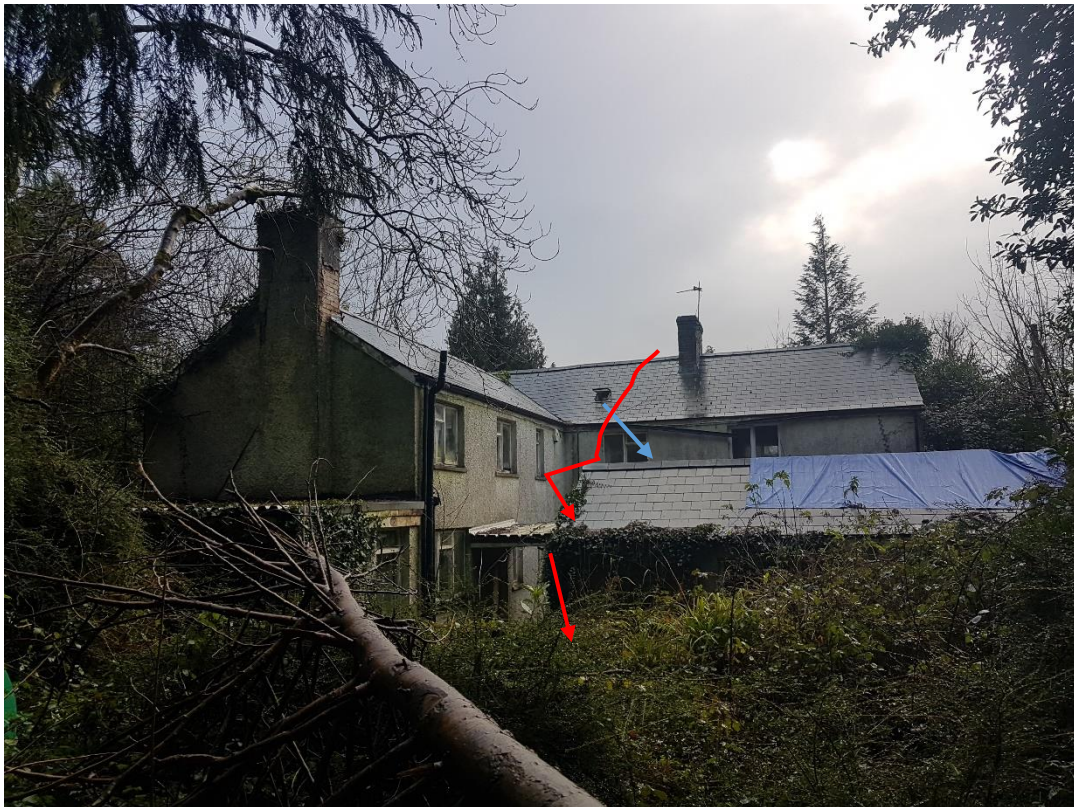
Figure 7 – emergence points Bolston House 09.07.2021
(soprano pipistrelle arrowed blue; lesser horseshoe arrowed red)

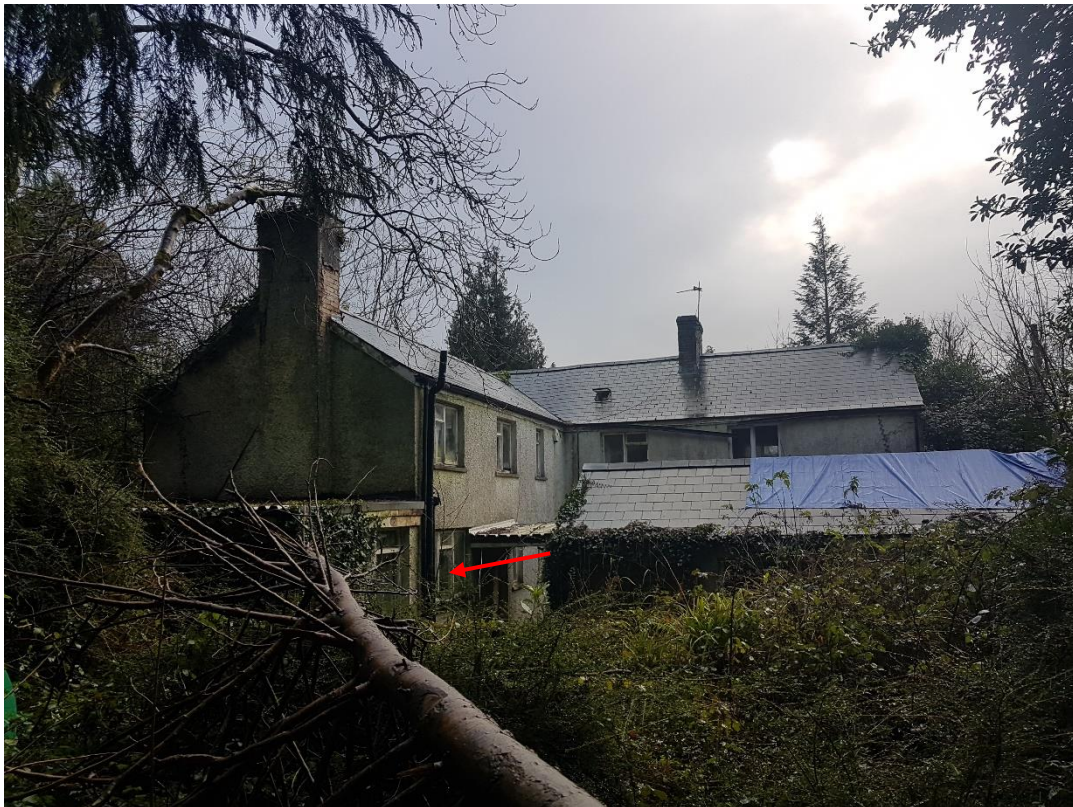
Figure 8 – emergence points Bolston House 13.08.2021
(Lesser horseshoe arrowed red)

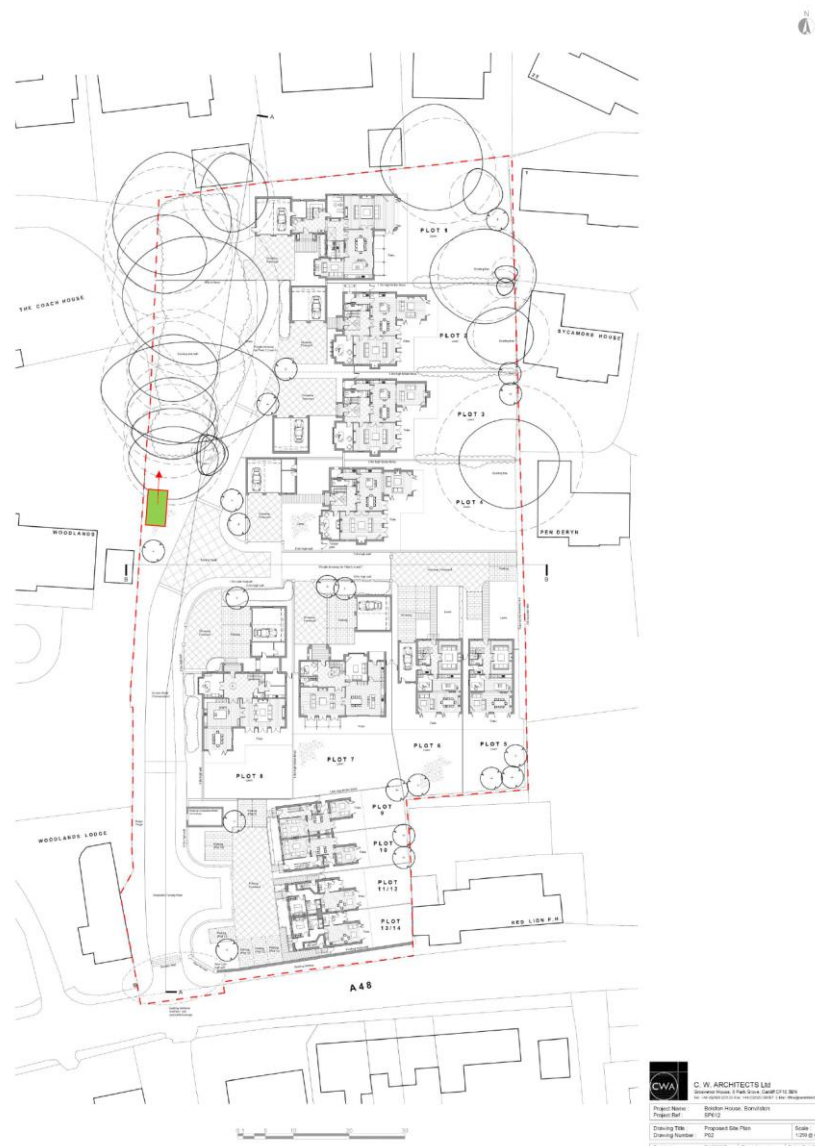
Figure 8 – location of mitigation bat roost and direction of entrance

There will be no lighting of the bat roost structure or any of the trees on the western boundary.

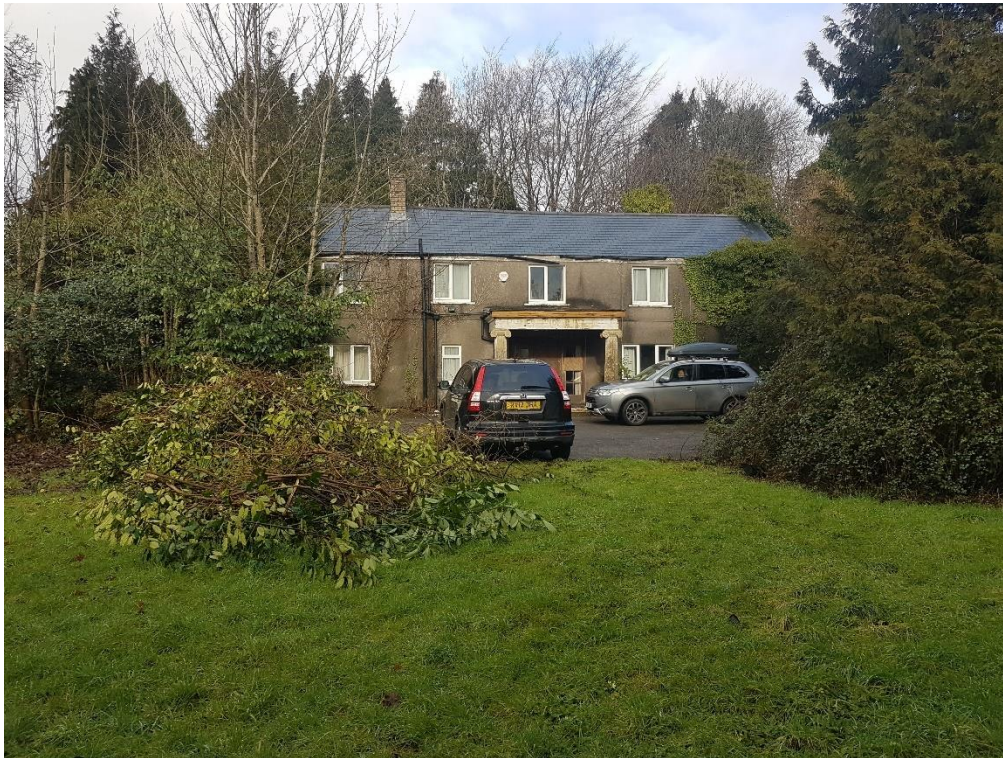
Plate 1 –front (southern) elevation

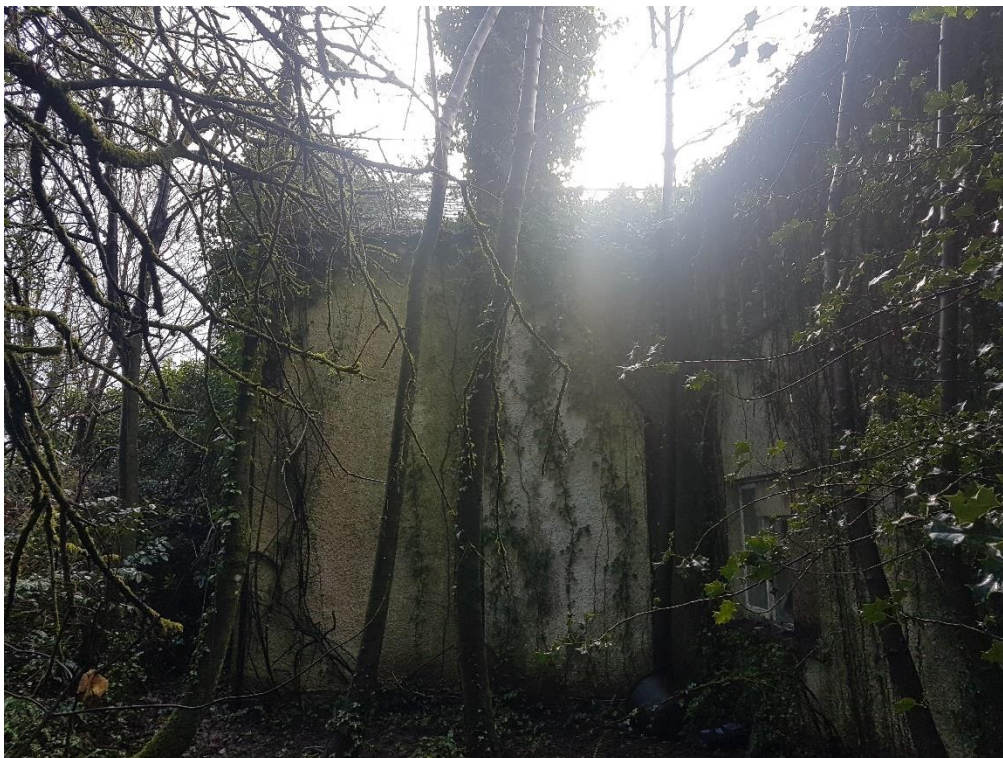
Plate 2 – side (eastern) elevation

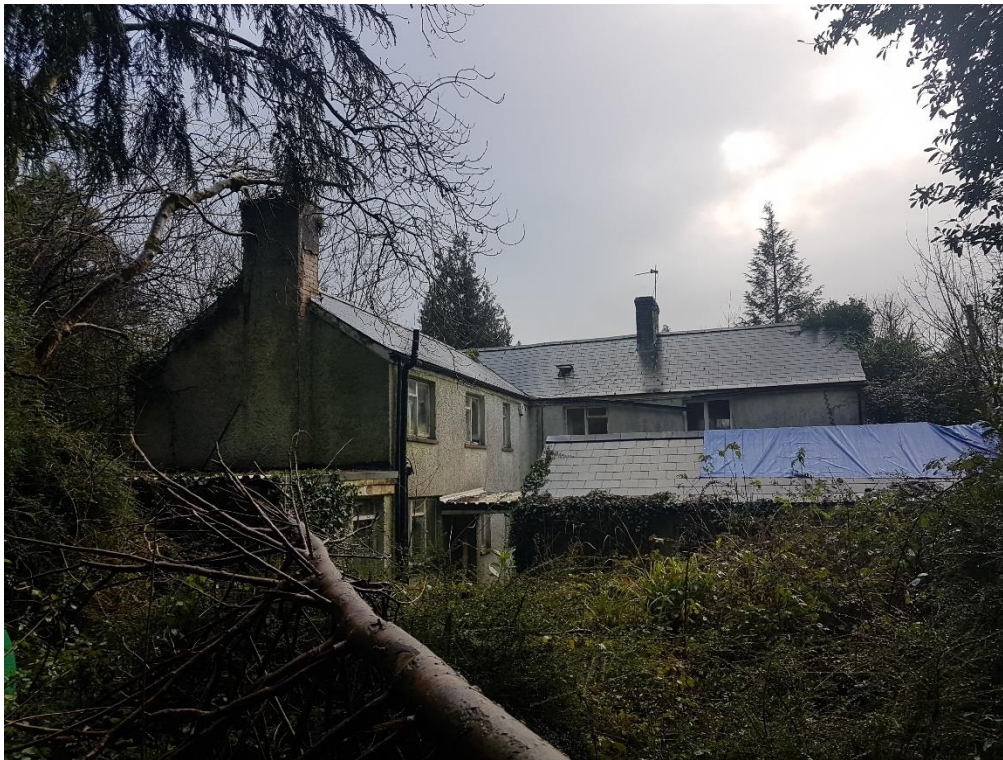
Plate 3 – rear (northern) elevation

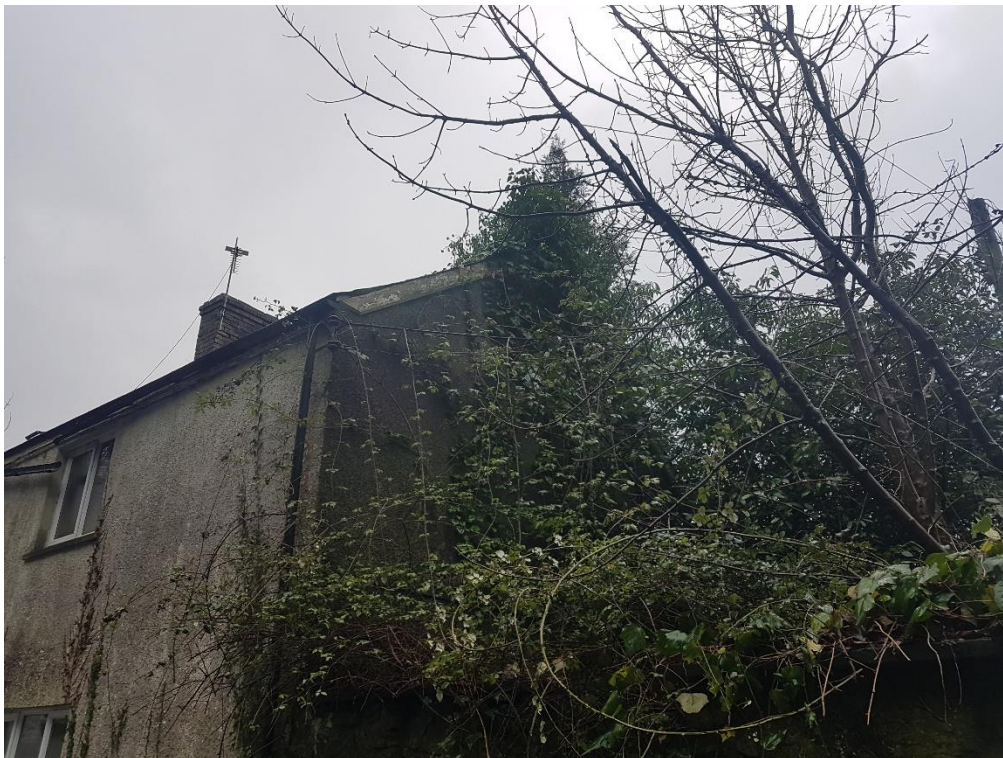
Plate 4 – side (western) elevation

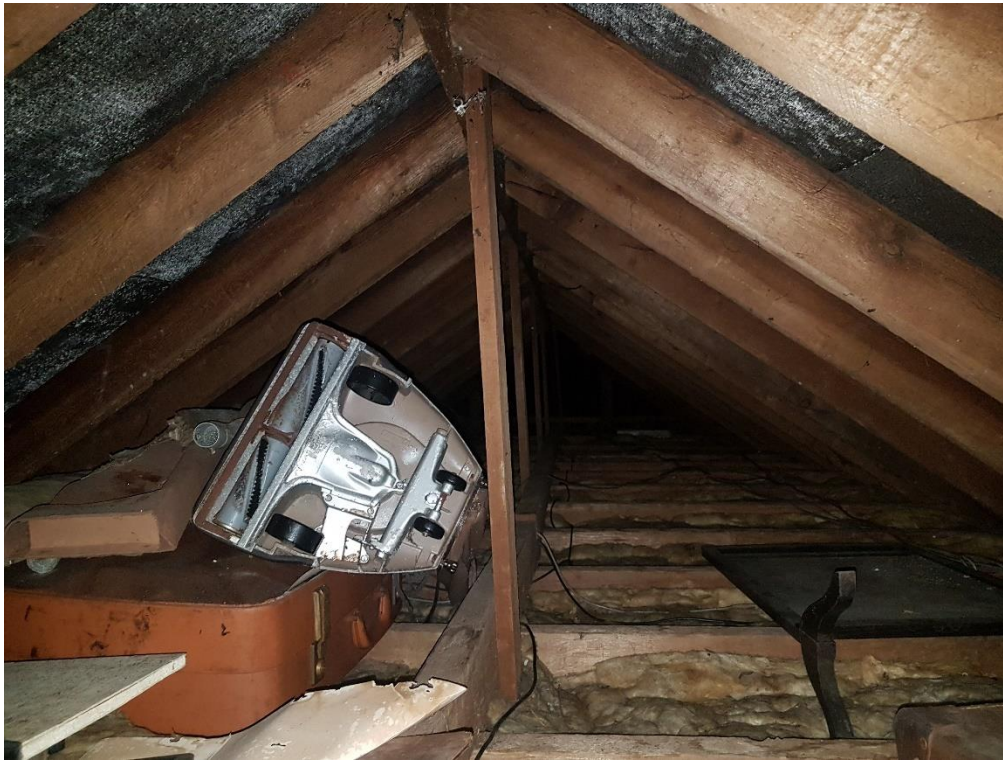
The north – south extension has a joist to ridge height of approximately 1.5m and is also lined with bitumen felt. The roof is of open trussed construction.

Plate 5 – Roof space of northern extension

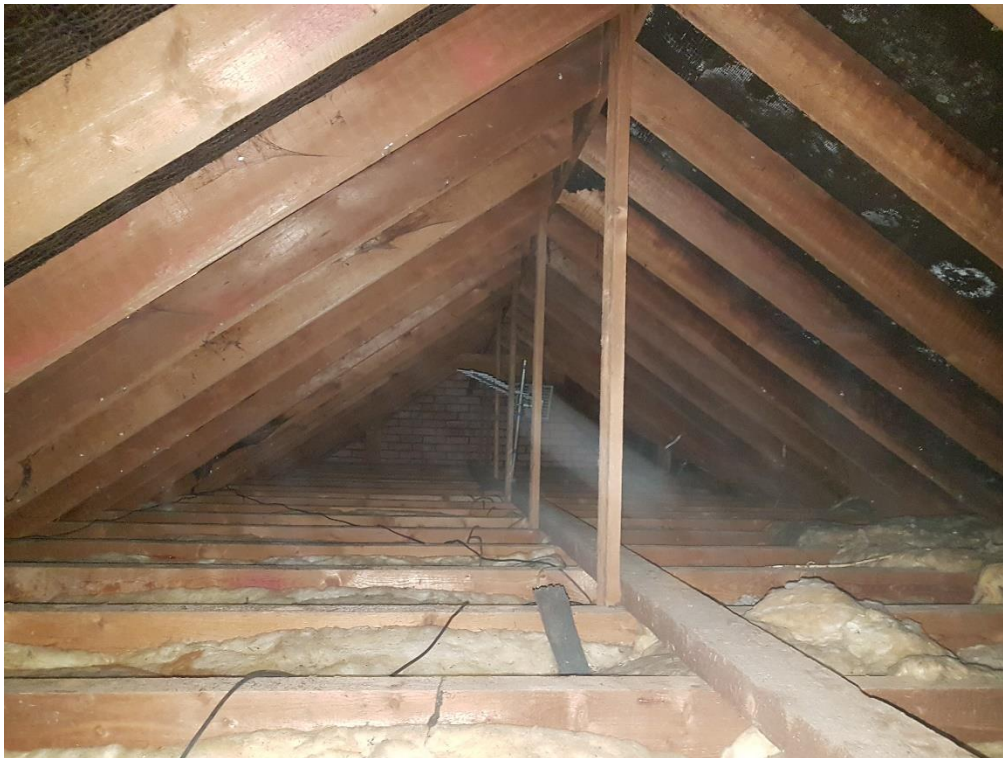
The main east – west roof has a joist to ridge height of approximately 2m and is of an open purlin and rafter construction. one continuous space lined with bitumen felt.

Plate 6 – Roof space of main attic

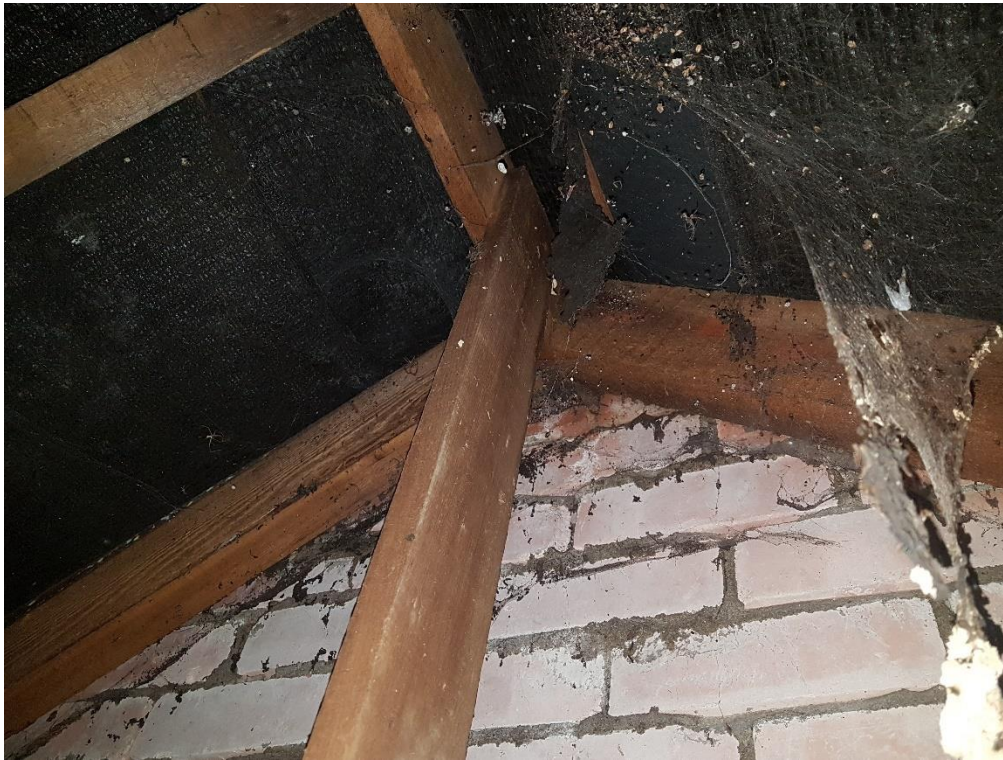
Plate 7 – Roof space of main attic

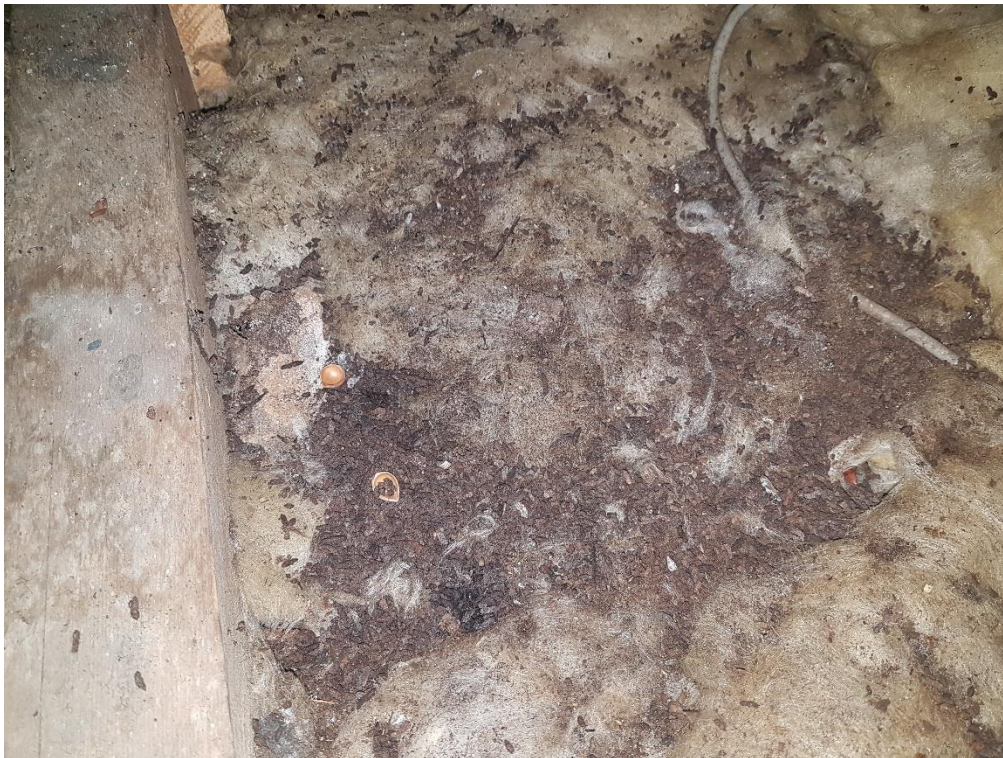
Evidence of bats in the form of droppings were observed all the roof spaces of the house and garage.

Plate 8 - Bat droppings in main attic space

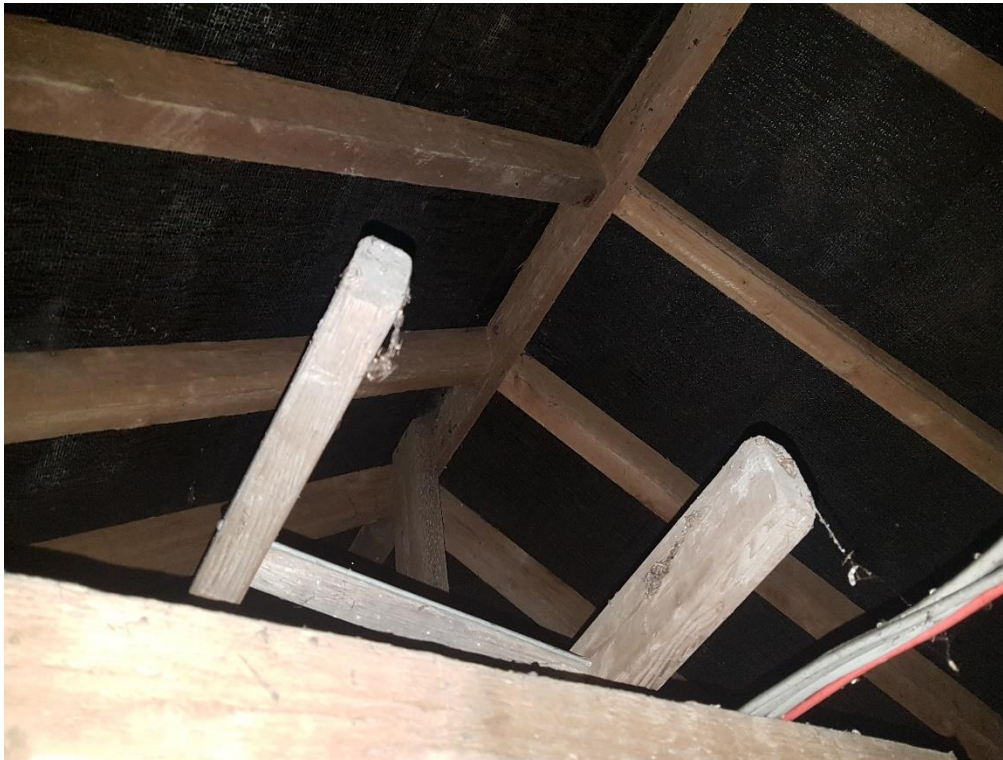
This is a single storey brick built structure under a pitched slate roof the ridge of which is oriented east – west. The roof is open but lined with bitumen felt.

Plate 9 – Garage roof space
