Ground Investigation No. 2071724
Factual and Interpretative Report

Cowbridge Primary School
Vale of Glamorgan

May 2021

Client:
Morgan Sindall Construction & Infrastructure
Ltd.

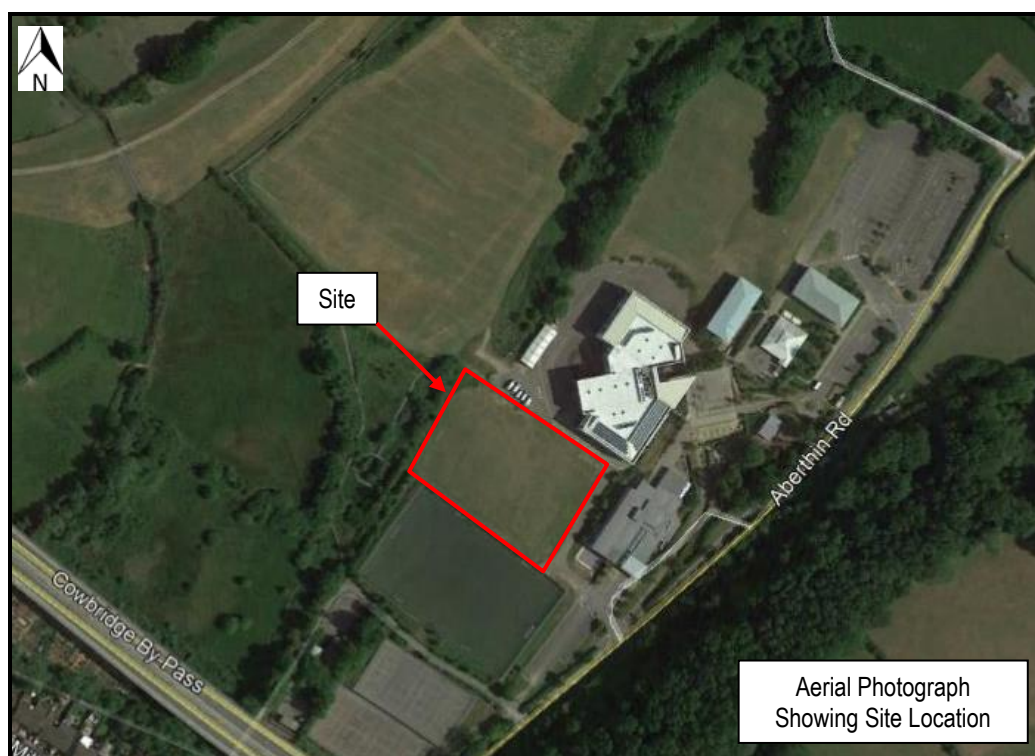
The site is an existing sports pitch located immediately southwest of the main buildings and associated infrastructure of Cowbridge Comprehensive School in the Vale of Glamorgan, South Wales at National Grid Reference ST 00232 74882, and is shown on the Site Location Plan, included in the Appendices to this report and in the aerial photograph below.

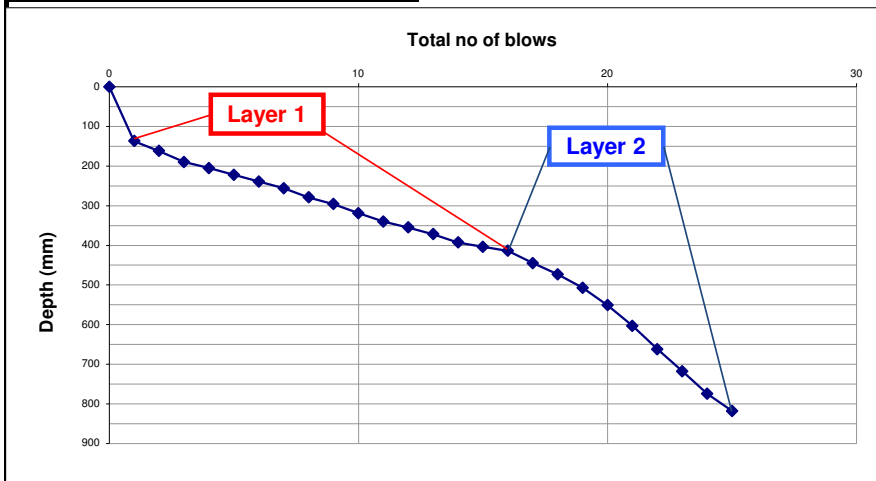
Remarks:		BS 1377 : Part 9 : 1990, IAN 73/06 (supercedes HD 25/94). Test started at existing ground level.			
Particles >20mm Operators	Yes AH/ME	Weather	Dry	Sheet	3 of 8

DYNAMIC CONE PENETROMETER TEST RESULTS						Date Job No.		07/04/2021 2071724		CJAssociates	
Client Name Job Name		Morgan Sindall Cowbridge Primary School				Zero Reading Test No.		116 1		Depth (mm): 0 Locn: DCP01	
Total No. of Blows	Depth Reading (mm)	Total depth (mm)	Mean penetration per blow (mm)	Layer	Top of layer (mm)	Base of layer (mm)	Blows at top of layer	Blows at base of layer	Mean penetration per blow (mm)	CBR of layer (%)	
0	116	0	0								
1	253	137	137.00	Layer 1	137	414	1	16	18.5	14	
2	278	162	25.00								
3	306	190	28.00								
4	321	205	15.00	Layer 2	414	818	16	25	44.9	5.4	
5	338	222	17.00								
6	355	239	17.00								
7	372	256	17.00								
8	395	279	23.00								
9	412	296	17.00								
10	435	319	23.00								
11	456	340	21.00								
12	471	355	15.00								
13	488	372	17.00								
14	509	393	21.00								
15	520	404	11.00								
16	530	414	10.00								
17	561	445	31.00								
18	589	473	28.00

19	623	507	34.00								
20	667	551	44.00								
21	719	603	52.00								
22	778	662	59.00								
23	834	718	56.00								
24	890	774	56.00								
25	934	818	44.00

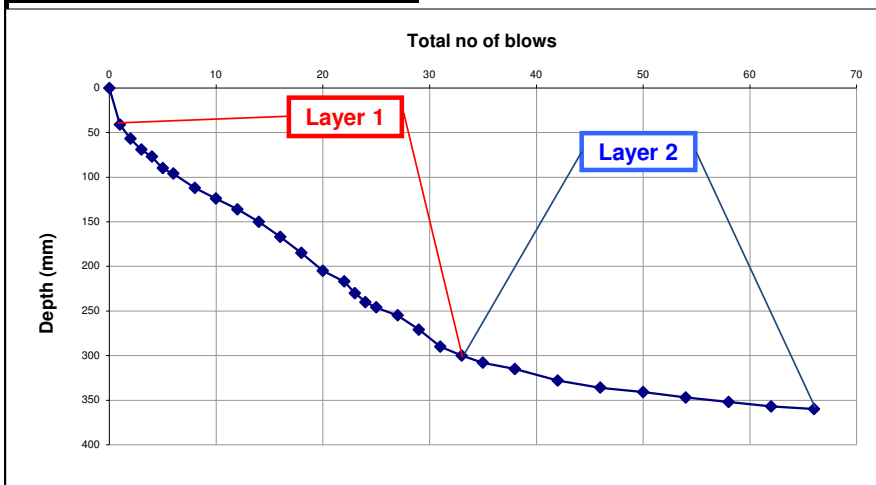
Remarks:		BS 1377 : Part 9 : 1990, IAN 73/06 (supercedes HD 25/94). Test started at existing ground level.			
Particles >20mm	Yes	Weather	Dry		
Operators	AH/ME	Sheet	7	of	8

DYNAMIC CONE PENETROMETER TEST RESULTS						Date Job No.		07/04/2021 2071724		CJAssociates	
Client Name Job Name		Morgan Sindall Cowbridge Primary School				Zero Reading Test No.		173 5		Depth (mm): 0 Locn: DCP05	
Total No. of Blows	Depth Reading (mm)	Total depth (mm)	Mean penetration per blow (mm)	Layer	Top of layer (mm)	Base of layer (mm)	Blows at top of layer	Blows at base of layer	Mean penetration per blow (mm)	CBR of layer (%)	
0	173	0	0								
1	214	41	41.00	Layer 1	41	300	1	33	8.1	33	
2	230	57	16.00								
3	242	69	12.00								
4	250	77	8.00	Layer 2	300	360	33	66	1.8	>100	
5	263	90	13.00								
6	269	96	6.00								
8	285	112	8.00								
10	297	124	6.00								
12	309	136	6.00								
14	323	150	7.00								
16	340	167	8.50								
18	358	185	9.00								
20	378	205	10.00								
22	390	217	6.00								
23	403	230	13.00								
24	413	240	10.00								
25	419	246	6.00								
27	428	255	4.50

29	444	271	8.00								
31	463	290	9.50								
33	473	300	5.00								
35	481	308	4.00								
38	488	315	2.33								
42	501	328	3.25								
46	509	336	2.00								
50	514	341	1.25								
54	520	347	1.50								
58	525	352	1.25								
62	530	357	1.25								
66	533	360	0.75
