### 3.3 Field along road into Llanmaes: trenches 19-21

**Llanmaes FRMS, Vale of Glamorgan: archaeological watching brief**

**Report Title:** ..... Llanmaes Flood Risk Mitigation Scheme, Llanmaes, Vale of Glamorgan:  
archaeological watching brief

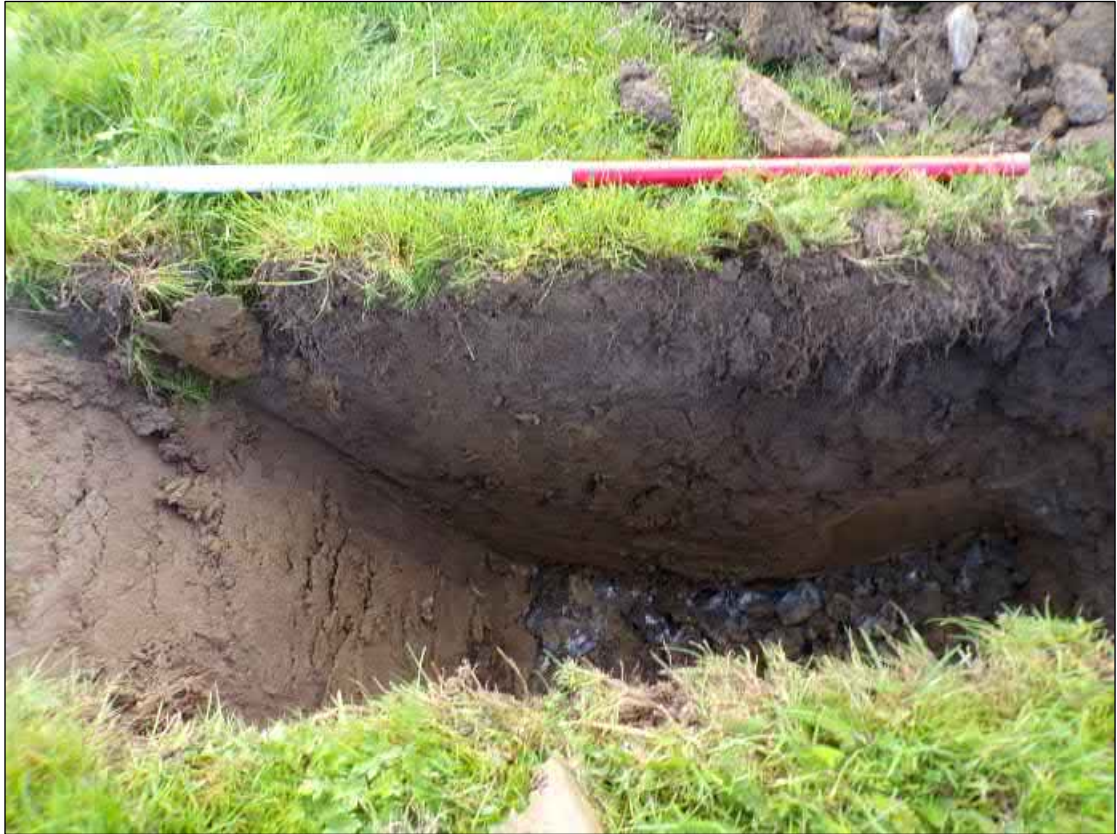
In Trenches 19 (Plate 7) and 20 the subsoil was a clayey mid-orange brown with occasional small rocks and occasional deeper roots (contexts 1901, 2001), thicker (0.95m) in the northernmost trench, Trench 19, and thinner (0.45) downhill in Trench 20. The subsoil overlay a limestone bedrock (contexts 1902, 2002).

Plate 7. West-facing section of Trench 19. View to the east. Scale in 0.5m increments

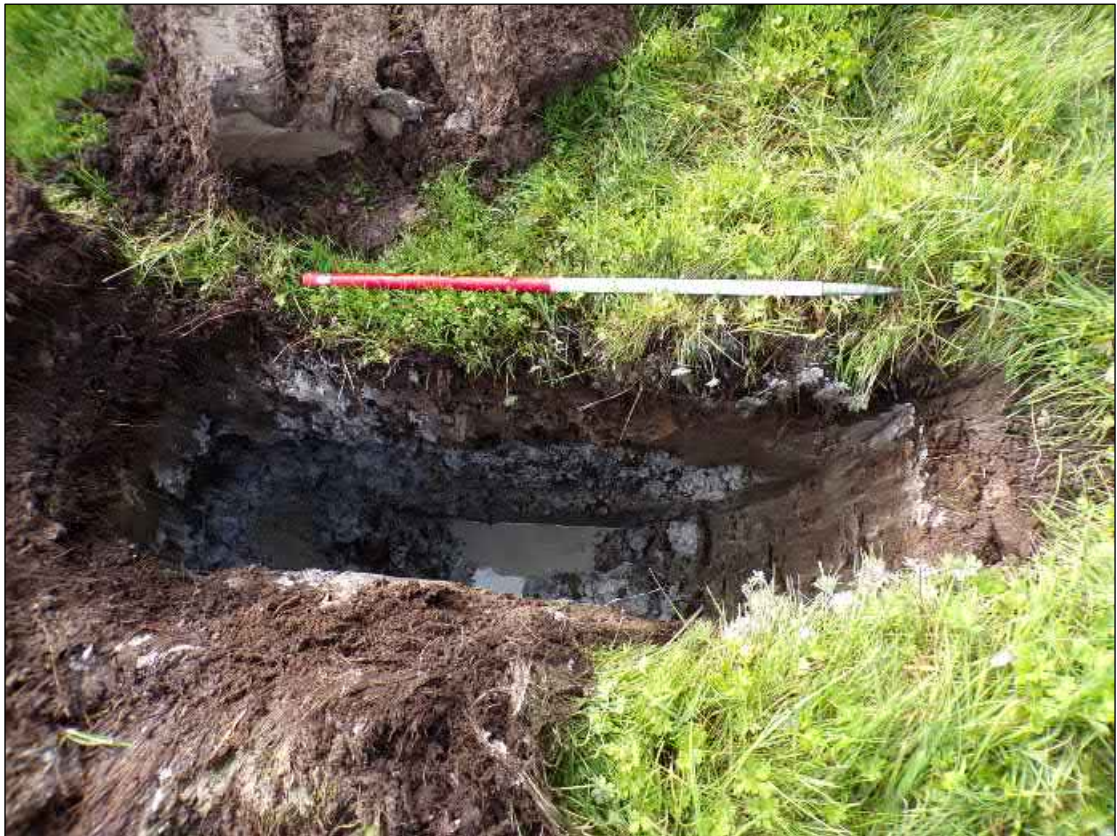
Trench 21 (Plate 8) was located in a depression in the southeastern corner of the field, which the landowner recalls previously being a pond. A pond is not shown on any of the historic mapping reviewed for the desk-based assessment (Baron *forthcoming*), but the topography shows that this area was likely part of the previous course of the brook and prone to being water-logged. The subsoil (context 2101) was similar to that in Trenches 19 and 20, but had a fine orange lens running through it. The subsoil overlay an 0.80m thick layer of very wet, soft, clayey light greyish-white sand with frequent small (<0.05m) rounded stones (context 2102). Bedrock was not seen as the bottom of the trench was submerged (the water table was noted at 1.20m below the surface), but was 'felt' by the machine driver at around 1.30m.

Plate 8. West-facing section of Trench 21. View to the east. Scale in 0.5m increments

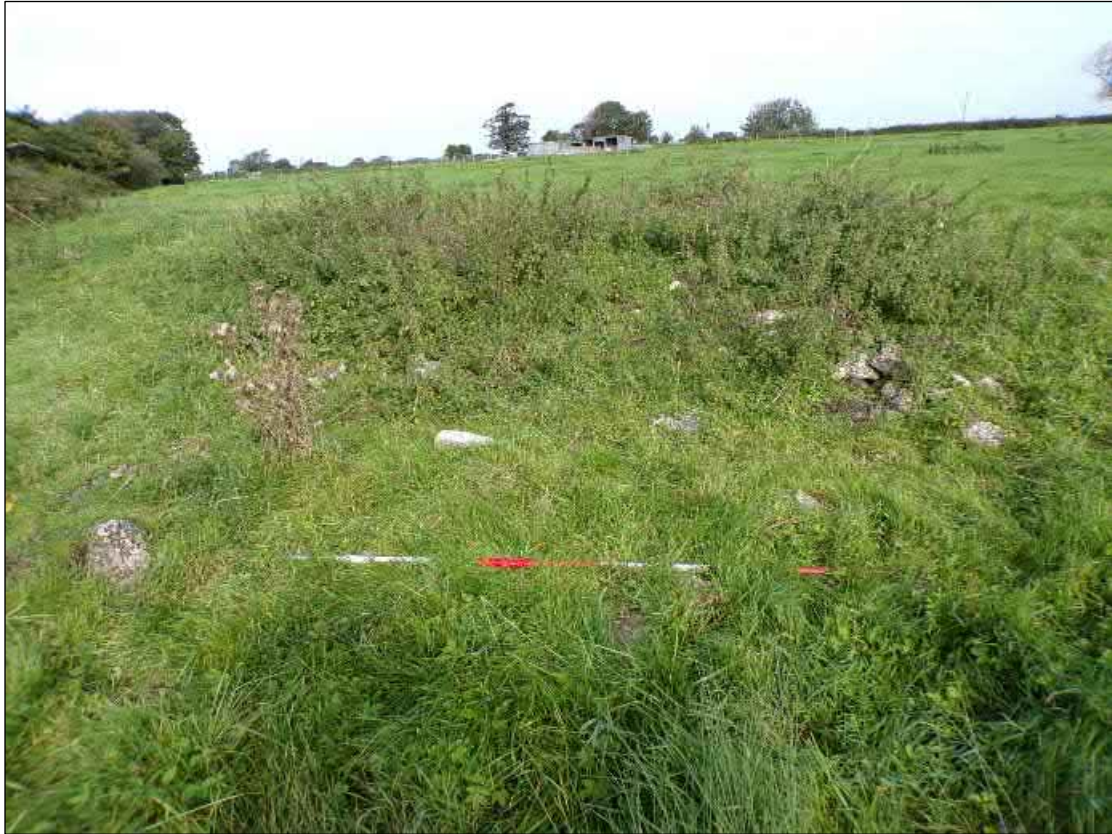
General observation of the field near the depression in the southeastern corner showed a change in vegetation around a spread of rubble aggregate concrete chunks and rocks (up to 0.35m). The eastern area of the spread formed a flat-topped circular cairn (context 2103) approximately 4.0m in diameter and up 0.5m height (Plate 9). There was a further, more irregular spread of rocks to the west for a further 9m. This may represent an attempt to reclaim some of the depression by levelling out the field with rubble and is visible on the LiDAR (Figure 3) but this interpretation is uncertain.

Plate 9. Possible clearance cairn or reclaimed land (2103). View to the north. Scale in 0.5m increments

An incidental observation of a possible clearance cairn was made near Trench 21, at the edge of a former pond in the southeastern corner of a field just north of the present course of Llanmaes Brook. This could also represent an attempt to reclaim some of the depression by in-filling with rubble.
