# Llanmaes Flood Alleviation Scheme

Phase 1 Geo-environmental Desk Study

Vale of Glamorgan Council

Project reference: 60160078-ACM-RP-ENV-001-1 Project number: 60160078

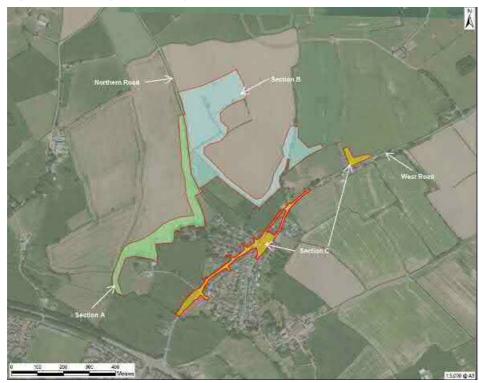
#### Figure 2.1. Site Layout Showing Site Sections for Report Description Purposes

Figure 2.1 below shows the layout of Sections A, B and C, used for description purposes throughout the report.

Given the complex geometry shown in Figure 2, the Site has been split into three sections for description purposes within this report:

- Section A: Land to the west of North Road and north of West Road, which will comprise the development of the proposed Ditch 1 and Overspill Bund 1. It is currently open agricultural land.
- Section B: Land to the east of North Road and north of West Road, which will comprise development of Flood Bunds 1, 2, and 3, and proposed Ditch 2. It is currently open agricultural land.
- Section C: Land adjacent and parallel to West Road, which will comprise development of the proposed Village Green Ditch 1, proposed Ditch 3, and Flood Bund 4. The village green ditch planned to be excavated within the current village green, with the areas of proposed ditch 3 and flood bund 1 currently open agricultural land.

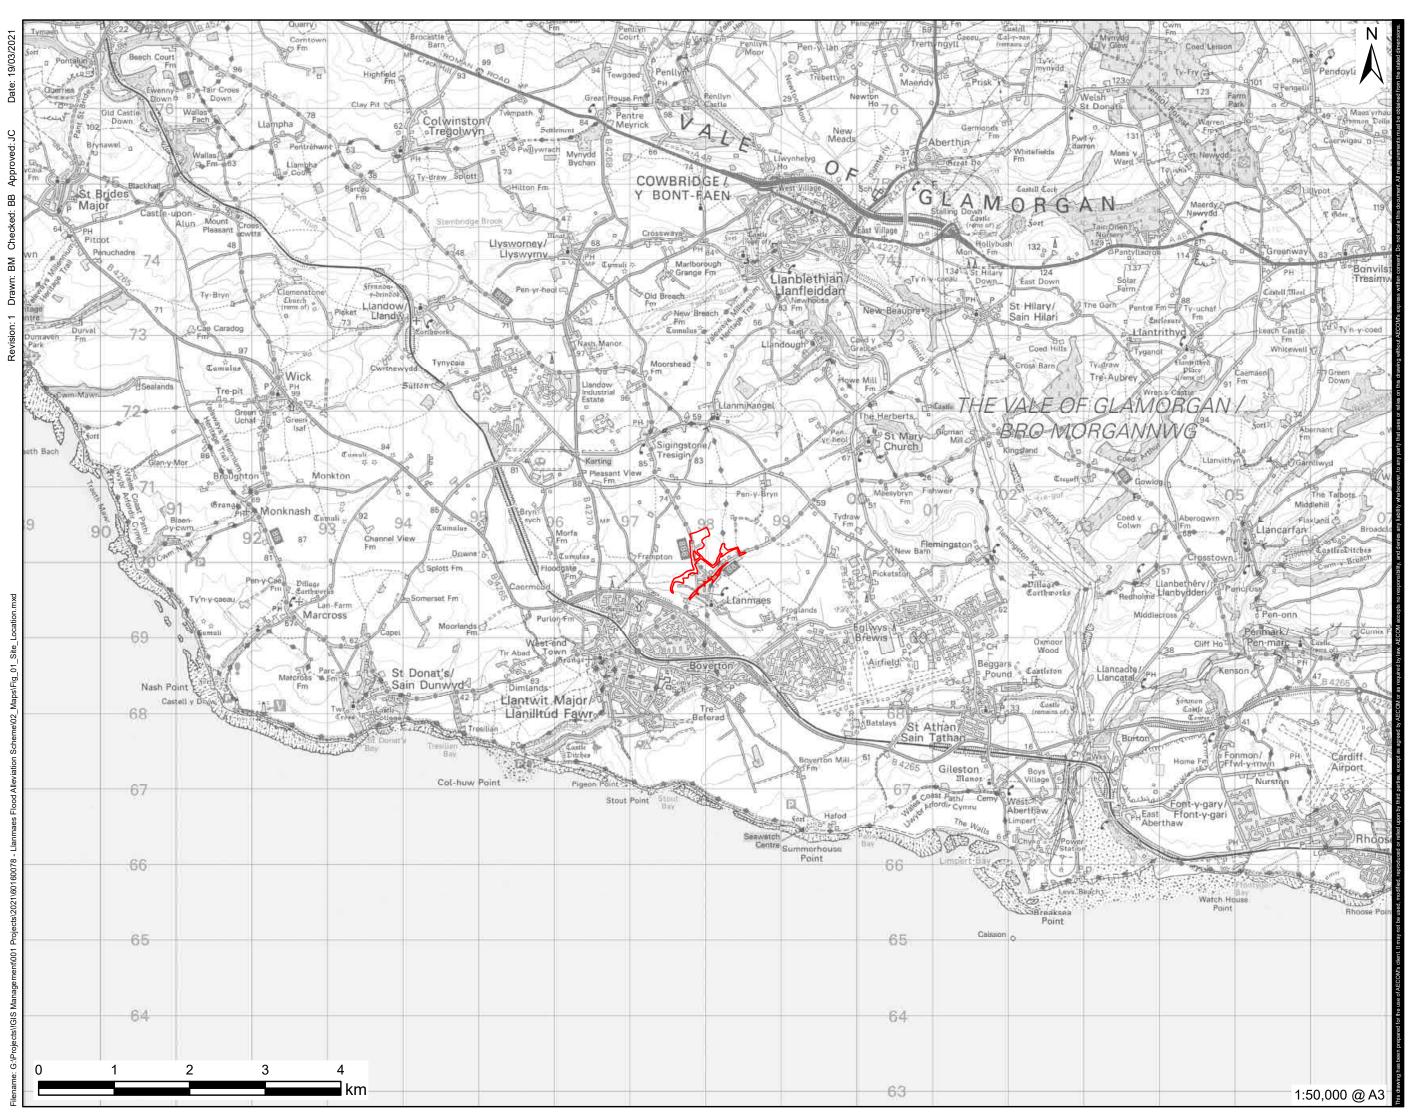
Figure 1

The Site is located to the north of Llanmaes village, in the Vale of Glamorgan, South Wales. It is centred on Ordnance Survey (OS) National Grid Reference 297856, 169884. A site location plan is provided as Figure 1.

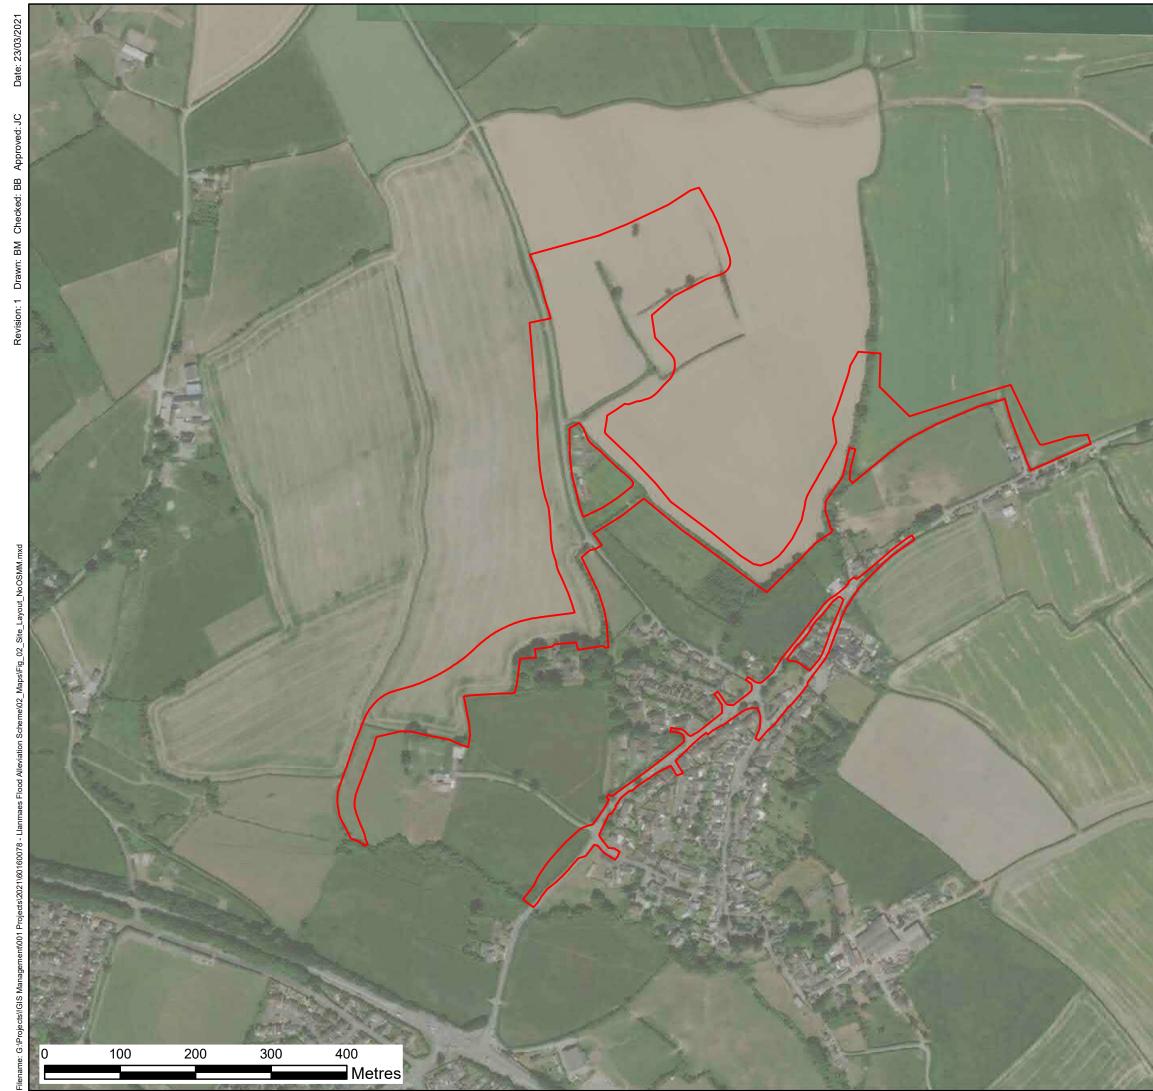
The Site covers an area of approximately 12.45 hectares (ha) and is defined by the red line boundary shown in Figure 2 and in the plans included as Appendix A.

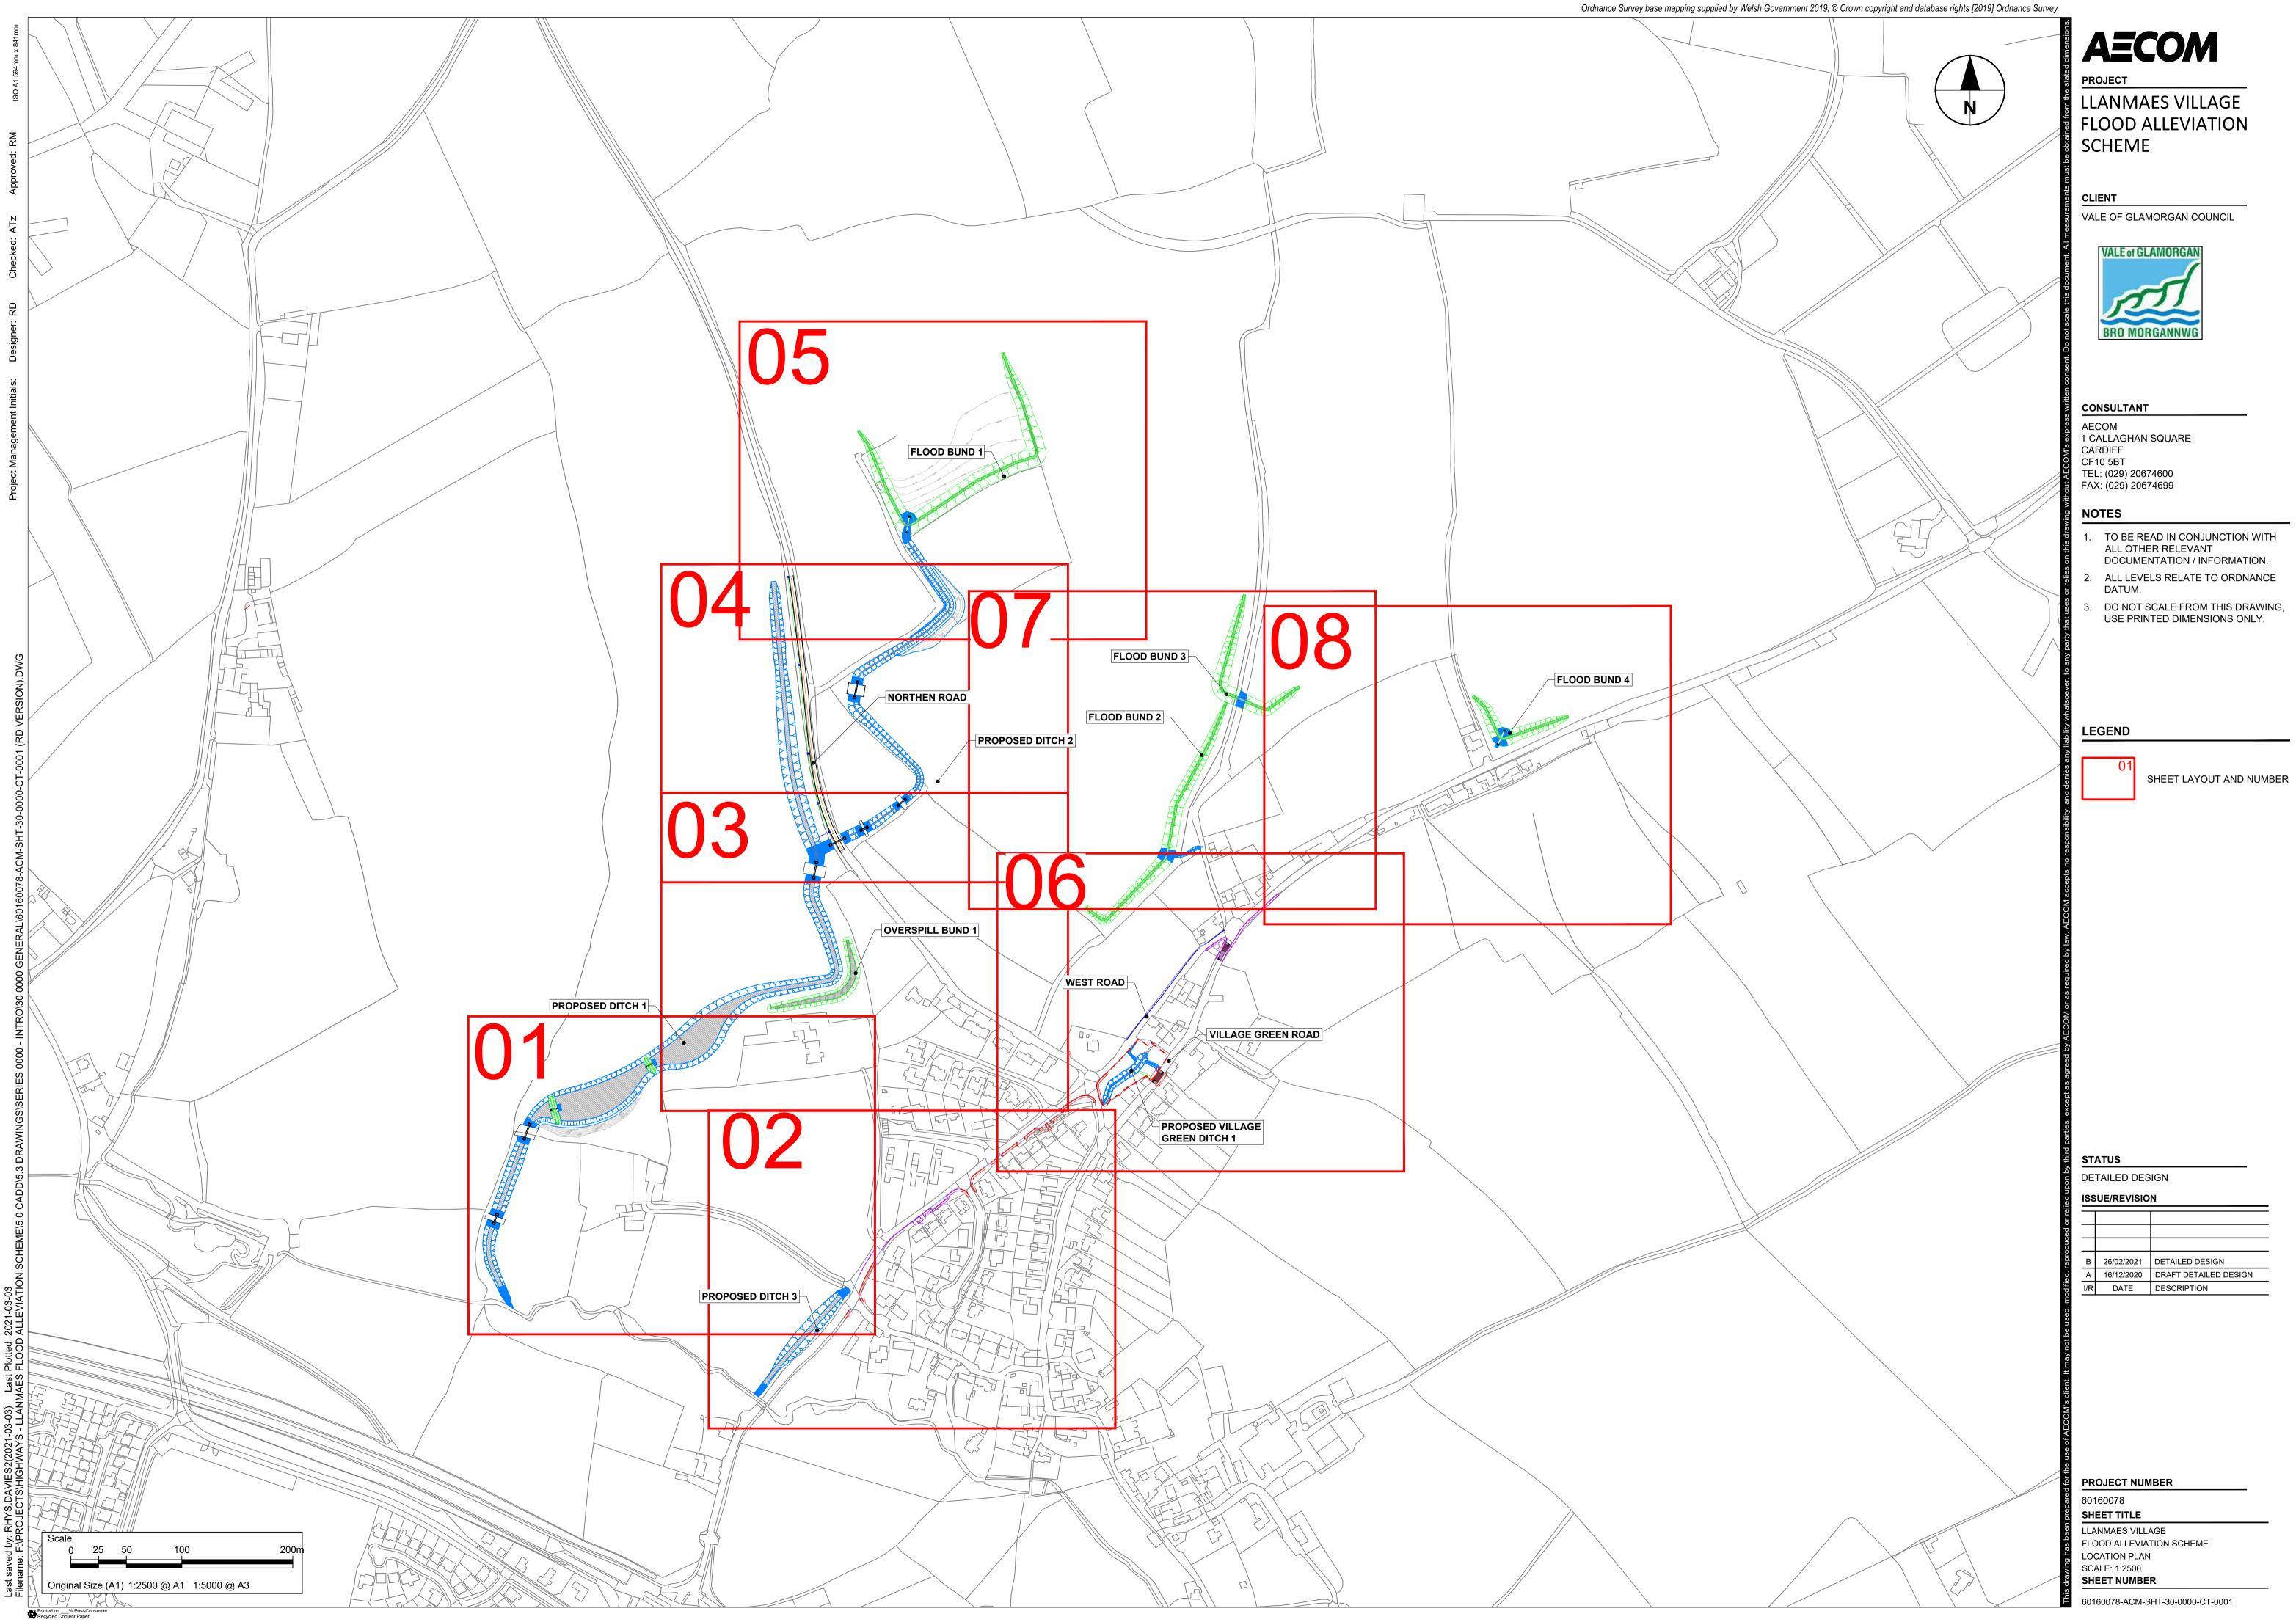
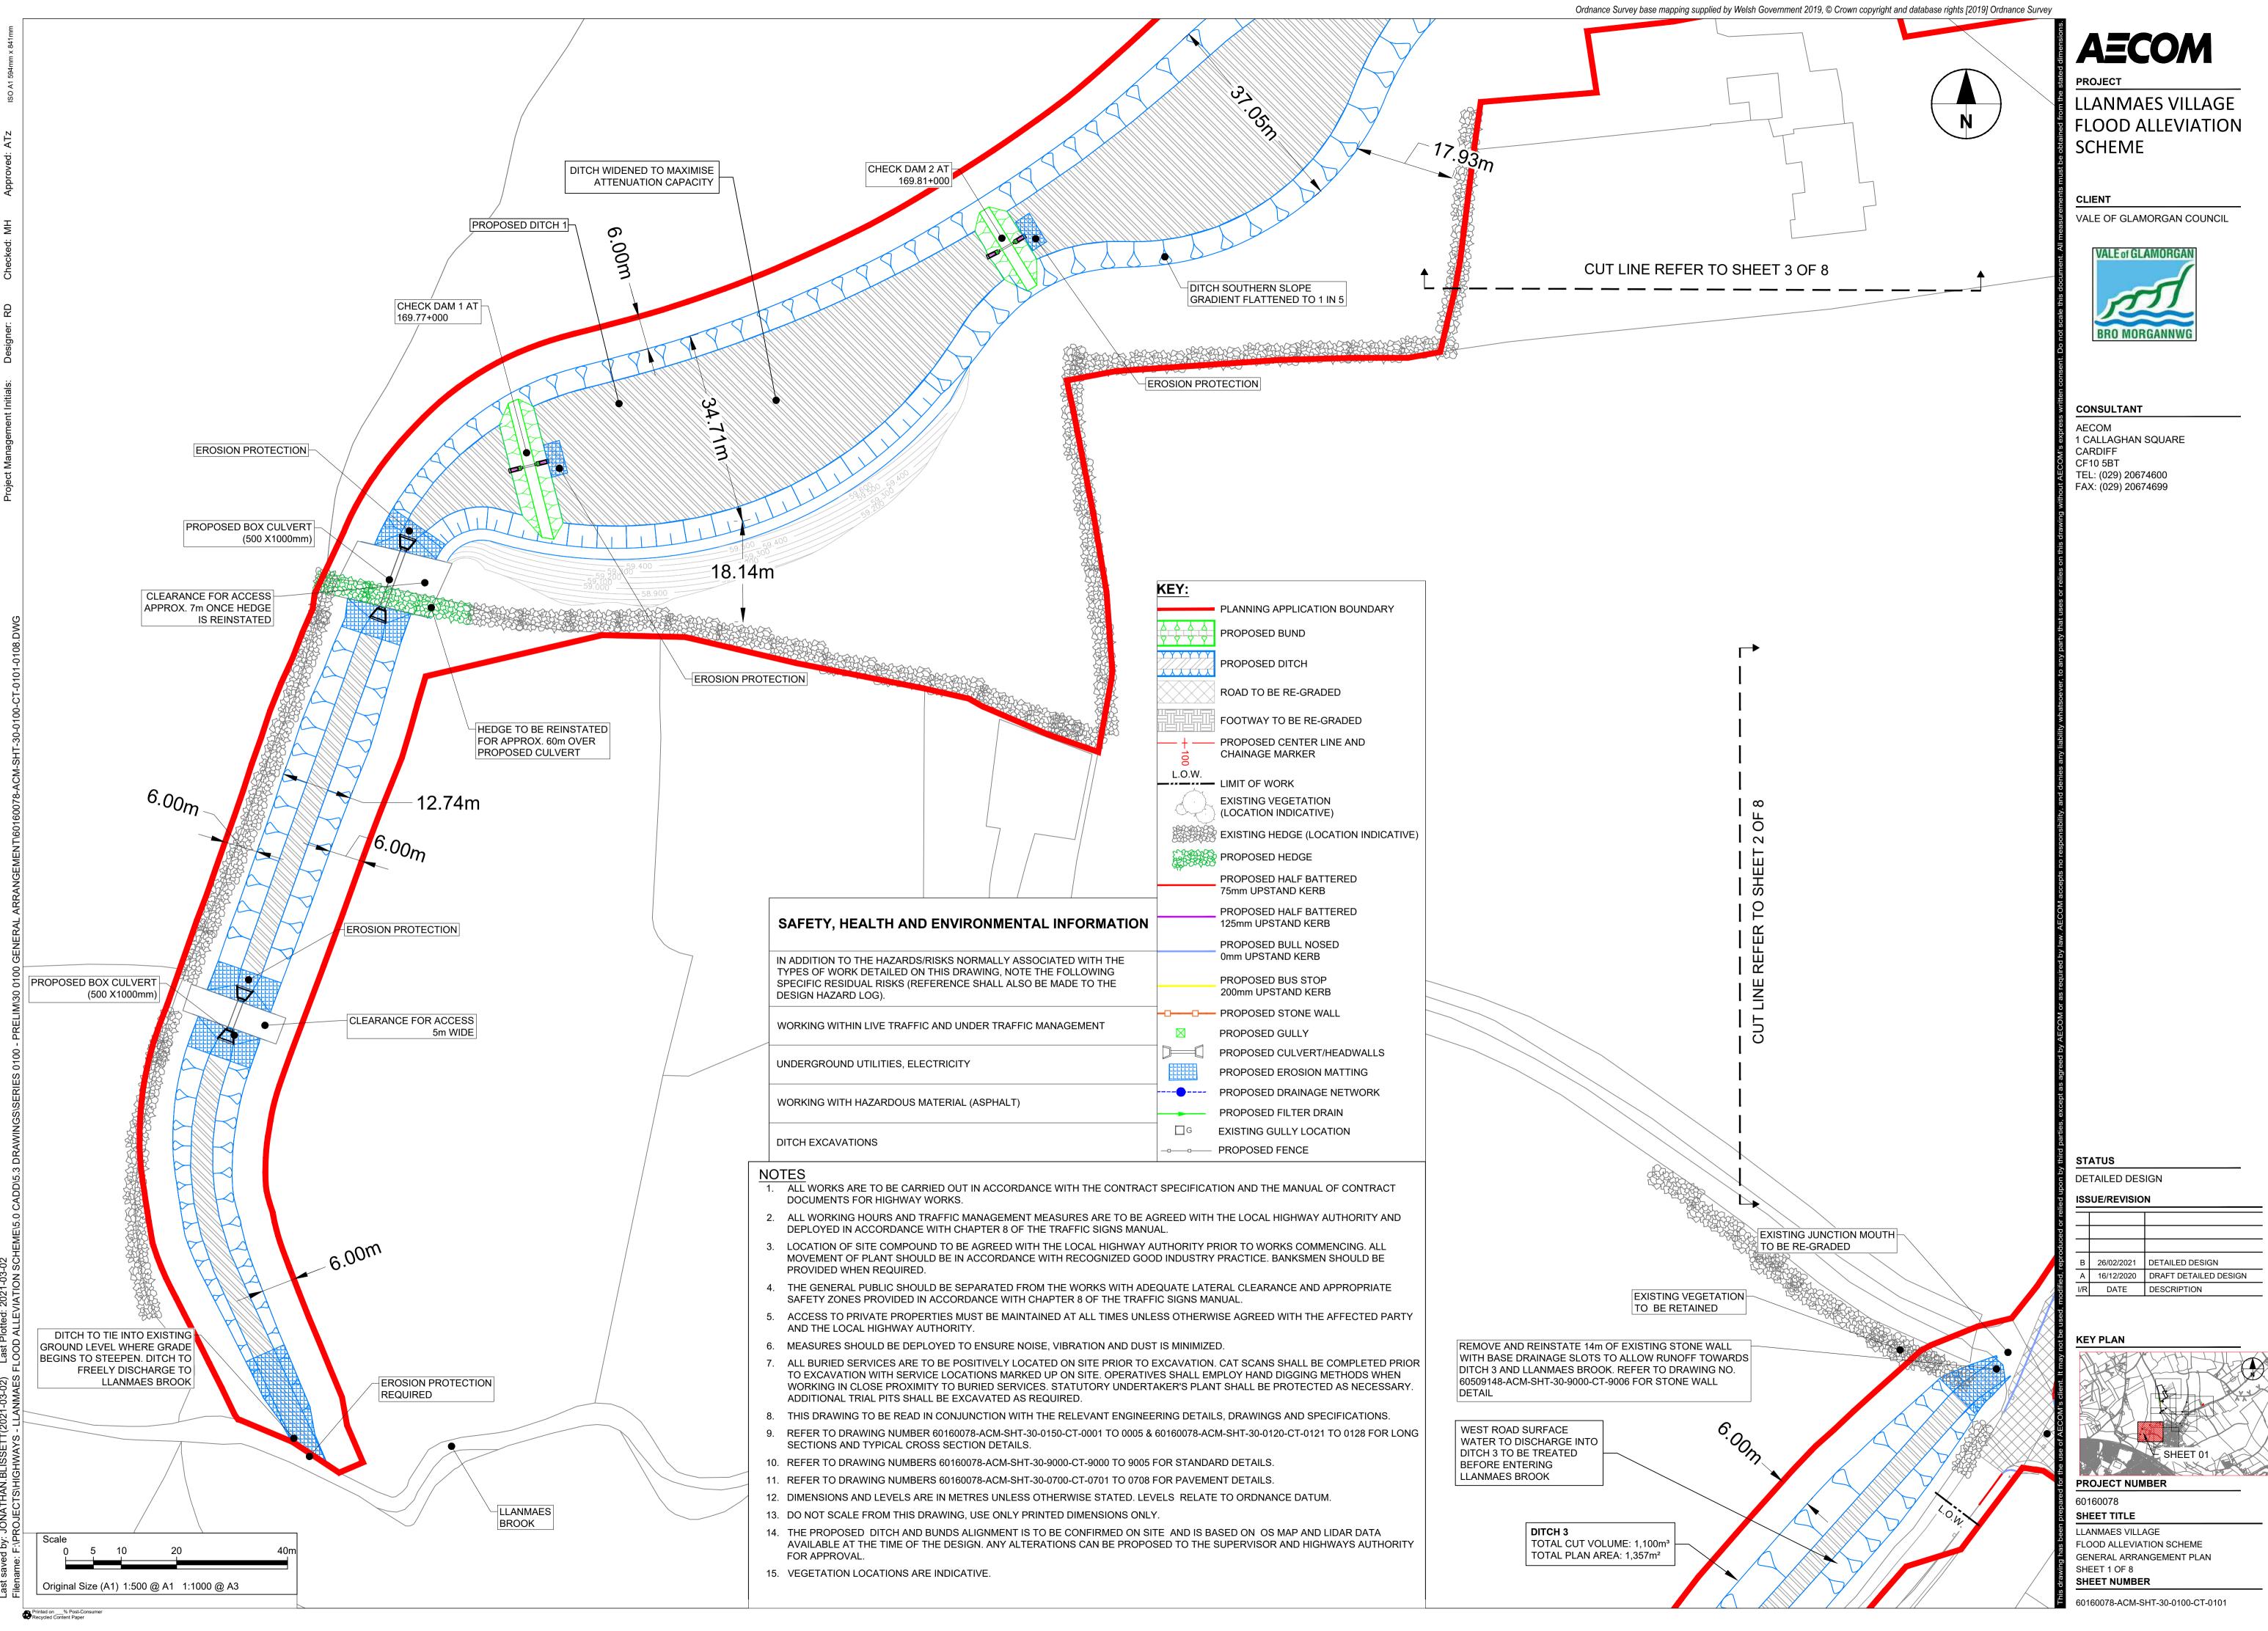
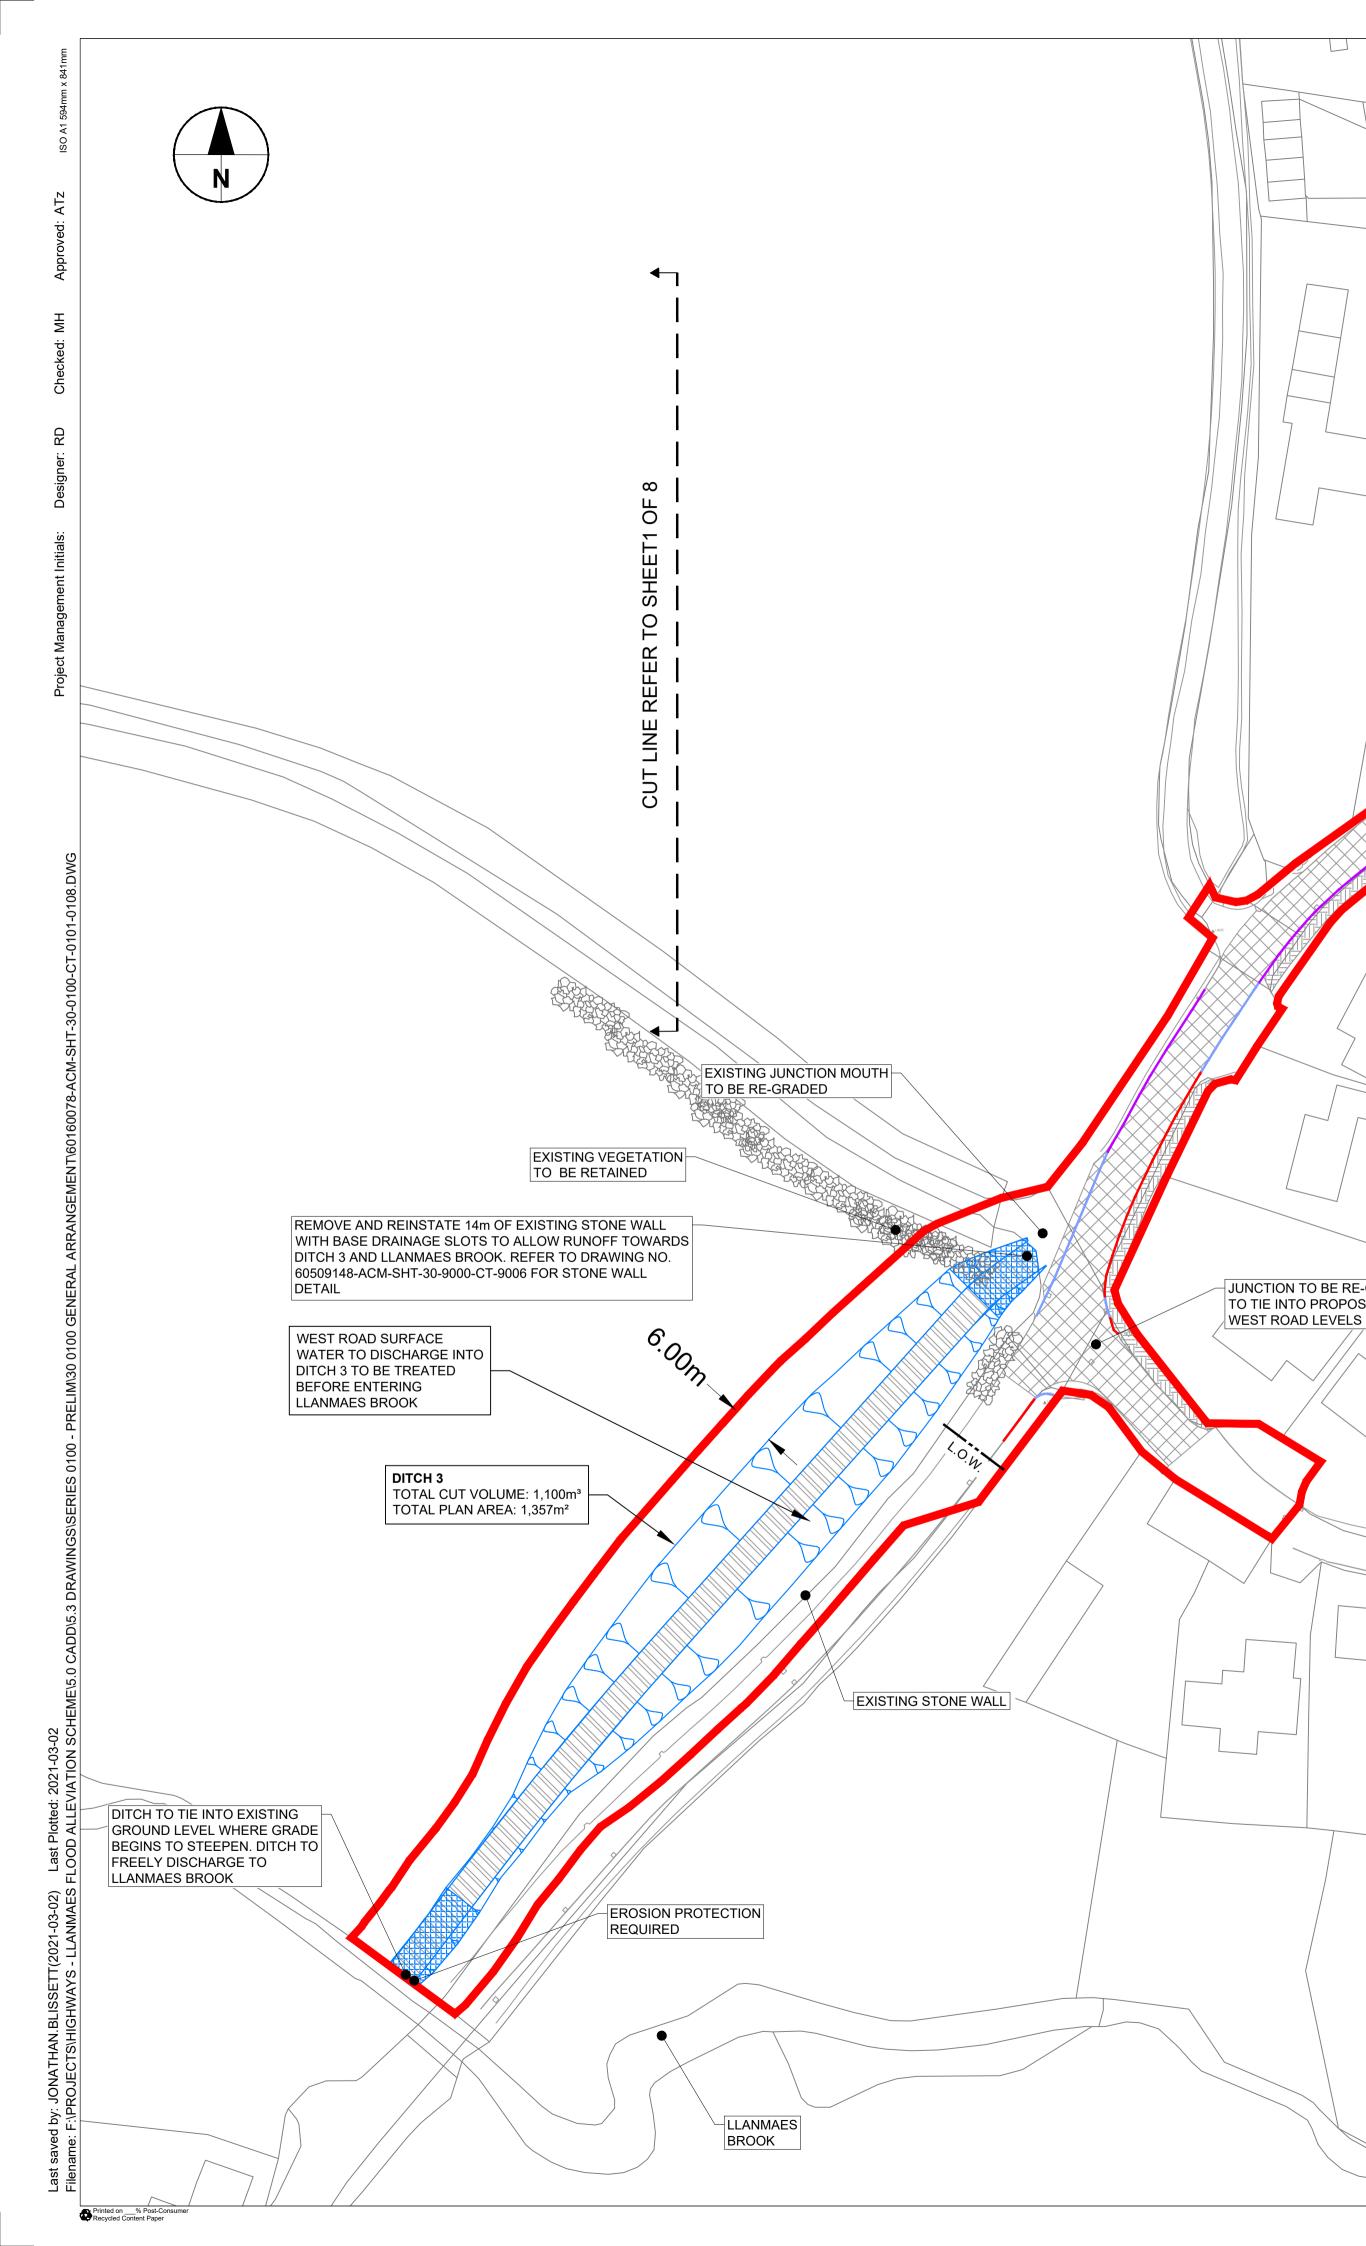
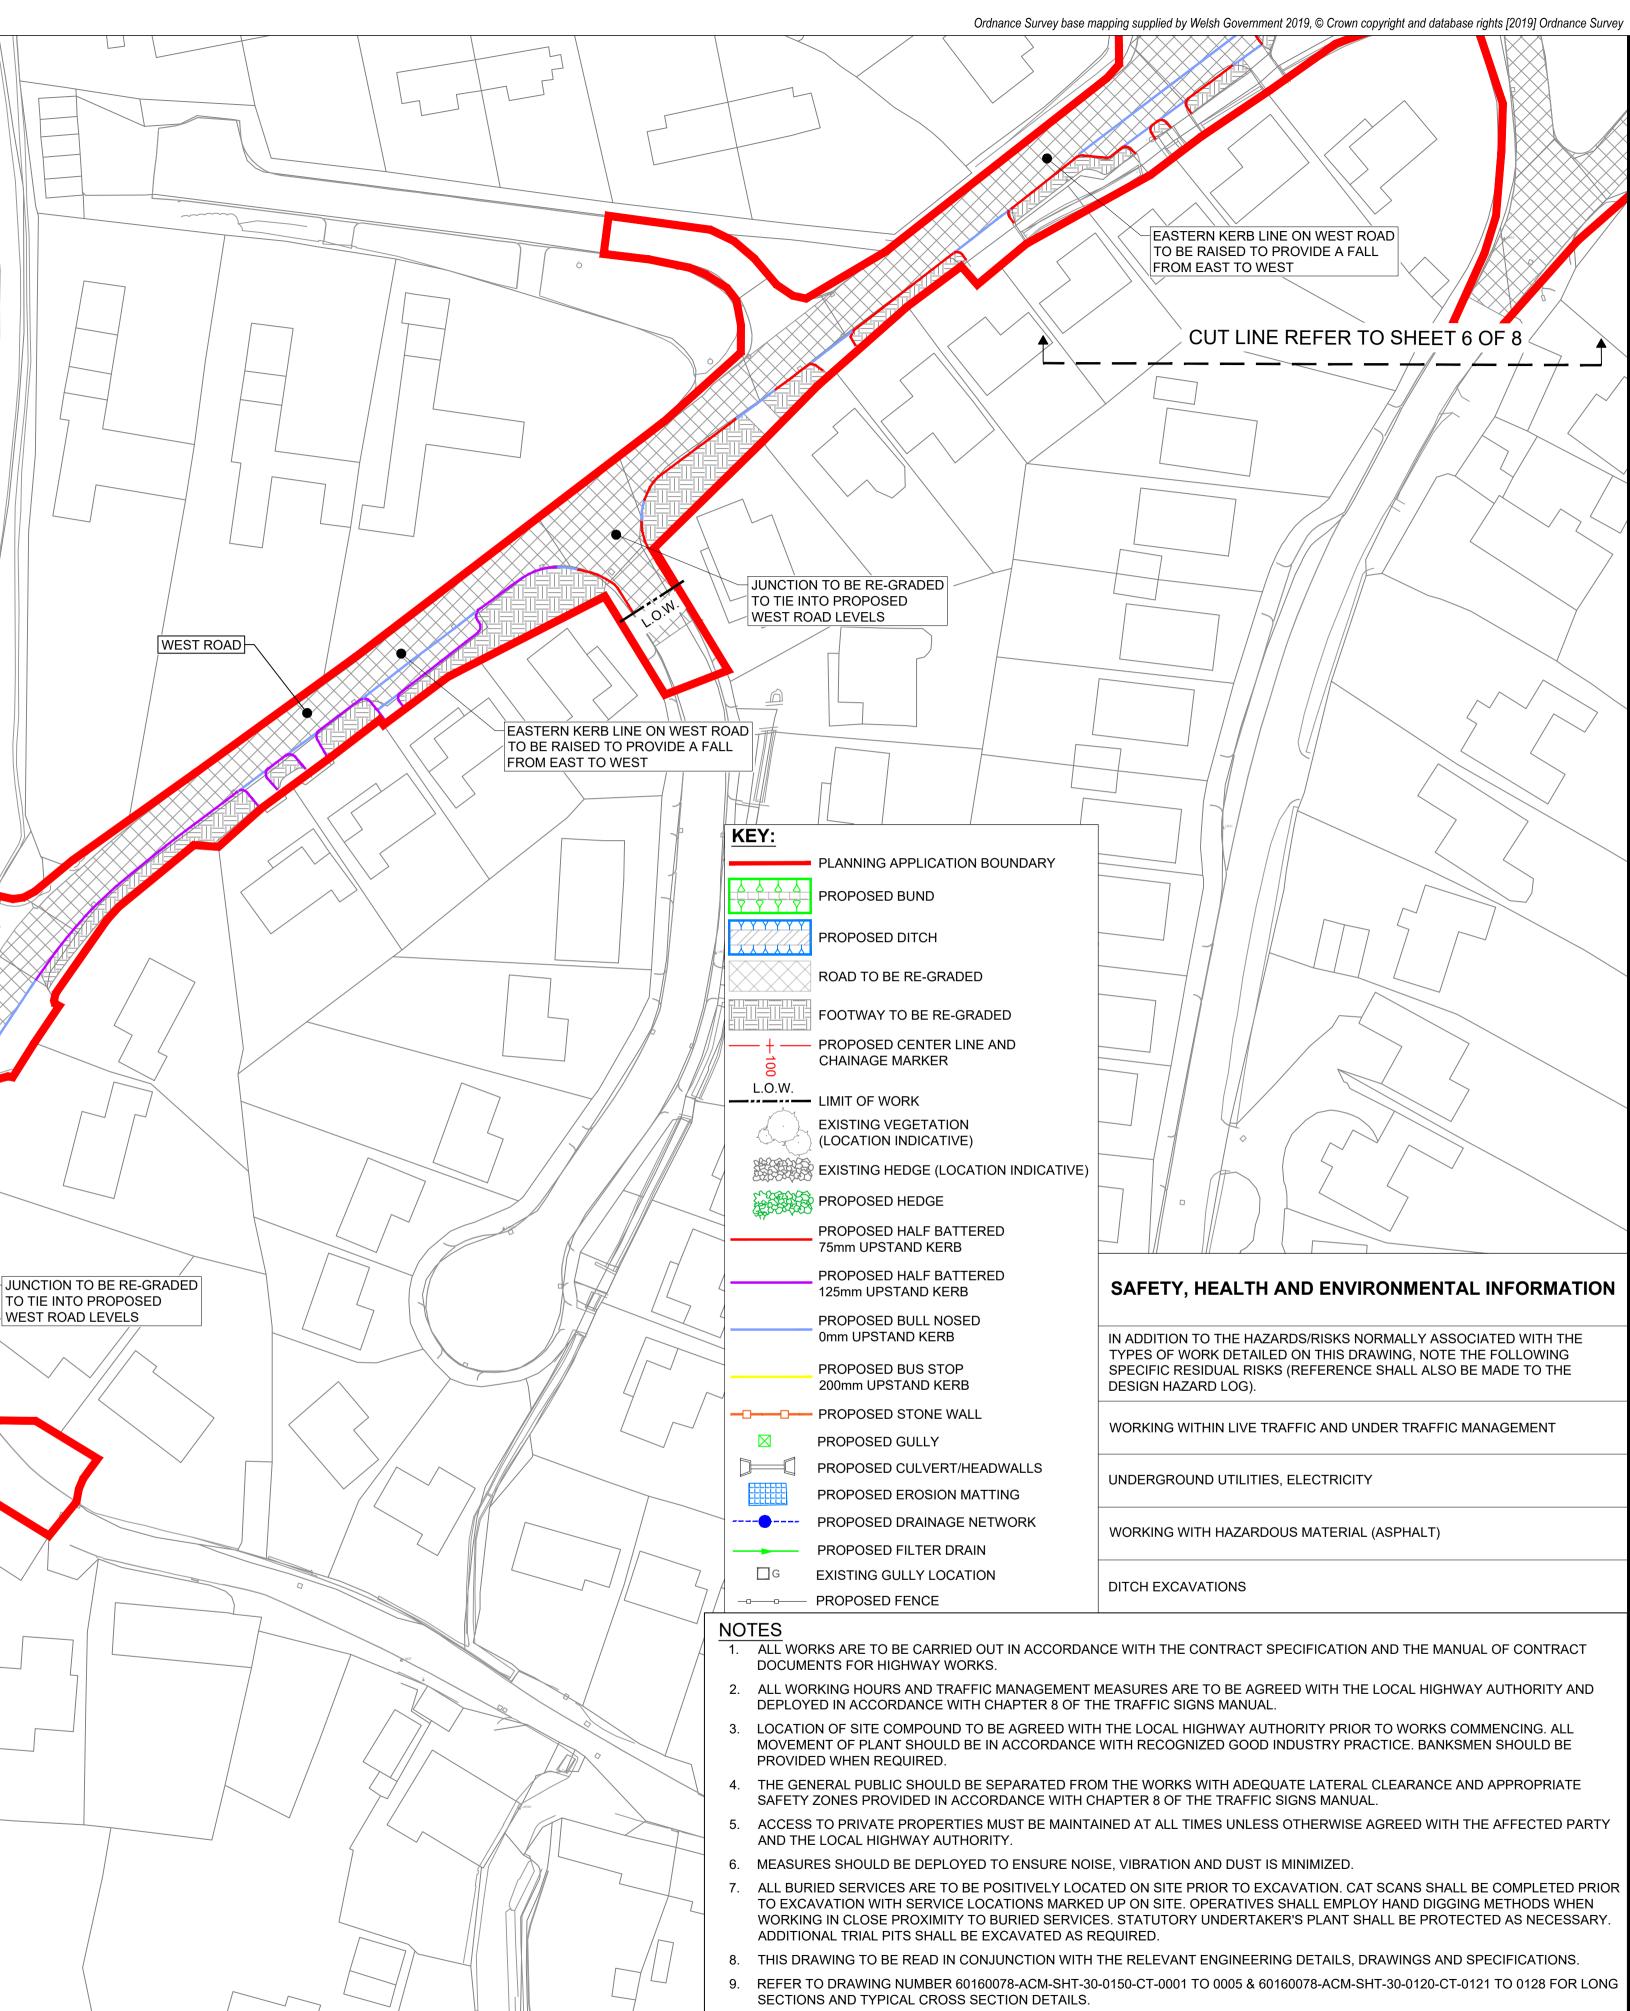
60160078-ACM-SHT-30-0100-CT-0102

- Excavation of four (4) ditches, with culverts and erosion protection;
- Construction of four (4) flood bunds, and one (1) overspill bund, using material excavated from ditches, constructed with 1:3 slopes with a minimum height of 1.5m;
- Reprofiling of North road and West road.

Detailed plans of the proposed development are included within Appendix A.
