**Buildings at Wild Rose Cottage, Duffryn Lane,
St Nicholas, Vale of Glamorgan, CF5 6TA**

Bat Survey Report for Mr A. Walker

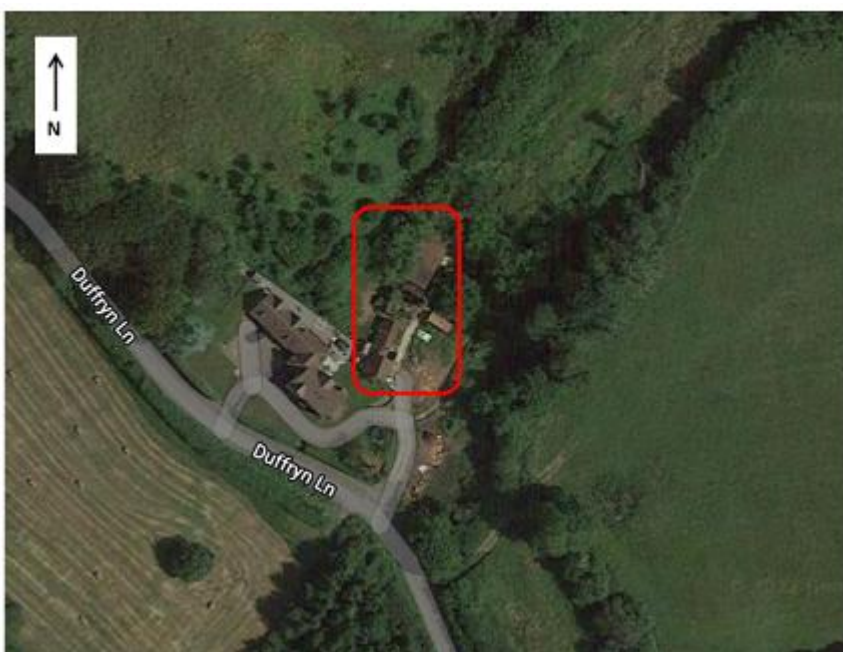
Figure 1 (left): Aerial view of the property – the **Outbuildings** are outlined in red (from Google® Maps)

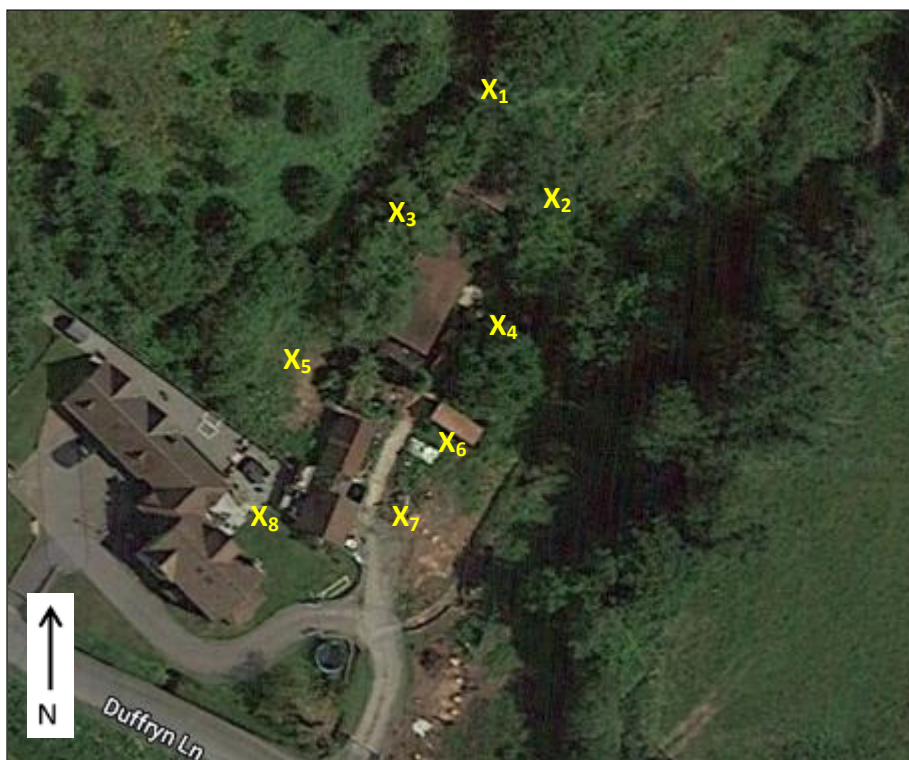
3.1.5 Figure 4 shows the position of surveyors during the activity survey. Each surveyor had a Magenta 5 or an Elekon Batscanner bat detector to assist in identification and detection of bats and their behaviour.

Figure 4: Surveyor positions during the activity survey (from Apple® Maps)

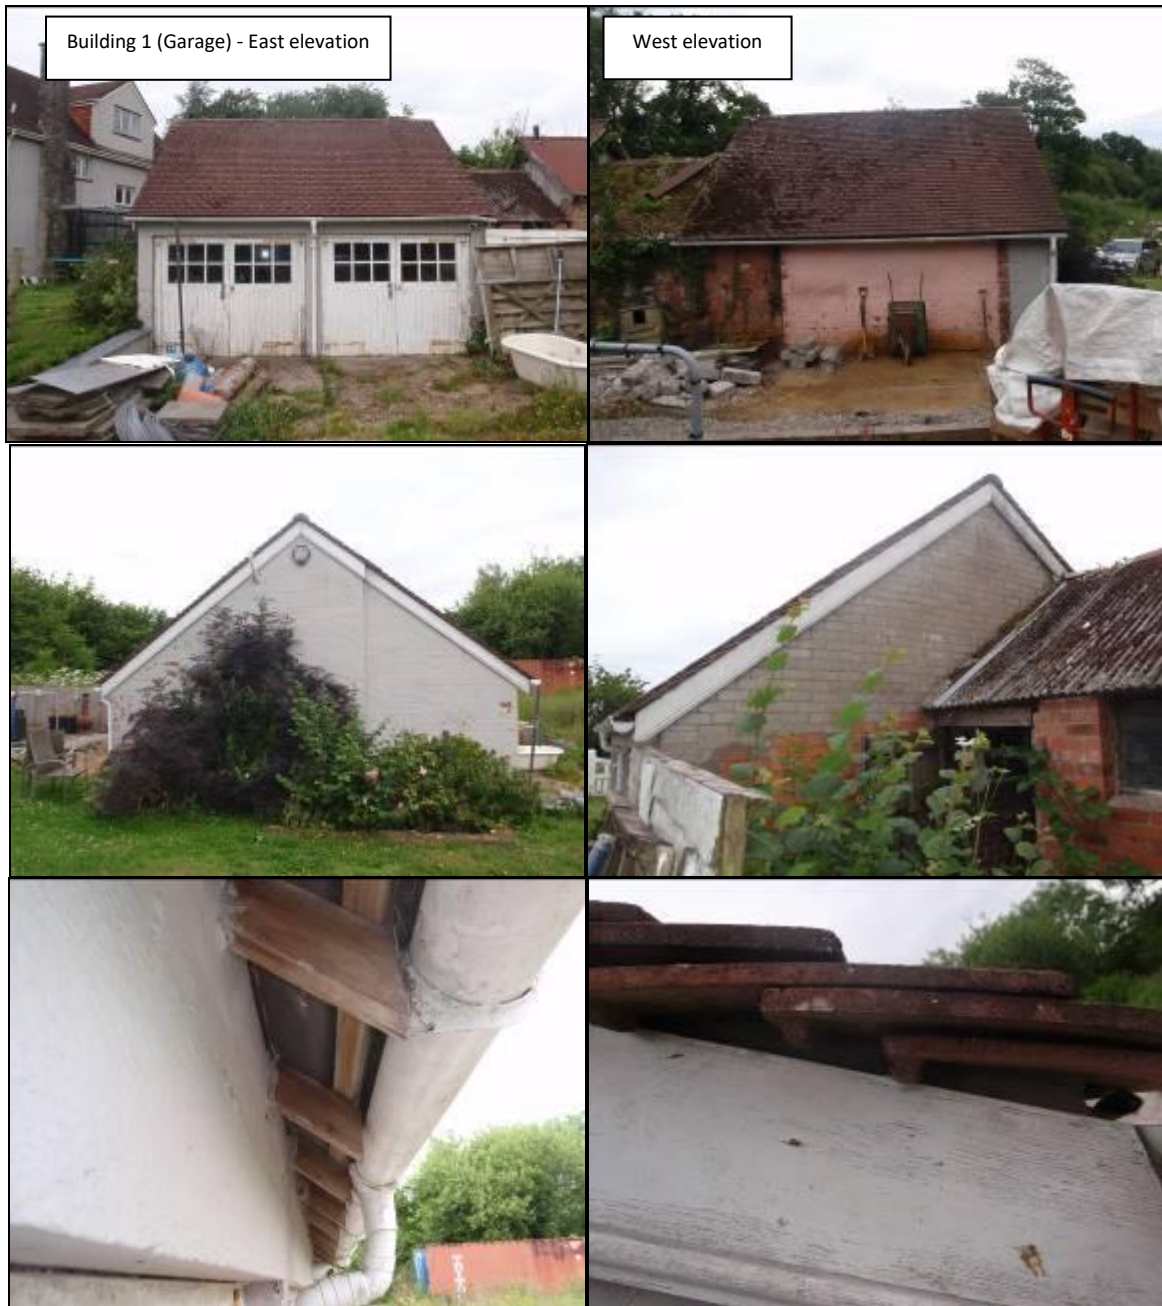
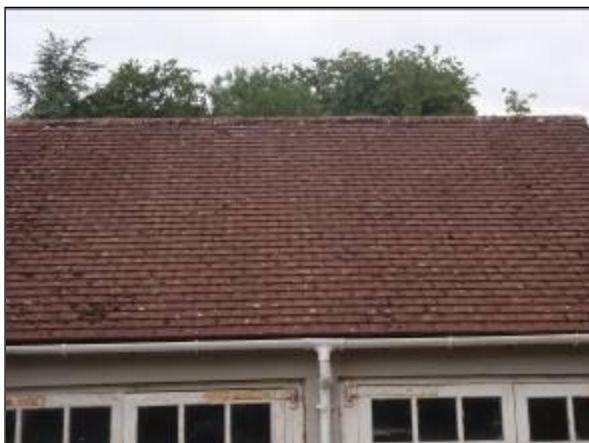
The **Garage (Building 1)** is a single storey, east facing structure that sits on the southern end of the **Outbuildings** and adjoins **Building 2**. It is subject to proposed plans for conversion to provide a 'front of house' building for the proposed development and is constructed of part painted brick walls with a pitched tile roof and is generally in good condition, has been well maintained and is well-sealed. The walls are intact with no potentially exploitable cracks or crevices and while the timber soffit/fascia/barge boards are beginning to rot, there are no gaps present which could offer roosting potential. In addition, the timber garage doors to the front only have small gaps around the frames; however, while there are no missing/slipped/damaged tiles on the roof, there are some small (but potentially exploitable) gaps under the tiles at the edges.

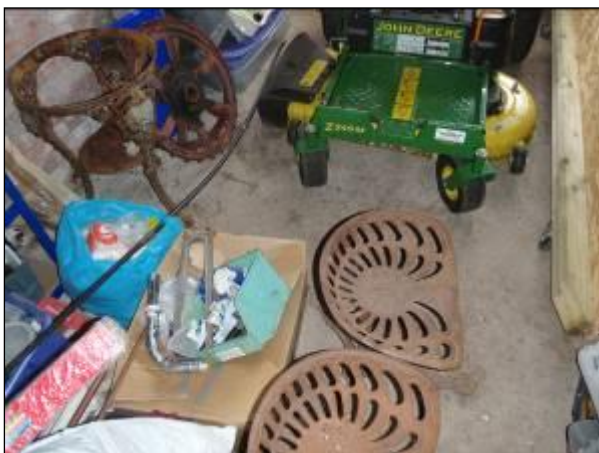
Within the **Garage** (currently used for storage) there is no enclosed loft space, and the bitumastic felt lining is in good condition with no natural light entering via the roof or wall tops. However, the glazing on the double doors does allow natural light to enter the building; thus, reducing any potential for day roosting, but there are dark, sheltered areas with crevices that could provide roosting opportunities as well as timbers which could provide purchase for free hanging bats. Nonetheless, all areas were carefully examined with the items and surfaces having only undisturbed cobwebs and dust on them, and **no live or dead bats or their signs (e.g., droppings, urine**

stains, smells) were found anywhere.

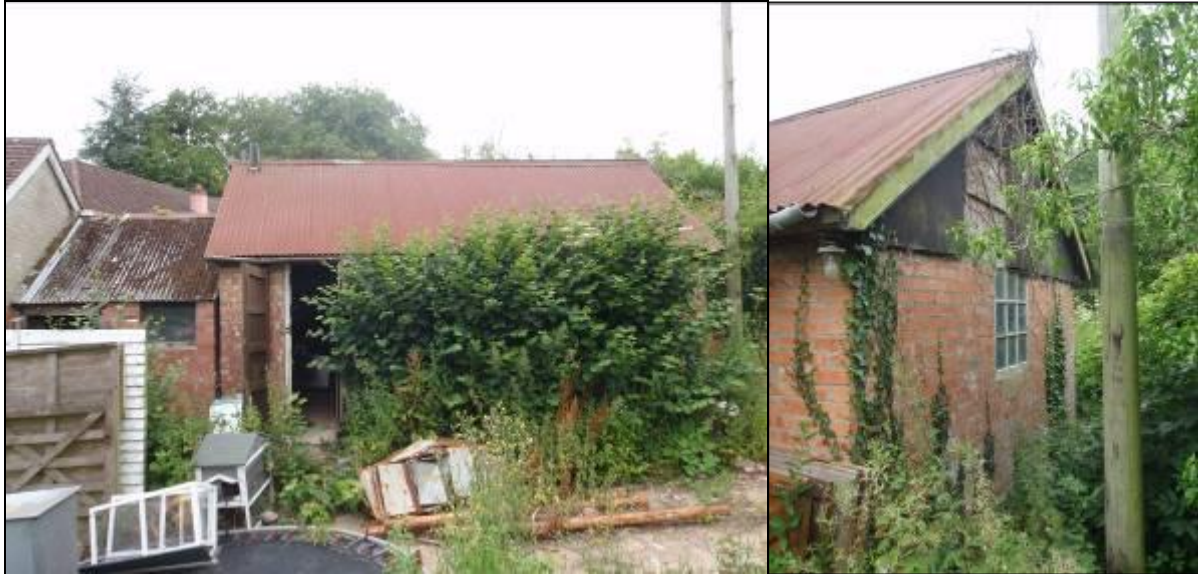
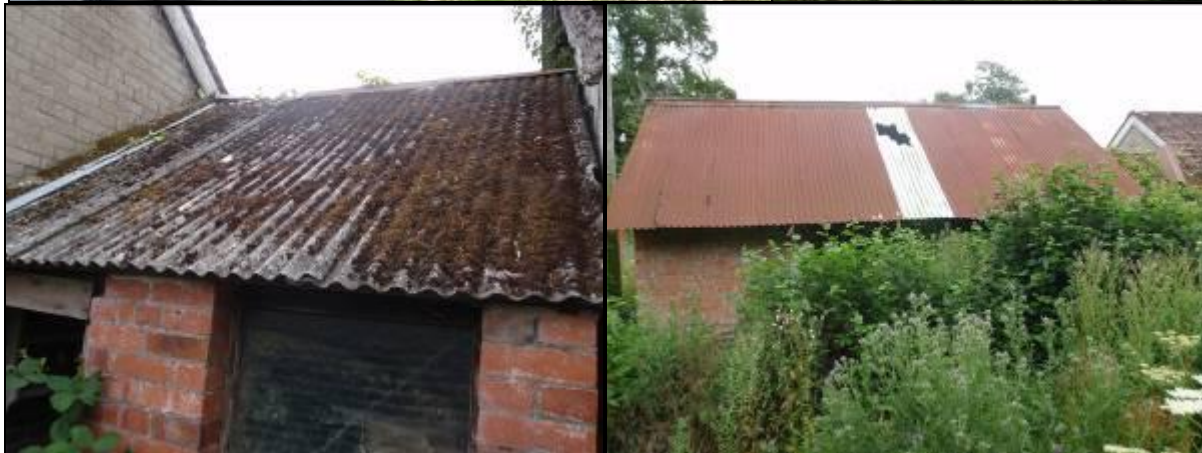
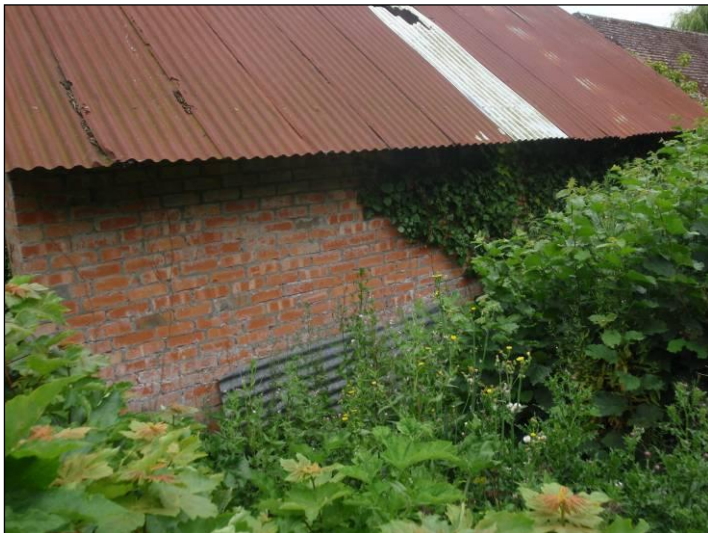
Building 2 is a single storey, east facing structure that adjoins the **Garage** on its northern elevation and is subject to proposed plans for conversion to provide a one bedroomed holiday let for the proposed development. It is constructed of brick walls with a pitched part corrugated metal sheet (with one transparent sheet to the rear)/part corrugated cement fibre or asbestos sheet roof and is generally in good condition and has been well maintained. The walls are intact with no potentially exploitable cracks or crevices but the timber soffit/fascia/barge boards (where

present) are beginning to rot and offer potentially exploitable gaps in places. In addition, while the timber framed window and timber door on the main part are intact and remain closed when not in use, the smaller section which adjoins the **Garage** is open to the front and could offer potential as a night roost/feeding perch. Further, while the roofs are predominantly intact, there is a hole in the transparent sheet to the rear that could enable access for all bat species.

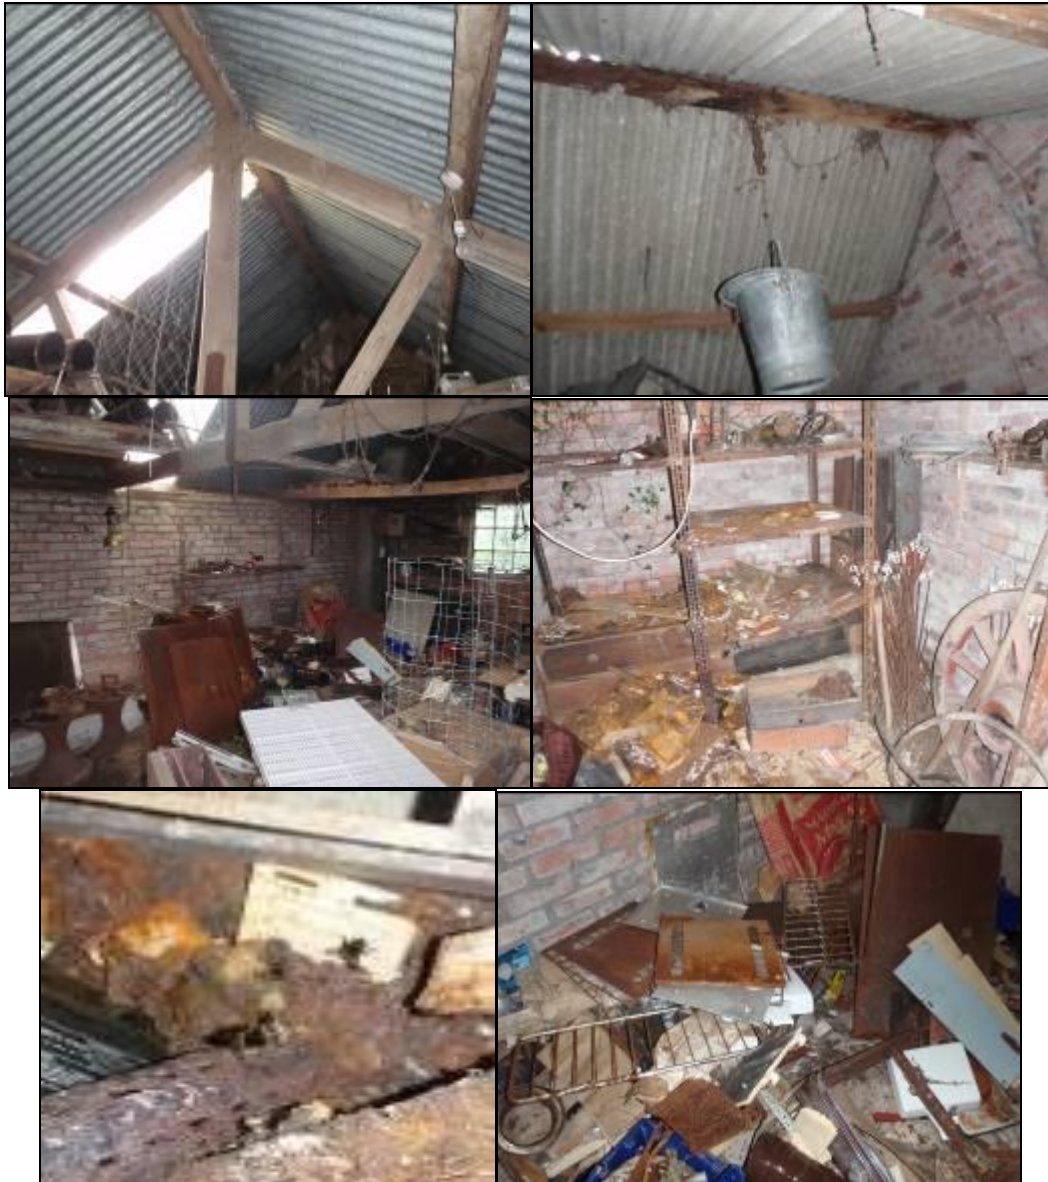
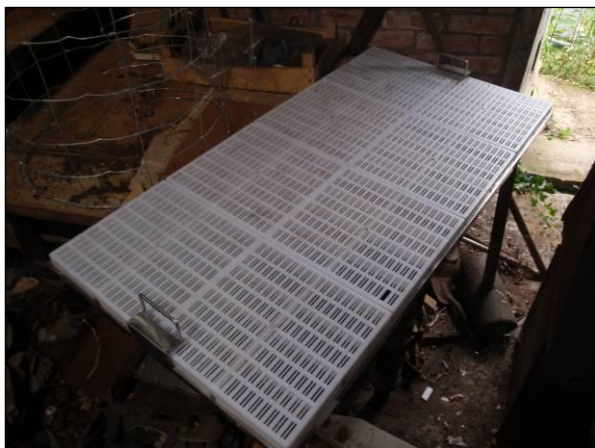
Within **Building 2** (currently used for storage) there is no enclosed loft space, and while the unlined roofs are in fairly good condition, natural light enters through the gaps in the transparent sheet as well as through the window. In addition, shafts of light are visible along the ridge line of the smaller section; thus, reducing any potential for day roosting. However, there are some dark, sheltered areas with crevices that could provide roosting opportunities as well as timbers which could provide purchase for free hanging bats. Nonetheless, all areas were carefully examined with the items and surfaces having only

undisturbed cobwebs and dust on them, and **no live or dead bats or their signs (e.g., droppings, urine stains, smells) were found anywhere.** However, a bumble bee nest was found within the building.

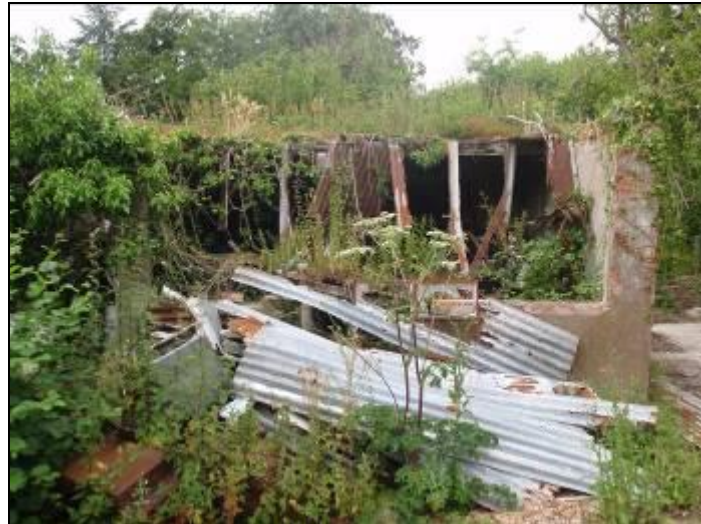
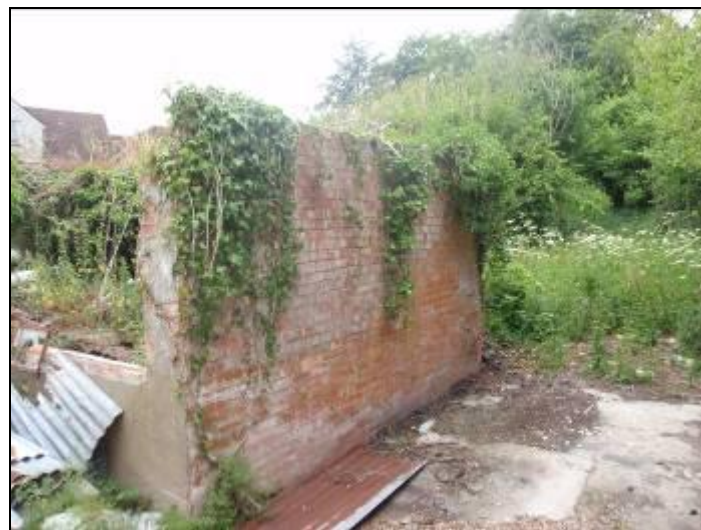
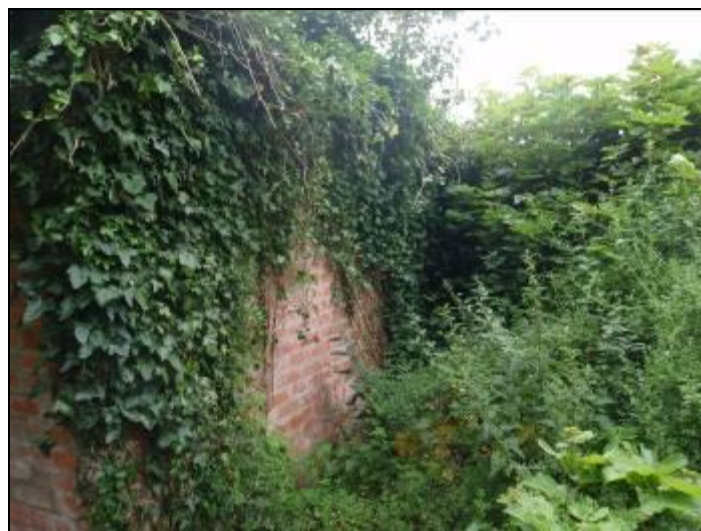
Building 3 is a single storey, detached, east facing structure that sits on the northern side of **Building 2** and is subject to proposed plans for conversion to provide a one bedroomed holiday let for the proposed development. It is constructed of brick walls and currently has no roof while all the apertures are open and is generally in a dilapidated state and open to the elements with a lot of vegetation coverage.

- ✦ **Recommendation 3 (Enhancement):** 1 x double House martin nest cup and 1 x Sparrow terrace to be affixed to the north elevation of Building 1 and Building 3, respectively.

- ✦ **Recommendation 3 (Enhancement):** 1 x double House martin nest cup and 1 x Sparrow terrace to be affixed to the north or elevation of Building 1 and Building 3, respectively.

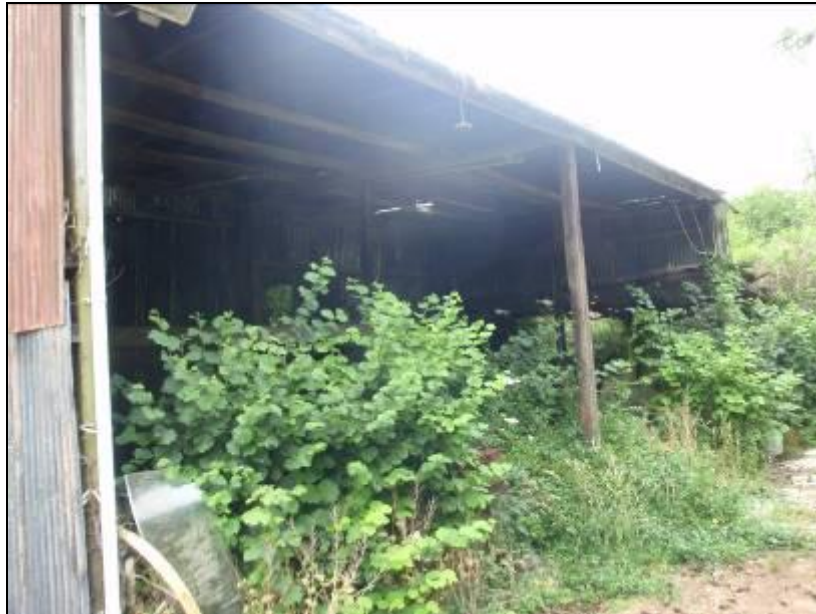
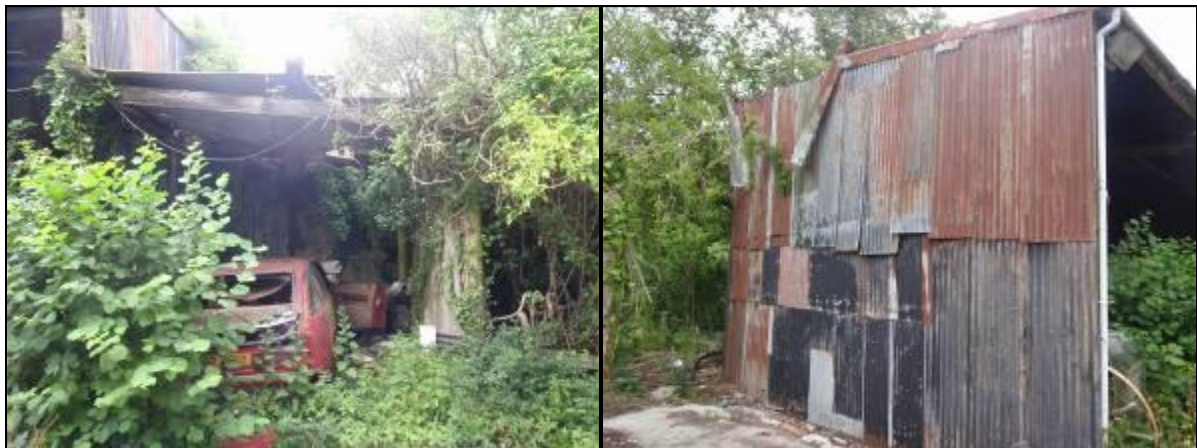
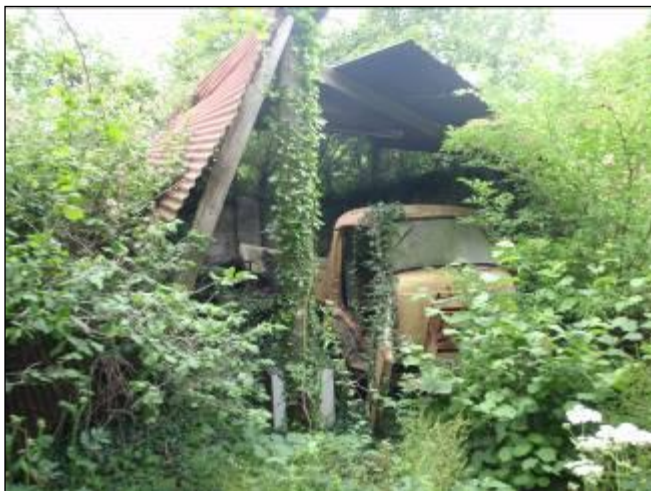
Building 4 is a single storey, detached, east facing structure that sits on the northern side of the other outbuildings and is subject to proposed plans for demolition to create space for lodges as part of the proposed development. It is constructed of a timber frame with corrugated metal sheet walls on three sides and a corrugated metal sheet roof and is generally in fair condition. The walls are predominantly intact but there are some damaged sheets with gaps underneath them, although the nature of the metal sheets means that they are subject to fluctuations in temperature and,

therefore, not ideal for roosting. However, the open nature means it could possibly offer potential as a night roost/feeding perch.

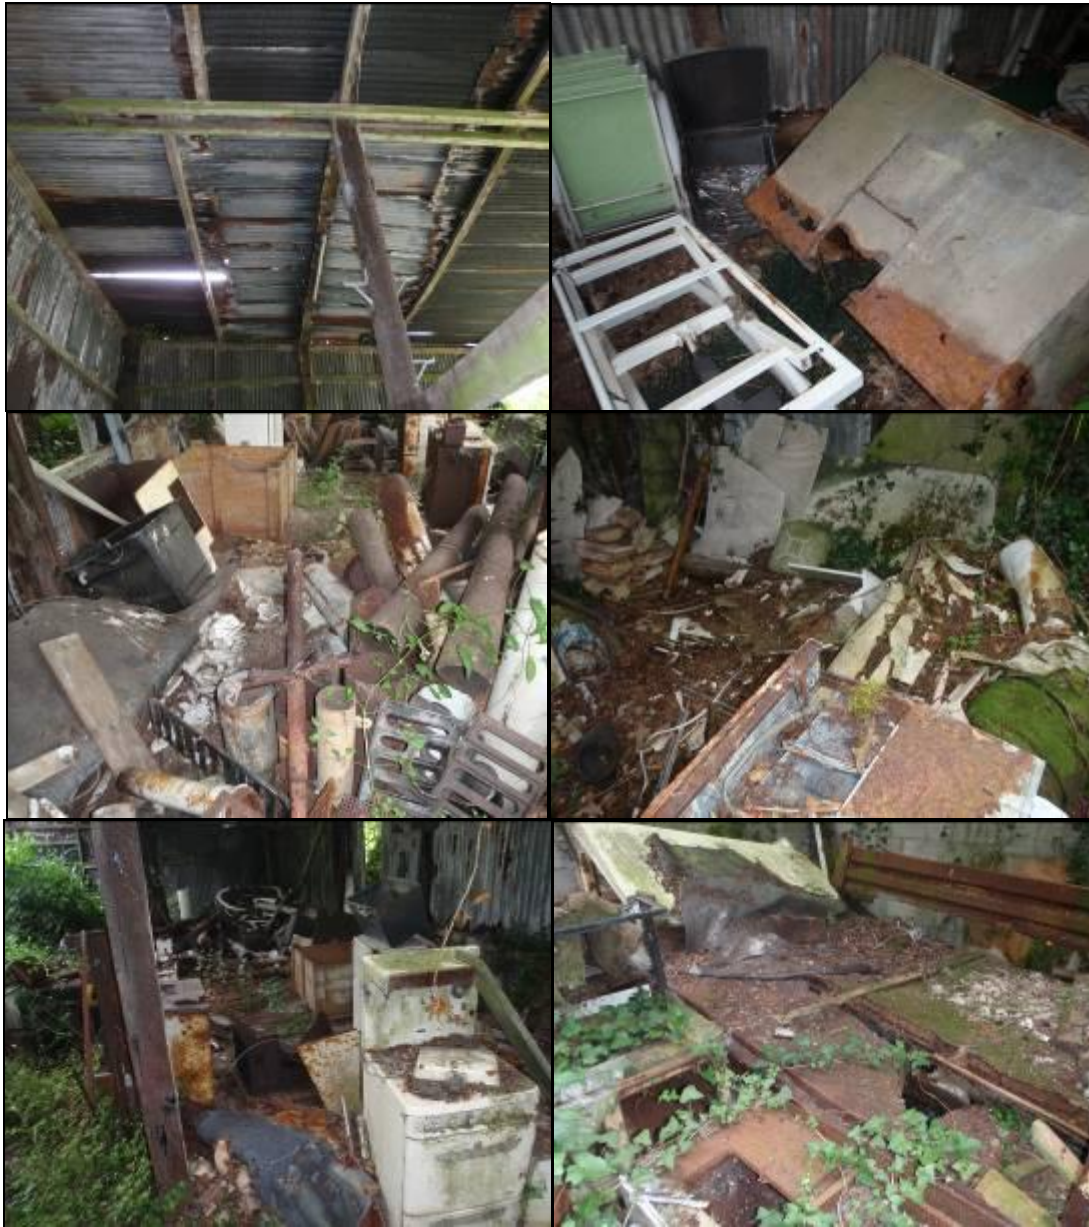
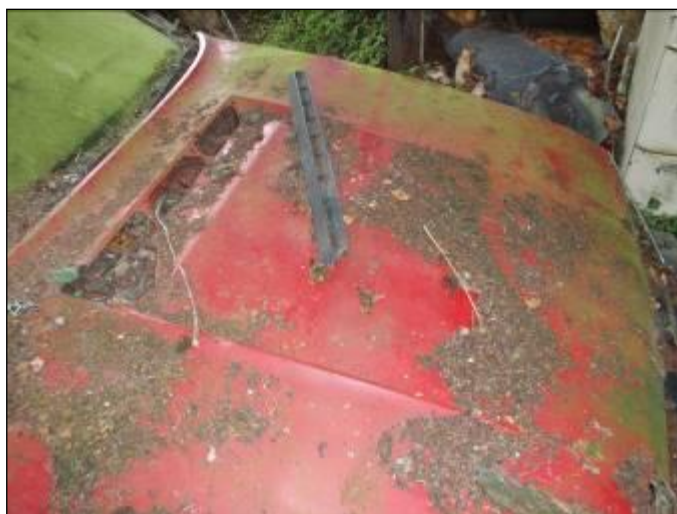
Internally, **Building 4** (currently used for storage) is open to the roof as well as being open to the front and is, therefore, very light internally; thus, reducing any potential for day roosting. However, there are some timbers which could provide purchase for free hanging bats to use it as a night feeding perch. Nonetheless, all areas were carefully examined with the items and surfaces having only undisturbed cobwebs and dust on them, and **no live or dead bats or their signs (e.g., droppings, urine stains, smells) were found anywhere.**

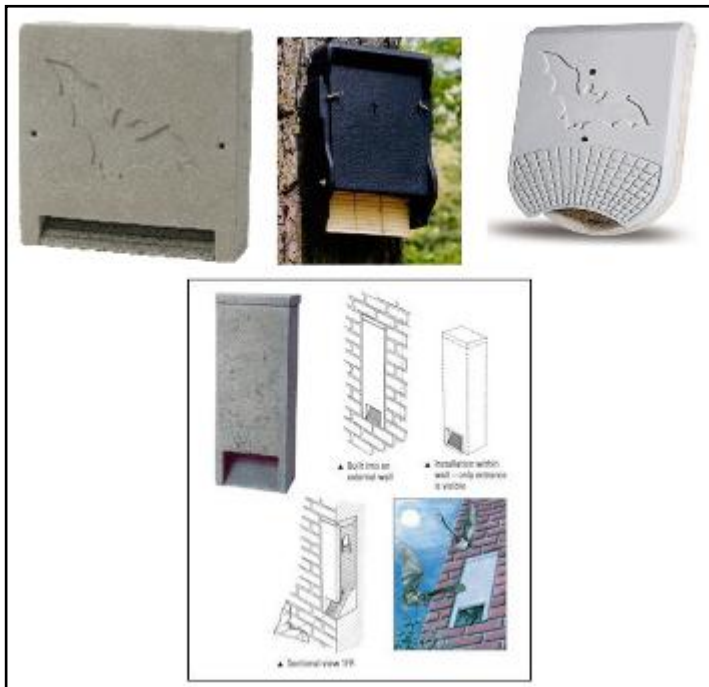
Top: From left to right, the in-wall Schwegler 1FE, the tree mounted 1FF and the multi season 1WQ. The bottom image shows the 1FR in situ.

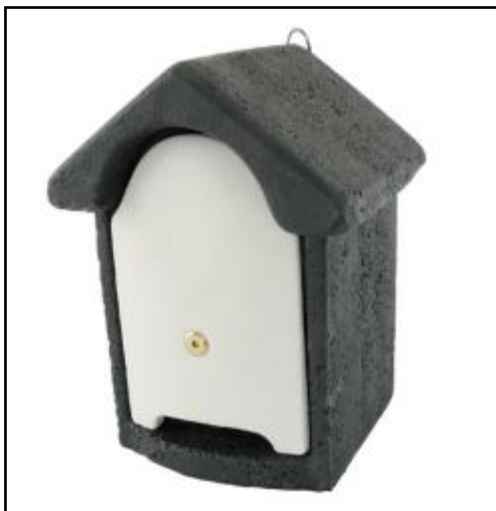
Left: The Harlech WoodStone bat box offers excellent insulation with a minimum of condensation for roosting bats. WoodStone® is a mixture of sawdust from FSC wood sources and concrete, and it is designed to last for years. It is breathable so there will be no problems with condensation and Woodstone maintains a consistent temperature inside, providing excellent insulation for roosting bats. Height 24cm x width 19cm x depth 18cm; Weight 4.4kg; Colour: Black with White front panel; Hook for hanging; Removable front panel for inspection/cleaning; and 10 Year Manufacturers Guarantee.

- ✦ **Recommendation 1 (Enhancement):** Prior to works commencing 2 x Harlech Woodstone, 2 x Kent Style, 2 x Vincent Pro, 2 x Improved Cavity, and 2 x Improved Maternity (or similar) bat boxes to be affixed to mature trees within the curtilage of the property. See [Putting up your box - Bat Boxes - Bat Conservation Trust \(bats.org.uk\)](#)

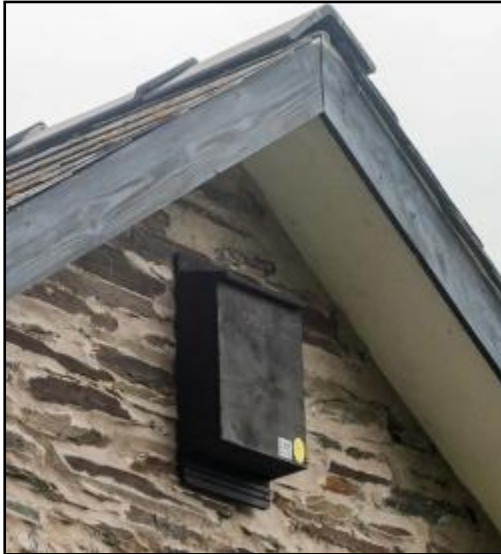
Left: The Improved Roost-Maternity Bat box is a large 3 crevice box suitable for larger roosts or maternity groups of the small British crevice-dwelling bats such as Pipistrelles. All external panels precision cut from 12mm Exterior Grade FSC plywood, for improved heat insulation. Exterior surface stained with black water based wood stain for improved thermal input, whilst avoiding any possibility of deterring use by bats due to vapour from the stain. Overhanging roof with additional internal insulation for protection from UK weather, and to seal crevices from internal airflow. 3 separate crevices each with different temperature characteristics. Wide entrance with accurately sized opening. Ideal for Pipistrelles and deters unwelcome birds etc. Internal ceramic heat sinks ensure improved temperature stability in crevices. Improved "Bat Ladder" at base of box facilitates bats landing and climbing into box. Ladder

continues inside box, while textured internal surfaces ensure bats find it easy to move around inside box and hang in crevices. Ladder acts as "convector heater" for box - when sun shines on ladder, warm air rises into the box, but does not come out when the outside cools. Easy and safe to erect box on walls or trees - relatively light weight for its size, with 2 screw holes for fixing. Easy (1 screw) to remove roof for cleaning or inspection where permitted. Improved draught-proofing enhances temperature stability inside box. Rectangular back plate facilitates fitting boxes side to side to increase colony size. Improved aesthetics - looks good to humans as well as bats. Suits any building or tree. See [Improved Roost-Maternity Bat Box | NHBS Practical Conservation Equipment](#) for an example.

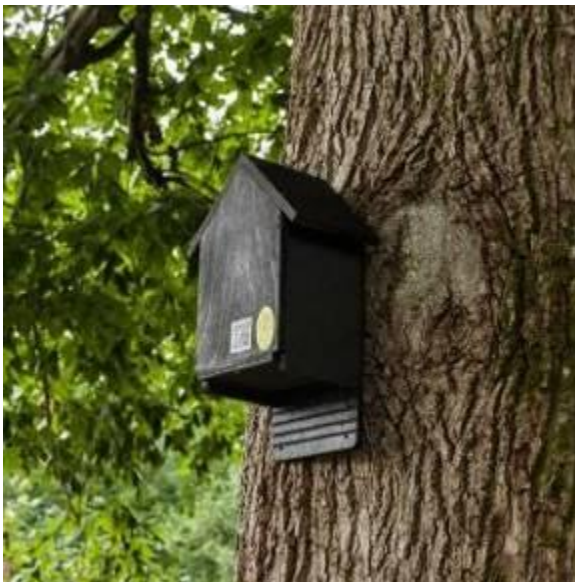
Left: Improved Cavity Bat Box. Suitable for the British cavity-dwelling bats including the Brown Long-Eared, External panels precision cut from 12mm Exterior Grade FSC plywood, for improved heat insulation, Exterior surface stained black with water based wood stain for improved thermal input, whilst avoiding any possibility of deterring the bats due to vapour from the stain, Overhanging apex roof for protection from UK weather, Single large cavity inside, with varying temperature characteristics, Wide entrance with accurately sized opening. Ideal for cavity dwelling bats and deters unwelcome birds etc., Internal ceramic heat sink ensures improved temperature stability, Improved "Bat Ladder" at base of box facilitates bats landing and climbing into box, Ladder continues inside box, while textured

internal surfaces ensure bats find it easy to move around inside box and on the walls, Ladder acts as "convector heater" for box - when sun shines on ladder, warm air rises into the box, but does not come out when the outside cools, Easy and safe to erect box on walls or trees – relatively lightweight with 1 keyhole mounting hole and 2 extra screw holes for secure fixing, Floor slides out (after removing 1 screw) for cleaning or inspection where permitted, Improved draught-proofing enhances temperature stability inside box, Improved aesthetics - looks good to humans as well as bats. Suits any building or tree.

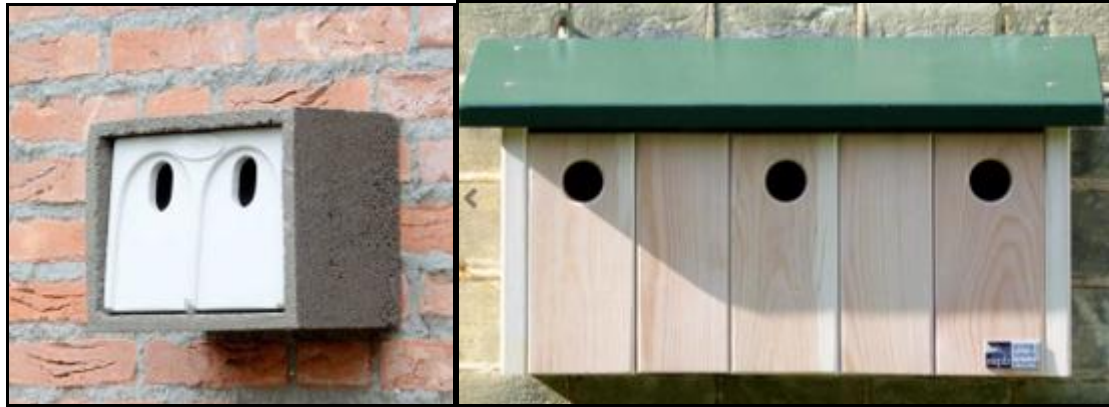
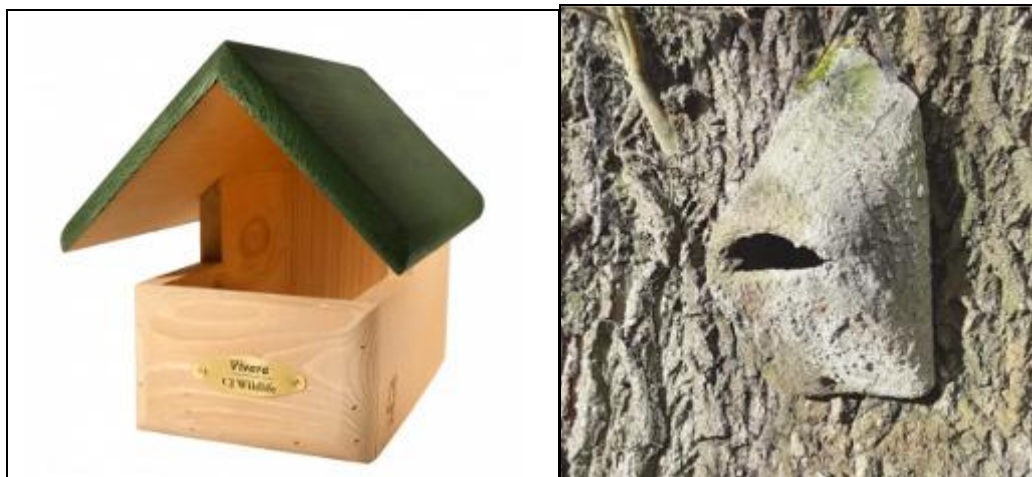
Examples of Sparrow terraces, House martin nest cups, Open-fronted nest boxes, and Small-holed nest boxes. Siting advice can be found at [Where To Put A Bird Box | Nestboxes - The RSPB](#)

- ✦ **Recommendation 2 (Enhancement):** Prior to works commencing 3 x Small-holed nest boxes and 3 x Open-fronted nest boxes to be affixed to mature trees within the curtilage of the proposed development site. See [Where To Put A Bird Box | Nestboxes - The RSPB](#) for siting advice.
