11.2021

BS5837 2012 Tree Information Land adjacent to Winchpit

Land adjacent to Winchpit
Duffryn Lane
Cardiff
CF5 6ST

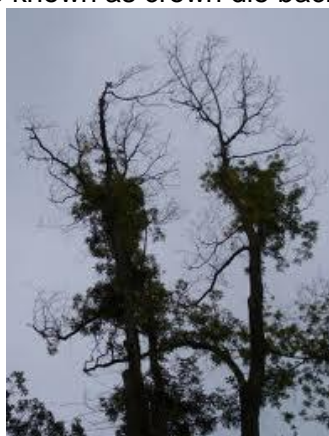
The picture to the right shows the years after the completion of a development site. Machine operators will often mention how driven over them. This is what site.

die back of foliage several years after the completion of a development site. Machine operators will often mention how driven over them or happens once they leave

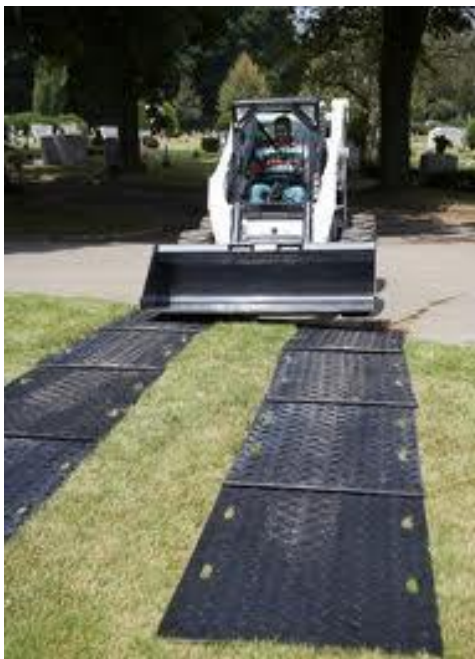
The use of ground protecting boards such as these seen in the adjacent picture should be used. Geo textile and felt may be required beneath these routes to minimize puddling of the soil surface. Should puddling occur, a capped layer may well be formed which will reduce the lateral diffusion of soil gasses and cause significant problems for retained trees.

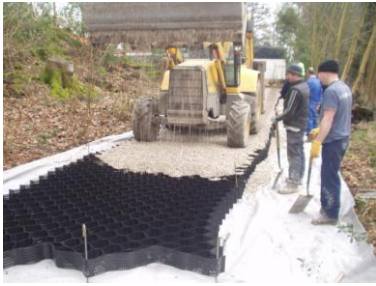
Cellular Confinement and Backfill Material.

Expand the confinement systems 2.56m wide panels to the full 8.1m length. Pin the panels with staking pins to anchor open the cells and staple adjacent panels together to create a continuous mattress. Infill the cells with a no fines angular granular fill (typically 40-20mm) within each open cell. The use of cellular confinement reduces the bearing pressure on the subsoil by stabilizing aggregate surfaces against rutting under wheel loads. Comparisons between cellular confinement and traditional aggregate and geo grid-reinforced structures

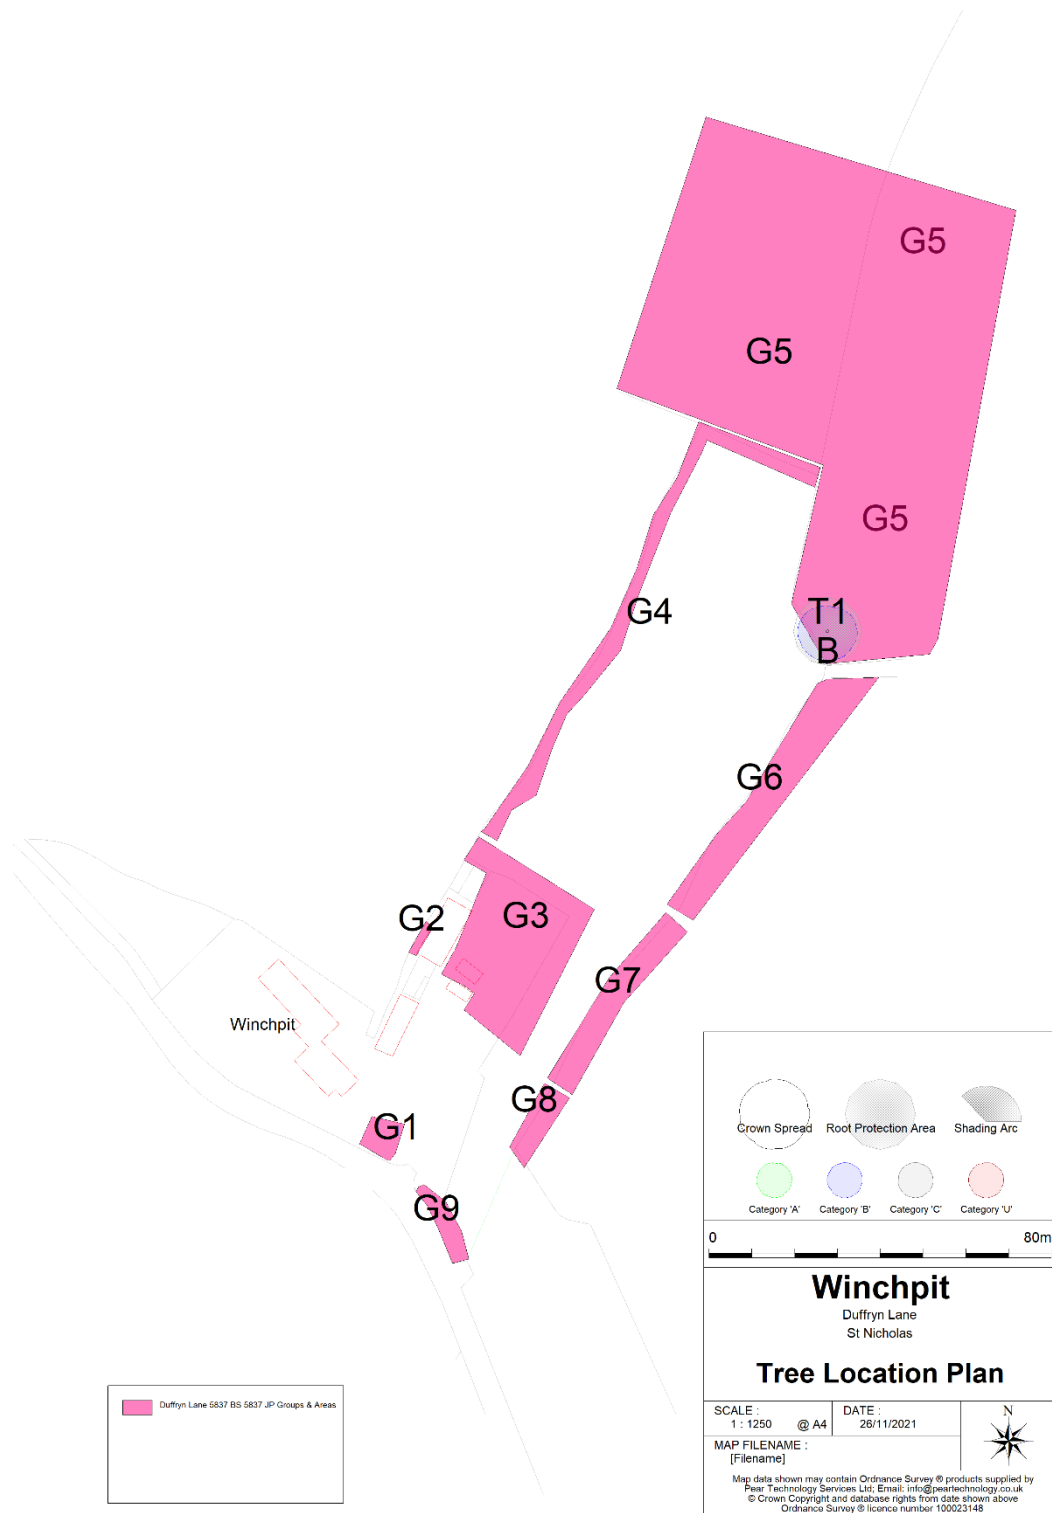
Site Plan screen grab – please see scale pdf plan also

Scale plans can be sent as PDF files if required. The plans are to indicate locations of trees, locations of main objects on site and the location of tree protection fencing. Stem diameters found in tree and tree group data tables should be used to mark out the location of root protection fencing on site.
