Phase II Geo-environmental Site Assessment

The Mole
Neptune road
Barry
CF62 5QR

October 2021

Client Name:	ABP Development Company
Project Name:	The Mole, Barry
Project No.:	413800.0000.0000
Document Title:	Phase II Geo-environmental Site Assessment
Date:	October 2021

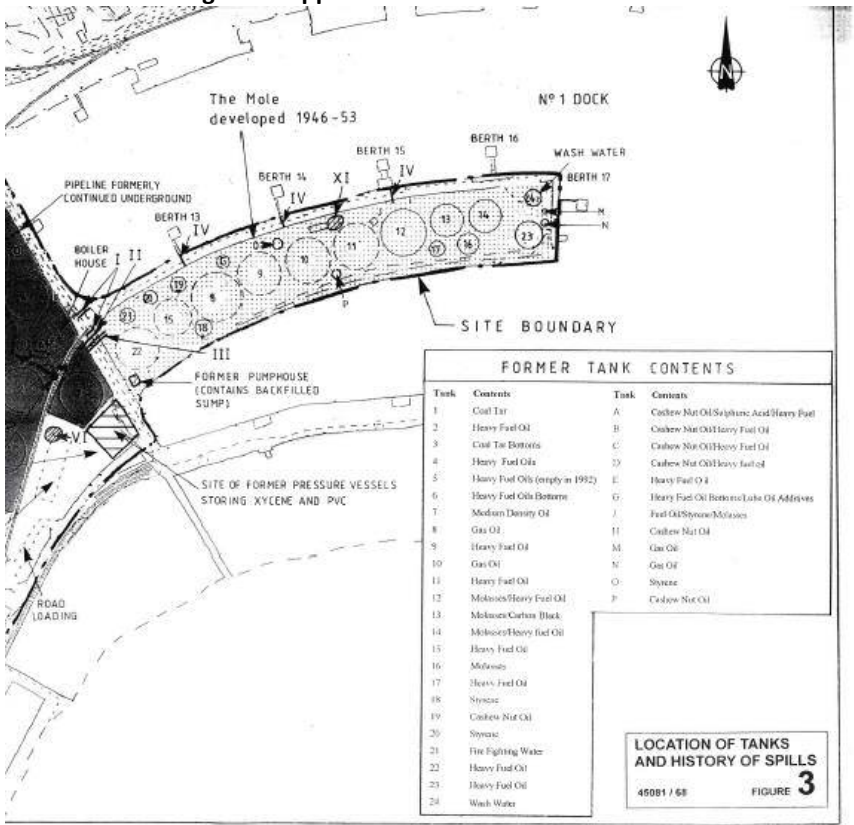
<p>Remediation of Ground Contamination – Options Report, The Waterfront, Barry ‘A’ Site and Mole</p> <p>(Ove Arup and Partners, Report Reference 97/3505, dated December 1997)</p>	<p>The report was commissioned to carry out a study into options for remediation ground contamination at the Site A and the Mole (the Site). The report detailed previous investigation findings and detailed the methodology for this investigation (trial pitting).</p> <p>The report identified that the Site contamination was limited to the uppermost 0.7m of fill, with some outliers also observed. The report identified four options for remediating the soils at the Site which were capping with removal of hotspots off Site, removal of contaminated soil to tip and replacement with imported fill, soil washing and bio-remediation.</p>																																																				
<p>The Waterfront, Barry – Contract 3B, Remediation of ‘A’ Site and Mole, Health and Safety File Volume 1</p> <p>(Associated British Ports document prepared by White Young Green, dated February 2000)</p>	<p>The report details that the scope of works comprised the removal of contaminated materials to an off-Site licensed tip, Site clearance, regrading and import of clean capping from stockpiles to the North of Barry No. 2 Dock (otherwise known as the ‘borrow’ area). The report details the remediation standards required for use as Type 3 (retail / highways and leisure) and Type 2/3 (general fill). The report details to the planners what the proposal was for the Site (ref: 97/3505, dated 1997). At the time of reporting TRC had not been provided with any evidence of the verification, with the exception of the drawing of the Site depicting final Site levels.</p> <p>The report also provided details of the approximate locations of former tanks at the Site, as displayed below.</p> <p>Figure 1: Approximate locations of former tanks</p>

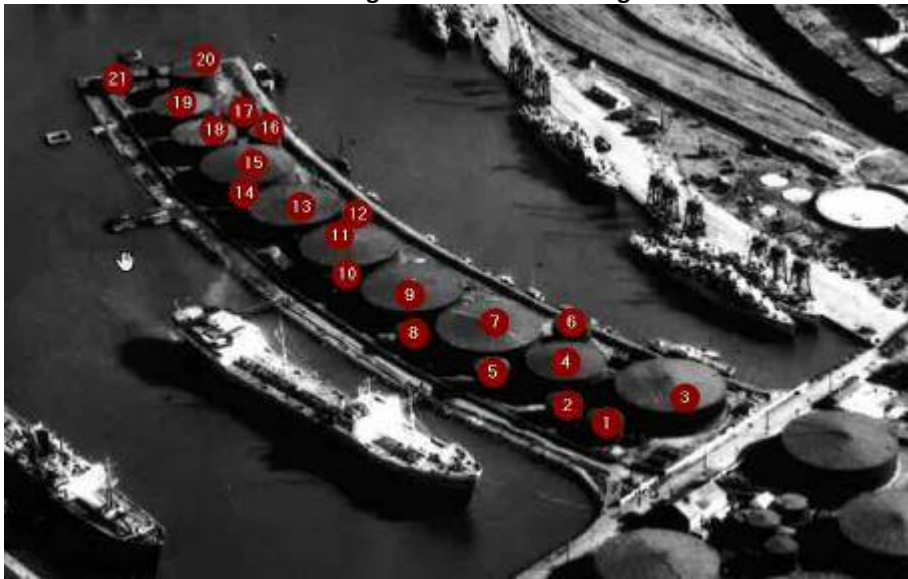
<p>Trial Excavations Carried out at The Mole, Barry Docks for ABP</p> <p>(Horizon, dated 24-06-20 – 26-06-20)</p>	<p>The scope of works was to locate the bases and thickness of the tanks at the Site. The following image shows the numbering used in the report.</p> <p style="text-align: center;">Figure 2: Tank numbering</p>

<p>A summary of each of the bases is presented below:</p> <ul style="list-style-type: none"> • Base 4 – Concrete was encountered at 1.4m and the excavation continued to expose the base thickness of 0.27m. • Base 5 – General fill was encountered to 1.0m, underlain by clean stone to 1.1m and then concrete to 1.45m.

<ul style="list-style-type: none"> • Base 6 – General fill was encountered to 0.75m, then clean stone to 1.0m, then demolition fill to 1.4m which was underlain by brickwork sections and demolition to approximately 1.7m. Groundwater was present at approximately 1.3m. • Base 7 – Concrete was encountered at 1.3m and trenching was carried out towards the location of base 4. The edge of the concrete slab was encountered within 12.5m and the slab had a 0.2m thickness. • Base 8 – General fill was encountered to 0.75m, then clean stone to 0.85m, then fill to 1.0m which was underlain by concrete to 1.35m. • Base 9 – General fill was encountered to 0.8m, then clean stone to 0.9m, then black fill to 1.2m which was underlain by concrete to 1.6m. Evidence of brickwork was also encountered. <p>Overall the levels of the Site had been raised by approximately 1.0m to 1.4m by general fill and demolition material. The bases of the majority of the tanks in the aerial photograph were still present. They were of concrete construction and varied in thickness between 0.2m and 0.4m.</p>

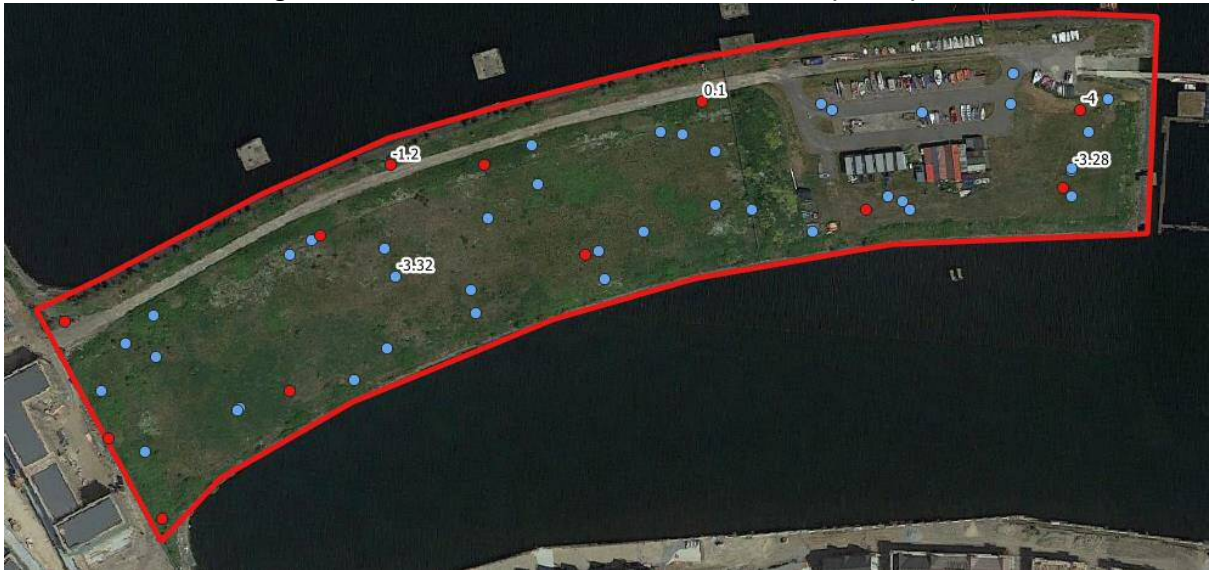
Figure 5: Elevation to the base of the Made Ground (mAOD)

The Made Ground was found to comprise both granular and cohesive deposits. Sand was fine to coarse grained and anthropogenic components included concrete, ash, clinker, geotextile membrane, steel and iron. Figure 5 below shows the elevation (mAOD) of the base of the Made Ground in the five exploratory holes that has proved the full thickness, which include historical records from the Site. This indicates that while the deepest Made Ground was located in the north-eastern corner of the Site, deep Made Ground, below an elevation of 0mAOD was also encountered elsewhere on the Site.

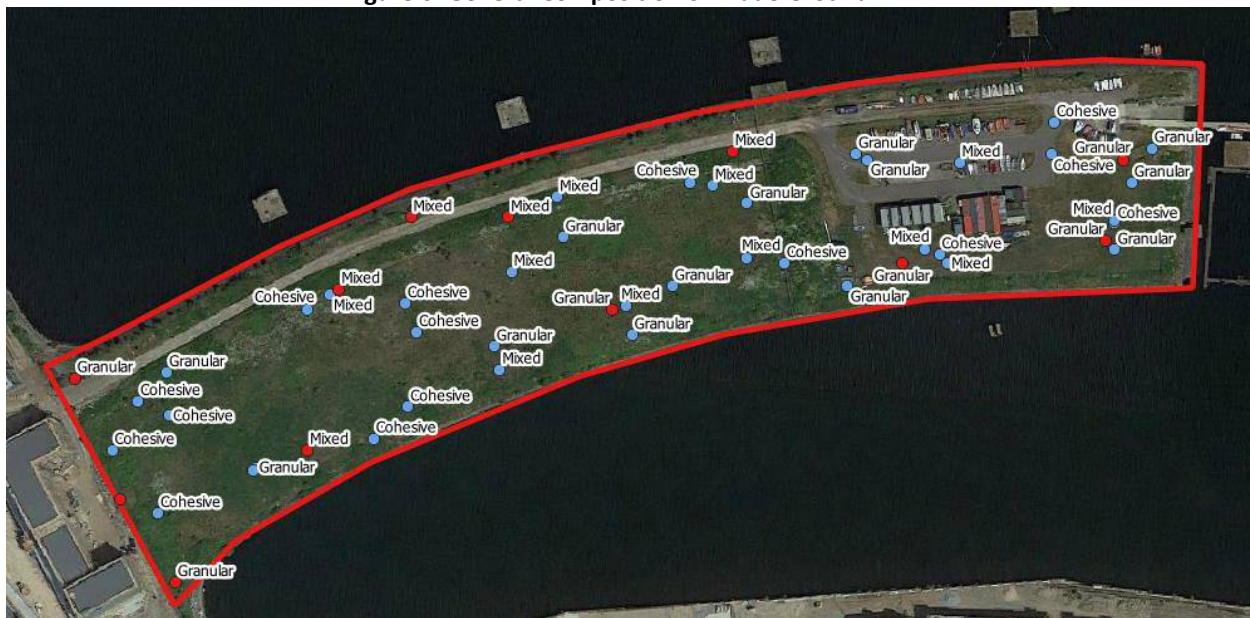
Figure 6: General Composition of Made Ground

Figure 6 provides an indication of the main composition of the Made Ground (i.e. predominantly granular, predominantly cohesive or approximately equal/mixed proportions). Figure 7 then provides an indication of where soft cohesive materials were encountered. As before, both Figure 6 and 7 include historical information to create the geological profile of the Site. It should be noted that the majority of the exploratory holes located at the Site were trial pits and therefore much of the data is limited in depth to typically less than 3m. The figures indicate that there were no particular zones where the Made Ground was either cohesive or granular and that there were soft zones located across the Site at varying depths.

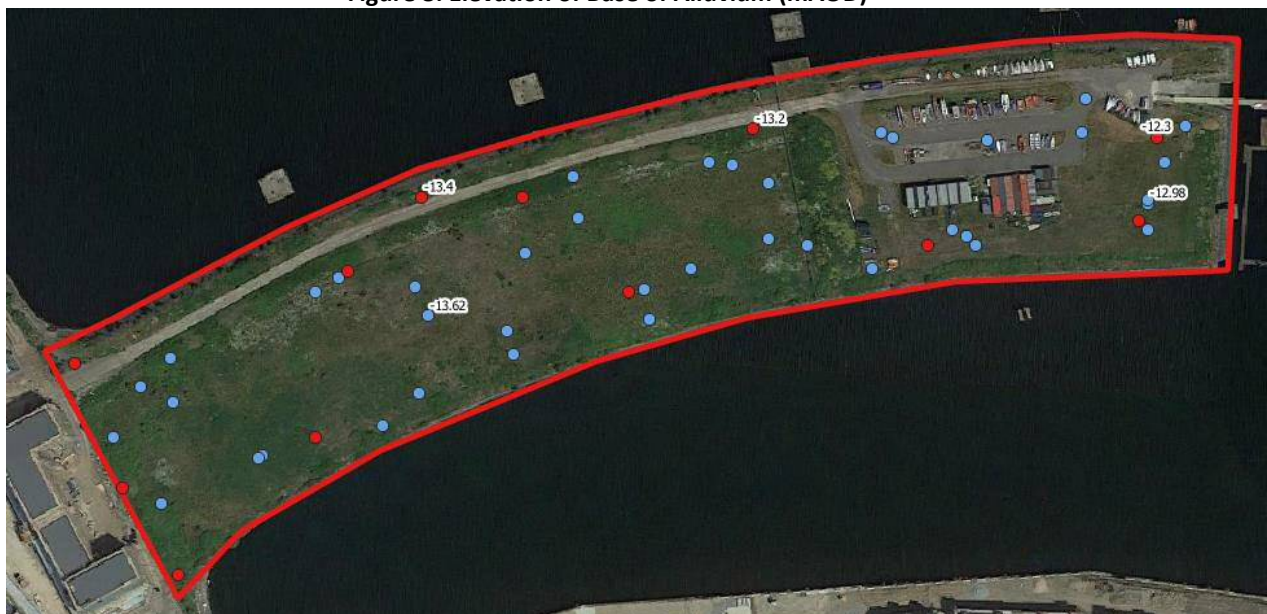
Figure 8: Elevation of Base of Alluvium (mAOD)

Figure 8 below provides an indication of the elevation of the base of the Alluvium, which includes historical information for the Site as well as TRC data. This indicates that the elevation to the base of the Alluvium was relative uniform ranging from -12.3 to -13.6mAOD. However, the deepest Alluvium was encountered in the borehole located to the southwest of the others. This suggests that the deepest part bedrock valley may actually be to the south of the Site.

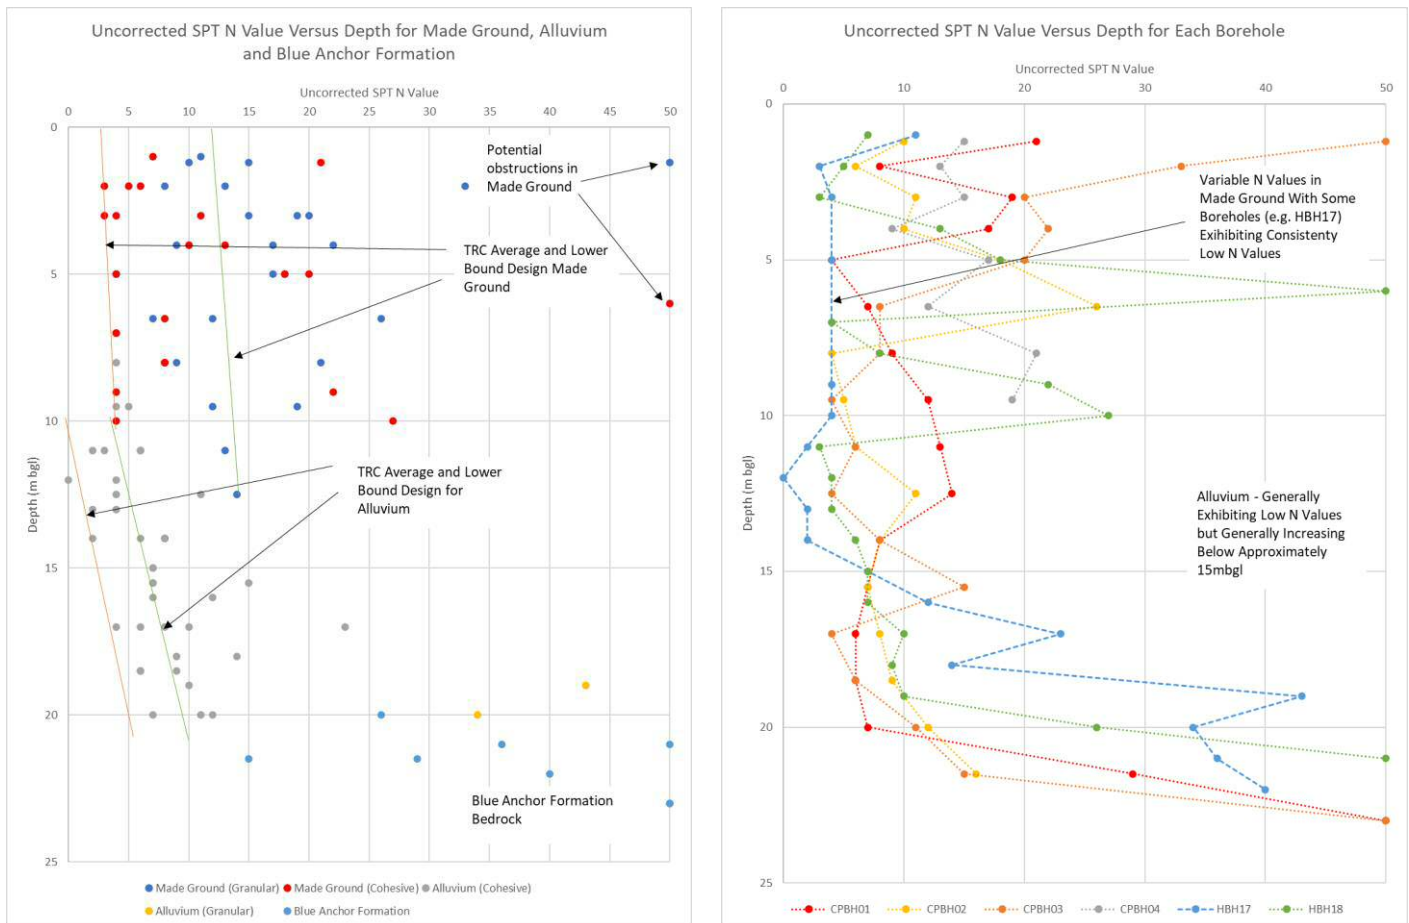
Figures 9 and 10 provide an indication of the variability of the ground conditions beneath the Site with uncorrected SPT N values plotted against depth. Figure 10 presents the data distinguishing the results based upon material type (e.g. granular Made Ground, cohesive Made Ground, granular Alluvium, cohesive Alluvium and Blue Anchor Formation) and Figure 11 presents the data separating the results based upon borehole. Data from the four TRC boreholes as well as the two historical boreholes have been used.

The results indicate that the Made Ground was highly variable with very low N values recorded alongside high values. It should be noted that N values in excess of 50 have been recorded (plotted as 50) and that these are considered to be associated with obstructions either in the Made Ground or associated with bedrock. Of particular note is that HBH17 consistently recorded low N values indicating that at some locations poor ground conditions were recorded throughout.

Figures 9 and 10: Uncorrected SPT N Value Versus Depth for Different Material Types and for Each Borehole

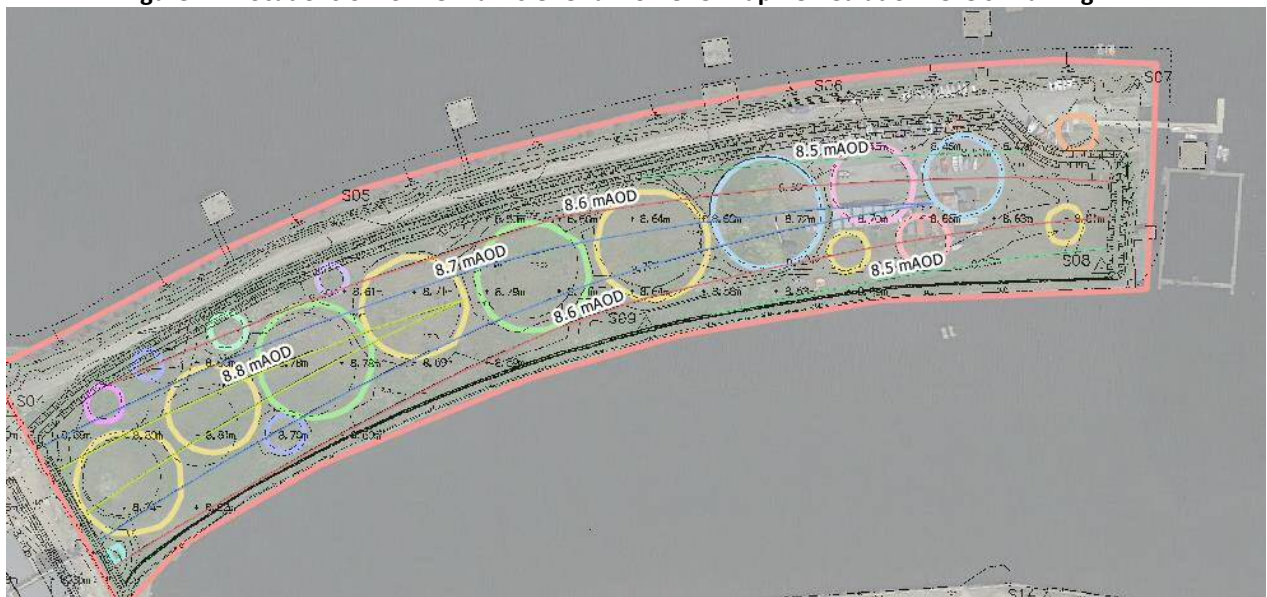
It should also be noted that the Ove Arup finished levels drawing also provided an indication of the levels prior to the remediation being undertaken. This indicates that in some parts of the Site, particularly along the southern and northern side the Site level was increased by other 1m. It should also be noted that the location and size of some of the tanks are not consistent with the other drawings showing the tank locations. Figure 12 provides details of the Ove Arup survey overlain with tank profiles taken from other provided drawings. The location of the tanks on the Ove Arup survey are outlined in black.

Figure 12: Locations of Former Tanks Overlain on Ove Arup Remediation Levels Drawing

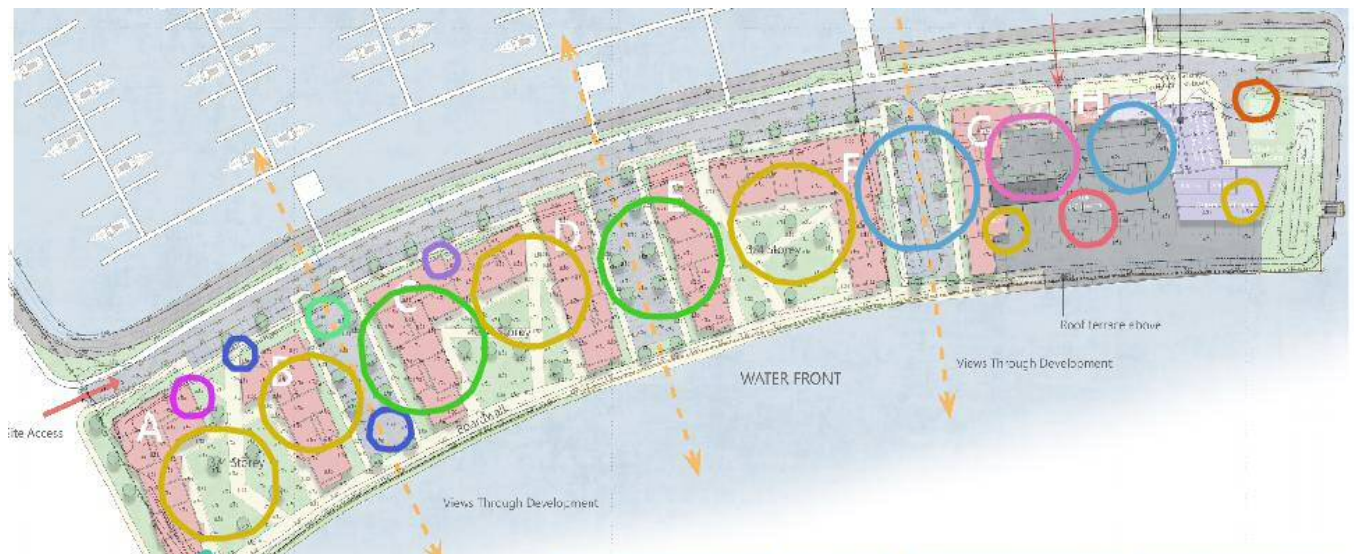
Figure 13: Proposed Development Plan

Figure 13 provides an indication of the location of the proposed development overlying the current topographical survey and the location of the former tanks. This demonstrates that in the current layout the buildings span across the location of the former tanks, locations where Site levels will need to be increased and areas where levels may need to be cut. It is therefore considered that the risk of differential settlement is likely to be high.

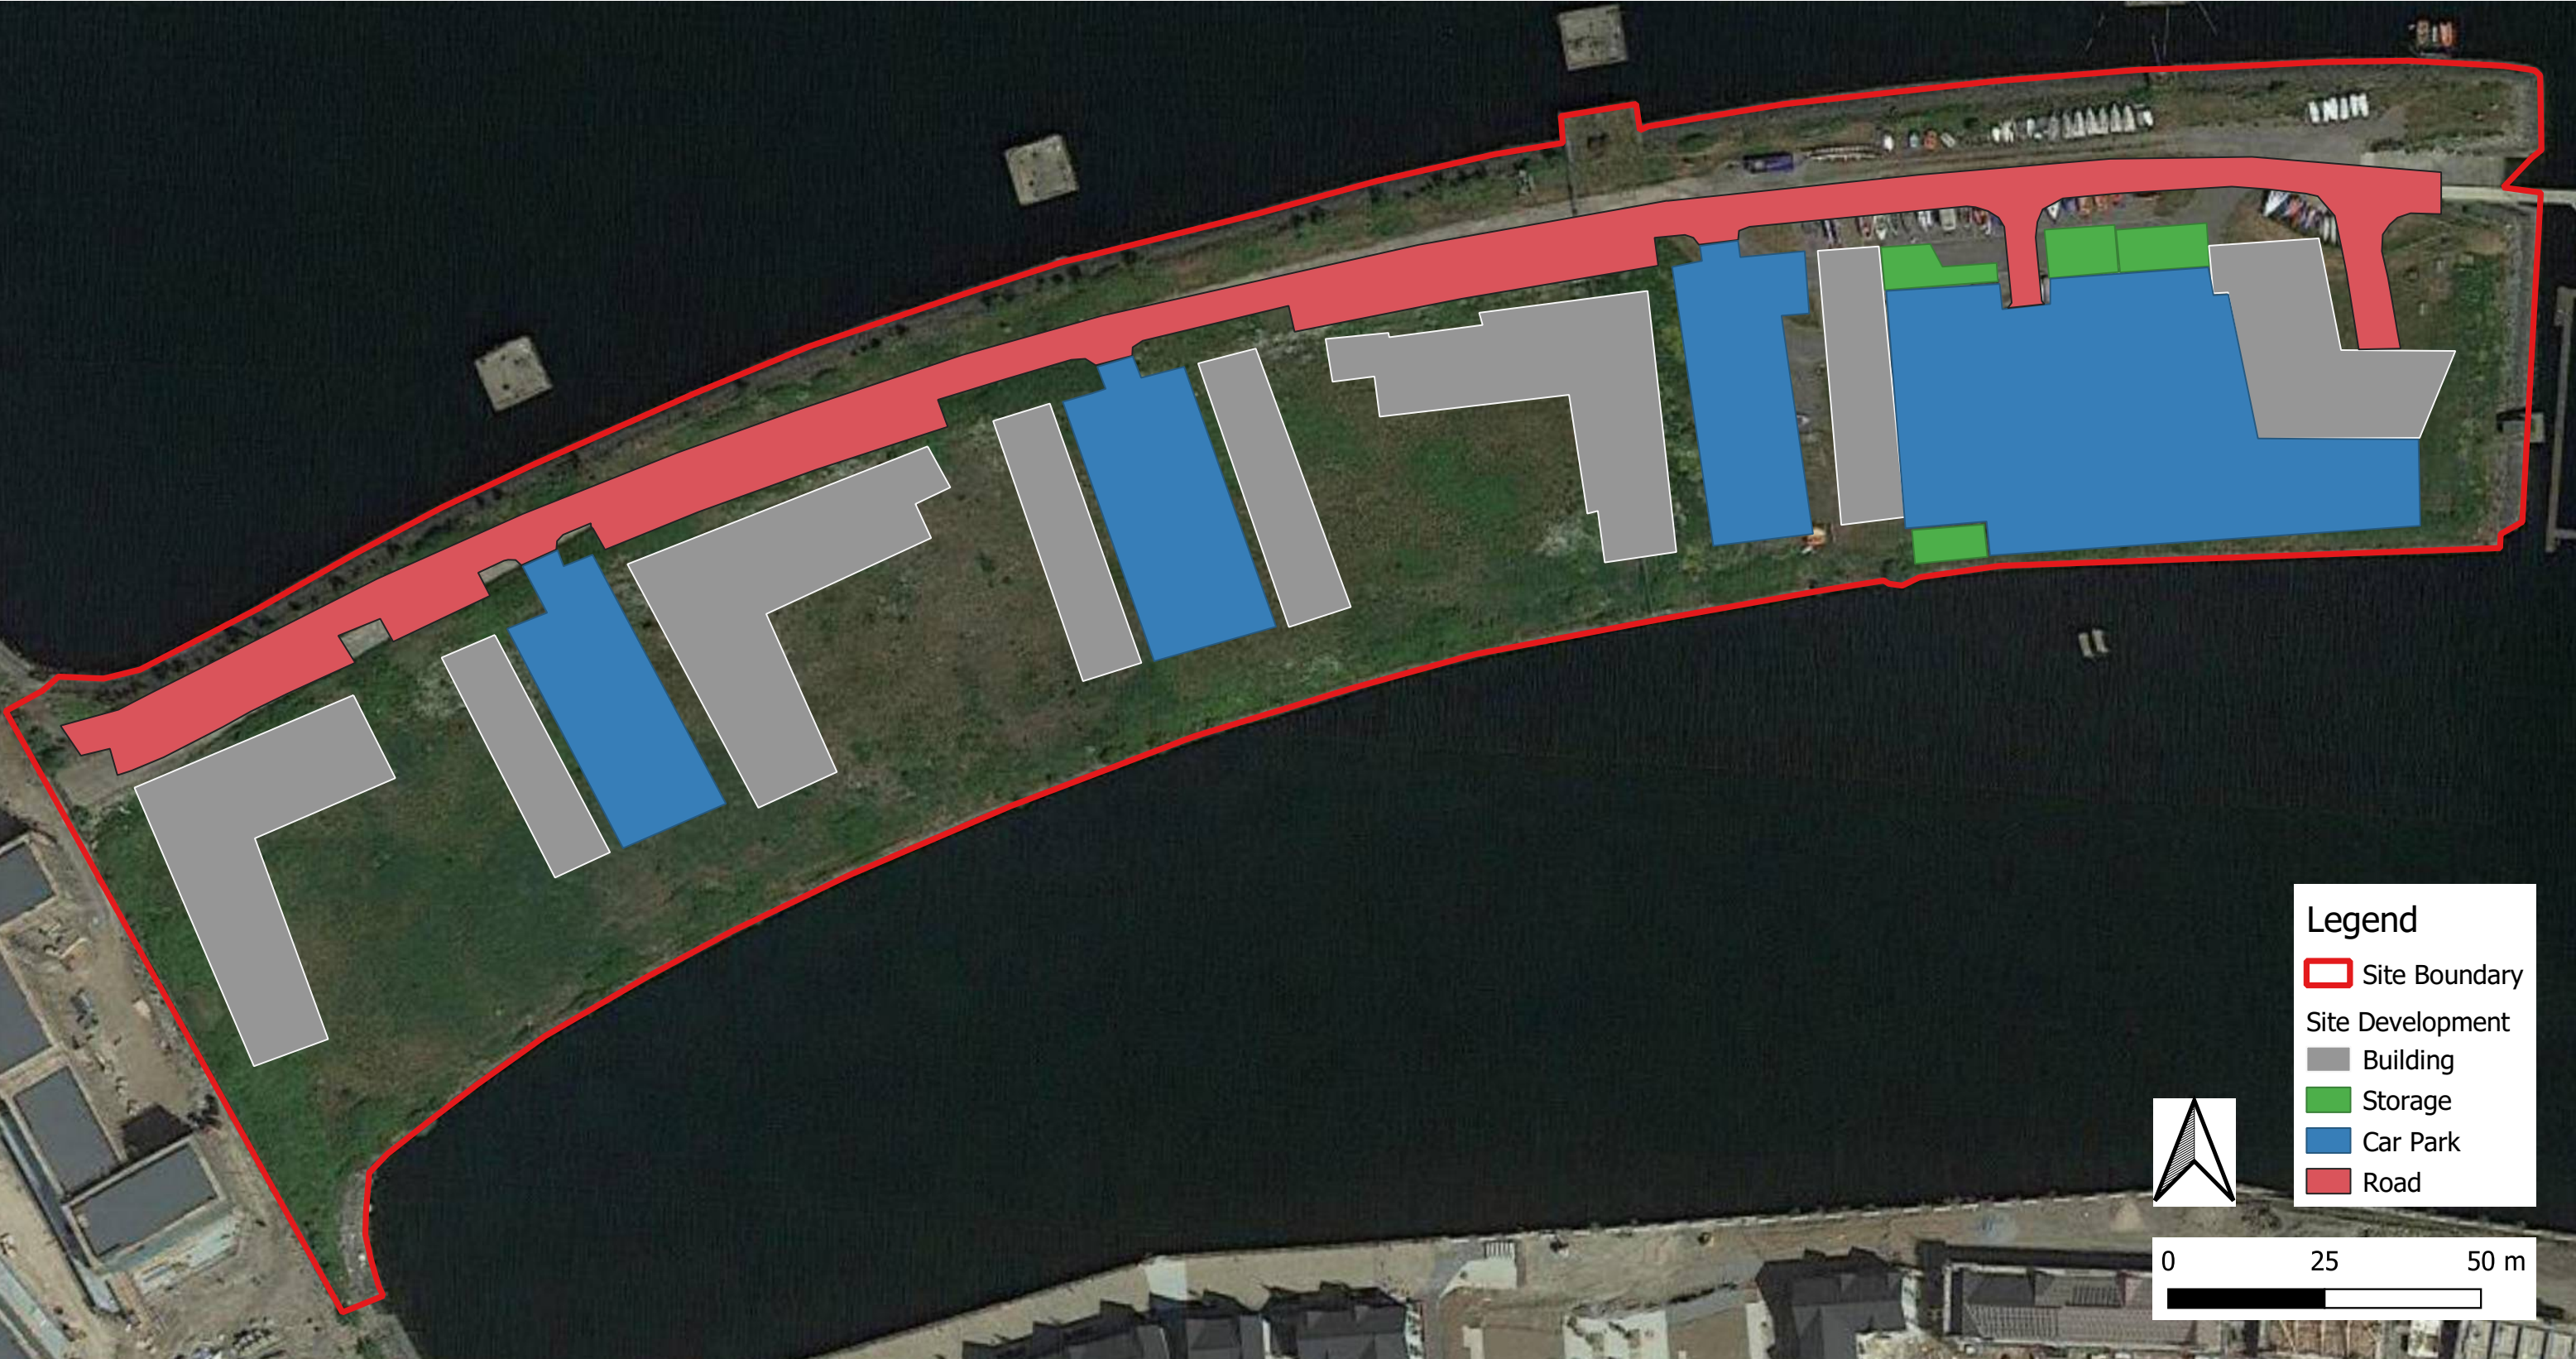
</div><div>Work.Life Brown Street, Manchester, M2 1DH</div></div>		TITLE	
											SITE DEVELOPMENT PLAN	
	TRC PROJECT NO.		SCALE									
	413800		1:1000 @ A3									
	P01		FIRST ISSUE				ABP PROPERTY		PURPOSE OF ISSUE		STATUS	
Initials			NJ	NJ	13/05/21	SUITABLE FOR INFORMATION						
REV.		REVISION NOTES/COMMENTS				PROJECT THE MOLE, BARRY		DRAWING NO		REVISION		
		Initials						FIGURE 02			PO1
