Lewis Homes (South Wales) Limited

LAND AT SANDY LANE, YSTRADOWEN

Site Investigation Report

12604/JJ/20/SI Rev A

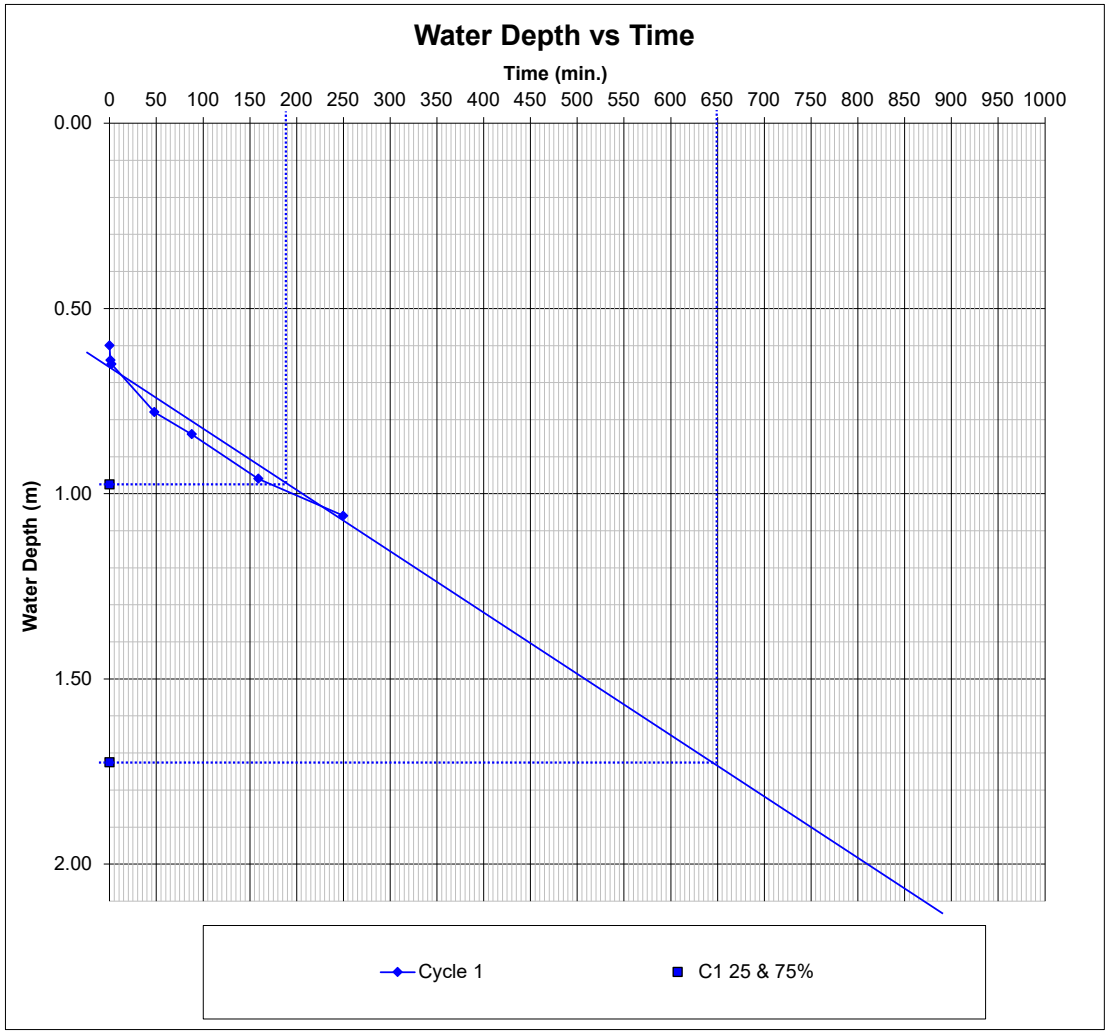
Final Excavation Depth (m)	Cycle 1	Cycle 2	Cycle 3
At end of testing cycle	2.10		
Water Depths (m)			
Water depth at start of test	0.60		
Water depth at end of test	1.06		
Effective depth (measured)	0.46		
% Effective storage depth	0.31		
Effective Storage Depths (m)			
Effective storage depth (100%)	1.50		
Effective storage depth (75%)	1.13		
Effective storage depth (50%)	0.75		
Effective storage depth (25%)	0.38		
Outflow Time (min)			
Time for measured outflow	250		
Time for 100% outflow	870		
Time for 75-25% outflow	460		
Volume of Outflow (m^3)			
Over measured effective depth	0.90		
Over 100% effective depth	2.94		
From 75% - 25% effective depth	1.47		
Surface Area (m^2)			
For 100% effective storage	12.46		
For 50% effective storage	7.21		
Over measured depth	5.18		
Soil Infiltration Rate (m/s)	**Cycle 1**	**Cycle 2**	**Cycle 3**
Over 100% effective depth	4.5E-06		
Over measured depth	1.2E-05		
Over 75% - 25% effective depth	**7.4E-06**

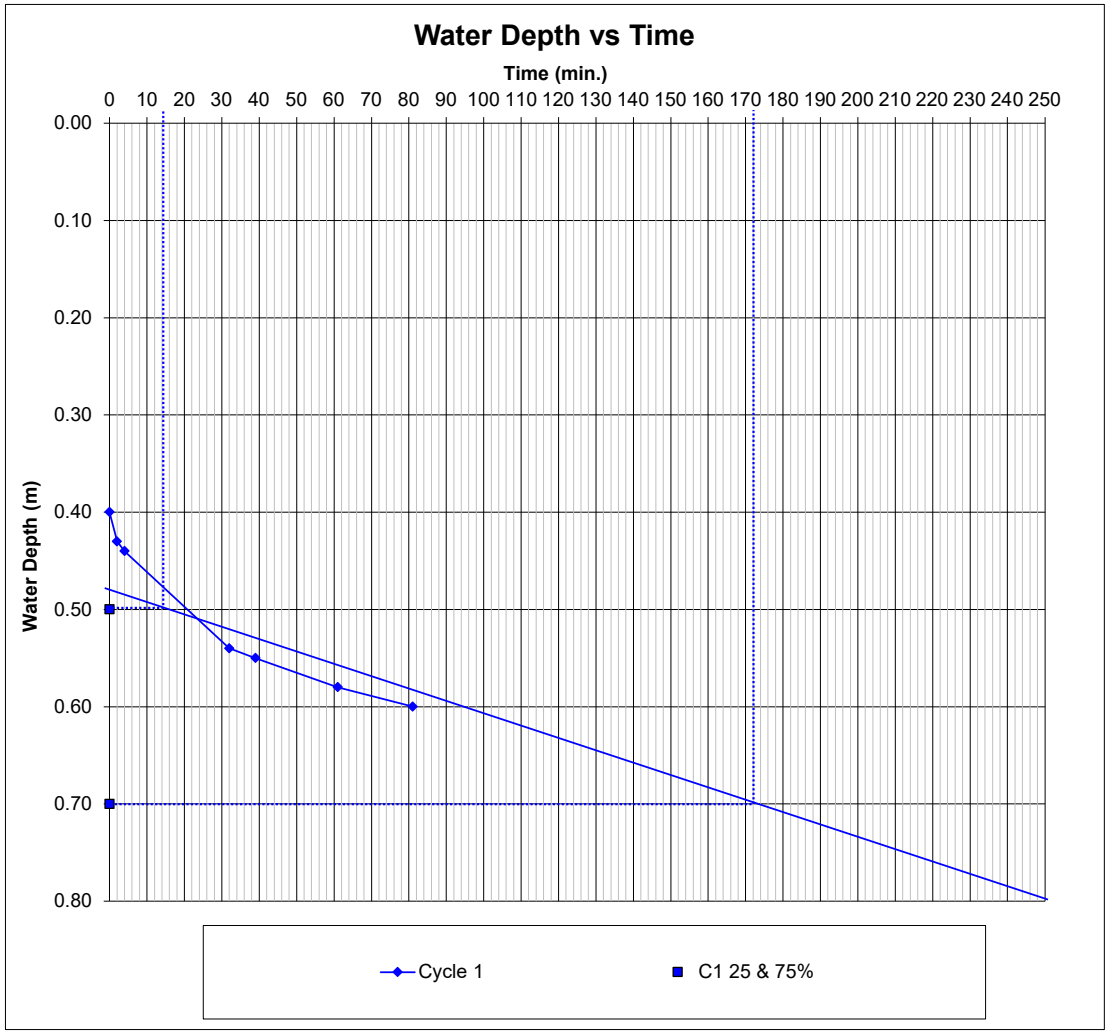
* It should be noted that the sides of the excavation in TP05-A collapsed during the soakaway test from 1.50m back up to 0.80m bgl. The soakaway test was continued and a soil infiltration rate of $1.2x10^{-5}$ m/s was calculated. This result should be used with caution.

Final Excavation Depth (m)	Cycle 1	Cycle 2	Cycle 3
At end of testing cycle	0.80		
Water Depths (m)			
Water depth at start of test	0.40		
Water depth at end of test	0.60		
Effective depth (measured)	0.20		
% Effective storage depth	0.50		
Effective Storage Depths (m)			
Effective storage depth (100%)	0.40		
Effective storage depth (75%)	0.30		
Effective storage depth (50%)	0.20		
Effective storage depth (25%)	0.10		
Outflow Time (min)			
Time for measured outflow	81		
Time for 100% outflow	250		
Time for 75-25% outflow	158		
Volume of Outflow (m^3)			
Over measured effective depth	0.35		
Over 100% effective depth	0.70		
From 75% - 25% effective depth	0.35		
Surface Area (m^2)			
For 100% effective storage	4.31		
For 50% effective storage	3.03		
Over measured depth	3.03		
Soil Infiltration Rate (m/s)	**Cycle 1**	**Cycle 2**	**Cycle 3**
Over 100% effective depth	1.1E-05		
Over measured depth	2.4E-05		
Over 75% - 25% effective depth	**1.2E-05**
