FORMER BOYS VILLAGE SAINT ATHAN

UPDATE BAT SURVEY

June 2015

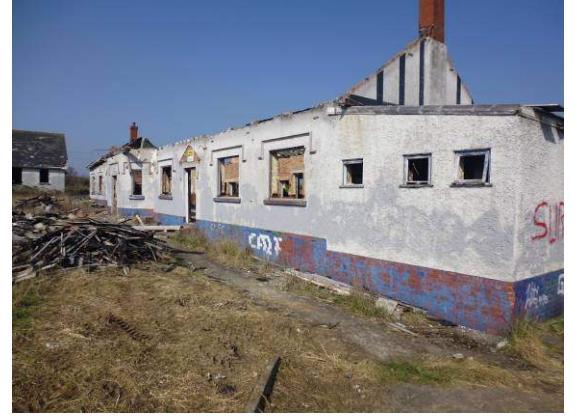
- In between multiple slipped or missing slates (See Plate 7);
- Gaps in the soffit boxes on all elevations of the building;
- Into the main roof structure between the exposed rafters (See Plate 8); and
- Within the uncapped chimney flue.

Plate 7: Numerous missing tiles and exposed cavities behind fascias of building 2

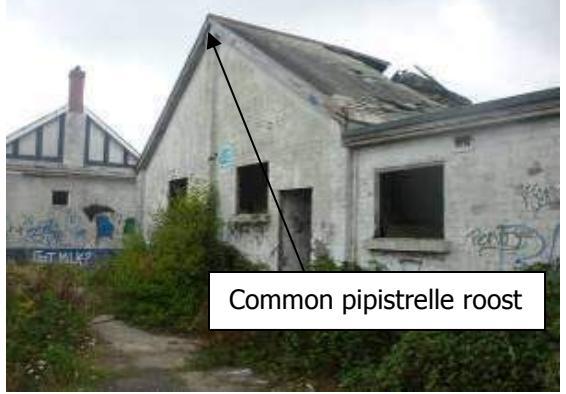
- Within the soffit box that can be accessed via the above gap;
- Between the two gaps at the apex of the southern wall (See Plate 14); and
- Where the plaster board ceiling has partially fallen away, exposing the slate roof at the far southern elevation of the building.

- Underneath multiple slipped or missing slates;
- Within the soffit box on the southern elevation;
- Within the two gaps at the apex of the southern elevation wall (See Plate 14); and
- Between the eroded ceiling plaster and the exposed slates of the roof structure (See Plate 17).

Plate 14: Eroded bargeboards at southern elevation

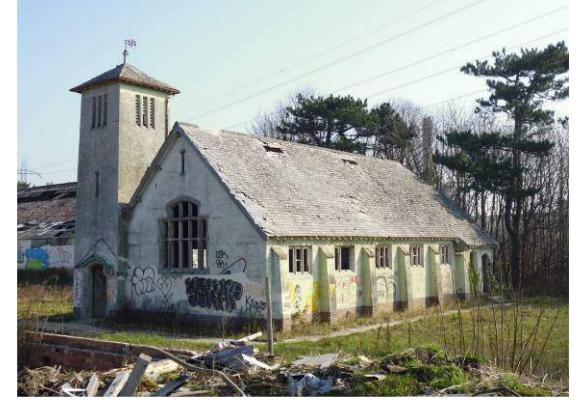
- Beneath the raised fascias (See Plate 19); and
- In between gaps formed where sections of the concrete ceilings have fallen away on the ground and first floors (See Plate 20).

- Beneath raised fascias (See Plate 19); and
- Within the cavities formed where portions of the concrete ceiling have fallen away on the ground and first floors, thus exposing the inner reaches of the ceiling (See Plate 20).

Plate 19: Gaps between fascias of building 5 (2012) Plate 20: Holes in concrete ceiling of building 5

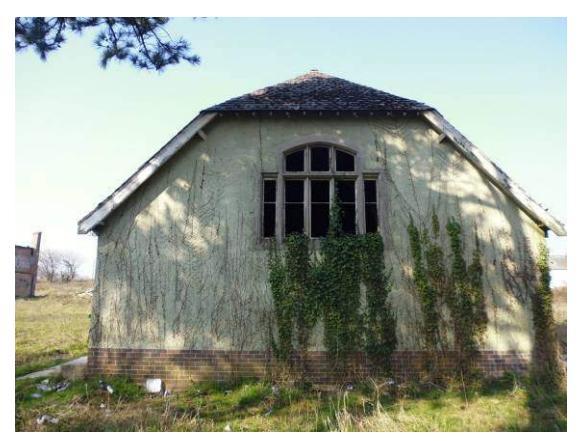
- Beneath slipped tiles (See Plate 23);
- Beneath missing ridge tiles;
- Within gaps created where the bargeboards have partially fallen away on the western elevation, near the bell tower (See Plate 24);
- Within gaps in the soffit boxes;
- Between the slit window grills of the bell tower (See Plate 22); and
- Through the large hole that has developed in the plaster board ceiling at the eastern end of the building, which allows access into the void above (See Plate 28).

Plate 23: Building 6: Slipped tiles and gaps in roof

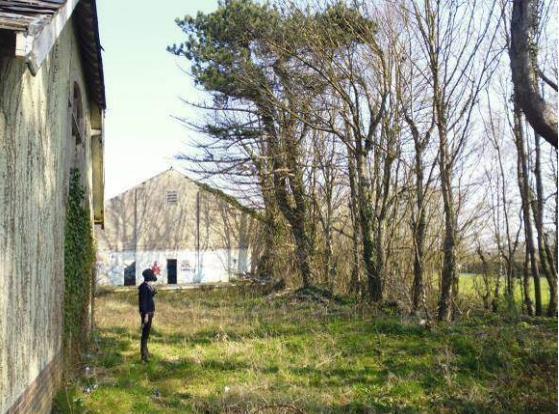
- Underneath multiple slipped or missing slates;
- Beneath ridge tiles;
- Within the cavity that is exposed at the western elevation (near the bell tower), where a section of the bargeboard has fallen away, thus exposing direct access up in between the sarking and slates of the main roof structure (See Plate 24);
- Within the soffit box;
- Behind gaps in the internal ceiling where sections of the plaster board ceiling have weathered or fallen away, thus exposing the slates and timber sarking above (See Plate 27);
- Within the void in the eastern end of the building (See Plate 28, 29); and
- Potentially within the bell tower.

Plate 24: Hole in the bargeboard of the western elevation of building 6, near the bell tower

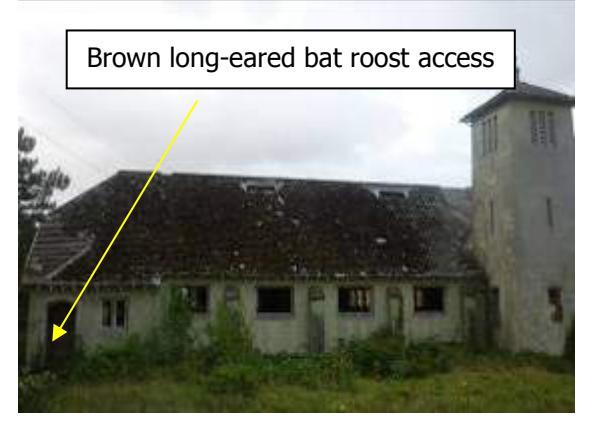
Plate 28: Access to roof void at east of building 6 (2012)

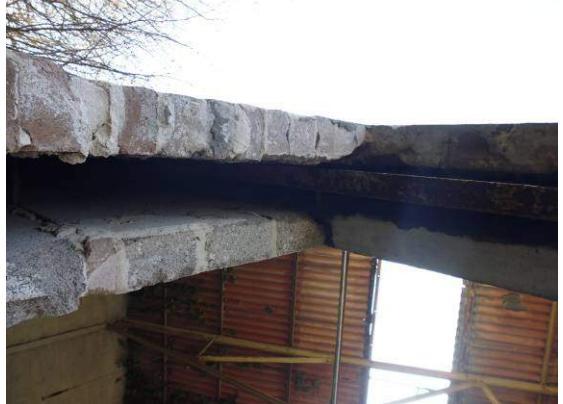
Plate 37: Gaps beneath asbestos bargeboards at Plate 38: Moderate sized gap at apex of northern elevation wall
