Structural Report

Marine Buildings
Penarth Marina
Penarth

Structural Report On

Marine Buildings, Penarth Marina, Penarth

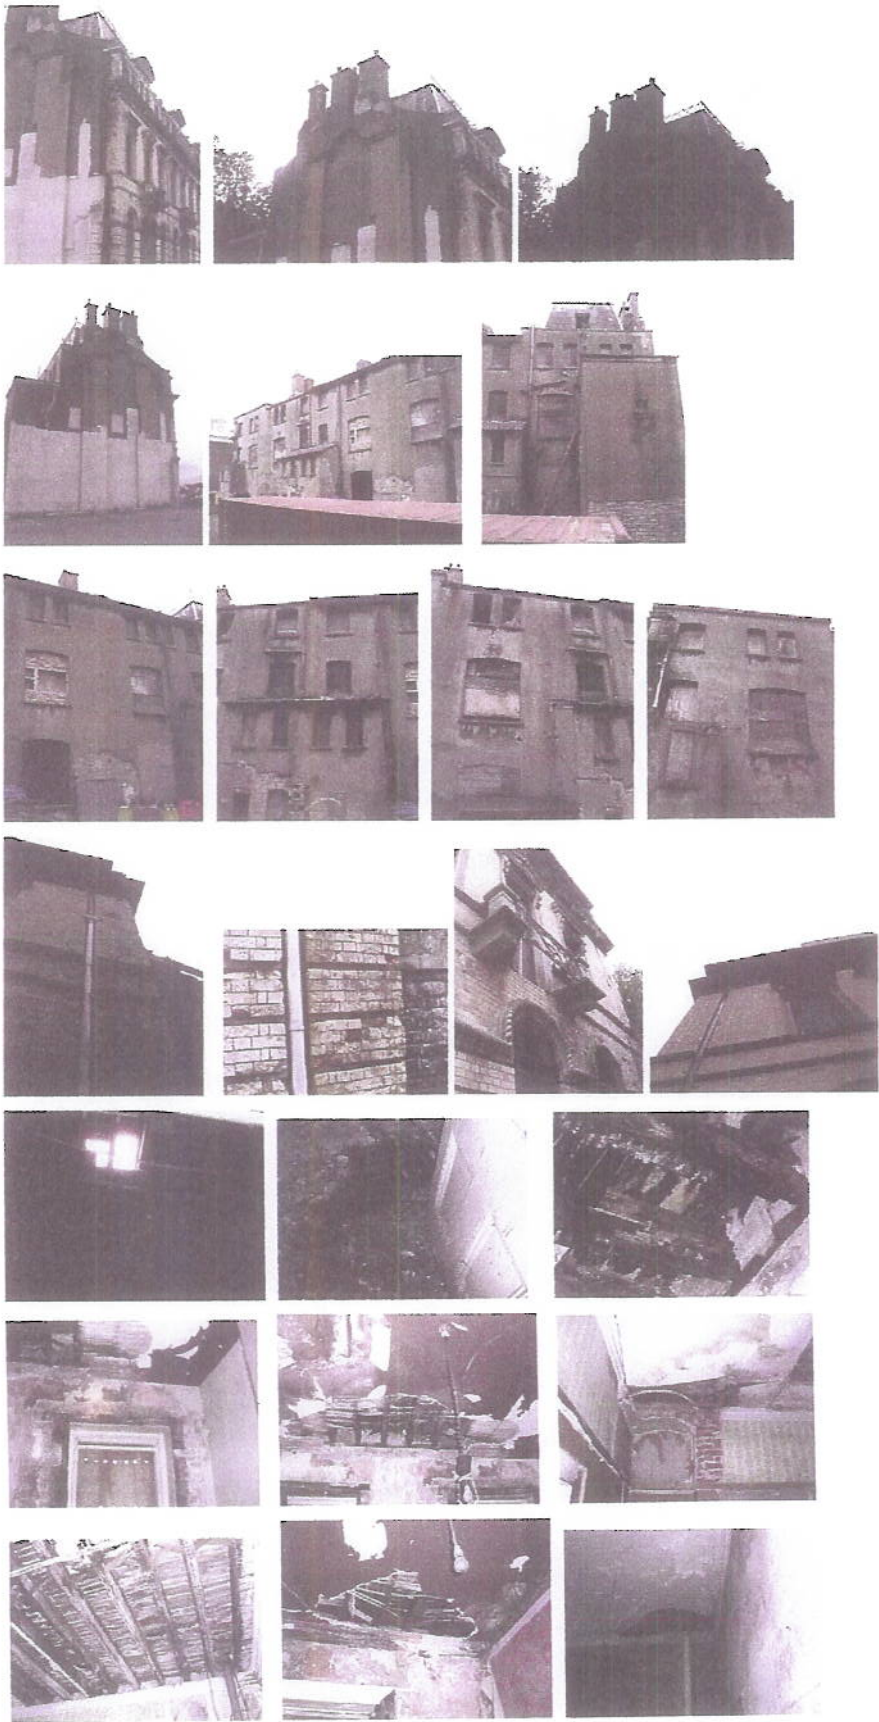
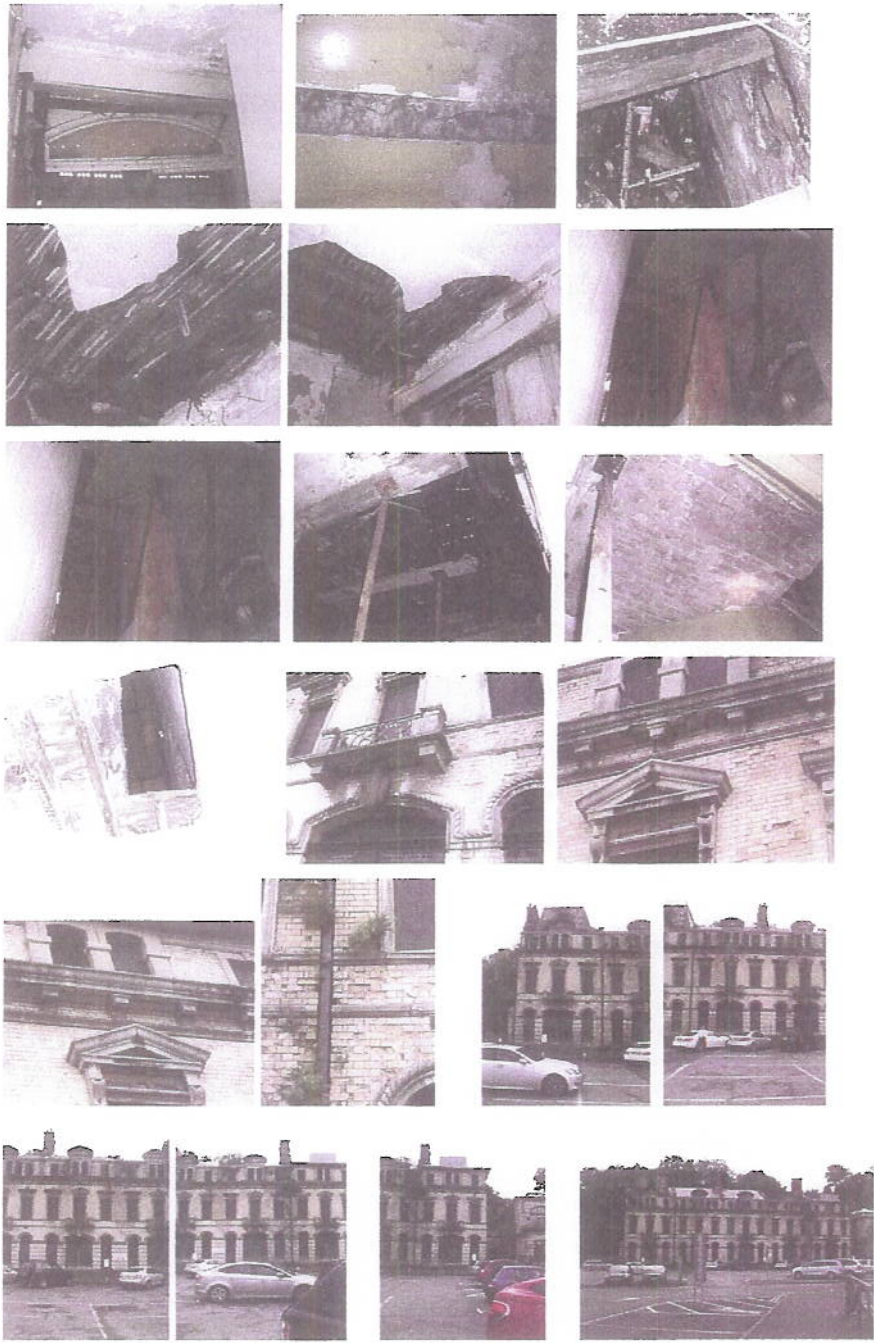
PHOTOGRAPHS

The whole of the property has been disused for a considerable period of time. As a consequence the general condition of the property could be described as extremely poor with evidence of dampness throughout, fire damage and collapse of sections of the internal structures including roof, floors and walls.

- The high level entablature stonework has spalled in areas and there are several cracks in evidence.
- Sections of the stonework balcony have collapsed
- Support corbels to the balcony have cracked.

- The high level entablature stonework has spalled and in one area has cracked and moved outwards.
- The soffit section to the stonework balcony has collapsed
- Support corbels to the balcony have cracked
