**Waterfront Barry,
Vale of Glamorgan**

Stage 1 Road Safety
Audit

March 2010

Job number 122374-00

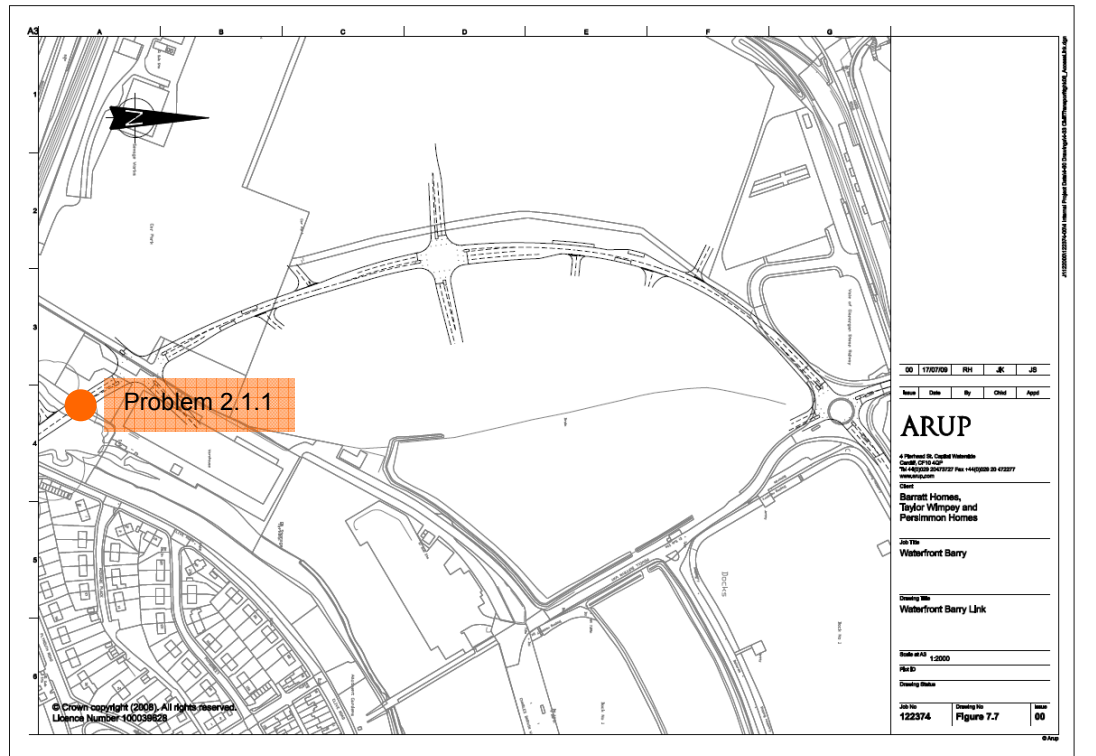
2.1 Waterfront Barry Link between Paget Road / Plymouth Road and West Pond / South Quay Junctions (TA Figure 7.7)

Location Waterfront Barry Link

Recommendation Ensure the grade does not exceed 6% (Waterfront Barry Link will be a bus route), and that vertical curves do not restrict the forward visibility of junctions.

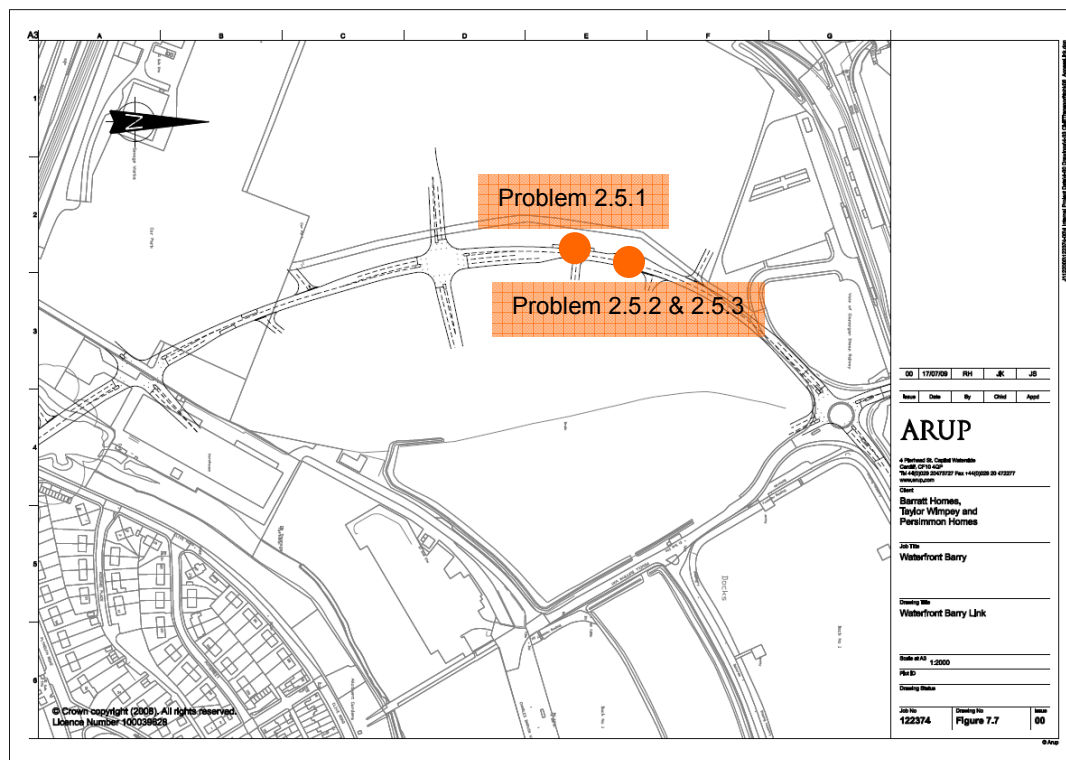
2.5 Waterfront Barry Link between West Pond / Supermarket West Pond Northern junctions (TA Figure 7.7)

Location

Recommendation Provide a minimum offset of 40 metres to allow traffic to safely pass a stationary vehicle.

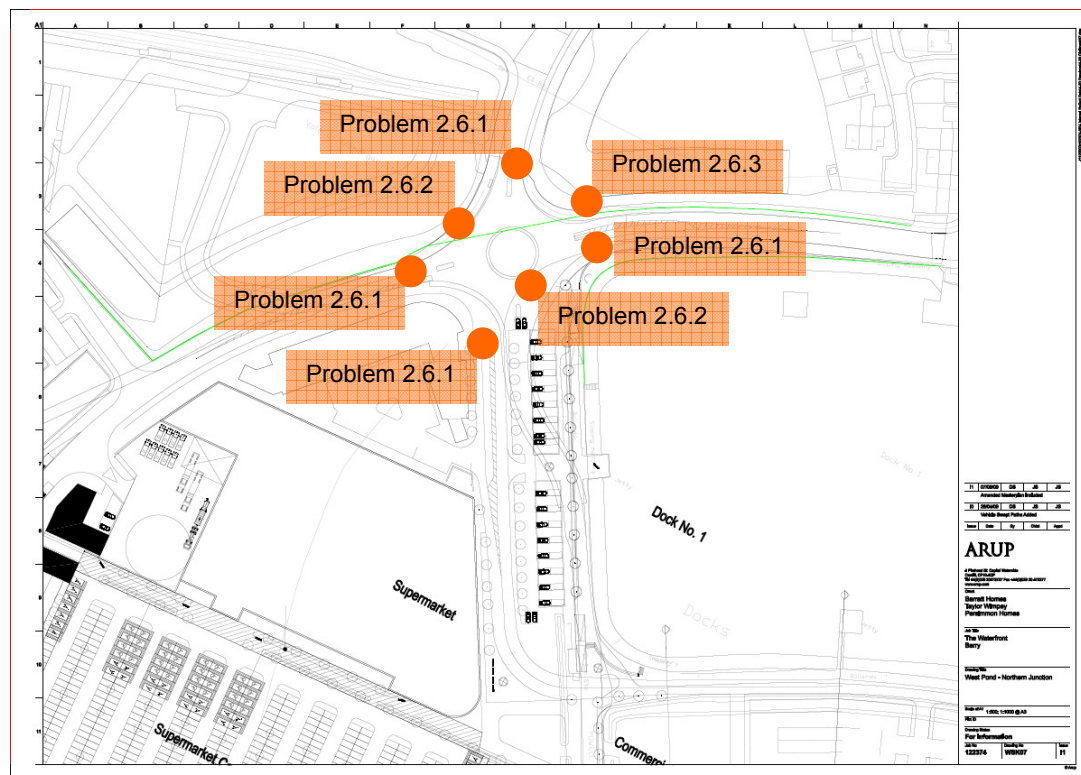
**2.6 Waterfront Barry Link / West Pond Northern Junction
 (TA Figure 7.7 , Drawing WSK07)**

Location Junction

Recommendation Reduce the size of the junction.

Recommendation Reduce the junction radii to reduce traffic speeds within the junction.

Recommendation Include measures to assist cycles at the junction.

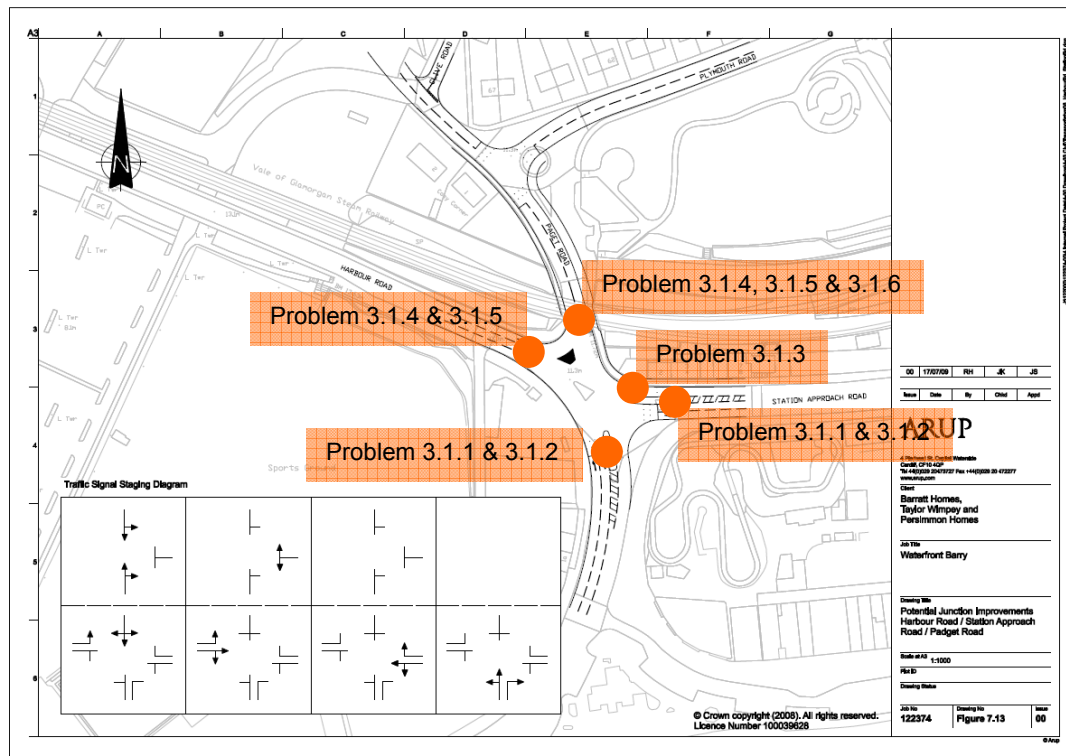
3.1 Harbour Road / Station Approach / Paget Road (TA Junction 08 Figure 7.13)

Location Station Road Approach / Harbour Road (south)

Limited crossing opportunities cause pedestrian frustration at busy times, such as the holiday season. As a result pedestrians will be likely to make crossing movements against the signals placing them at risk of injury.

This is likely to result in overrunning of the splitter island, damage to street furniture and possibly injury to pedestrians.

As a result the signals may be difficult to see, especially in bright or low winter sun conditions, leading to overrunning of the stop line.

Recommendation Provide the crossings with a left-right stagger.

Recommendation Consider an all red crossing arrangement of this junction.

Recommendation Assess the junction using AutoTrack to ensure there is adequate carriageway width for large vehicles.

Recommendation Provide backing boards on the traffic signal heads in order to maximise visibility.

Ensure the lane markings provided on Paget Road can accommodate buses turning from Harbour Road.

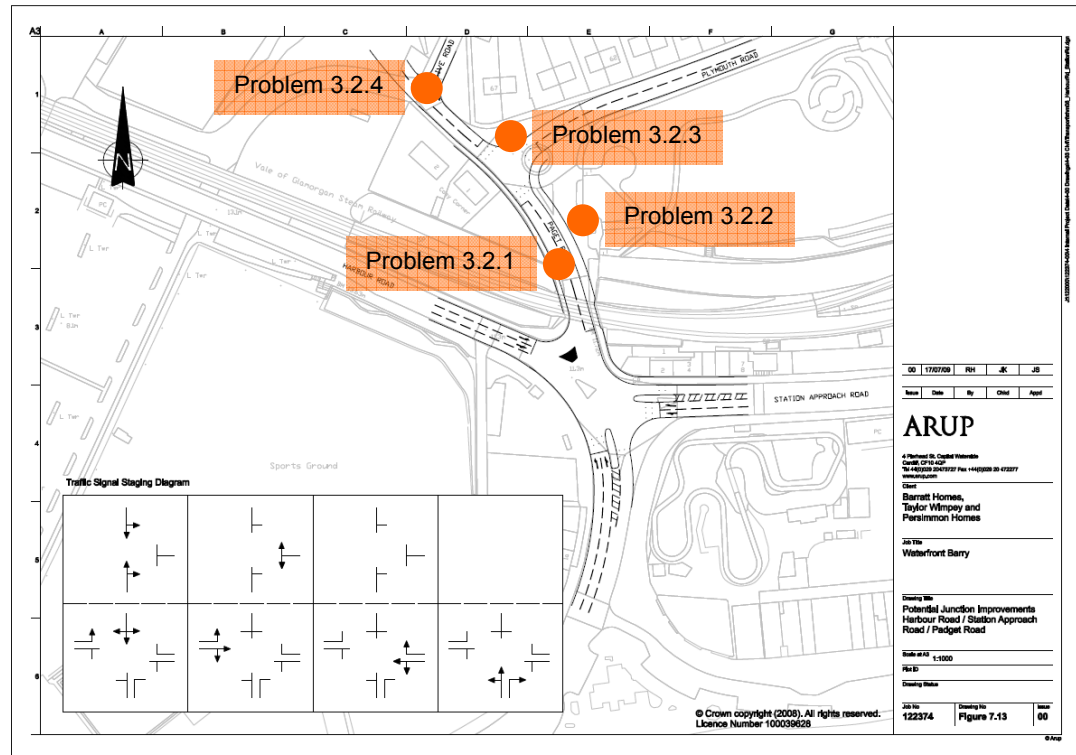
3.2 Paget Road / Plymouth Road (TA Junction 22 Figure 7.13)

A failure to provide for existing accesses can result in damage to footways and unexpected pedestrian vehicle conflicts.

Parking on footways causes damage leading to trips and falls. Furthermore vehicles joining the carriageway within the controlled junction are unexpected and can present a danger to other drivers.

Provide speed reduction measures and high friction surfacing on the Clive Road approach to the Waterfront Barry Link

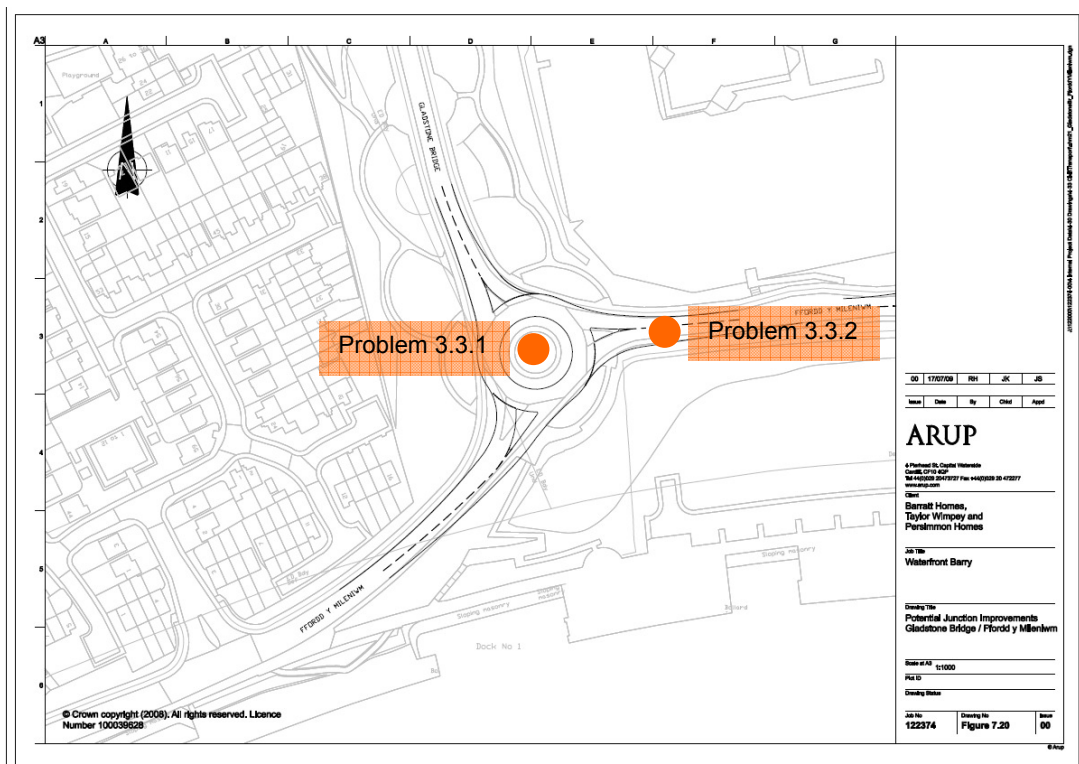
3.3 Gladstone Bridge / Ffordd y Mileniwm (TA Junction 21, Figure 7.20)

Excessive landscaping blocks visibility for all road users, especially pedestrians who cannot see approaching vehicles, whilst hard landscaping can present a hazard for errant vehicles.

Summary Inadequate entry deflection

Recommendation Remove the vegetation and hard landscaping.

Recommendation Alter the junction layout in order to provide sufficient entry deflection.

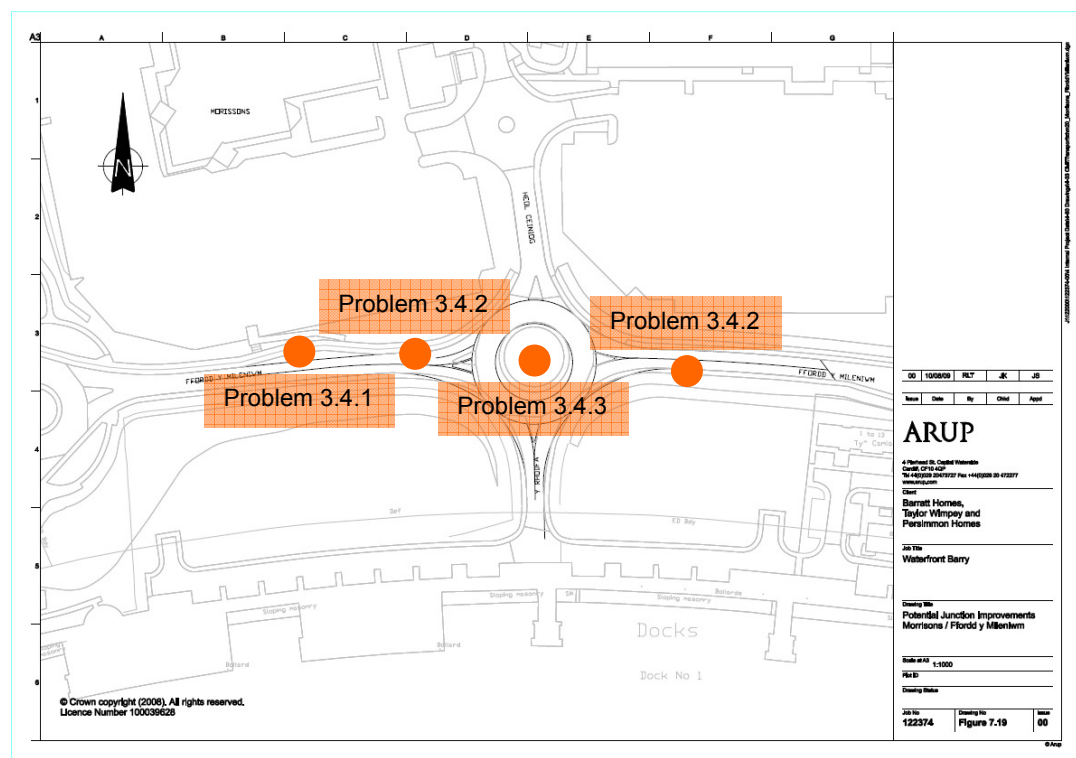
3.4 Heol Ceiniog / Ffordd y Mileniwm (TA Junction 20, Figure 7.19)

Location Ffordd y Mileniwm

Inadequate entry deflection

Excessive landscaping blocks visibility for all road users, especially pedestrians who cannot see approaching vehicles, whilst hard landscaping can present a hazard for errant vehicles.

Remove the vegetation and hard landscaping from the roundabout

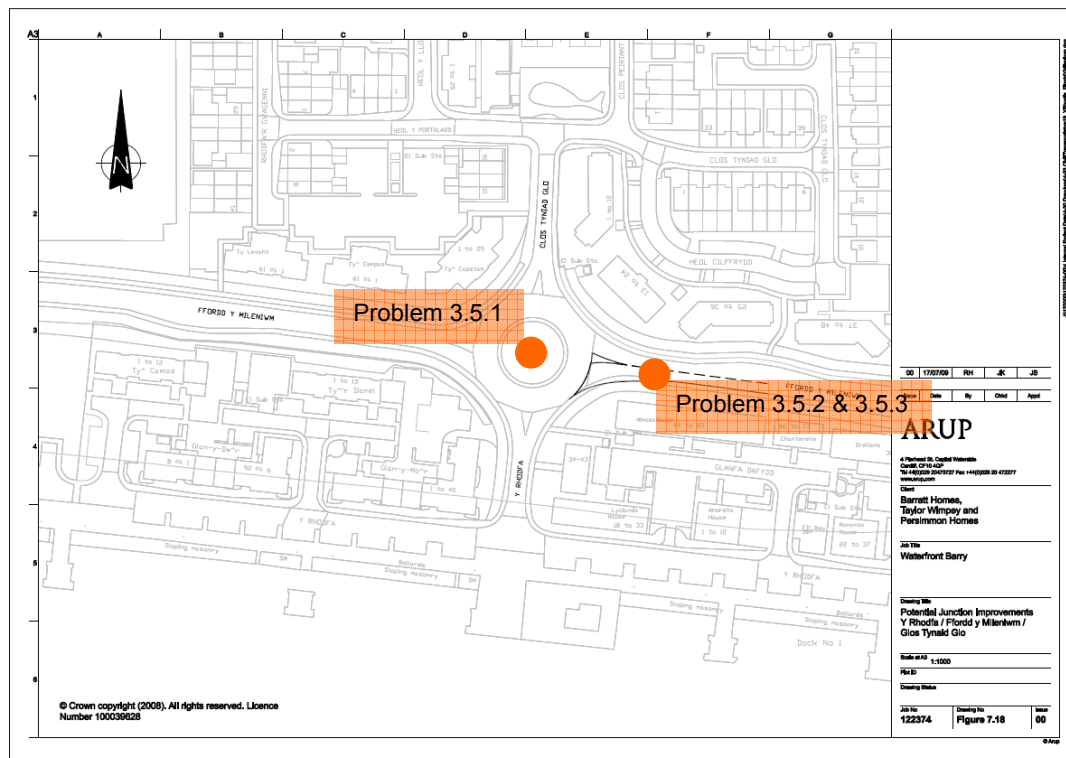
3.5 Y Rhodfa / Clos Tyniad Glo / Ffordd y Mileniwm (TA Junction 19, Figure 7.18)

Excessive landscaping blocks visibility for all road users, especially pedestrians who cannot see approaching vehicles, whilst hard landscaping can present a hazard for errant vehicles.

Inadequate entry deflection

Recommendation Remove the vegetation and hard landscaping from the roundabout

Alter the junction layout in order to provide sufficient entry deflection.

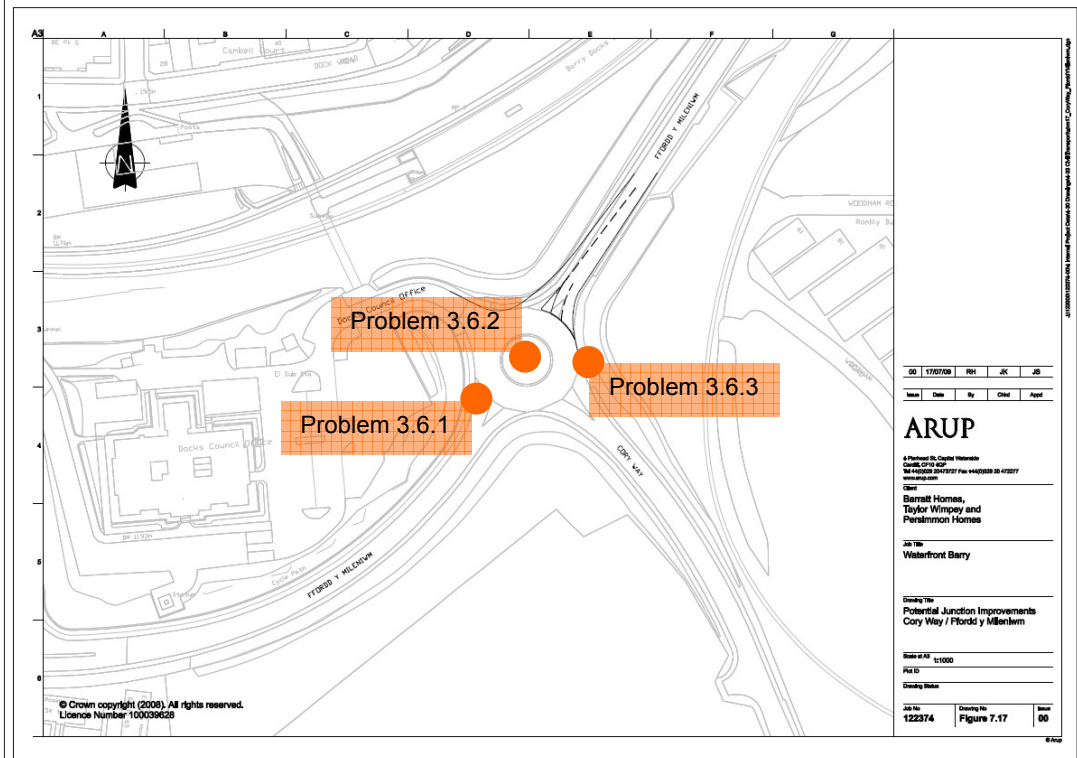
3.6 Cory Way / Ffordd y Mileniwm (TA Junction 17, Figure 7.17)

Inadequate entry deflection

Summary Missing footway link

Recommendation Remove the vegetation.

Recommendation Extend the footway on the eastern side of Cory Way to Ffordd y Mileniwm and provide an appropriate pedestrian crossing point on Ffordd y Mileniwm.

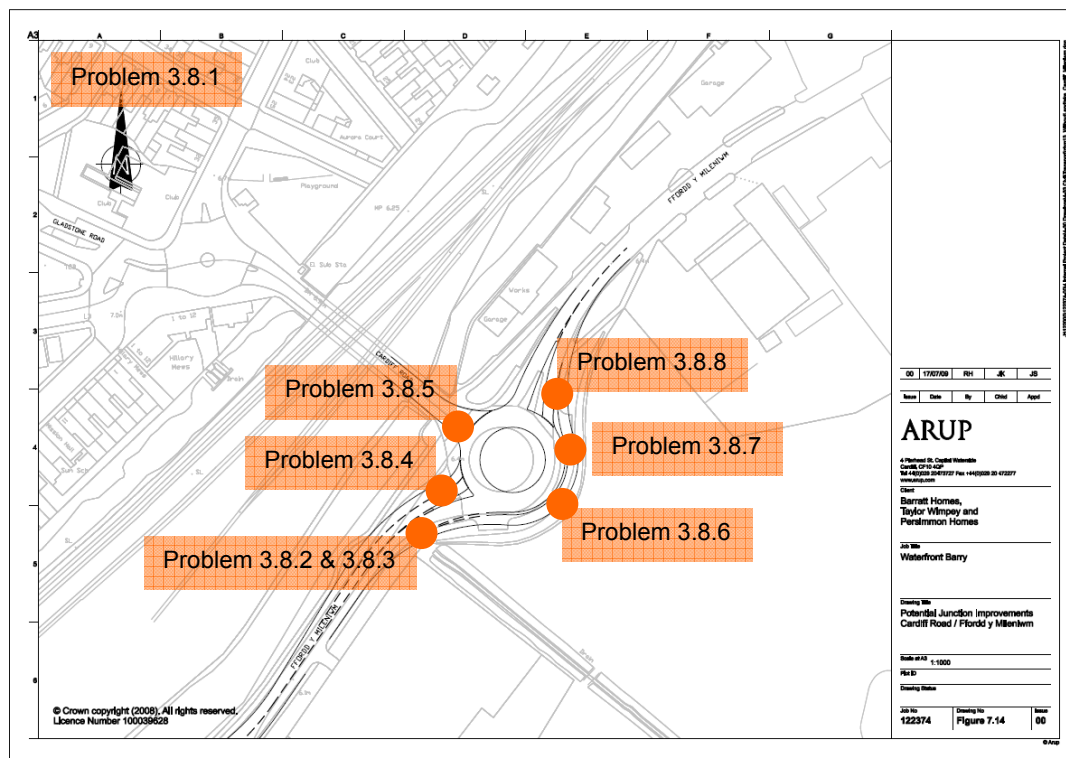
3.8 Cardiff Road / Ffordd y Mileniwm (TA Junction 13, Figure 7.14)

Location Ffordd y Mileniwm

Inadequate entry deflection

Recommendation Provide consistent lane widths, able to accommodate all types of traffic.

Recommendation Provide appropriate road markings at the merge.

Recommendation Provide an alternative access for utilities.

Recommendation Provide appropriate lane widening on tight radii to accommodate larger vehicles.

Recommendation Ensure there is an appropriately sized refuge between the traffic streams at the crossing, and that pedestrians are aware of the road layout.

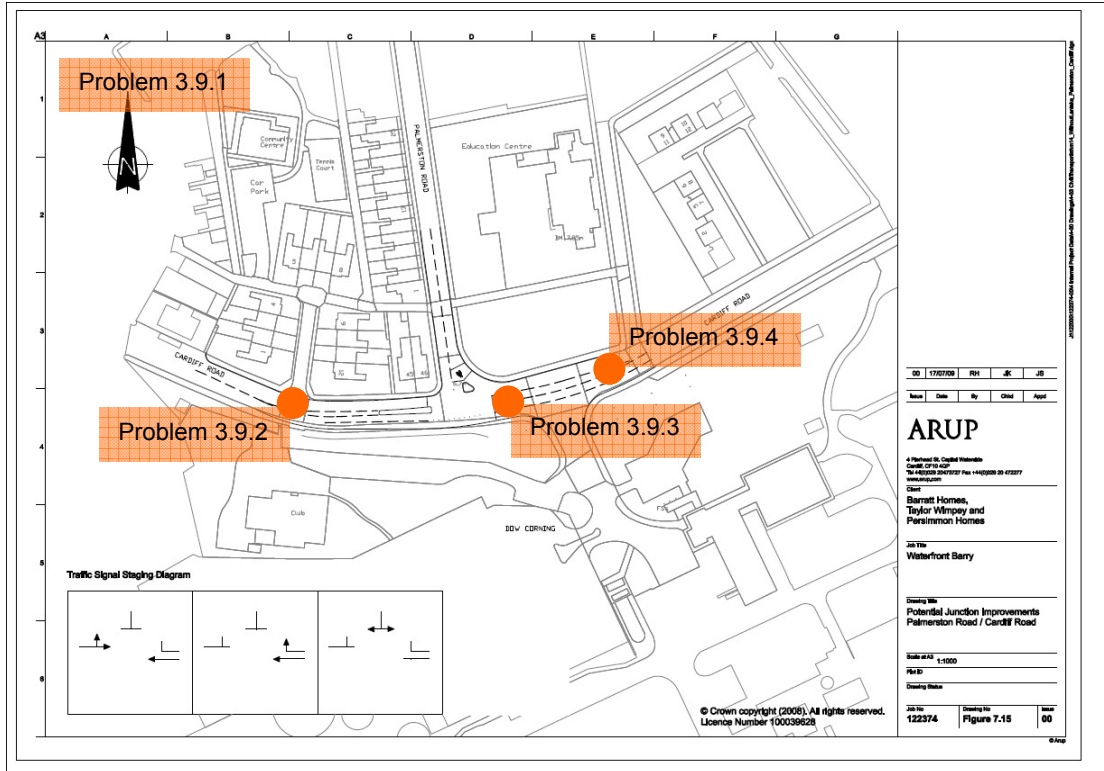
3.9 Cardiff Road / Palmerston Road (TA Junction 14, Figure 7.15)

Location Cardiff Road

Incorrect road markings can cause confusion leading to unnecessary lane changing and sideswipe and late braking accidents.

Recommendation Replace the cycle stop lines.

Provide pedestrian facilities at the junction.

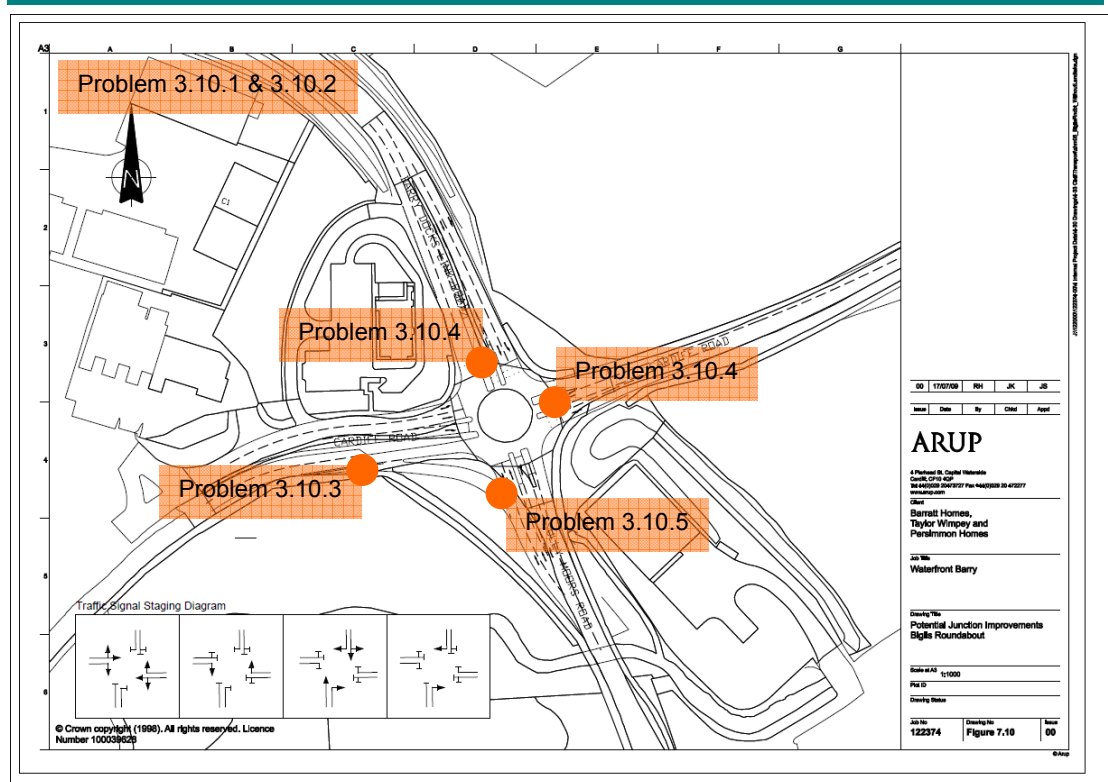
3.10 Sully Moors Road / Cardiff Road / A4231 Barry Docks Link Road (TA Junction 5, Figure 7.10)

Summary Inadequate space for turning manoeuvres

Insufficient turning space at junctions can result in damage to vehicles and street furniture including traffic signals, or could result in drivers reversing within the junction to complete their turning manoeuvres placing other road users at risk.

Location	Sully Moor Road
Summary	Access to Left Turn Slip Lane (LTSL)
Description	The LTSL from Sully Moors Road to Cardiff Road diverges close to the stop line. The proposed diverge location provides limited storage for traffic moving ahead before the LTSL becomes blocked, limiting its effectiveness, leading to driver frustration which could lead to vehicles using the verge to access the lane placing pedestrians and other road users at risk.
Recommendation	Lengthen the LTSL from Sully Moors Road allowing traffic to diverge earlier, reducing queuing and driver frustration on this approach.

Recommendation Include measures to assist cycles at the junction.

Recommendation Undertake an AutoTrack assessment of the junction to ensure all turning manoeuvres are possible by larger vehicles.

Recommendation	Ensure the bus stop is relocated so as to avoid undue influence on the LTSL merge.
-----------------------	--

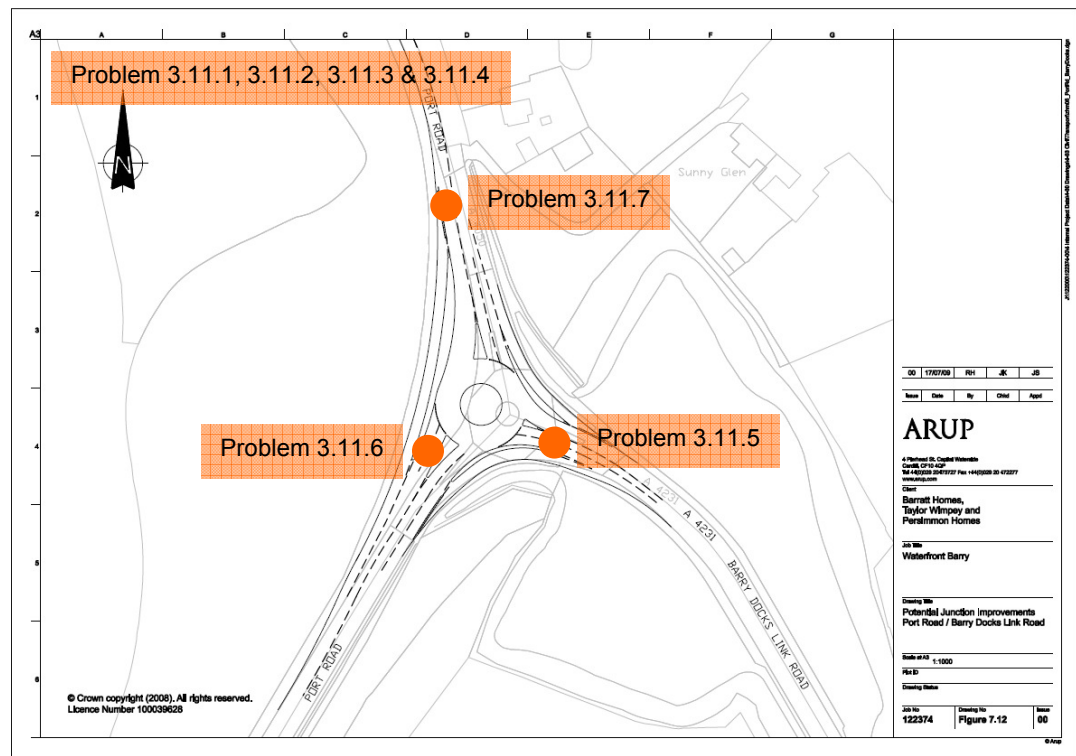
3.11 A4050 Port Road / A4231 Barry Docks Link Road (TA Junction 6, Figure 7.12)

Location Junction
Summary Poor lane development
