**Waterfront Barry, Vale
of Glamorgan**

Stage 1 Road Safety
Audit - Designer's
Response

April 2010

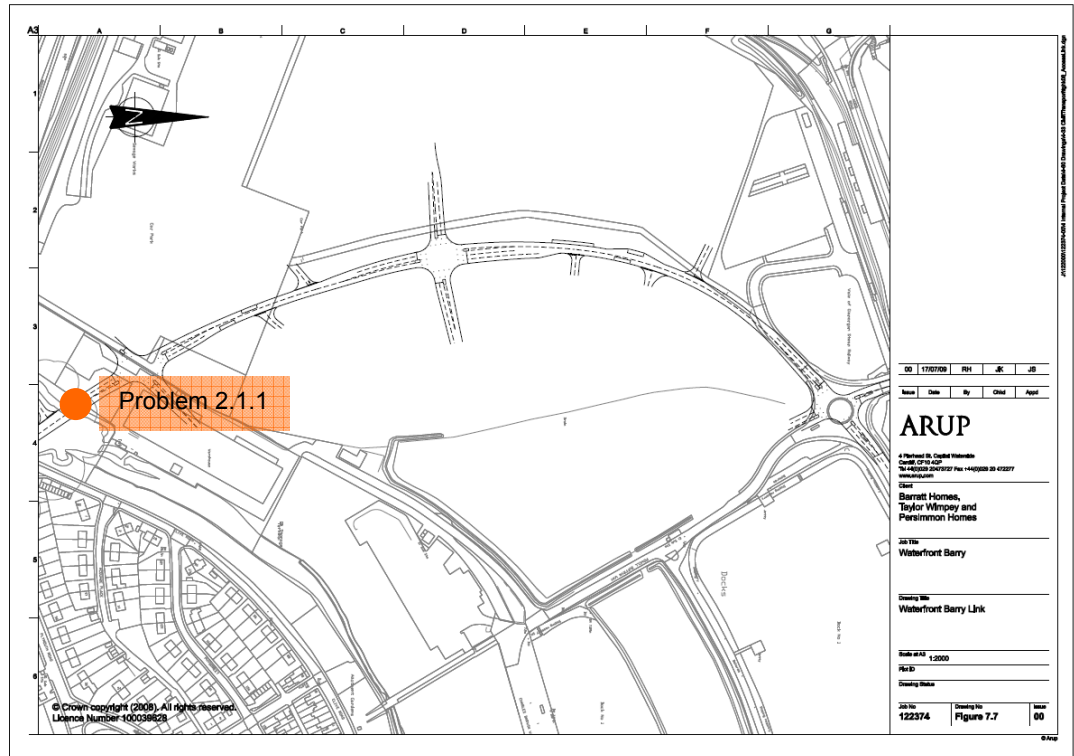
2.1 Waterfront Barry Link between Paget Road / Plymouth Road and West Pond / South Quay Junctions (TA Figure 7.7)

Location Waterfront Barry Link

Recommendation Ensure the grade does not exceed 6% (Waterfront Barry Link will be a bus route), and that vertical curves do not restrict the forward visibility of junctions.

Designer's response Agreed. This will be dealt with in detailed design.

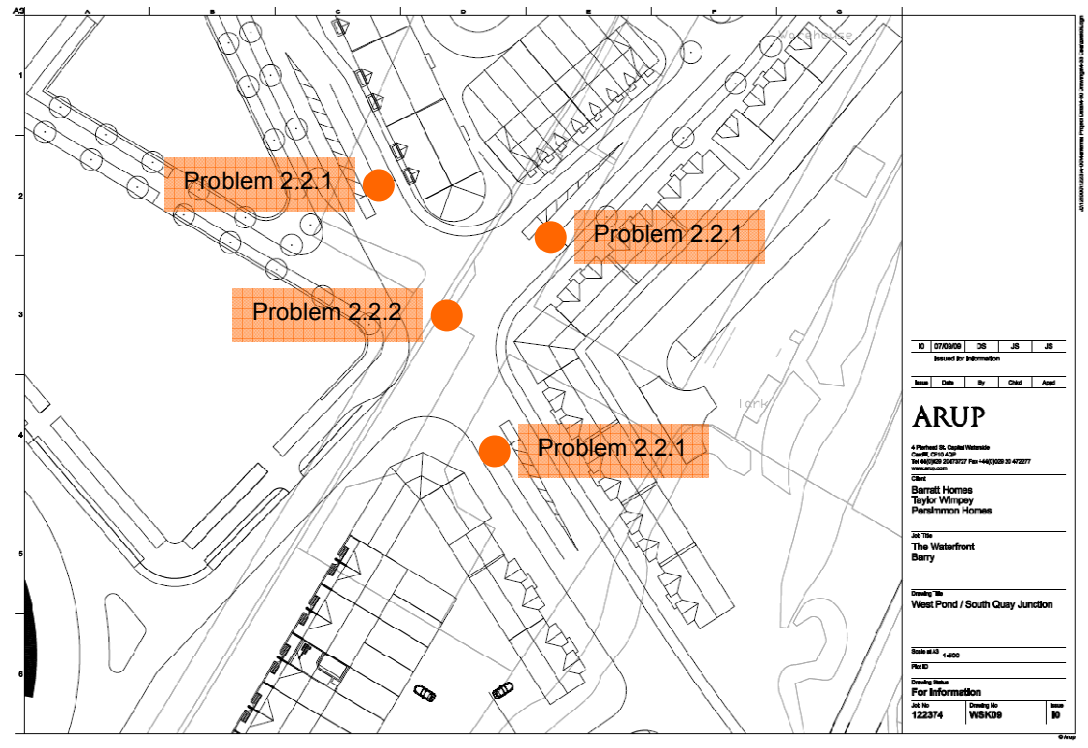
**2.2 Waterfront Barry Link / West Pond / South Quay Junction
 (TA Figure 7.7 Drawing WSK09)**

Location Junction

Recommendation Reduce the size of the junction.

Recommendation Provide additional road markings in the junction as appropriate to assist right turning drivers.

Designer's response Agreed. However, the crossing movements may need to remain on the off-side as a result of the overall development layout.

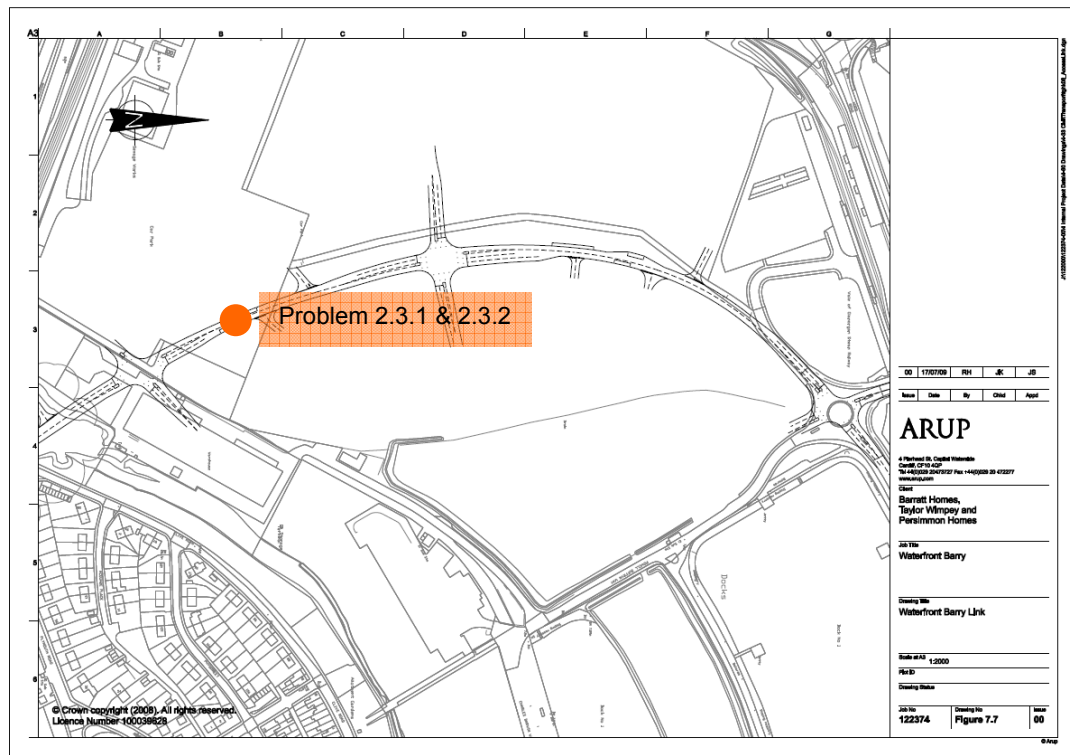
2.3 Waterfront Barry Link between West Pond / South Quay and West Pond / Supermarket junctions (TA Figure 7.7)

Location Waterfront Barry Link

Location	Waterfront Barry Link
Summary	Spacing of bus stops
Description	The eastbound and westbound bus stops provided on this section of the link road are located approximately 25 metres apart. Insufficient space between bus stops can result in traffic congestion and passing conflicts.
Recommendation	Provide a minimum tail to tail offset of 40 metres to allow traffic to safely pass a stationary vehicle.
Designer's response	This will be checked during detailed design to assess whether this degree of separation between bus stops can be achieved.

Recommendation Relocate the bus stops away from the junction.

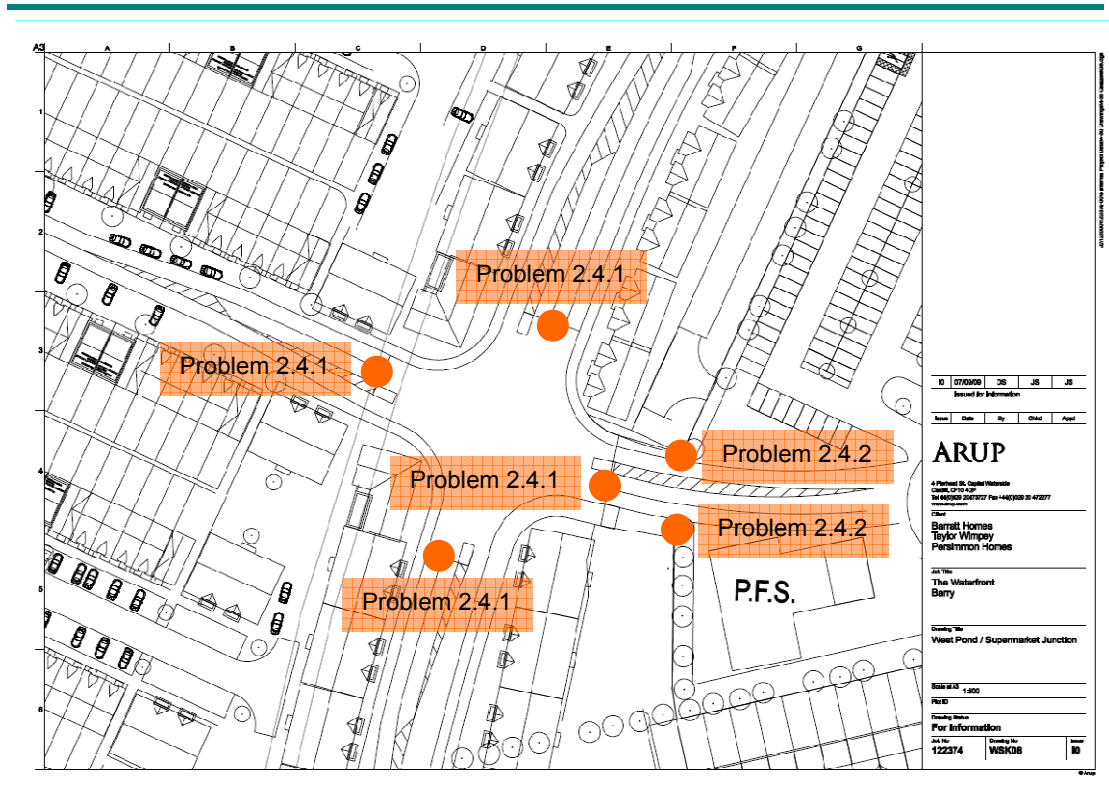
**2.4 Waterfront Barry Link / West Pond / Supermarket
 (TA Figure 7.7 , Drawing WSK08)**

Location	Junction
Summary	Stop line set back
Description	The stop lines at the proposed junction are set back a significant distance from the junction centre. As a result there is a significant distance (approximately 50m) between opposing stop lines, resulting in a large expanse of unmarked road surface. This is likely to result in large unused areas promoting the build up of detritus on the carriageway. In addition, some drivers may find the lack of direction here confusing leading to hesitancy.
Recommendation	Reduce the size of the junction.

Recommendation Ensure adequate intuitive footway links are provided to the supermarket.

Designer's response We agree that this is required. However, the area within the supermarket site will be developed by the supermarket operator and is outside the control of the highways designer.

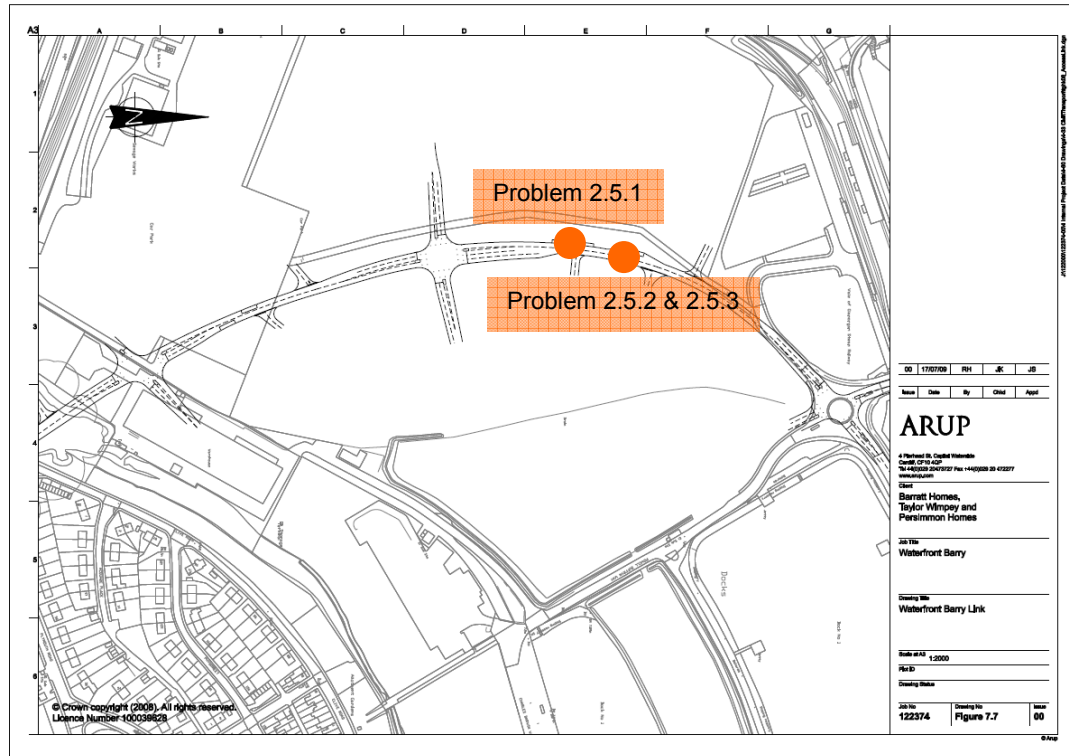
2.5 Waterfront Barry Link between West Pond / Supermarket West Pond Northern junctions (TA Figure 7.7)

Location	Waterfront Barry Link
Summary	Parking bays within a junction
Description	<p>There is a group of kerbside parking bays opposite the junction to service residential properties on the northern section of the Waterfront Barry Link.</p> <p>The parking bays on the northbound carriageway introduce an additional conflict within the junction.</p>
Recommendation	Relocate the parking area away from the junction.
Designer's response	Not agreed. The junction is a minor access into a development plot, and on-street parking is proposed as a traffic calming measure.

Location	Waterfront Barry Link
Summary	Bus stops close to a junction
Description	<p>The bus stops on the northern section of the Waterfront Barry Link are located in close proximity to two priority accesses serving residential properties and the supermarket service yard.</p> <p>The position of the southbound bus stop is within the junction visibility splay, which is likely to result in turning conflicts. Whilst the northbound bus lay-by introduces an additional conflict within the junction.</p>
Recommendation	Relocate the bus stops away from the junction.
Designer's response	Not agreed. Bus stops are required in this location to serve local needs.

Recommendation Provide a minimum offset of 40 metres to allow traffic to safely pass a stationary vehicle.

Designer's response Not agreed. There is insufficient space to provide this degree of separation. As the northbound bus stop will be positioned within a lay-by, the degree of interaction between bus stops is minimised.

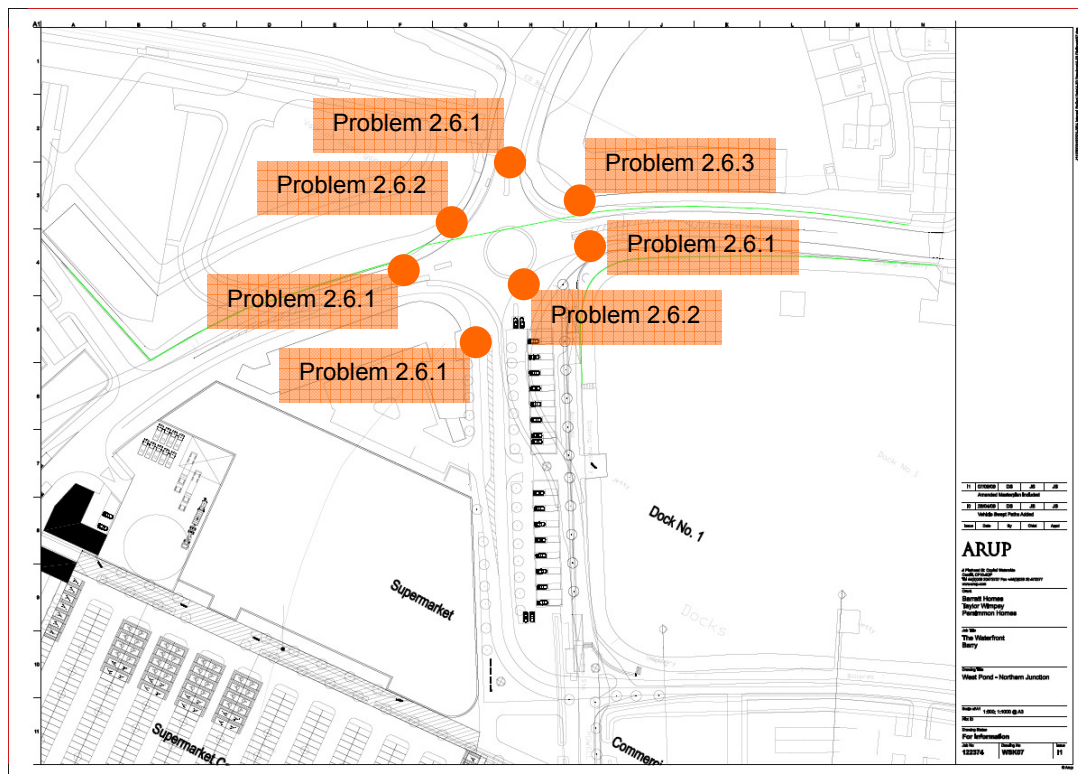
2.6 Waterfront Barry Link / West Pond Northern Junction (TA Figure 7.7 , Drawing WSK07)

Location Junction

Recommendation Reduce the size of the junction.

Recommendation Reduce the junction radii to reduce traffic speeds within the junction.

Recommendation Include measures to assist cycles at the junction.

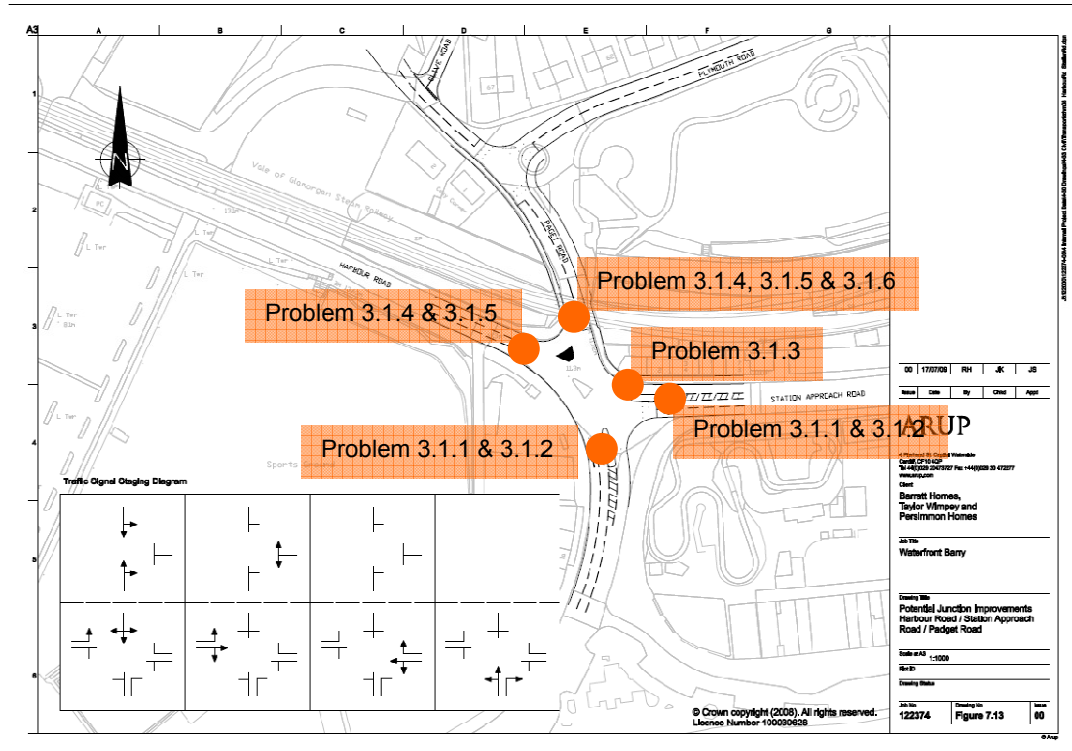
3.1 Harbour Road / Station Approach / Paget Road (TA Junction 08 Figure 7.13)

Location Station Road Approach / Harbour Road (south)

Limited crossing opportunities cause pedestrian frustration at busy times, such as the holiday season. As a result pedestrians will be likely to make crossing movements against the signals placing them at risk of injury.

This is likely to result in overrunning of the splitter island, damage to street furniture and possibly injury to pedestrians.

As a result the signals may be difficult to see, especially in bright or low winter sun conditions, leading to overrunning of the stop line.

Recommendation Provide the crossings with a left-right stagger.

Recommendation Consider an all red crossing arrangement of this junction.

Recommendation Assess the junction using AutoTrack to ensure there is adequate carriageway width for large vehicles.

- Recommendation** Provide backing boards on the traffic signal heads in order to maximise visibility.
- Designer's response** Agreed.

- Recommendation** Ensure the lane markings provided on Paget Road can accommodate buses turning from Harbour Road.
- Designer's response** Agreed.

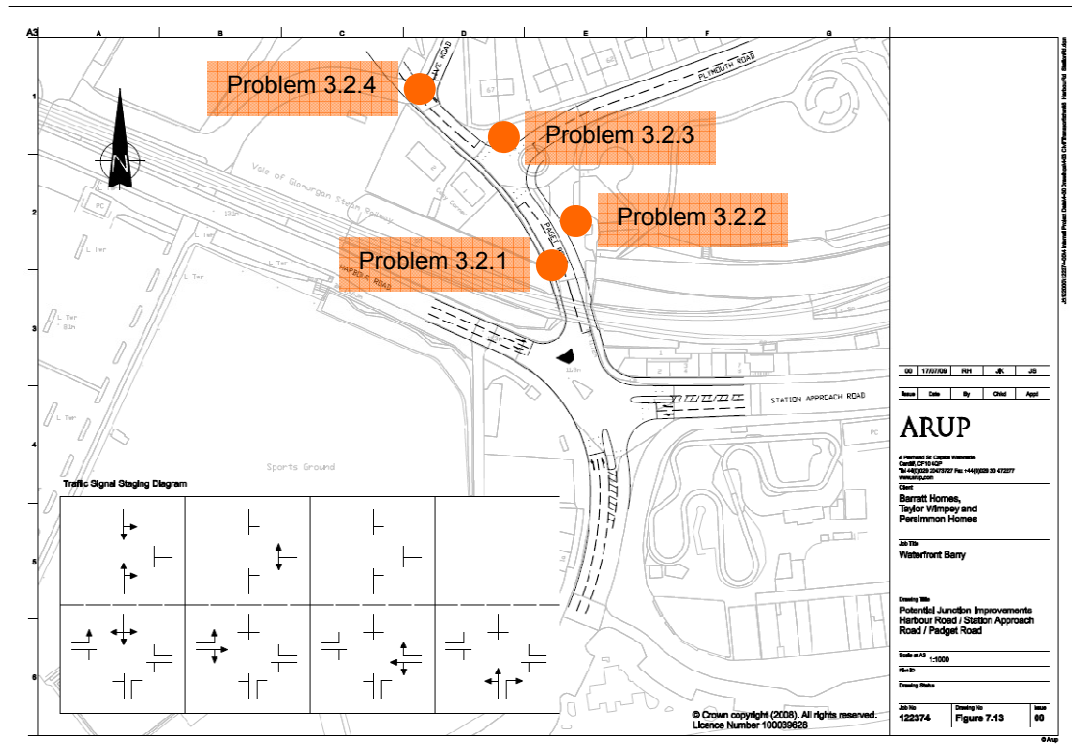
3.2 Paget Road / Plymouth Road (TA Junction 22 Figure 7.13)

Location Junction

A failure to provide for existing accesses can result in damage to footways and unexpected pedestrian vehicle conflicts.

Parking on footways causes damage leading to trips and falls. Furthermore vehicles joining the carriageway within the controlled junction are unexpected and can present a danger to other drivers.

Recommendation Provide appropriate traffic signing and/or road markings to guide visitors to the car park.

Recommendation Ensure adequate access is maintained for the park.

Recommendation Introduce deterrent measures to prevent footway parking around the junction.

Recommendation Provide speed reduction measures and high friction surfacing on the Clive Road approach to the Waterfront Barry Link

Designer's response Agreed.

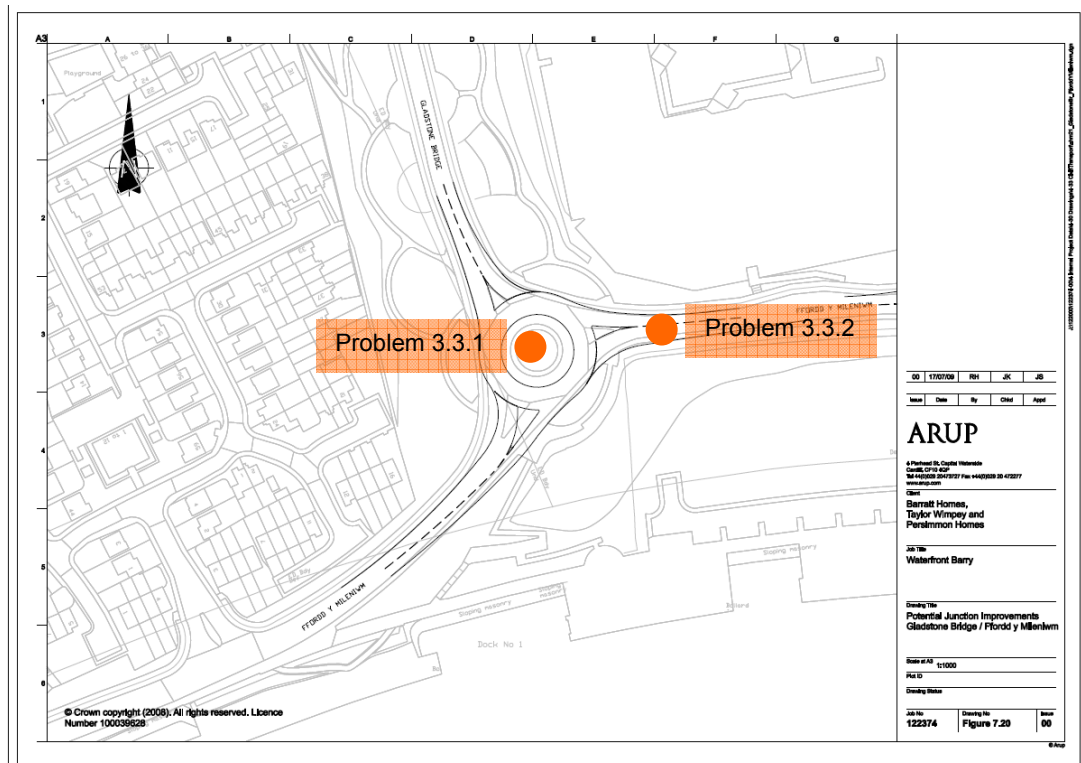
3.3 Gladstone Bridge / Ffordd y Mileniwm (TA Junction 21, Figure 7.20)

Location Junction

Excessive landscaping blocks visibility for all road users, especially pedestrians who cannot see approaching vehicles, whilst hard landscaping can present a hazard for errant vehicles.

Summary Inadequate entry deflection

Recommendation Remove the vegetation and hard landscaping.

Recommendation Alter the junction layout in order to provide sufficient entry deflection.

Designer's response Not agreed. Although there is a small increase in the approach radius, this has been checked and the radius is still less than 100m. This is within standards for the roundabout.

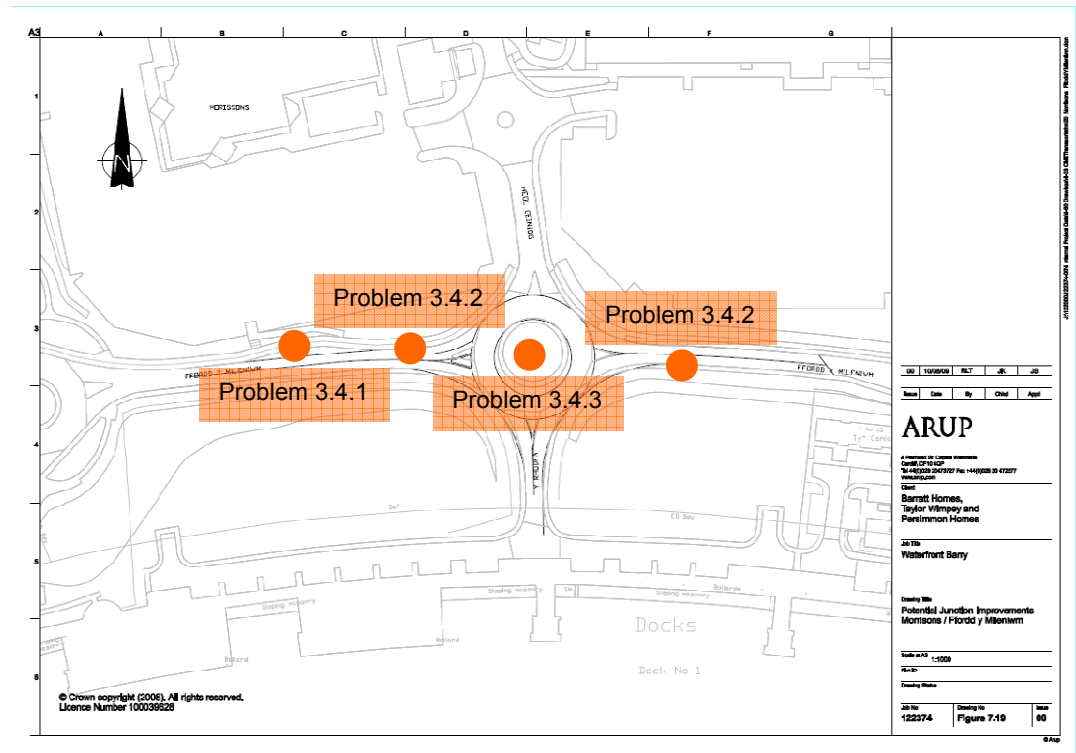
3.4 Heol Ceiniog / Ffordd y Mileniwm (TA Junction 20, Figure 7.19)

Location Ffordd y Mileniwm

Location	Ffordd y Mileniwm
Summary	Inadequate entry deflection
Description	<p>The proposed alteration to the junction layout results in an increase in the deflection radius on the approaches to the junction, particularly Ffordd y Mileniwm</p> <p>Insufficient entry deflection can lead to inappropriate entry speed into and around the junction, resulting in overrunning of the give-way lines, conflicts within the circulatory carriageway, and loss of control accidents, especially on the exit arms.</p>
Recommendation	Alter the junction layout in order to provide sufficient entry deflection.
Designer's response	There are no works now proposed to this junction.

Description	Excessive landscaping blocks visibility for all road users, especially pedestrians who cannot see approaching vehicles, whilst hard landscaping can present a hazard for errant vehicles.
Recommendation	Remove the vegetation and hard landscaping from the roundabout
Designer's response	There are no works now proposed to this junction.

Recommendation Retain the bus stop bay on Ffordd y Mileniwm.

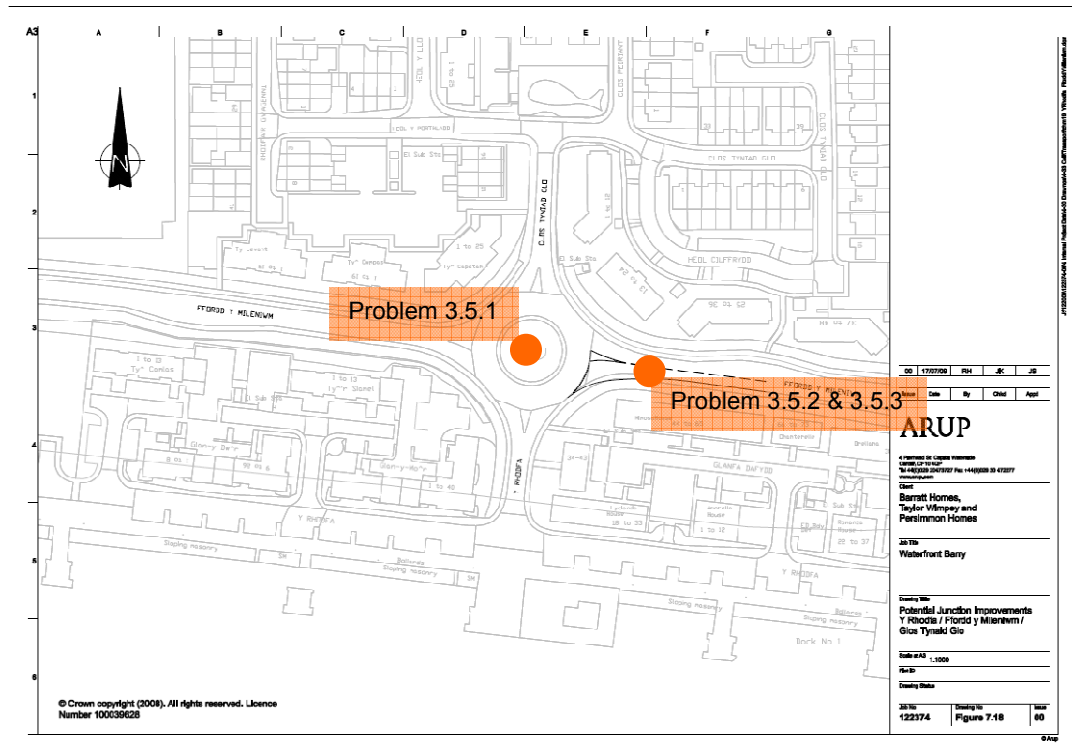
3.5 Y Rhodfa / Clos Tyniad Glo / Ffordd y Mileniwm (TA Junction 19, Figure 7.18)

Location Junction

Excessive landscaping blocks visibility for all road users, especially pedestrians who cannot see approaching vehicles, whilst hard landscaping can present a hazard for errant vehicles.

Summary Inadequate entry deflection

Recommendation Remove the vegetation and hard landscaping from the roundabout

Recommendation Review the junction layout to ensure sufficient entry deflection is provided to minimise entry speeds.

Recommendation Alter the junction layout in order to provide sufficient entry deflection.

Designer's response There are no works now proposed to this junction.

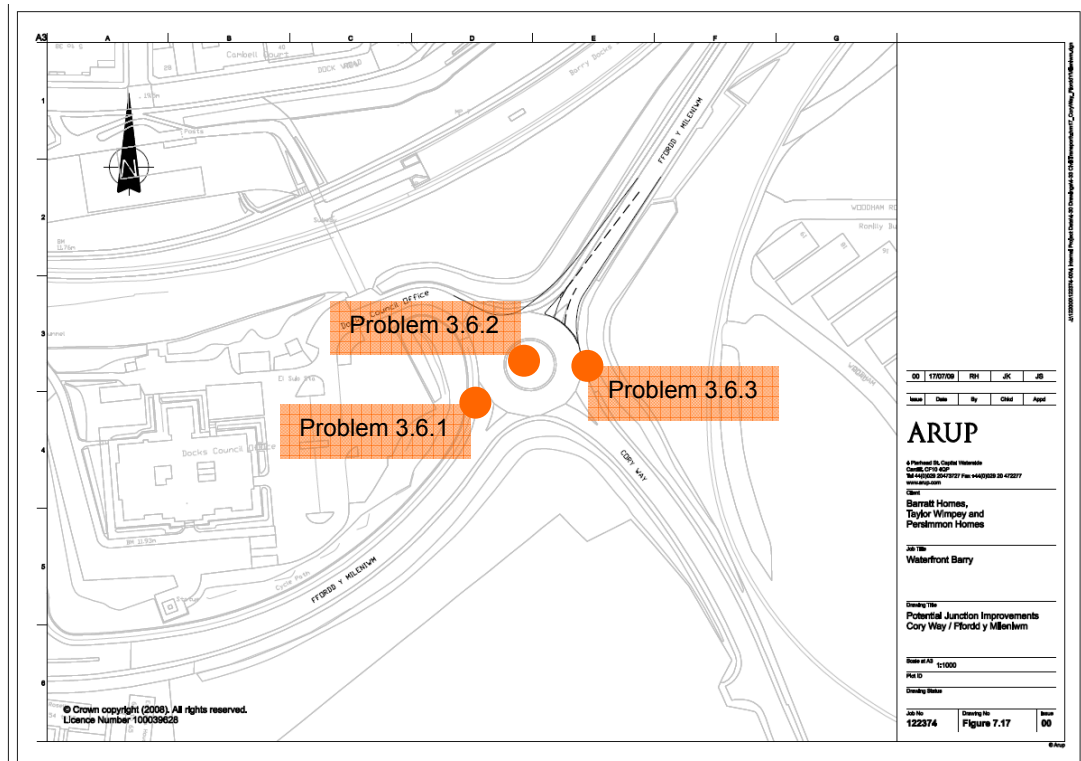
3.6 Cory Way / Ffordd y Mileniwm (TA Junction 17, Figure 7.17)

Location Ffordd y Mileniwm (northeast)

Summary Inadequate entry deflection

Summary Missing footway link

Recommendation Alter the junction layout in order to provide sufficient entry deflection.

Recommendation Remove the vegetation.

Recommendation Extend the footway on the eastern side of Cory Way to Ffordd y Mileniwm and provide an appropriate pedestrian crossing point on Ffordd y Mileniwm.

Designer's response Not agreed. There are no works now proposed to this junction. In addition, there is an adequate pedestrian crossing facility over Ffordd-y-Mileniwm on the west side of the roundabout which is considered to correctly reflect the probable pedestrian desire line.

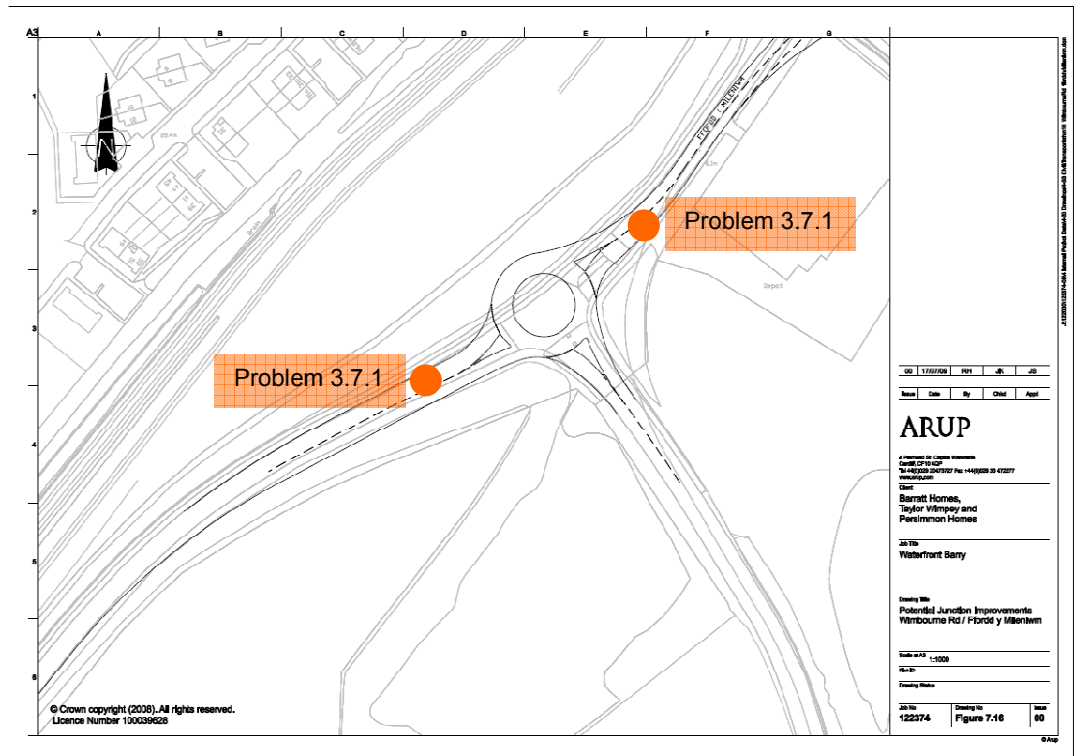
3.7 Wimbourne Road / Ffordd y Mileniwm (TA Junction 16, Figure 7.16)

Location Ffordd y Mileniwm

Recommendation Extend the 30 mph speed limit to the west of the junction and introduce speed reducing measures on Ffordd y Mileniwm on the approaches to the junction.

Designer's response Agreed.

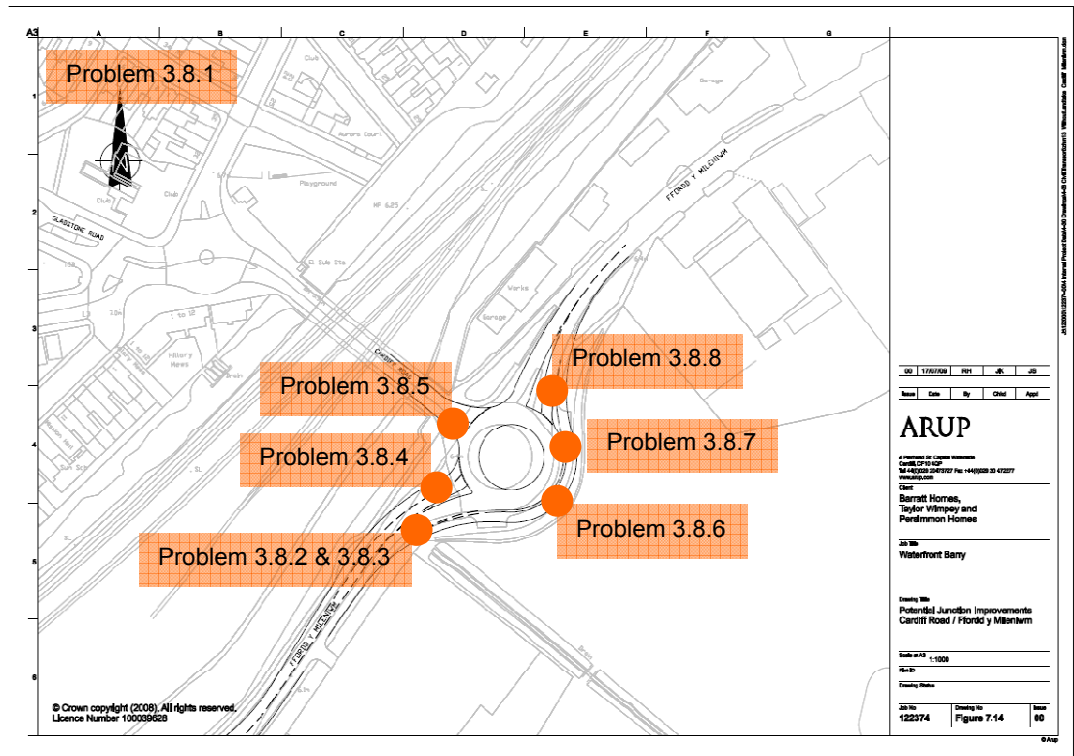
3.8 Cardiff Road / Ffordd y Mileniwm (TA Junction 13, Figure 7.14)

Summary Inadequate entry deflection

Recommendation Relocate the pedestrian route away from the merge.

Recommendation Alter the junction layout in order to provide sufficient entry deflection.

- Recommendation** Ensure the exit lane can accommodate all types of traffic.
- Designer's response** There are no works now proposed to this junction.

- Recommendation** Provide an alternative access for utilities.
- Designer's response** There are no works now proposed to this junction.

- Recommendation** Provide appropriate lane widening on tight radii to accommodate larger vehicles.

Recommendation Ensure there is an appropriately sized refuge between the traffic streams at the crossing, and that pedestrians are aware of the road layout.

Designer's response There are no works now proposed to this junction.

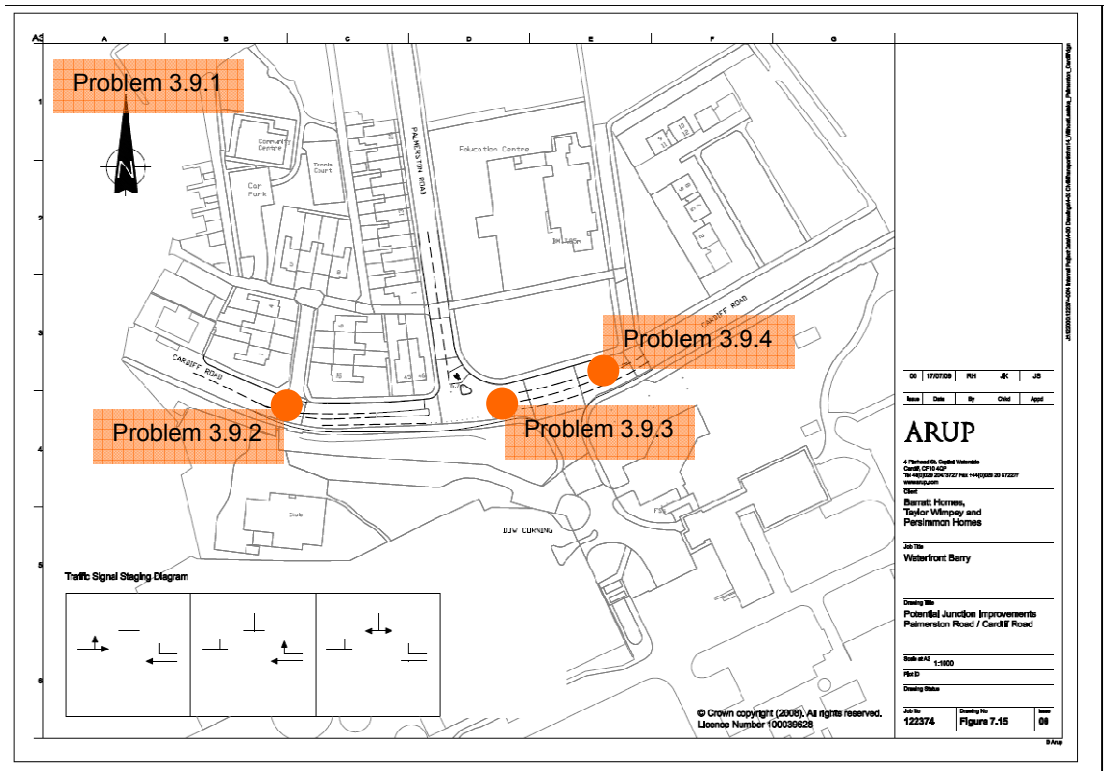
3.9 Cardiff Road / Palmerston Road (TA Junction 14, Figure 7.15)

Location Cardiff Road

Recommendation Replace the cycle stop lines.

Recommendation Alter the proposed road layout in order to provide a right turning pocket for Edmund Place.

Designer's response There are no works now proposed to this junction.

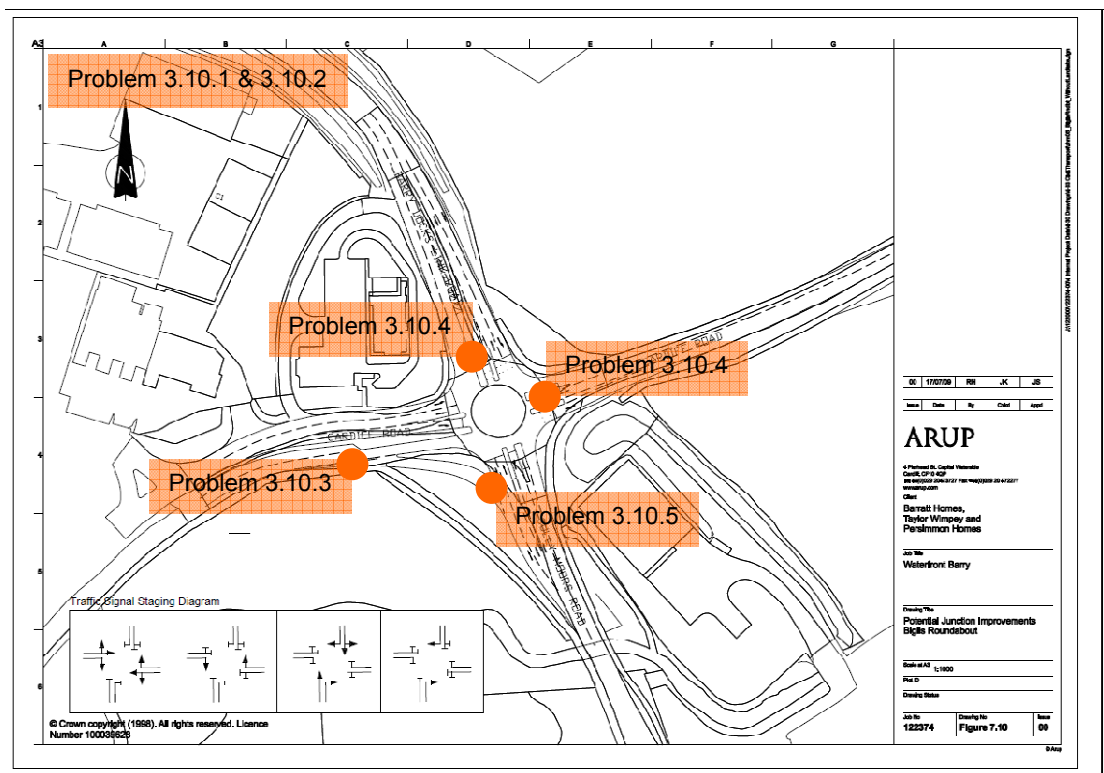
3.10 Sully Moors Road / Cardiff Road / A4231 Barry Docks Link Road (TA Junction 5, Figure 7.10)

Location	Junction
Summary	Provision for cycles
Description	<p>The proposed junction makes no provision for cyclists but it is located on National Cycle Route 88.</p> <p>Cyclists are particularly vulnerable to side swipes at junctions and could be struck while crossing at splitter islands not specifically designed to accommodate them.</p>
Recommendation	Include measures to assist cycles at the junction.
Designer's response	There are now no works proposed at this junction.

Designer's response There are now no works proposed at this junction.

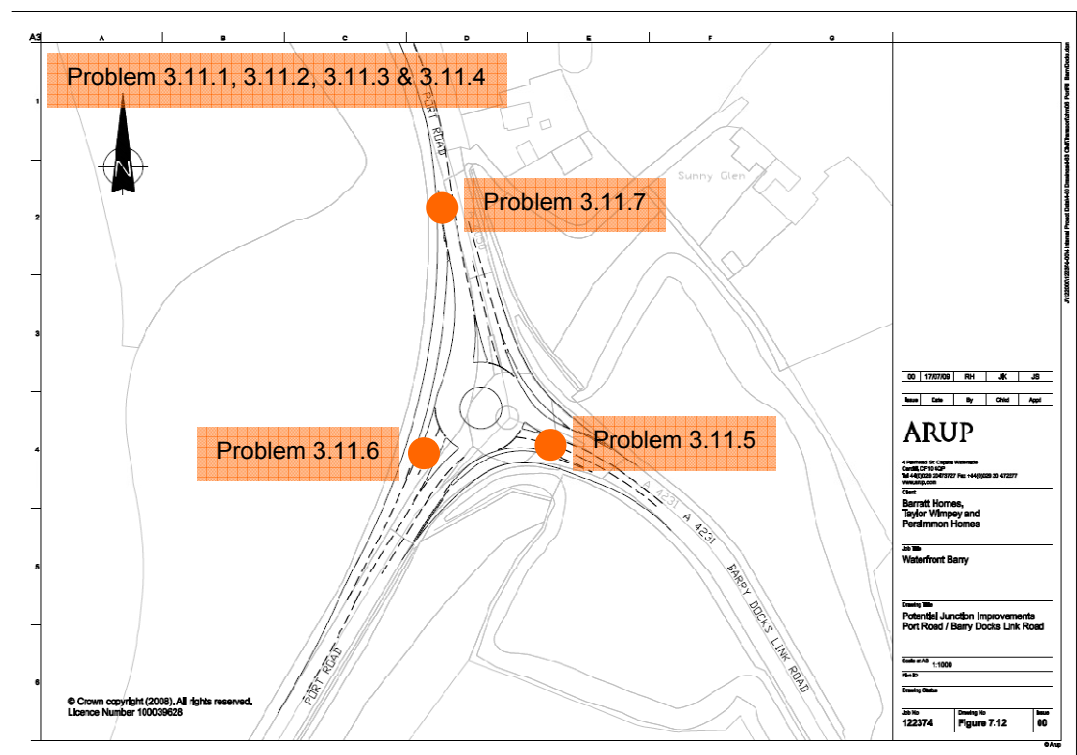
3.11 A4050 Port Road / A4231 Barry Docks Link Road (TA Junction 6, Figure 7.12)

Location	Junction
Summary	Poor lane development
Description	<p>It is not immediately clear from the proposal how the multiple lane approaches for the roundabout or the slip lanes are developed from the single lane approaches.</p> <p>Multiple lane development from a single lane approach can be confusing for drivers leading to late lane changing resulting in side swipes and rear end shunts due to late braking.</p>
Recommendation	Ensure lane development at each arm of the junction is clear and consistent to avoid confusion and reduce late lane changing on the approaches to the roundabout.
Designer's response	Agreed. The roundabout has been altered since the audit, but this issue will be dealt with during detailed design.
