11 April 2014

**Hayes Point, Sully:  
Preliminary assessment of trees near the former mortuary building.**

SITE **Hayes Point, Sully:  
 Former mortuary building**

DRAWING TITLE  
**Tree Location Pla  
 (preliminary tree assessment)**

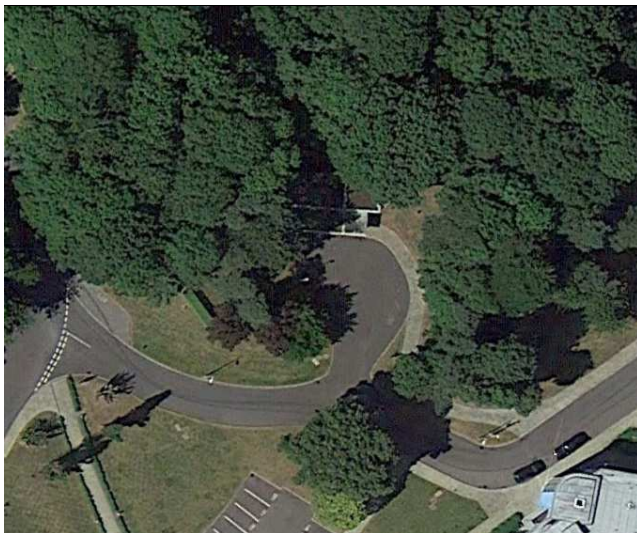
1- Satellite image

As can be seen in the images below, the building is currently largely surrounded by trees and some clearance is likely to be essential in order to create appropriate surroundings for a dwelling.

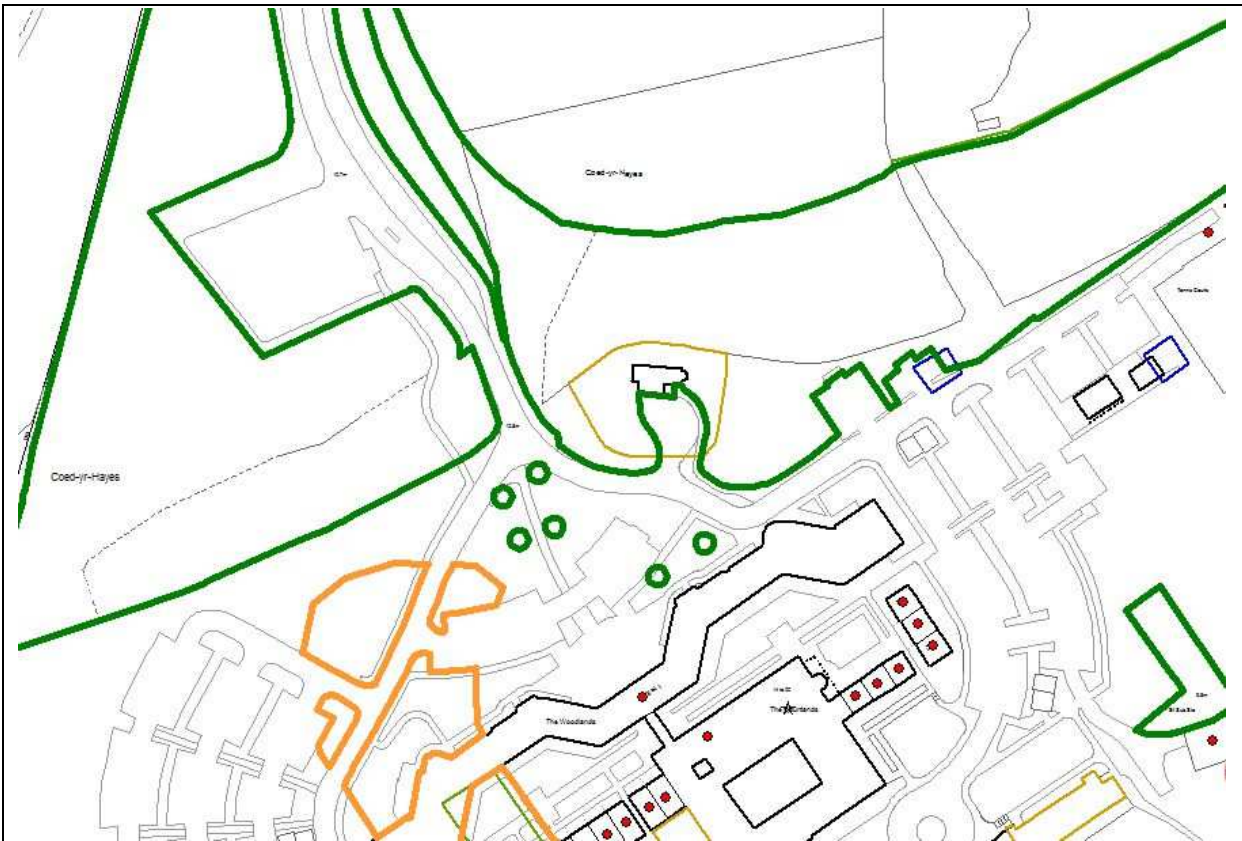
The image below is a screen-shot provided by the Vale of Glamorgan Council indicating Tree Preservation Orders outlined in green.

It will be seen that all of the trees included in this report are within an area that is presumed to be designated as an Area or Woodland under the TPO. At the time of writing I have no information on the details of the schedule and so cannot be specific about which trees are included but until further information is available it should be assumed that *all* of the trees discussed are protected.
