TARGET NOTES FOR DAY-TIME INSPECTION, 03 JULY 2015

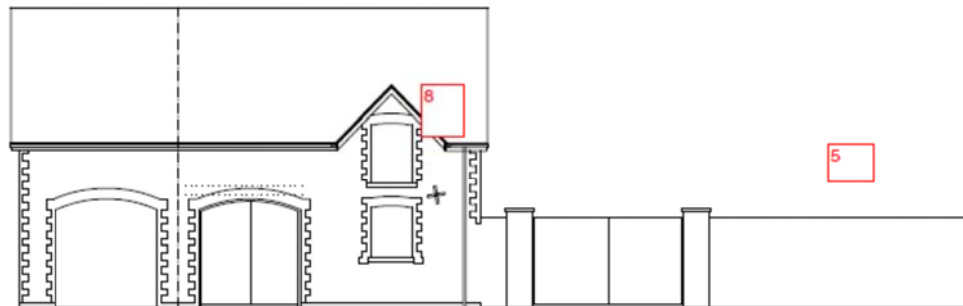
LANE ELEVATION

Target Note	Description/Comment
	timber or wall below.
Note 8	<p>Lane elevation (north). Numerous gaps at eaves and top of 1st floor window (Plate 6) – both windows boarded. No evidence on boarding or walls below the gaps around the windows or eaves. Old nest material noted in the hole to the top right corner of the first floor window.</p> <p>Gap at top of garage door provides possible access to interior but no droppings on the door and none noted inside the building (see above).</p>
	Overall no evidence of use by bats and building considered of Negligible/Low potential.
