TARGET NOTES FOR DAY-TIME INSPECTION, 03 JULY 2015

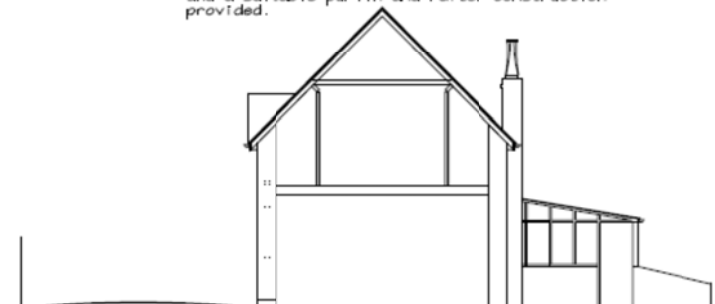
LANE ELEVATION

Structural Engineer's Recommendations
4.4 ~ The roof structure is unstable and requires
replacement. The structure should be reconfigured
and a suitable purlin and rafter construction
provided.
