Bryneithen, Dinas Powys BS5837 2012 Tree Information

Mr D Loosemore

Bryneithen
St Andrew's Road
Dinas Powys

Data Sheets - site survey carried out January 2015

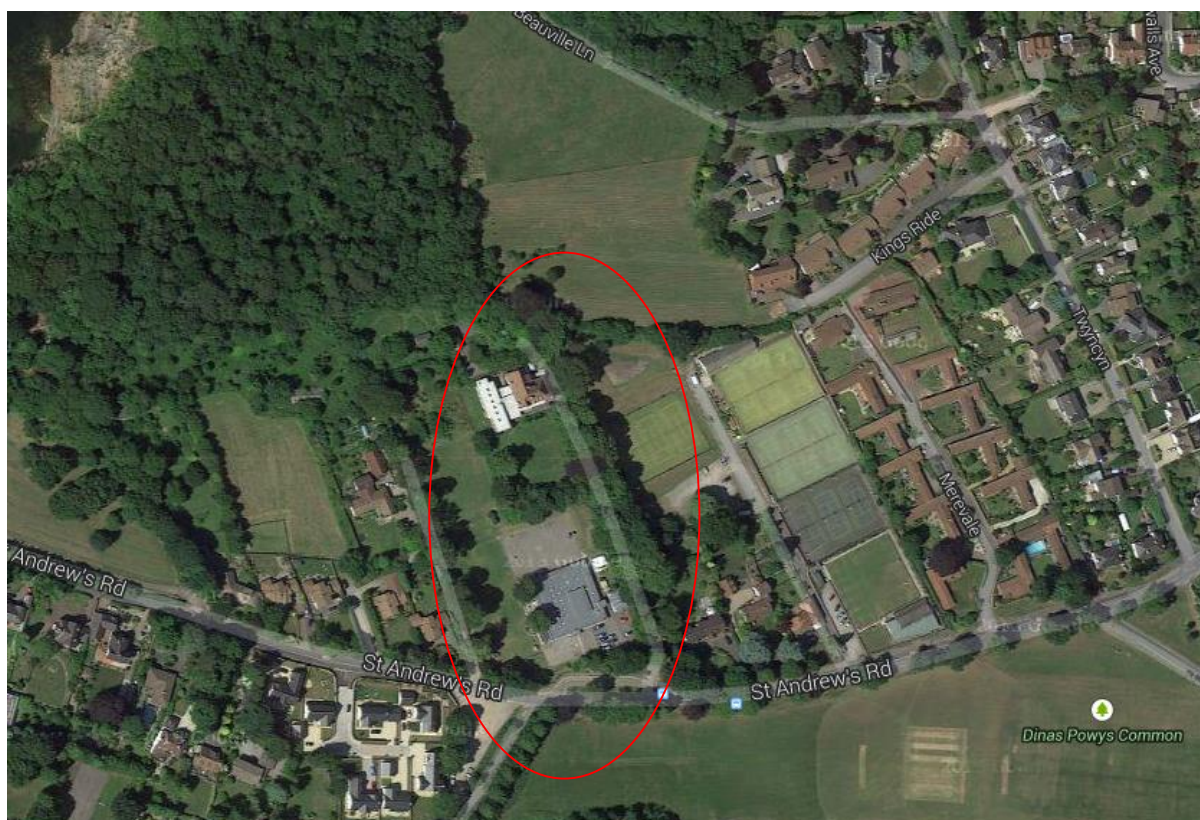
Site Location/descriptions

- I accessed the site on foot from St Andrews Road.
- The site previously had a building present which has now been removed.
- Trees are present all around the site both as woodland groups and individual specimens. This document focuses on trees that are potentially affected by development.
- Private domestic gardens adjoin the site perimeters to the east along with the tennis club. A school lies to the west with farm land to the north.
- Some management recommendations have been made regarding trees due defects that require management (tree surgery).
- Several significant defects were noted within the trees assessed within this document but the retention of these tree is worthwhile within the groups as ecological habitat features.
- The site has only one access and significant steps will need to be taken to prevent damage to existing trees and rooting systems.
