# **Sully Sports and Social Club** Geo-environmental Interpretative Report

St. Modwen Homes Limited

October 2014

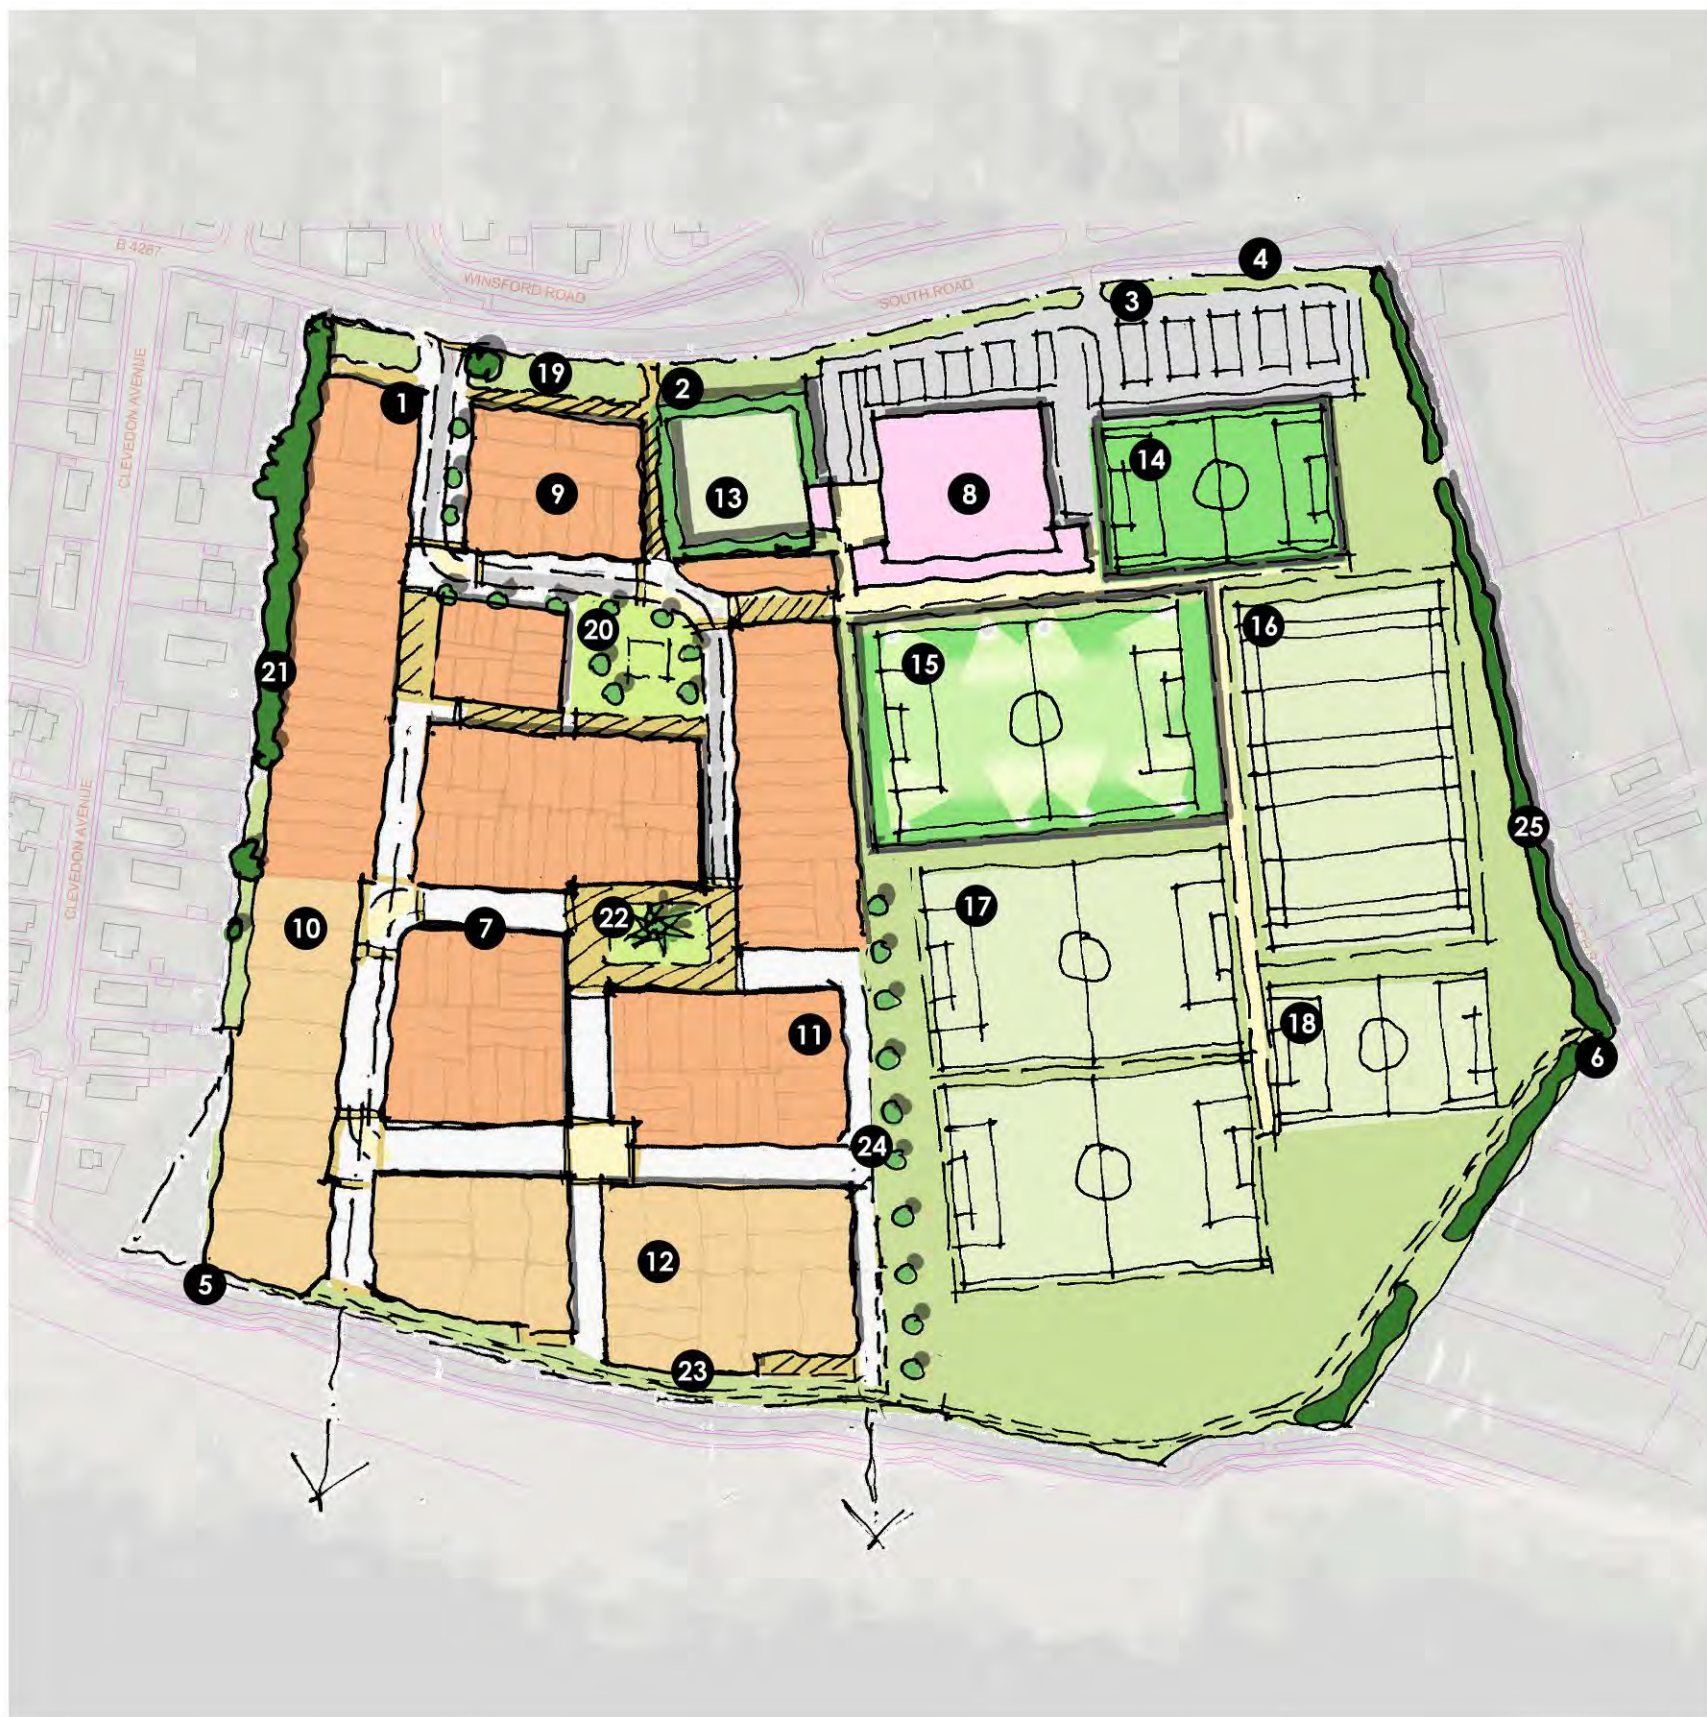
Pad Design Drawing No. 13162/3007 – Concept Master Plan

## Access

- 1: Vehicular access from South Road to residential area re-using existing access with long range view to coast
- 2: Pedestrian/cycle connection and potential emergency access
- 3: Vehicular access to Sully Sports and Leisure Club car parking
- 4: Existing bus stops on South Road
- 5: Public Right of Way access from coastal footpath alongside housing to west
- 6: Public Right of Way access from Beach Road to coastal footpath alongside caravan park
- 7: Potential for vehicular loop within residential area with highway deflections to help create a low speed environment
