## Land off Sandy Lane, Ystradgwyn, Cowbridge

### SAB COMPLIANCE STRATEGY

Document ref no. 19351-R-601-SAB COMPLIANCE STRATEGY

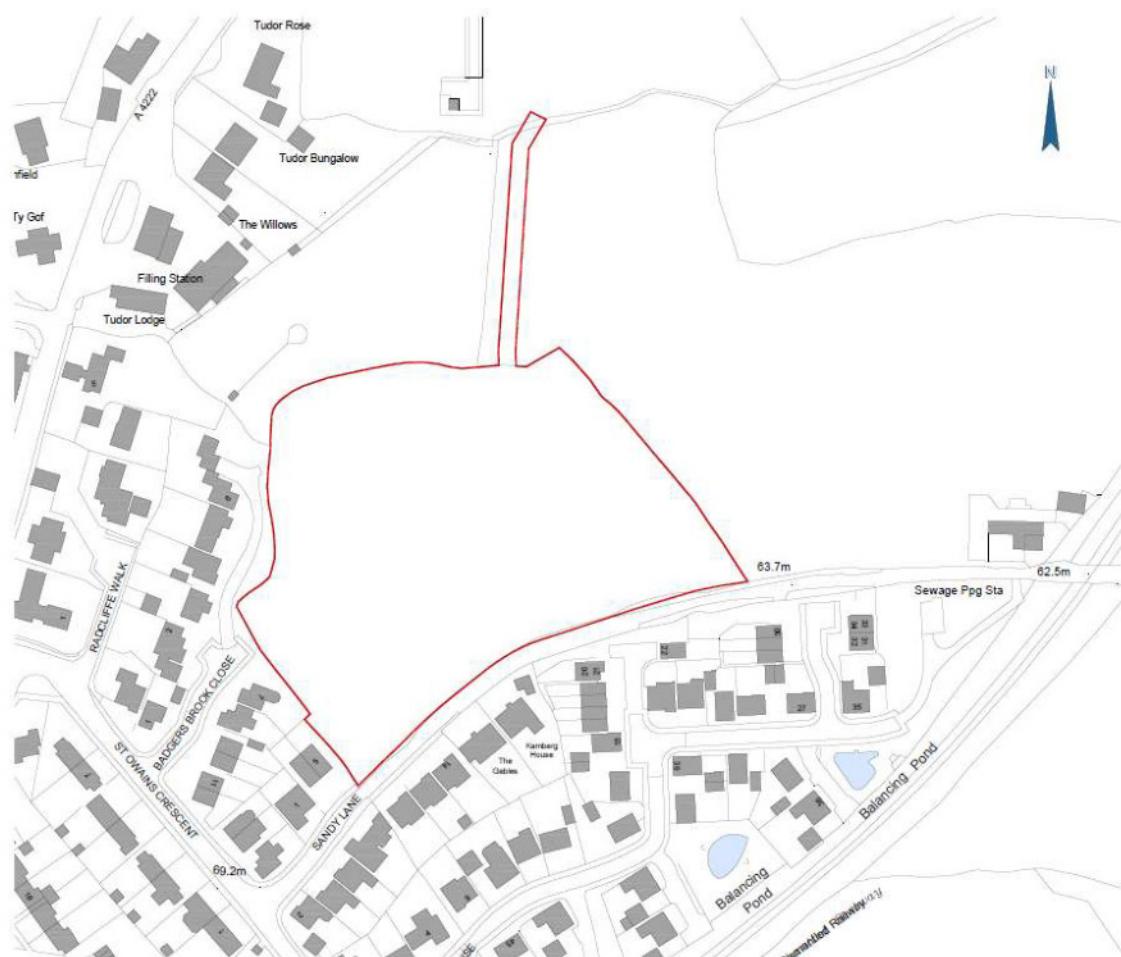
Figure 1 – Site Location Plan and Application Boundary

- 2.1 The site is located on Sandy Lane in Ystradown, located in the Vale of Glamorgan. Approximately 3 miles north of Cowbridge nearest post code is CF71 7TZ, site coordinates E:301551, N:177865.
- 2.2 The existing site topography (Appendix 1) falls in a northerly direction. The site is currently open green space and is bounded to the north and east by greenfield areas. Sandy Lane and existing residential development to the south and Badgers Brook close with existing residential development to the west. The A4222 (Cowbridge Road) is located circa 90m to the north and west.
- 2.3 The redline land parcel site boundary is 1.58ha (Application Boundary 1.63ha)

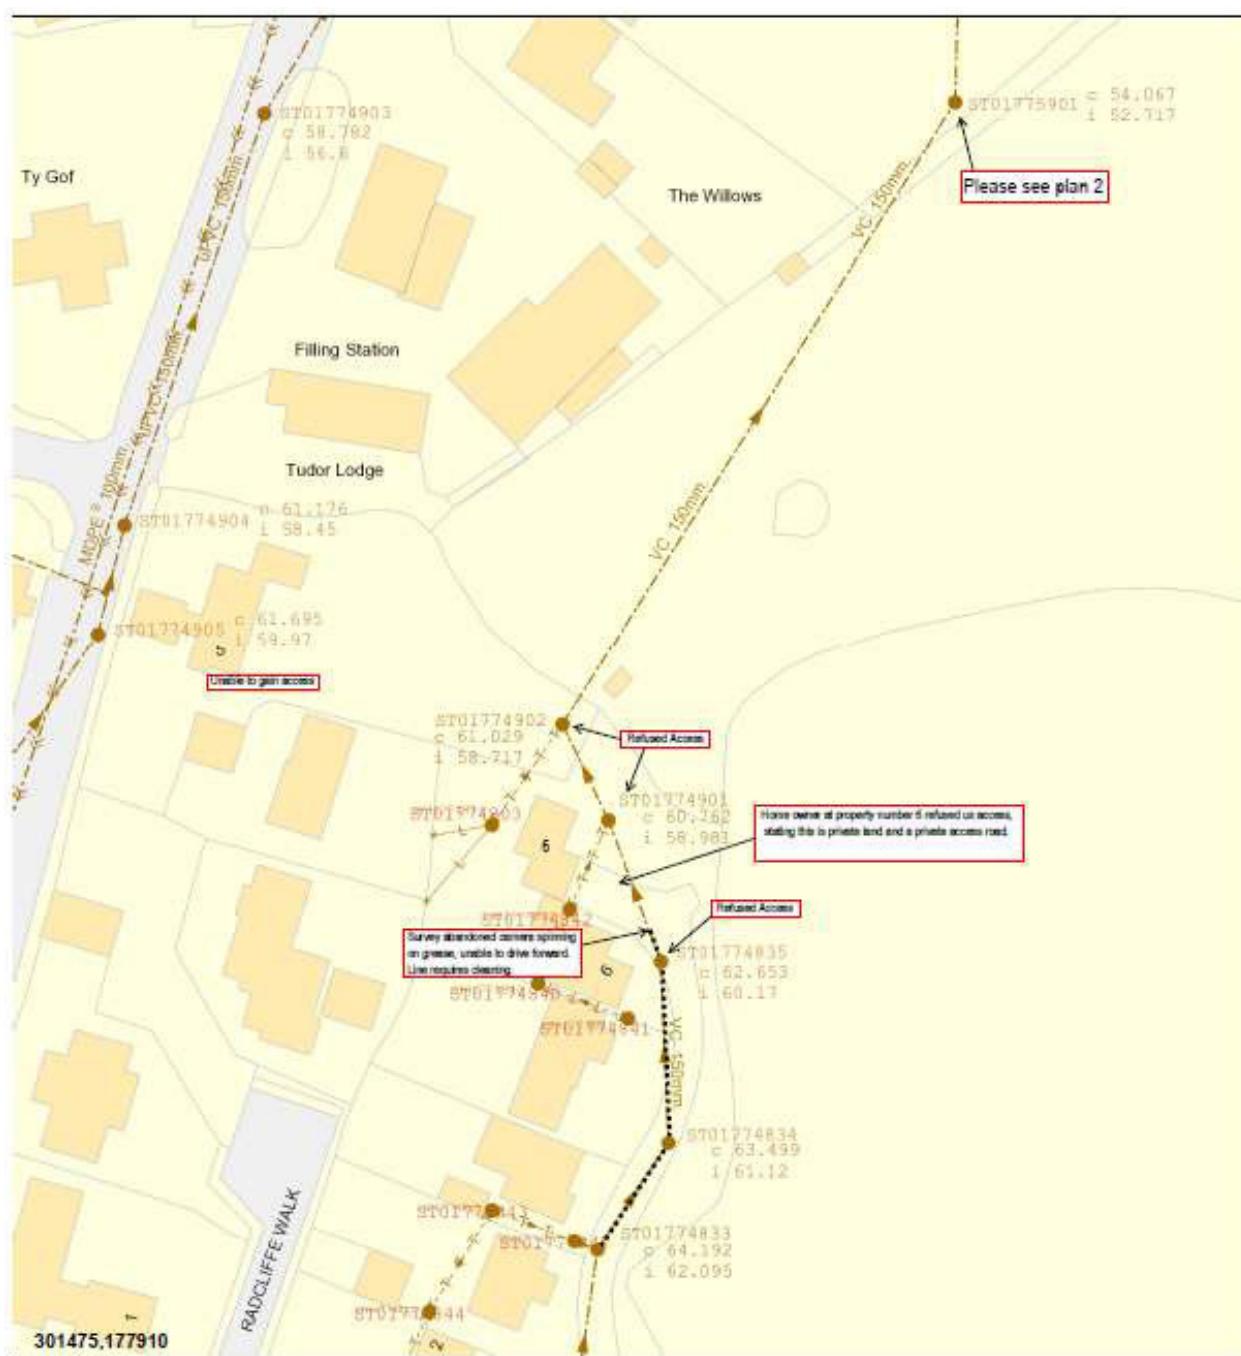
**APPENDIX 2 – EXISTING DRAINAGE SURVEY**

Draintech Surveys Ltd  
Job / Plan Ref : 14177 - 01 - 001

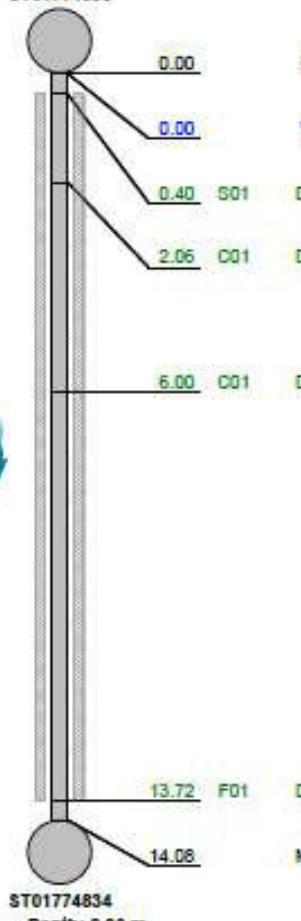
Draintech Surveys Ltd Atlantic House, Charlwood park, CF31 3PL									
<b>Section Inspection - 21/03/2022 - ST01774833X</b>											
<b>Item No.</b>	<b>Insp. No.</b>	<b>Date</b>	<b>Time</b>	<b>Client's Job Ref</b>	<b>Weather</b>	<b>Pre Cleaned</b>	<b>PLR</b>				
1	1	21/03/22	10:05	Not Specified	No Rain Or Snow	No	ST01774833X				
Operator	M.COX	Vehicle	YXH	Camera	Preset Length	Legal Status	Alternative ID				
				Ipek	Not Specified	Public Sewer	Not Specified				
Town or Village:	Ystradownen		Inspection Direction:	Downstream	Upstream Node:	ST01774833					
Road:	Off Sandy Lane		Inspected Length:	14.08 m	Upstream Pipe Depth:	2.370 m					
Location:	Road		Total Length:	14.08 m	Downstream Node:	ST01774834					
Surface Type:			Joint Length:		Downstream Pipe Depth:	2.300 m					
Use:	Foul			Pipe Shape:	Circular						
Type of Pipe:	Gravity drain/sewer			Dia/Height:	150 mm						
Flow Control:	No flow control			Material:	Vitrified clay

Year Constructed:	Not Specified			Lining Type:	No Lining						
Inspection Purpose:	Investment planning			Lining Material:	No Lining						
Comments:											
Recommendations:											
Scale:	1:122	Position [m]	Code	Observation	MPEG	Photo	Grade				
Depth: 2.37 m											
ST01774833

0.00	MH	Start node type, manhole, reference number: ST01774833			00:00:07						
0.00	WL	Water level, 5% of the vertical dimension			00:00:08						
0.40	S01	DEG	Attached deposits, grease from 7 o'clock to 5 o'clock, 5% cross-sectional area loss, start: Patchy			00:00:13

2.06	C01	DEG	Attached deposits, grease from 7 o'clock to 5 o'clock, 10% cross-sectional area loss, change: Patchy			00:01:09					
6.00	C01	DEG	Attached deposits, grease from 7 o'clock to 5 o'clock, 5% cross-sectional area loss, change: Patchy

13.72	F01	DEG	Attached deposits, grease from 7 o'clock to 5 o'clock, 5% cross-sectional area loss, finish: Patchy			3					
14.08	MHF	Finish node type, manhole, reference number: ST01774834			00:01:35						
Depth: 2.30 m											
Construction Features					Miscellaneous Features						
Structural Defects					Service & Operational Observations						
STR No.	Def.	STR Peak	STR Mean	STR Total	STR Grade	SER No.	Def.	SER Peak	SER Mean	SER Total	SER Grade
0		0.0	0.0	0.0	1.0	1		4.0	4.0	56.0	4.0

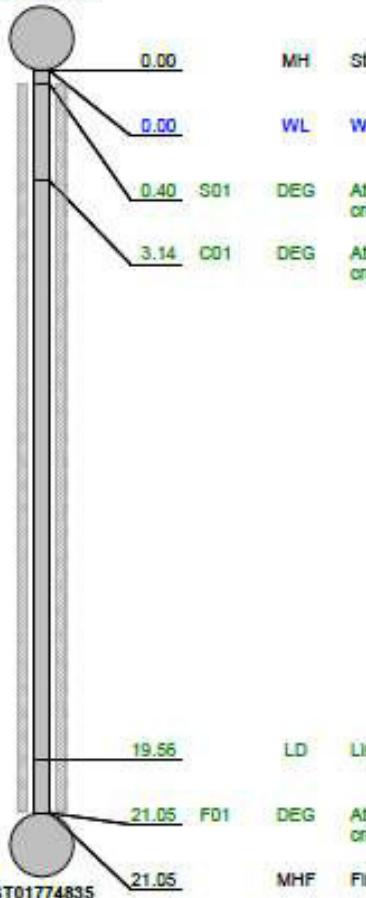
Draintech Surveys Ltd Atlantic House, Chamwood park, CF31 3PL			
<b>Section Inspection - 21/03/2022 - ST01774834X</b>											
Item No.	Insp. No.	Date	Time	Client's Job Ref	Weather	Pre Cleaned	PLR				
2	1	21/03/22	10:14	Not Specified	No Rain Or Snow	No	ST01774834X				
Operator	Vehicle			Camera	Preset Length	Legal Status	Alternative ID				
M.COX	YXH			Ipek	Not Specified	Public Sewer	Not Specified				
Town or Village:	Ystradoden	Inspection Direction:	Downstream	Upstream Node:	ST01774834						
Road:	Off Sandy Lane	Inspected Length:	21.05 m	Upstream Pipe Depth:	2.300 m						
Location:	Road	Total Length:	21.05 m	Downstream Node:	ST01774835						
Surface Type:		Joint Length:		Downstream Pipe Depth:							
Use:	Foul	Pipe Shape:	Circular								
Type of Pipe:	Gravity drain/sewer	Dia/Height:	150 mm								
Flow Control:	No flow control	Material:	Vitrified clay								
Year Constructed:	Not Specified	Lining Type:	No Lining

Inspection Purpose:	Investigation planning	Lining Material:	No Lining								
Comments:	Private, refused access										
Recommendations:											
Scale:	1:183	Position [m]	Code	Observation	MPEG	Photo	Grade				
Depth: 2.30 m											
ST01774834

0.00	MH	Start node type, manhole, reference number: ST01774834 00:00:05									
0.00	WL	Water level, 5% of the vertical dimension 00:00:06									
0.40	S01	DEG	Attached deposits, grease from 7 o'clock to 5 o'clock, 5% cross-sectional area loss, start: Patchy 00:00:12

3.14	C01	DEG	Attached deposits, grease from 7 o'clock to 5 o'clock, 10% cross-sectional area loss, change: Patchy 00:00:37								
19.56	LD	Line deviates down: Slight 00:06:46

21.05	FD1	DEG	Attached deposits, grease from 7 o'clock to 5 o'clock, 10% cross-sectional area loss, finish: Patchy 00:07:14								
21.05	MHF	Finish node type, manhole, reference number: ST01774835 00:07:15									
Construction Features					Miscellaneous Features						
Structural Defects					Service & Operational Observations						
STR No.	Def	STR Peak	STR Mean	STR Total	STR Grade	SER No.	Def	SER Peak	SER Mean	SER Total	SER Grade
0		0.0	0.0	0.0	1.0	1		4.0	4.0	84.0	4.0

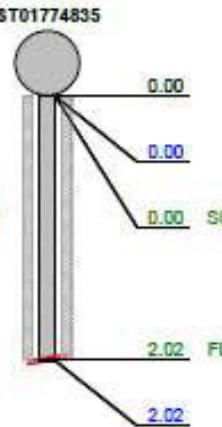
Item No.	Insp. No.	Date	Time	Client's Job Ref	Weather	Pre Cleaned	PLR				
3	1	21/03/22	10:35	Not Specified	No Rain Or Snow	No	ST01774835X				
Operator	M.COX	Vehicle	YXH	Camera	Preset Length	Legal Status	Alternative ID				
				Ipek	Not Specified	Public Sewer	Not Specified				
Town or Village:	Ystradownen	Inspection Direction:	Downstream	Upstream Node:	ST01774835						
Road:	Off Sandy Lane	Inspected Length:	2.02 m	Upstream Pipe Depth:							
Location:	Road	Total Length:	2.02 m	Downstream Node:	ST01774901						
Surface Type:		Joint Length:		Downstream Pipe Depth:							
Use:	Foul	Pipe Shape:	Circular								
Type of Pipe:	Gravity drain/sewer	Dia/Height:	150 mm								
Flow Control:	No flow control	Material:	Vitrified clay								
Year Constructed:	Not Specified	Lining Type:	No Lining								
Inspection Purpose:	Investment planning	Lining Material:	No Lining								
Comments:	No Manhole Depths - Private - Refused access

Recommendations:											
Scale:	1:50	Position [m]	Code	Observation	MPEG	Photo	Grade				
Depth: m

ST01774835											
0.00 MH Start node type, manhole, reference number: ST01774835 00:00:05 0.00 WL Water level, 5% of the vertical dimension 00:00:06 0.00 S01 DEG Attached deposits, grease from 7 o'clock to 5 o'clock, 10% cross-sectional area loss, start: Patchy 00:00:10  2.02 F01 DEG Attached deposits, grease from 7 o'clock to 5 o'clock, 10% cross-sectional area loss, finish: Patchy 00:02:50 3  2.02 SA Survey abandoned: Line needs cleaning - Spinning on grease 00:02:52 1											
<b>Construction Features</b> <b>Structural Defects</b>					<b>Miscellaneous Features</b> <b>Service &amp; Operational Observations</b>						
STR No.	Def	STR Peak	STR Mean	STR Total	STR Grade	SER No.	Def	SER Peak	SER Mean	SER Total	SER Grade
0		0.0	0.0	0.0	1.0	1		4.0	5.9	12.0	5.0

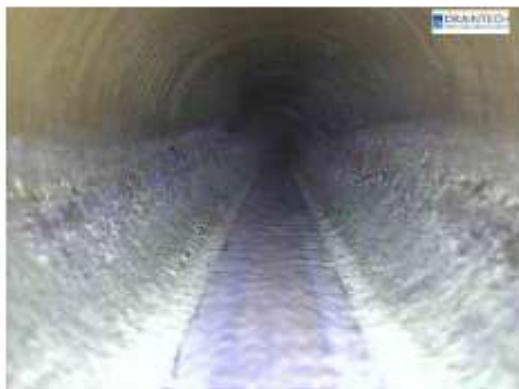
1, 00:02:52, 2.02 m

Survey abandoned, Line needs cleaning - Spinning on grease

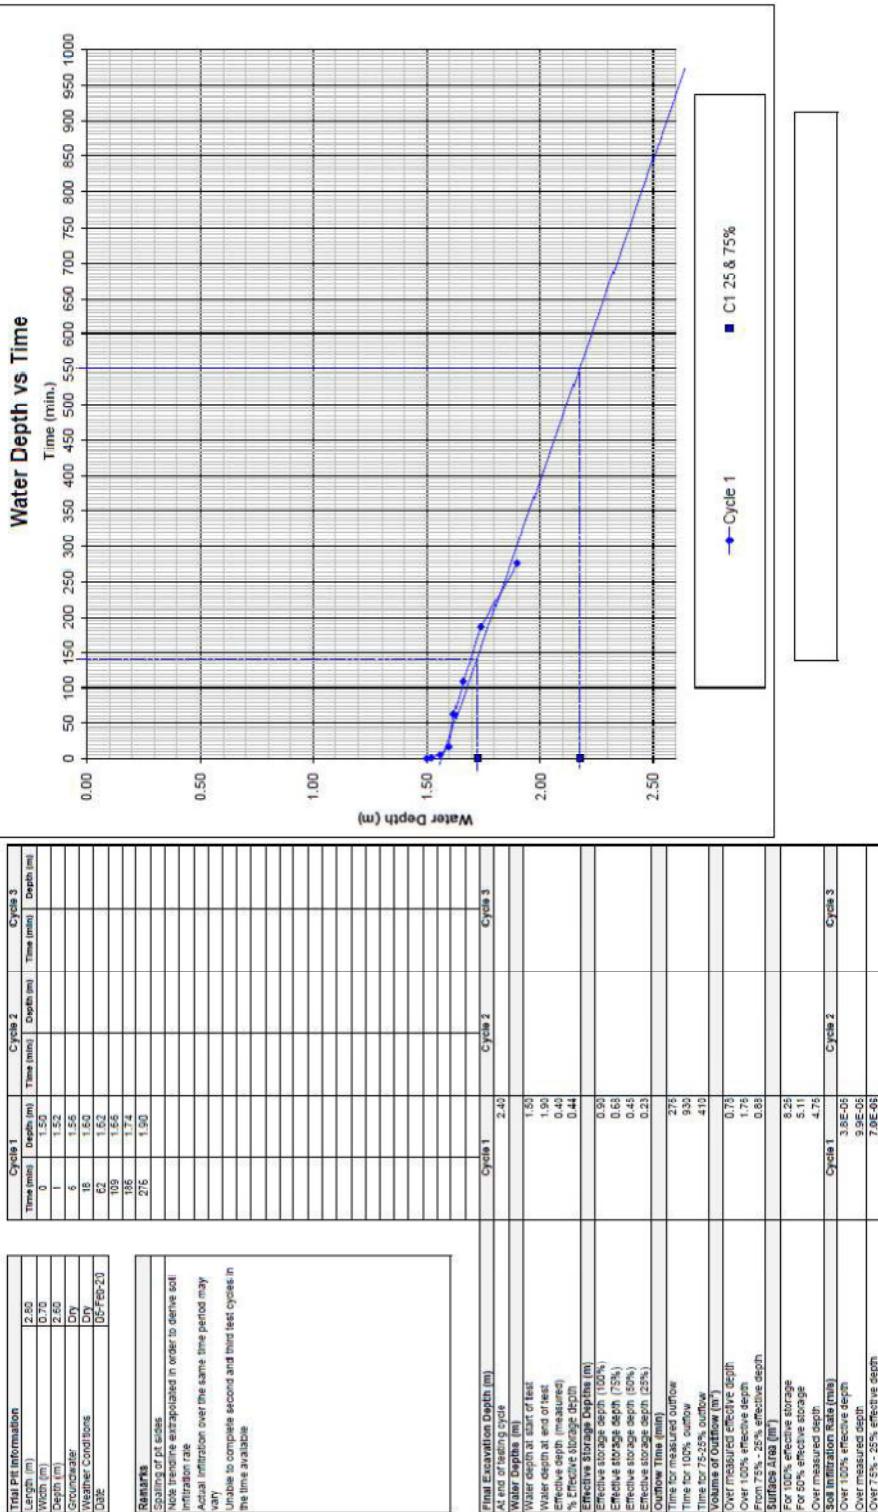
## BRE365 SOIL INFILTRATION RATE TEST - TP03

12604 Sandy Lane, Ystradowen

Test Location	Test Depth (m bgl)	Soil Infiltration Rate (m/s)		
		Test Cycle 1	Test Cycle 2	Test Cycle 3
TP03	2.6	$7.0 \times 10^{-6}$	n/a	n/a
TP06	2.1	$7.4 \times 10^{-6}$	n/a	n/a
TP05-A	1.5*	$1.2 \times 10^{-5}$	n/a	n/a
TP07	1.7	$2.1 \times 10^{-5}$	$2.1 \times 10^{-5}$	n/a
TP08	1.4	$8.2 \times 10^{-6}$	n/a	n/a
TP12	2.0	$7.9 \times 10^{-6}$	n/a	n/a

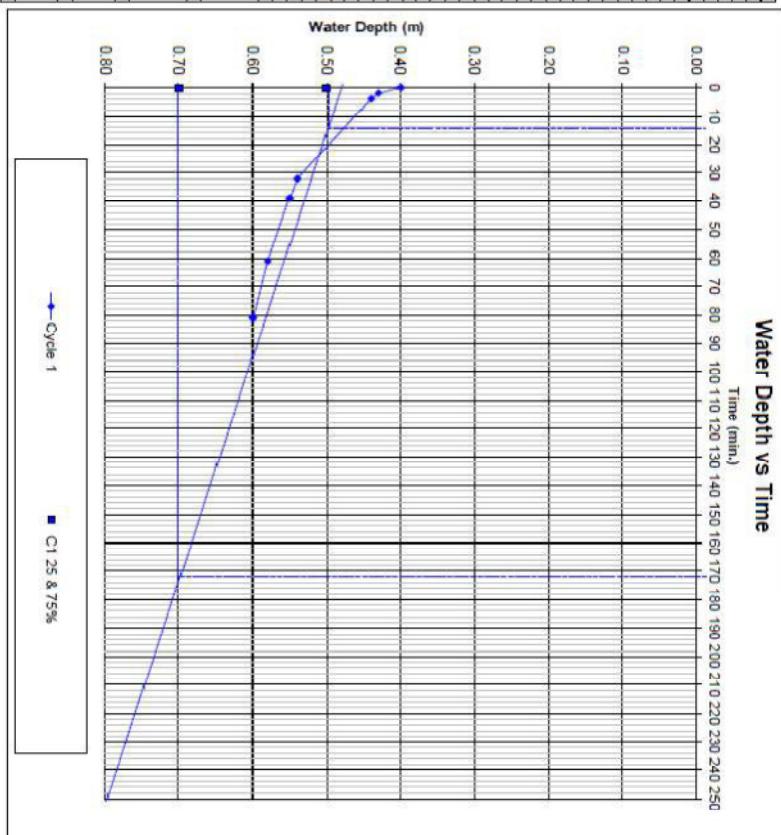
BRE365 SOIL INFILTRATION RATE TEST - TP05A

Trial PH Information	
length (m)	2.50
width (m)	0.70
depth (m)	1.50
Groundwater	1.5
Weather Conditions	dry
Date	05-FEB-20

spang o' pit sides.

\* It should be noted that the sides of the excavation in TP05-A collapsed during the soakaway test from 1.50m back up to 0.80m bgl. The soakaway test was continued and a soil infiltration rate of  $1.2 \times 10^{-5}$  m/s was calculated. This result should be used with caution.

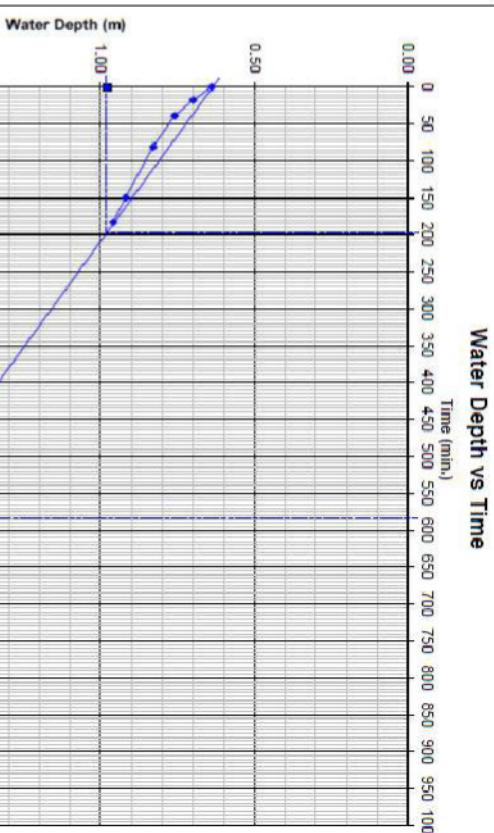
## BRE365 SOIL INFILTRATION RATE TEST - TP12

Total P1 Information	2.00
Length (m)	0.55
Width (m)	2.00
Depth (m)	0.50
Groundwater	Dry
Weather Conditions	Overcast
Date	21/02/20

Note: Trendline extrapolated in order to derive soil infiltration rate  
Actual infiltration over the same time period may vary  
unable to complete second and third test cycles in the time available

Initial Excavation Depth (m)	2.00
At end of testing Cycle	
Water Depth (m)	
Water depth at start of test	0.54
Water depth at end of test	0.96
Effective depth (measured)	0.32
% Effective storage depth	0.24
Effective Storage Depths (m)	
Effective storage depth (100%)	1.56
Effective storage depth (75%)	1.02
Effective storage depth (50%)	0.68
Effective storage depth (25%)	0.34
Other Test Details	
Time to recorded outlet	18.5
Time to 1.00% outlet	7.50
Time to 75-50% outlet	3.00
Volume of Outflow (m³)	
Over-measured effective depth	0.42
Over 100% effective depth	1.77
From 75-25% effective depth	0.66
Surface Area (m²)	
For 100% effective storage	8.51
Over measured depth	4.90
Soil Infiltration Rate (m/h)	
Cycle 1	4.1E-06
Cycle 2	3.00
Cycle 3	1.3E-05
Over measured depth	7.3E-06
Over 100% effective depth
