Leckwith Quays
Applicant Response to Vale of Glamorgan Landscape Officer Comments
Planning App. Ref. 2020/01218/HYB
Phil Worthing – instructed by Gareth Davies Project Services Ltd

May 2021

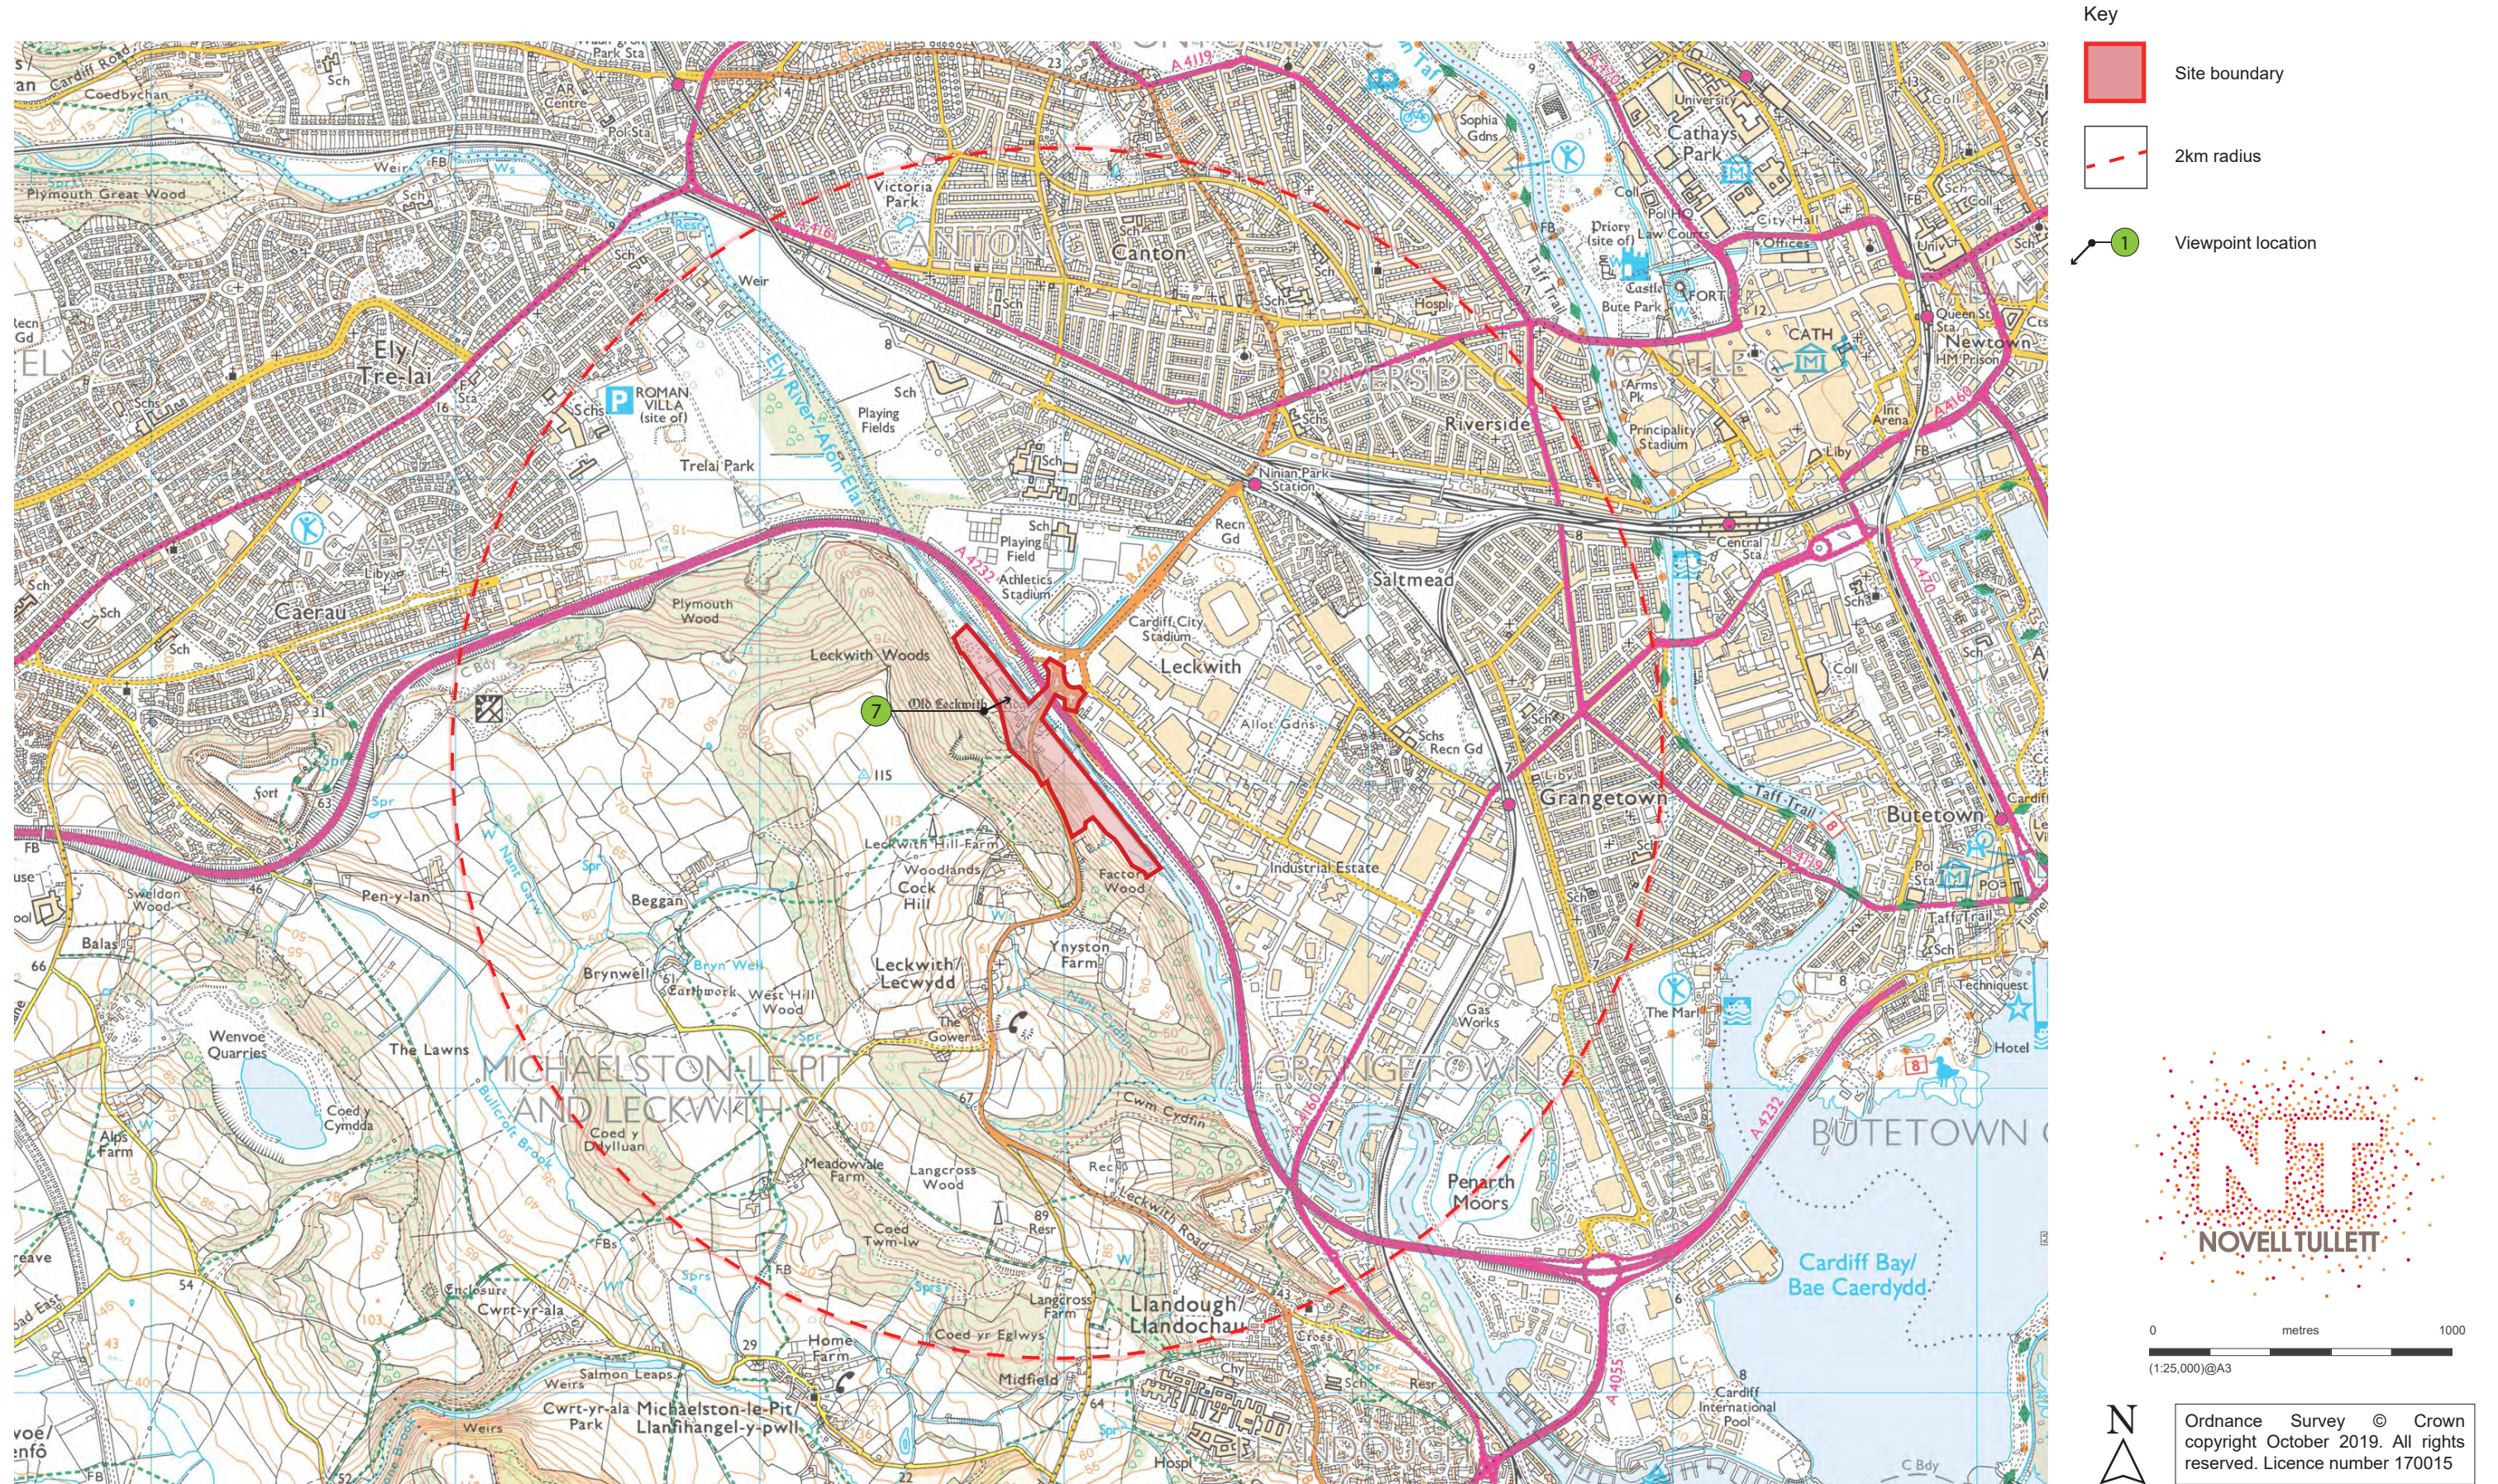
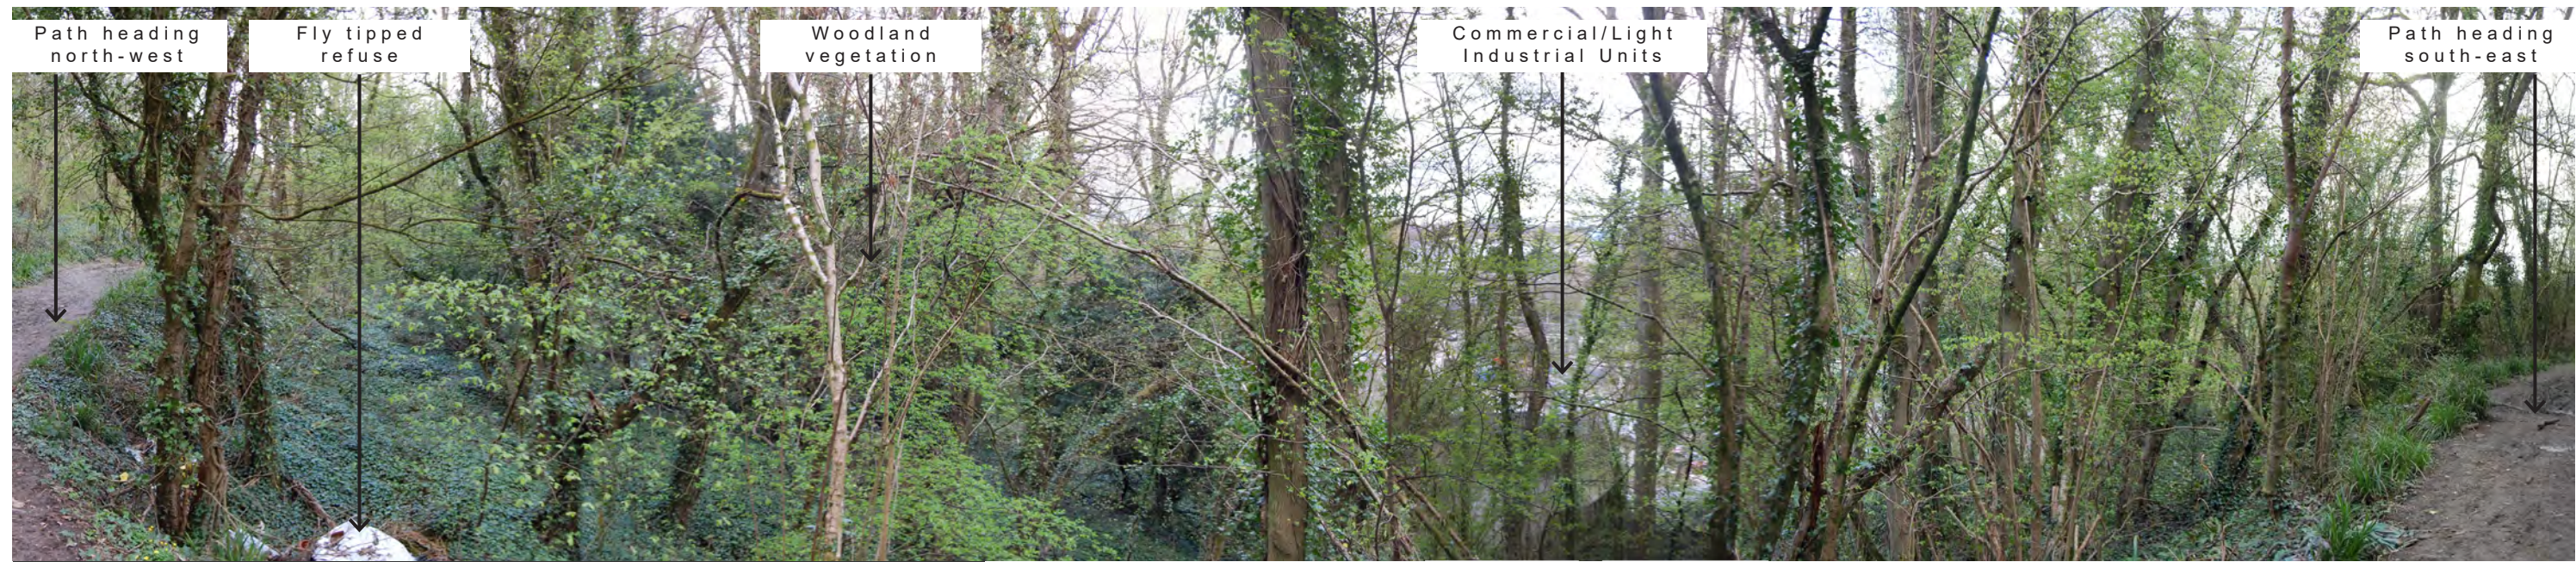
Viewpoint 7 – Plan and panorama

VIEWPOINT 7: Path in Leckwith Woods looking north-east.

Photographs taken with 50mm lens (35mm digital equivalent) and scaled to be viewed from a distance of 300mm on A2. However due to image scaling and page formatting necessary within this document, accuracy in this respect is not guaranteed in reproduction. Please contact Novell Tullett if you would like to obtain copies of the original images.

VIEWPOINT 7:	
GRID REFERENCE	51.46923 -3.21128
ELEVATION	30m
DISTANCE FROM SITE	25m
Sensitivity of receptor	Medium
Magnitude of impact	Medium
Significance of effects	
Construction	Moderate adverse
Operation	Moderate beneficial

**Visual Effects - Construction
Viewpoint 7.**

View 7: Path within Leckwith Woods, looking north-east		
	Assessment	Significance
Baseline Description	<p>This is a close view from a path that runs within the eastern boundary of Leckwith Woods, approximately 25m south-west of the proposed site boundary, looking north-east through the woodland edge towards the development site.</p> <p>The foreground is dominated by the vegetated slope at the base of Leckwith Hill.</p> <p>This vegetation comprises a mix of tree species of varying maturity, understorey and groundcover, which are just starting to come into leaf. The path visible on the left-hand side of the view is well used by cyclists. Also visible is some fly tipped refuse, which this part of the wood has an abundance of.</p>

<p>Down and through the vegetation can be glimpsed the existing structures, vehicles and activities currently on the site.</p> <p>Beyond this is the flyover of the raised and embanked flyover section of the A4232. In the background is the peri-urban landscape of the out-of-town shopping centre, Cardiff City Stadium and their associated roads and infrastructure.</p>	
Value of View	<p>This view is from a pedestrian/cycle route looking through trees over the existing ad hoc industrial estate, a busy, elevated, four lane highway and the peri-urban surrounds of Cardiff. The woodland also contains a large amount of fly-tipped refuse.</p> <p>The view through the woodland is glimpsed at best and curtailed when the vegetation is in full leaf.</p>	Medium
Susceptibility of visual receptors to change	<p>Typical receptors might be cyclists and some pedestrians using the path for commuting or recreation, dog walking etc. The numbers of users is likely to be greater during the summer months.</p>	Medium

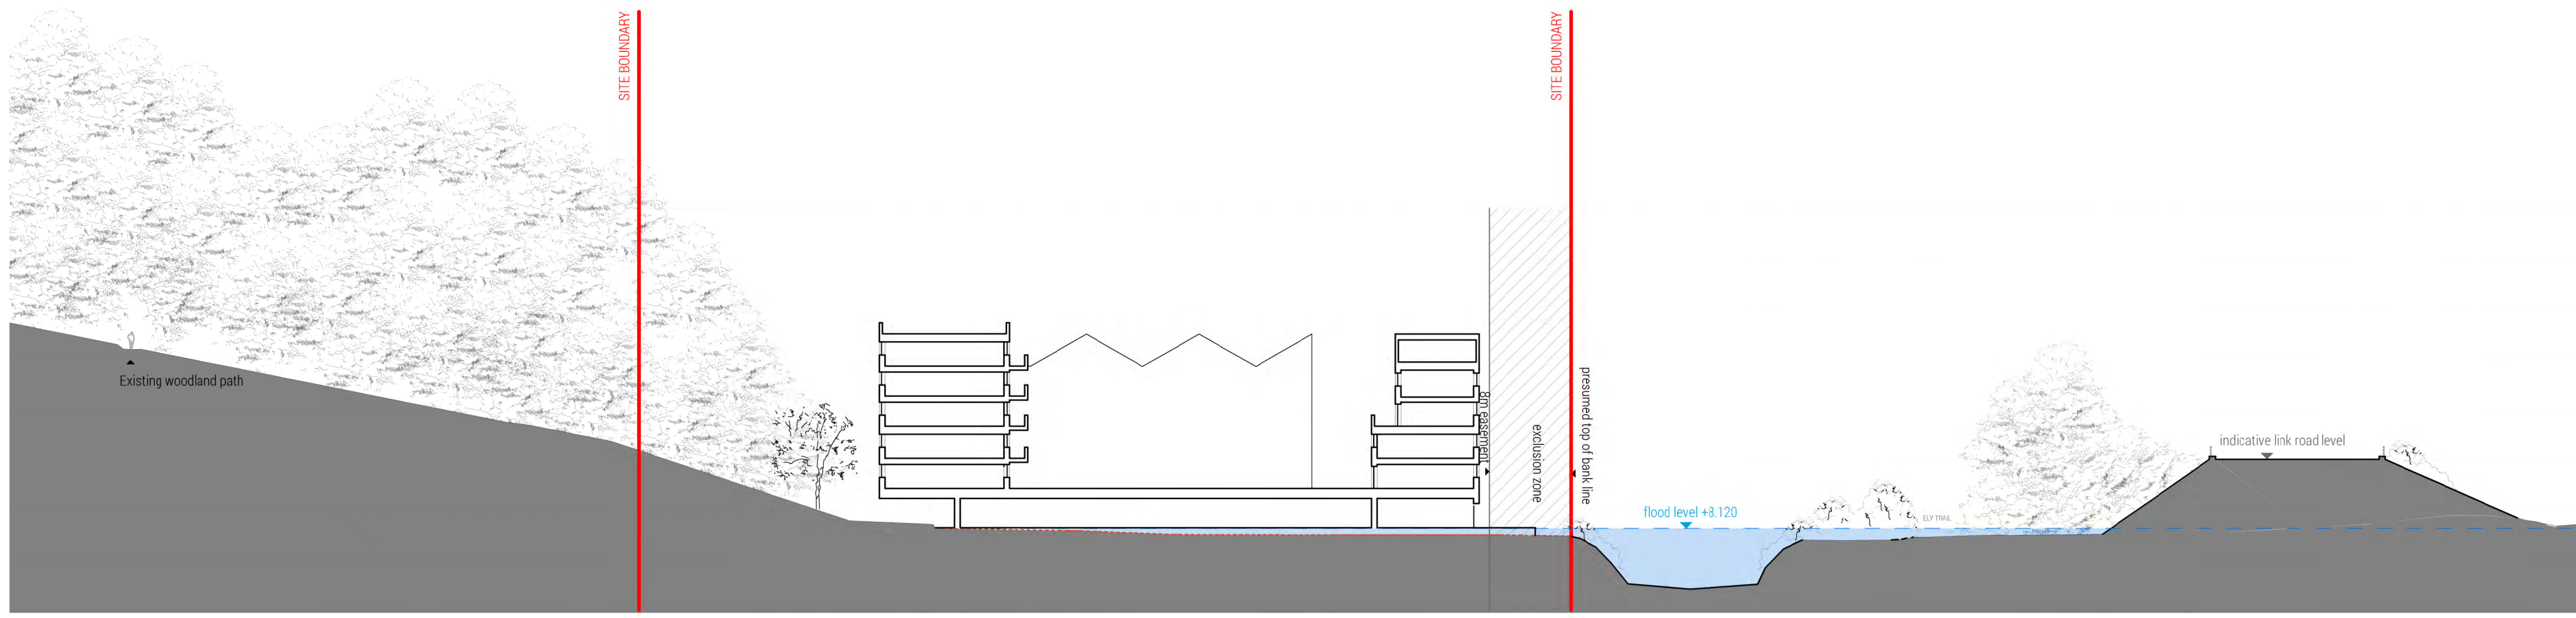
AREA 01 - INDICATIVE MASSING SECTION 1A
1:500

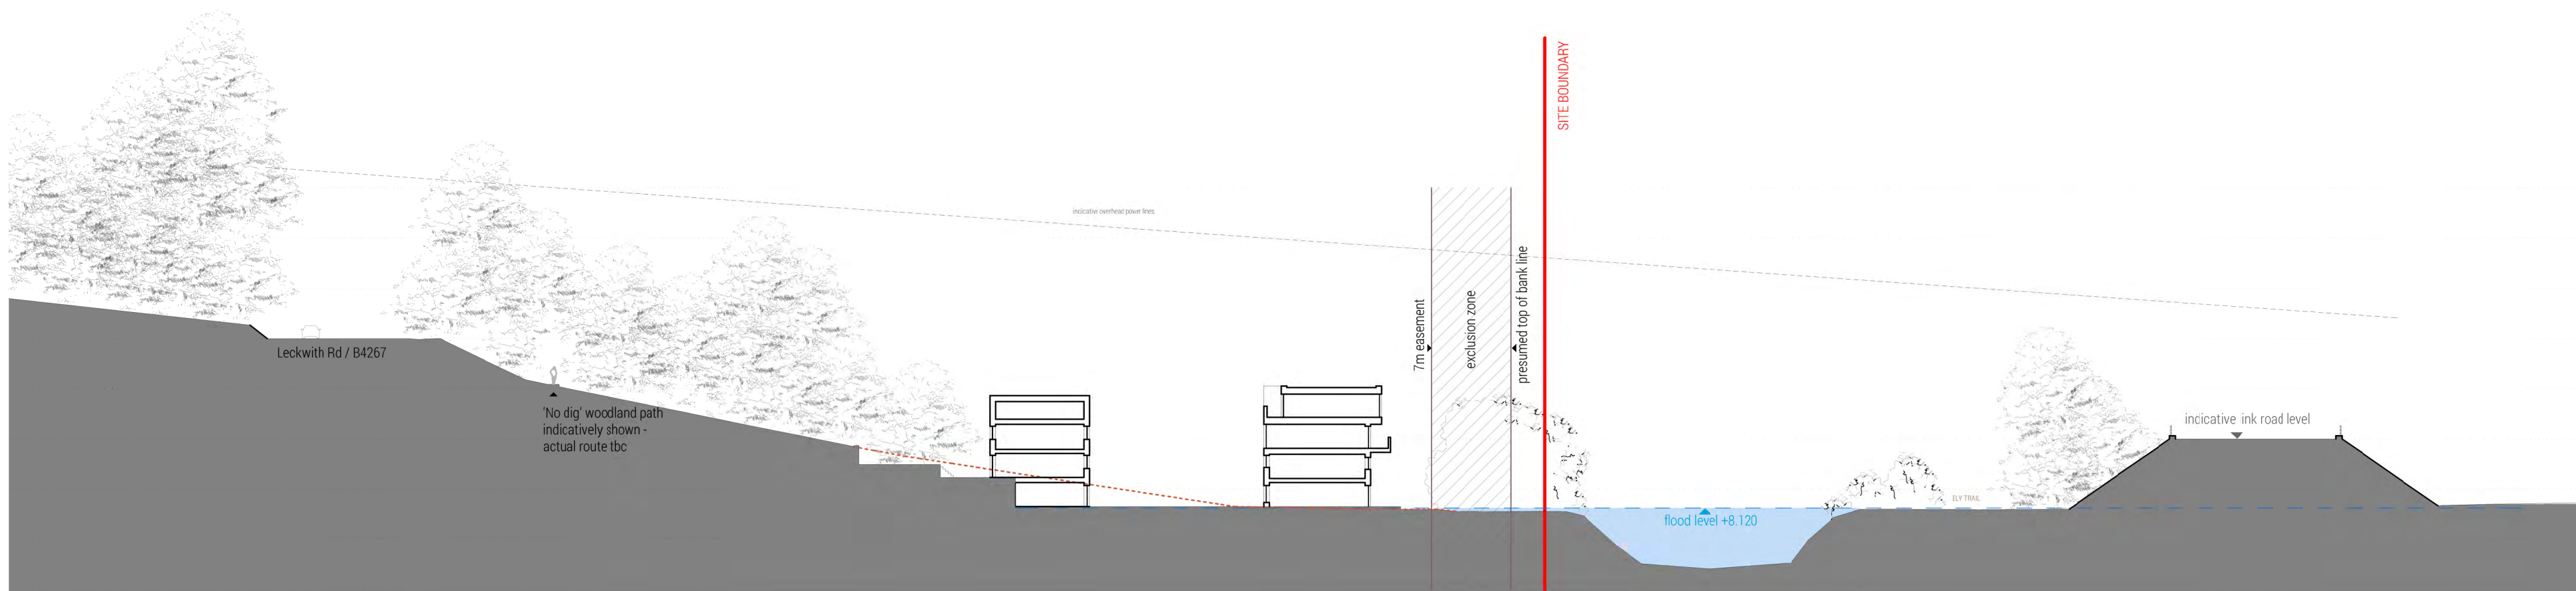
AREA 02 - INDICATIVE MASSING SECTION 2C
1:500

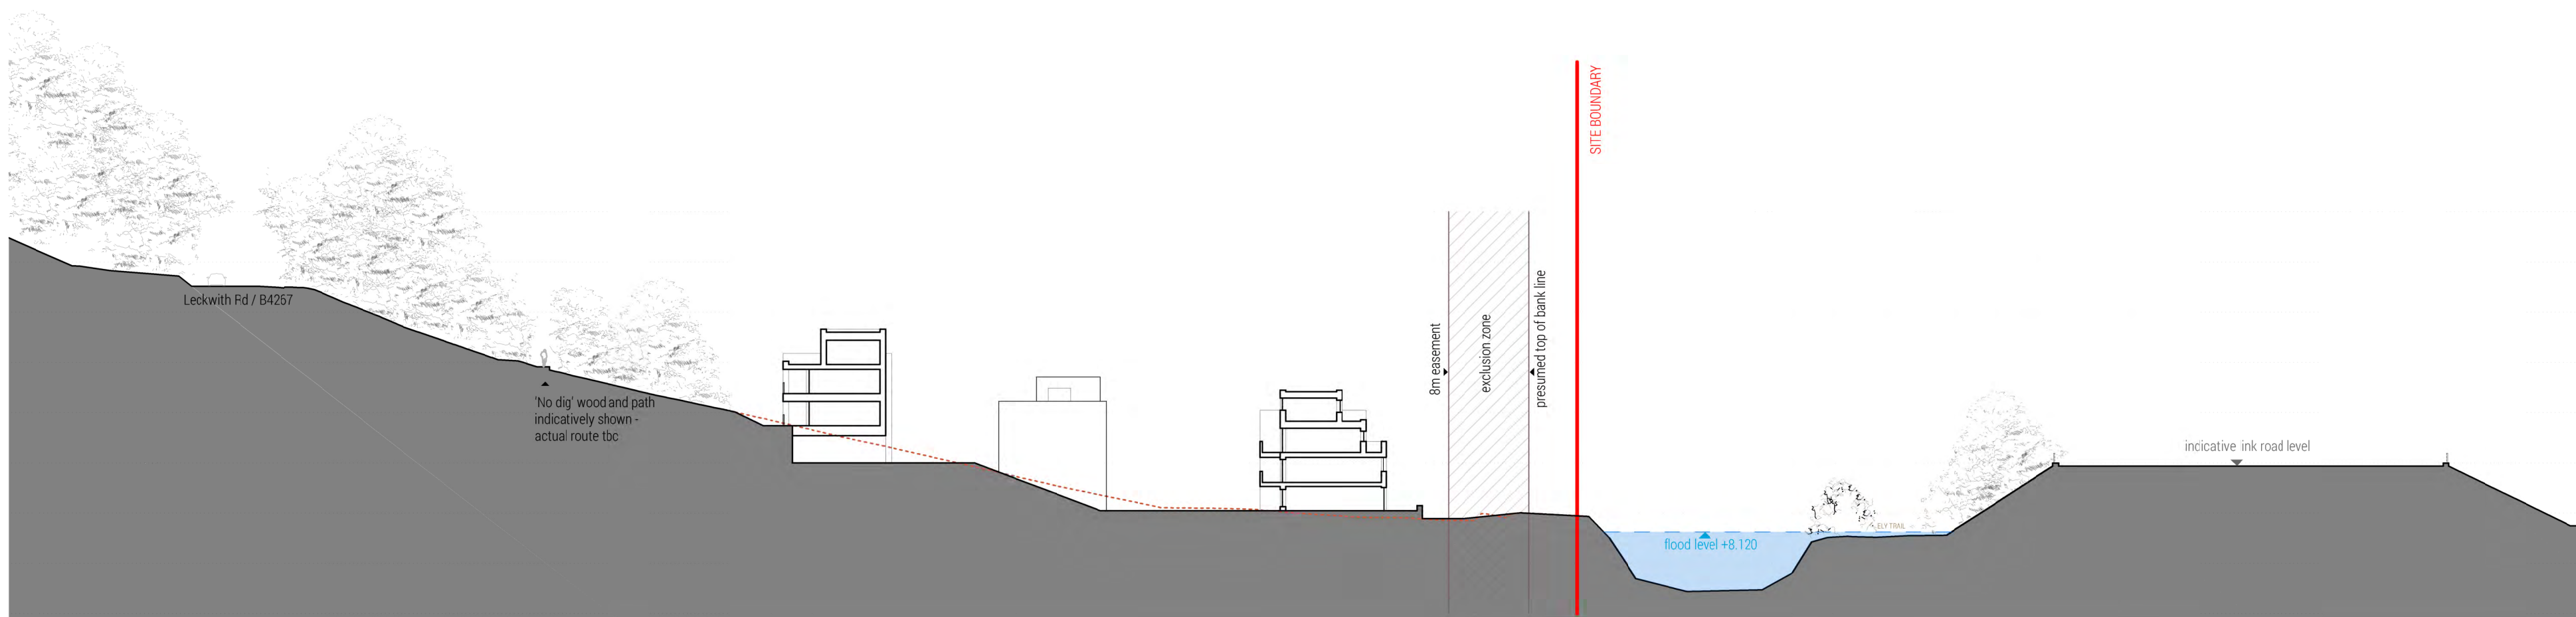
AREA 03 - INDICATIVE MASSING SECTION 3A
1:500

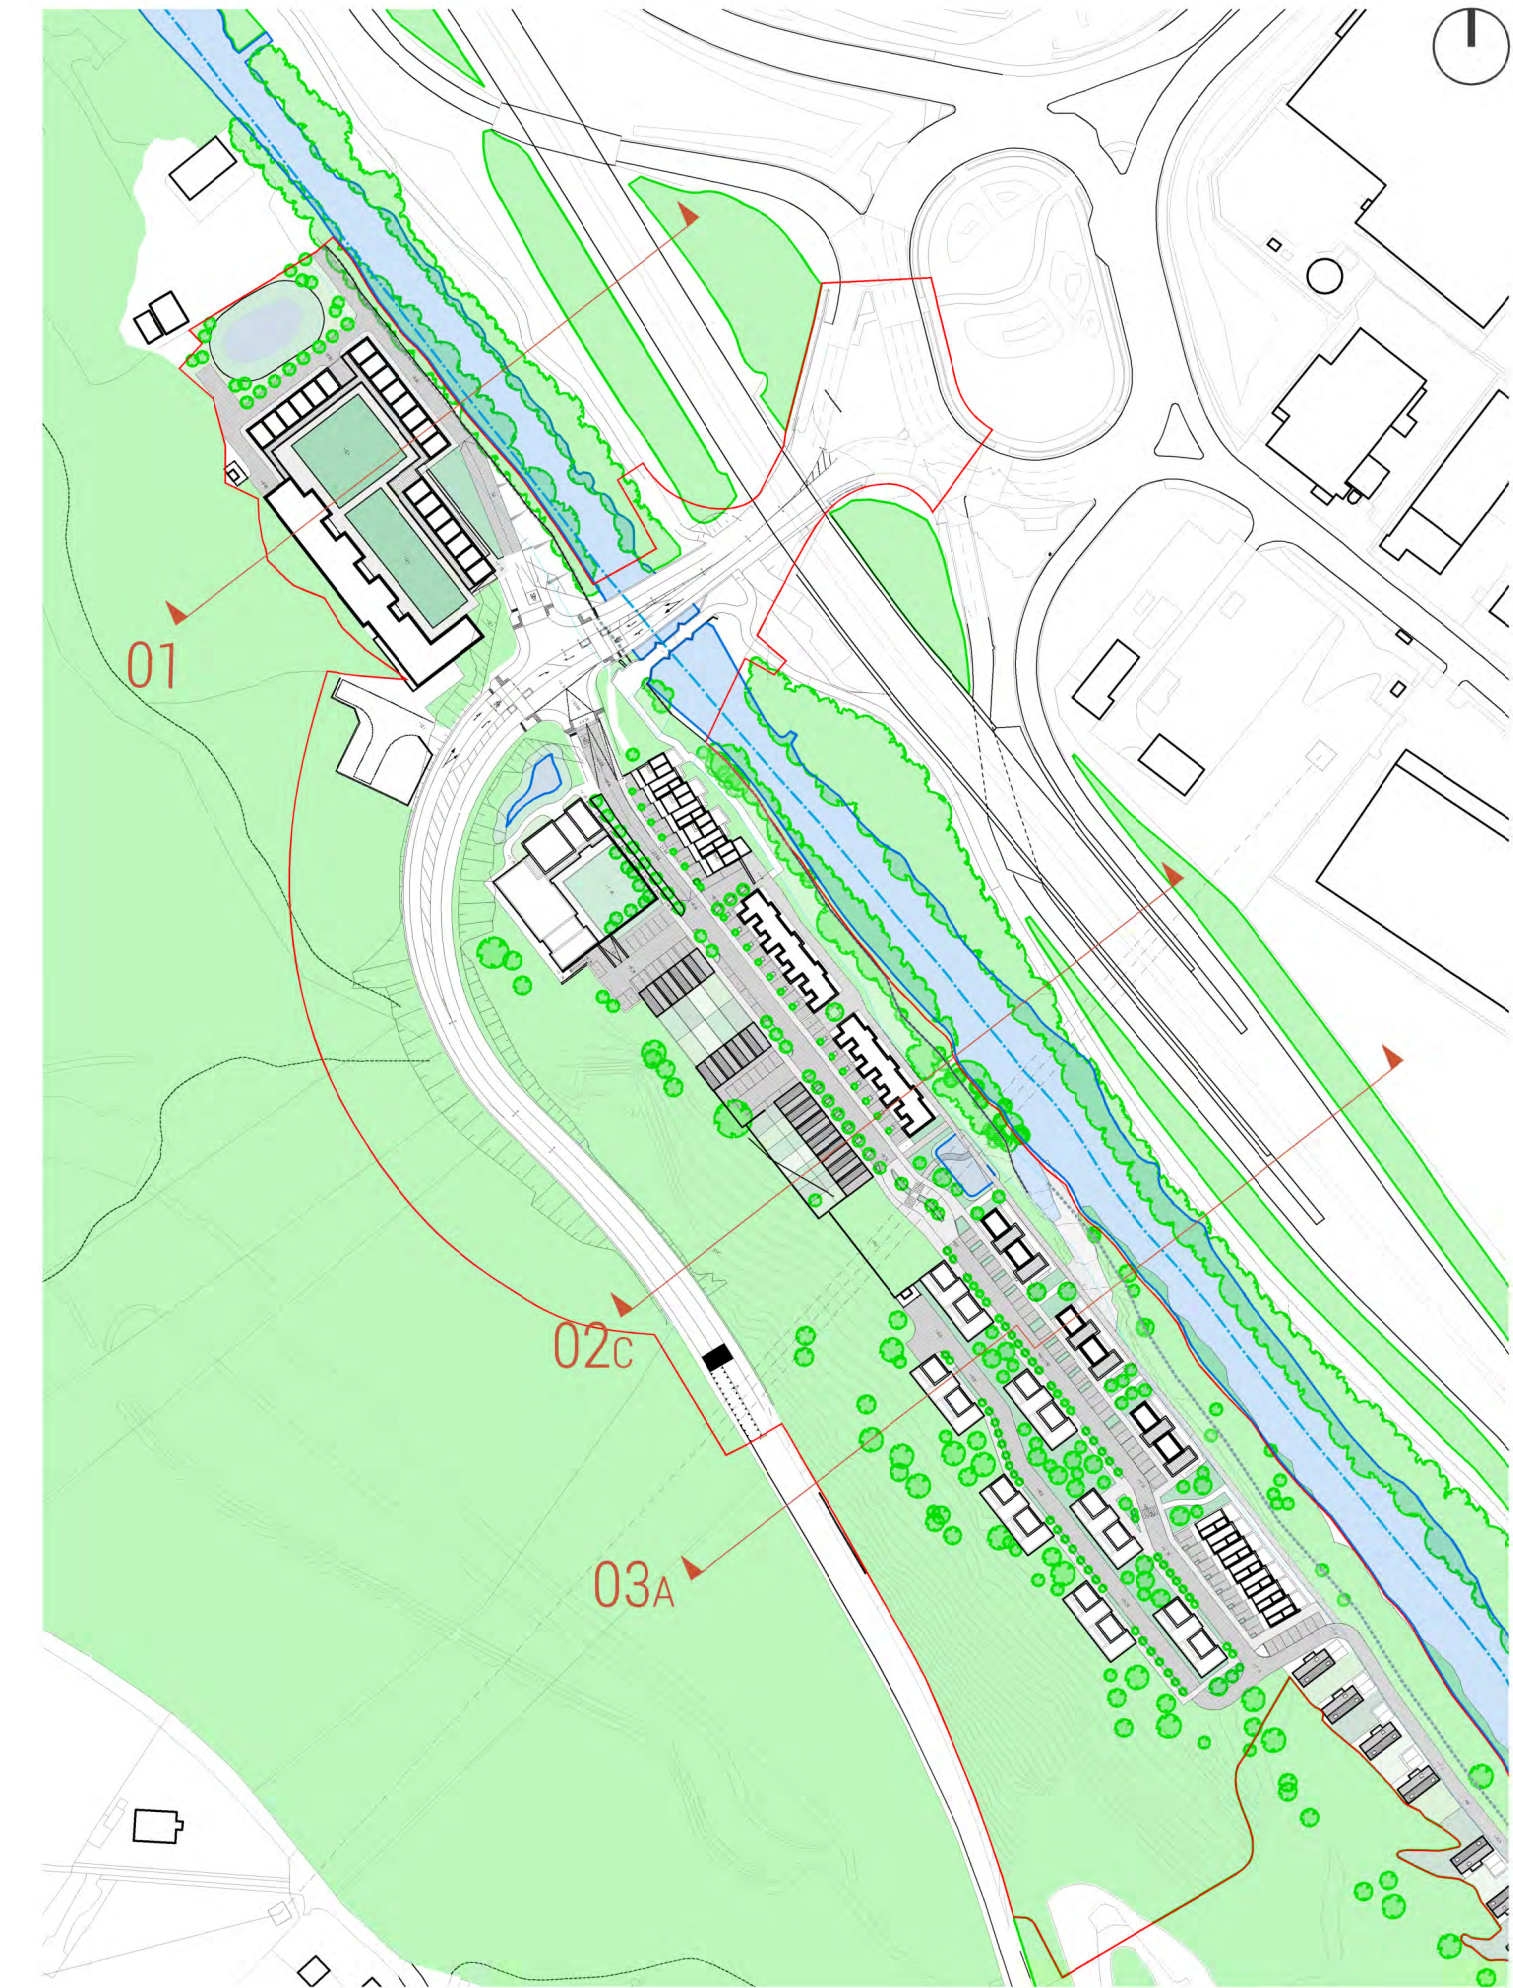
OUTLINE PLANNING
1844/S.301A
LECKWITh QUAY

REVISIONS:
A - 08.03.21 - DRAWING UPDATED TO CLEARLY SHOW
LECKWITh ROAD AND WOODLAND PATHS
