# **MODEL FARM**

# **Ecology Surveys Report**

- 1.1.1 RPS were commissioned by Legal and General Strategic Land Ltd (the client) to undertake Phase II protected species surveys, as recommended in the Preliminary Ecological Appraisal (PEA, RPS May 2018), at a site named 'Land at Rhoose aka. 'Model Farm' with a central grid reference of ST08026 67338.

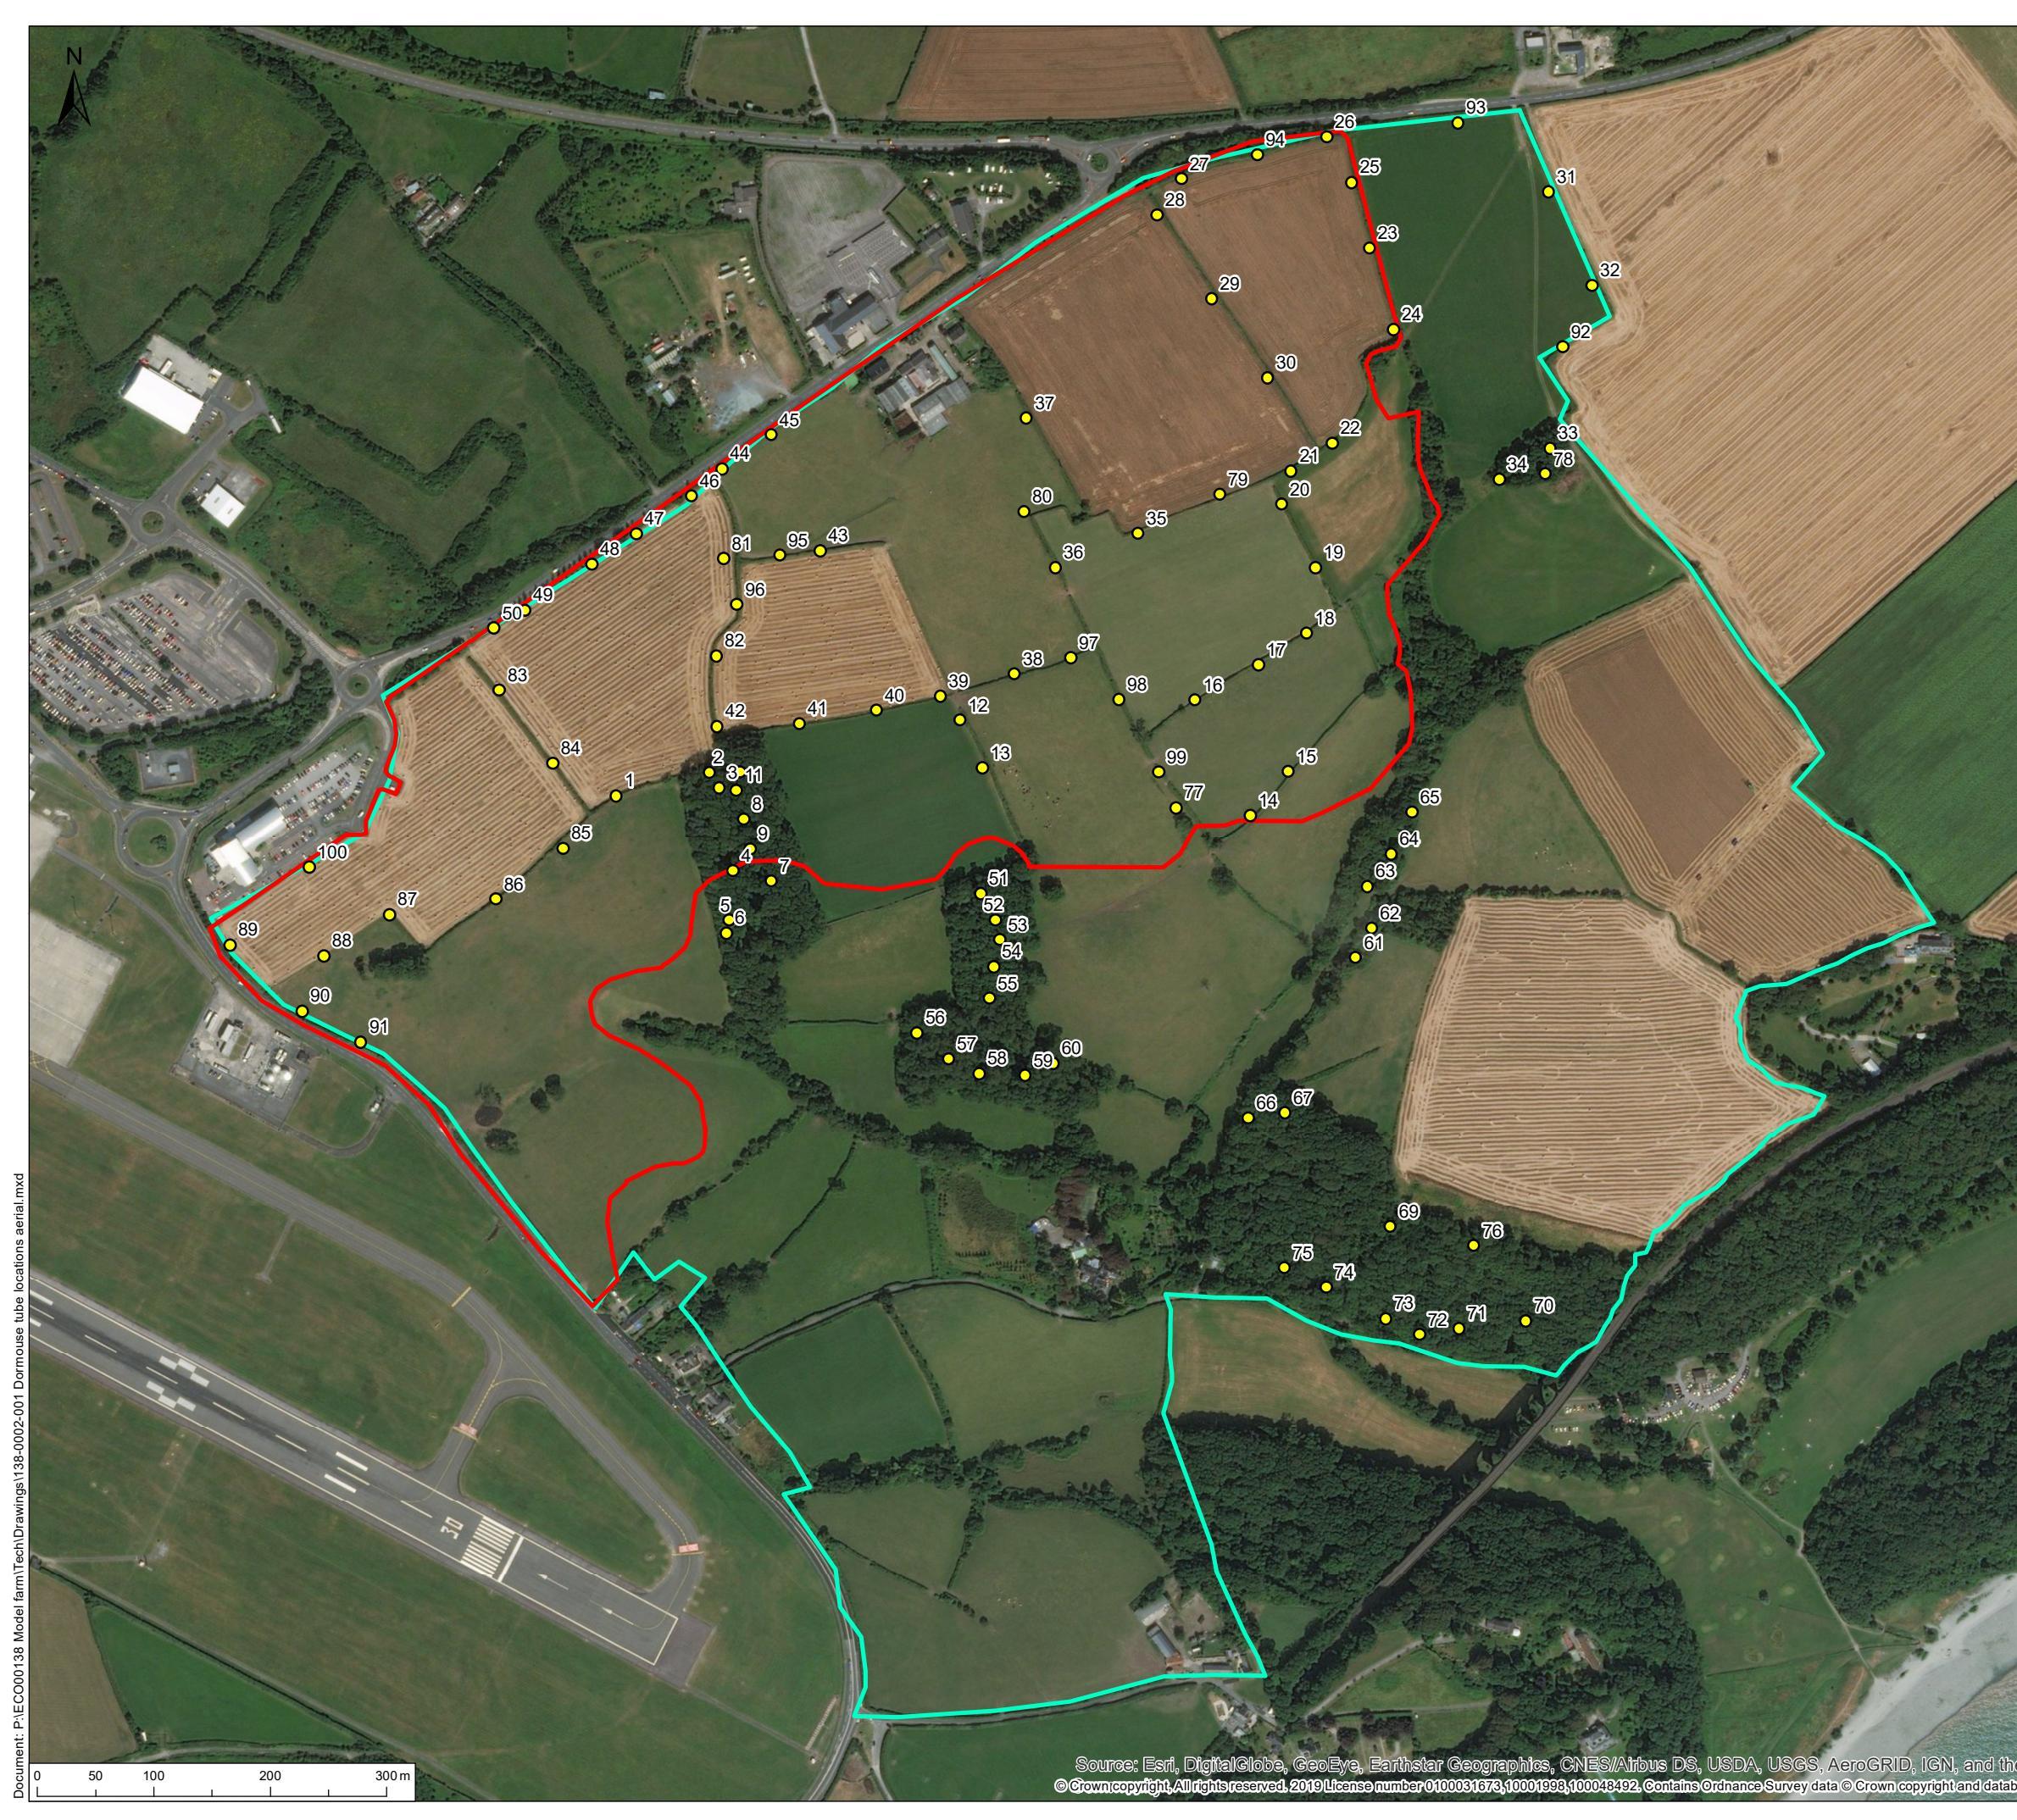
- 2.5.4 The survey comprised the deployment of 100 nest tubes which were placed in all areas of suitable habitat within the site and in woodland habitat in the wider landholding (Figure 2).
- 2.5.5 Each nest tube was checked monthly at times when dormice will be active (excluding May 2019). Any signs of occupation or evidence of activity was recorded. All visits were carried out in suitable weather conditions. All survey visits, including tube deployment, were carried out by NRW dormouse license holder Georgia Kelly (S085812/1). Nest tubes were installed at the site on 4<sup>th</sup> October 2018 and inspected on the following dates:
  - 25th October 2018
  - 29th November 2018
  - 26th April 2019
  - 9th July 2019
  - 31st July 2019
  - 30th August 2019
  - 2nd October 2019

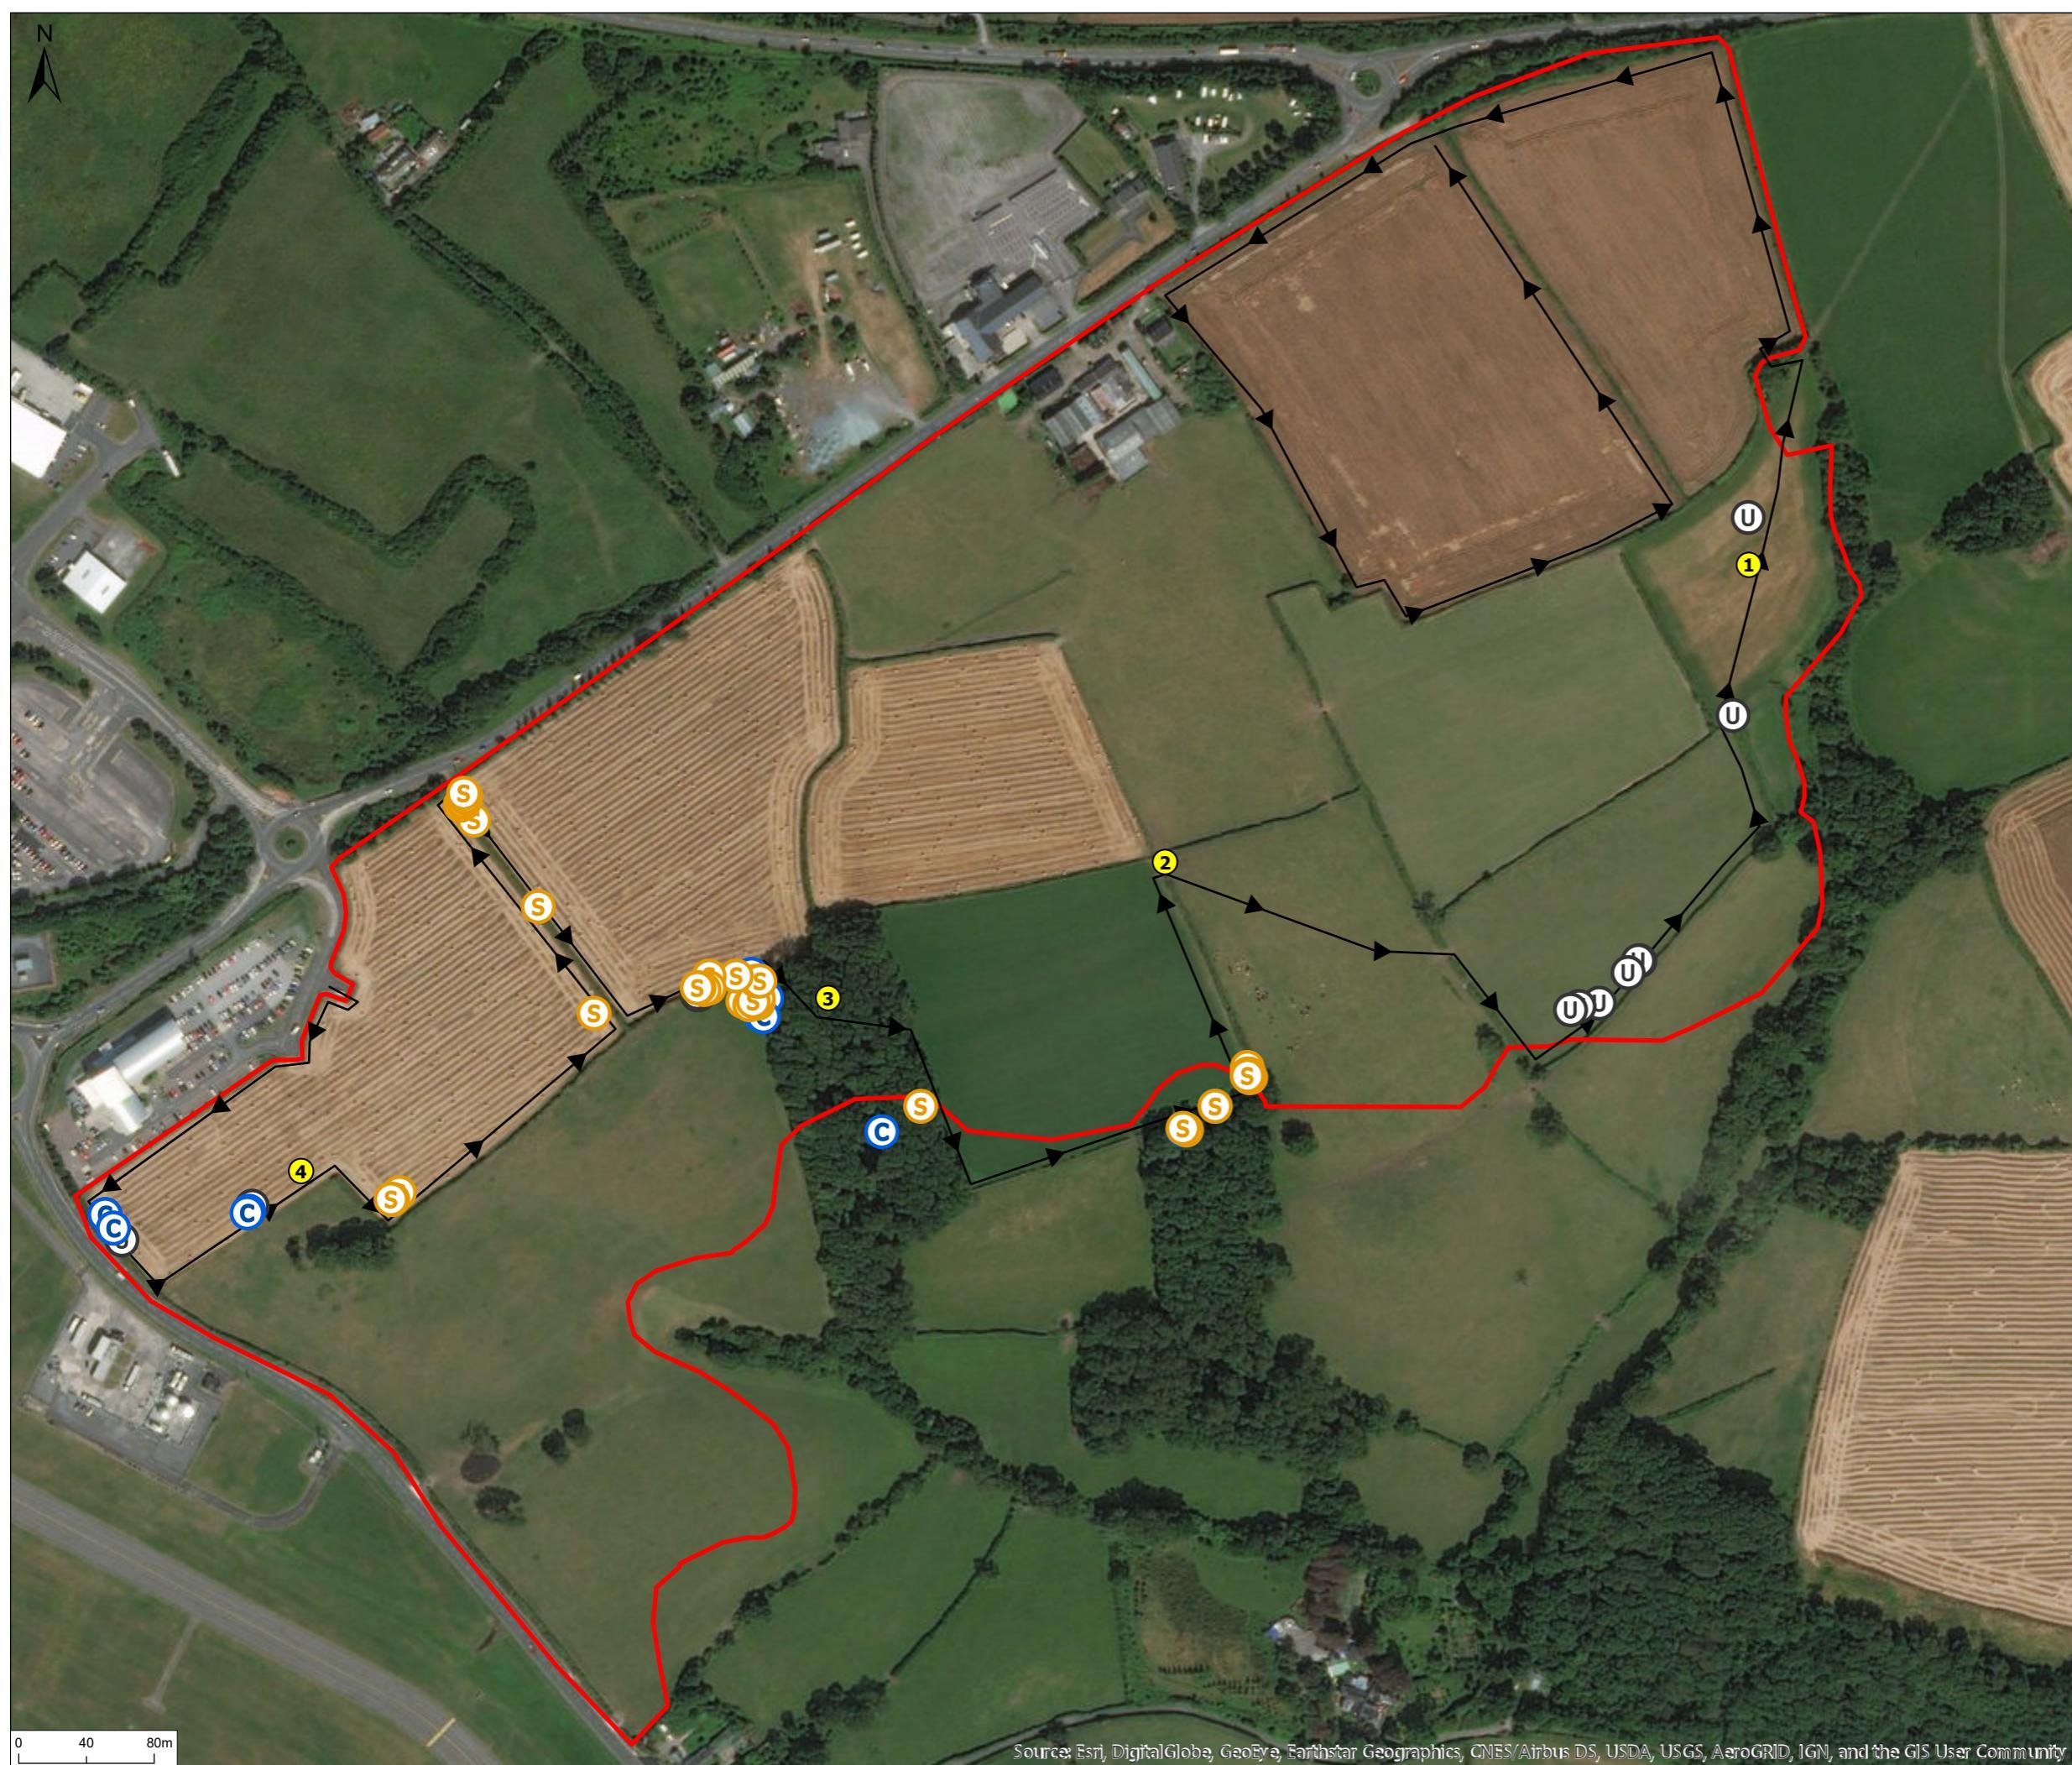
- Client
- Legal & General
- Land at Rhoose (aka Model Farm) Project
- Title Bat Activity Transect Results July 2019

4.2.1 A minimum of four species of bat were recorded using the site during each survey visit including common and soprano pipistrelle, NSL<sup>1</sup> and Myotis sp<sup>2</sup>. The majority of NSL calls were considered to be noctule. A qualitative description of each transect can be found below with corresponding Figures 5A – 5F.
