## Site Analysis (2 of 4) Figure 7 Ely Brickworks Landfill Development Date: 20/05/2015 Drawn: LA Rev: A Checked: AJW T. 01275 795859 E. info@amalgamlandscape.co.uk W. www.amalgamlandscape.co.uk

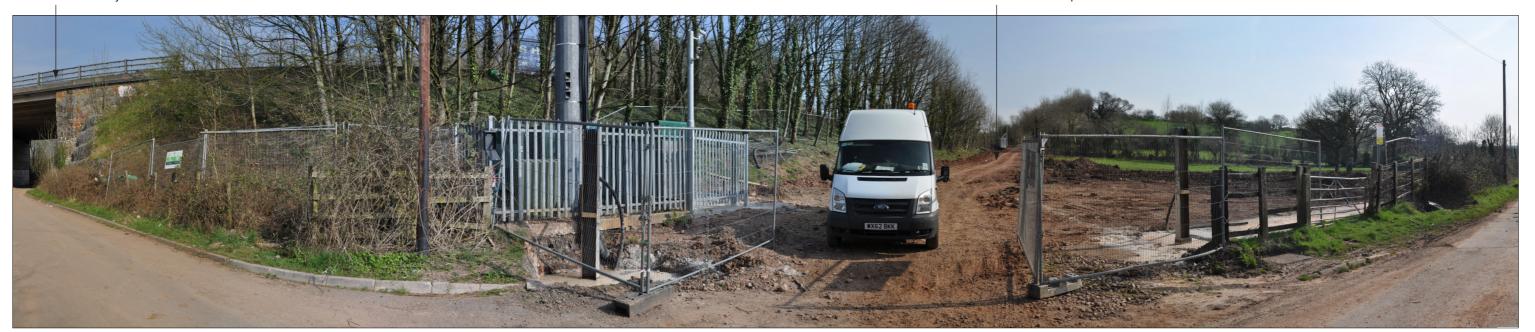
Site photo 1: From Cwrt-yr-Ala Road

Undulating and well-vegetated farmland landscape restricts the wider influence of the access road

Existing access track to the proposed restoration area

A4232 obscured by a combination of screening by mature vegetation and sloping landform
