Visual Analysis (1 of 4) Figure 10 Viewpoints 1&2	
Ely Brickworks Landfill Development	
Date: 28/05/2015	Drawn: LA
Rev: A	Checked: AJW
	T. 01275 795859
	E. info@amalgamlandscape.co.uk
	W. www.amalgamlandscape.co.uk

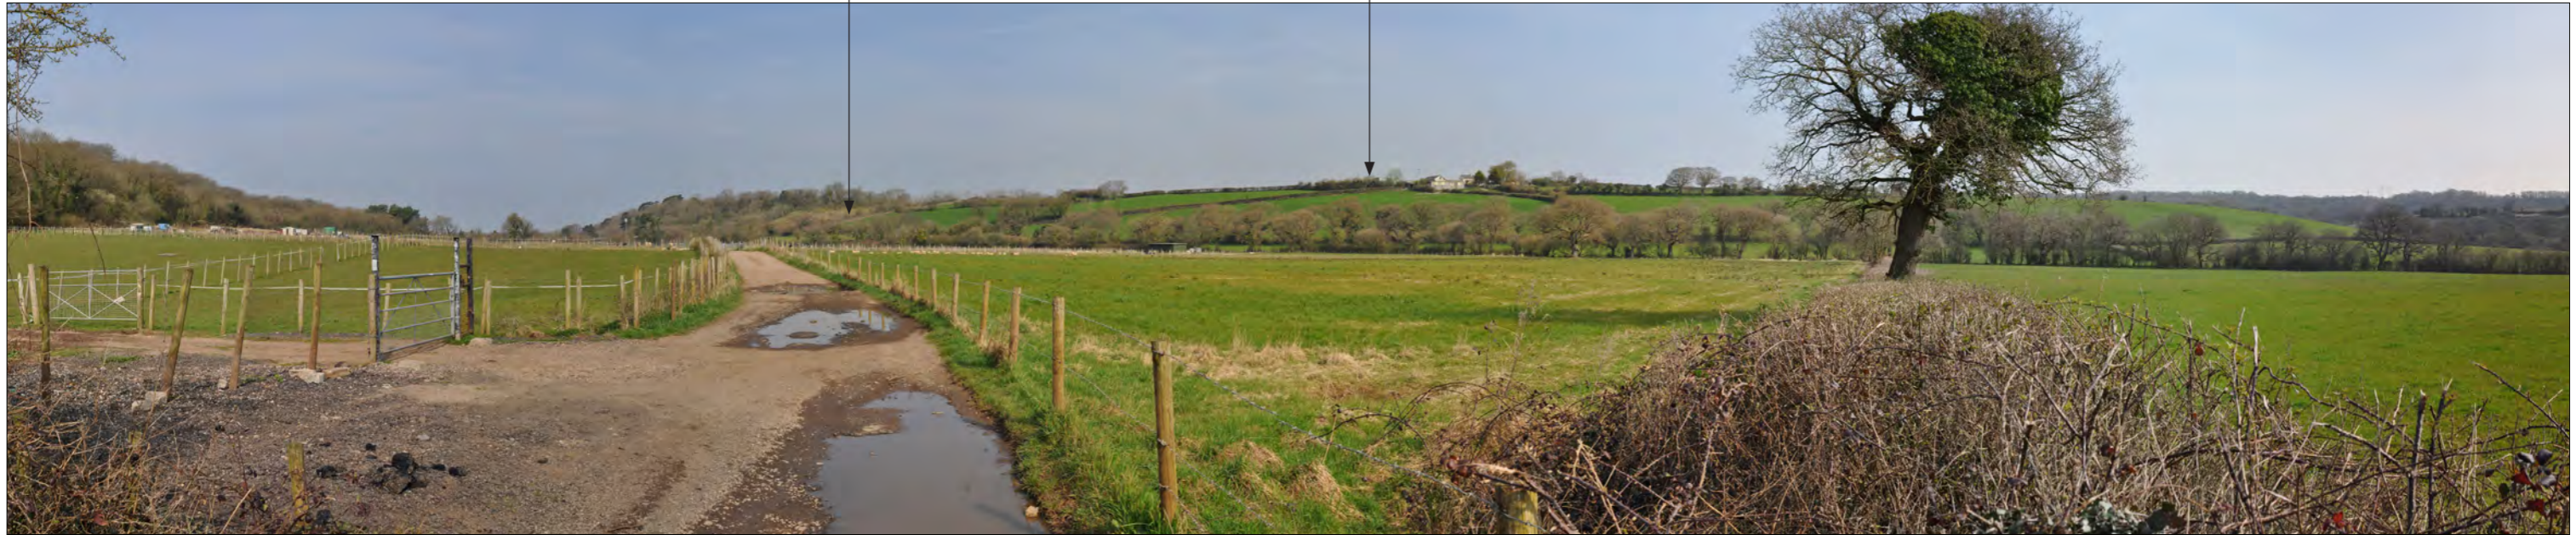
Viewpoint 1: From public right of way

Existing access road is enclosed by surrounding mature vegetation

Any views of the proposed restoration area will be restricted by the intervening sloping landform and mature vegetation

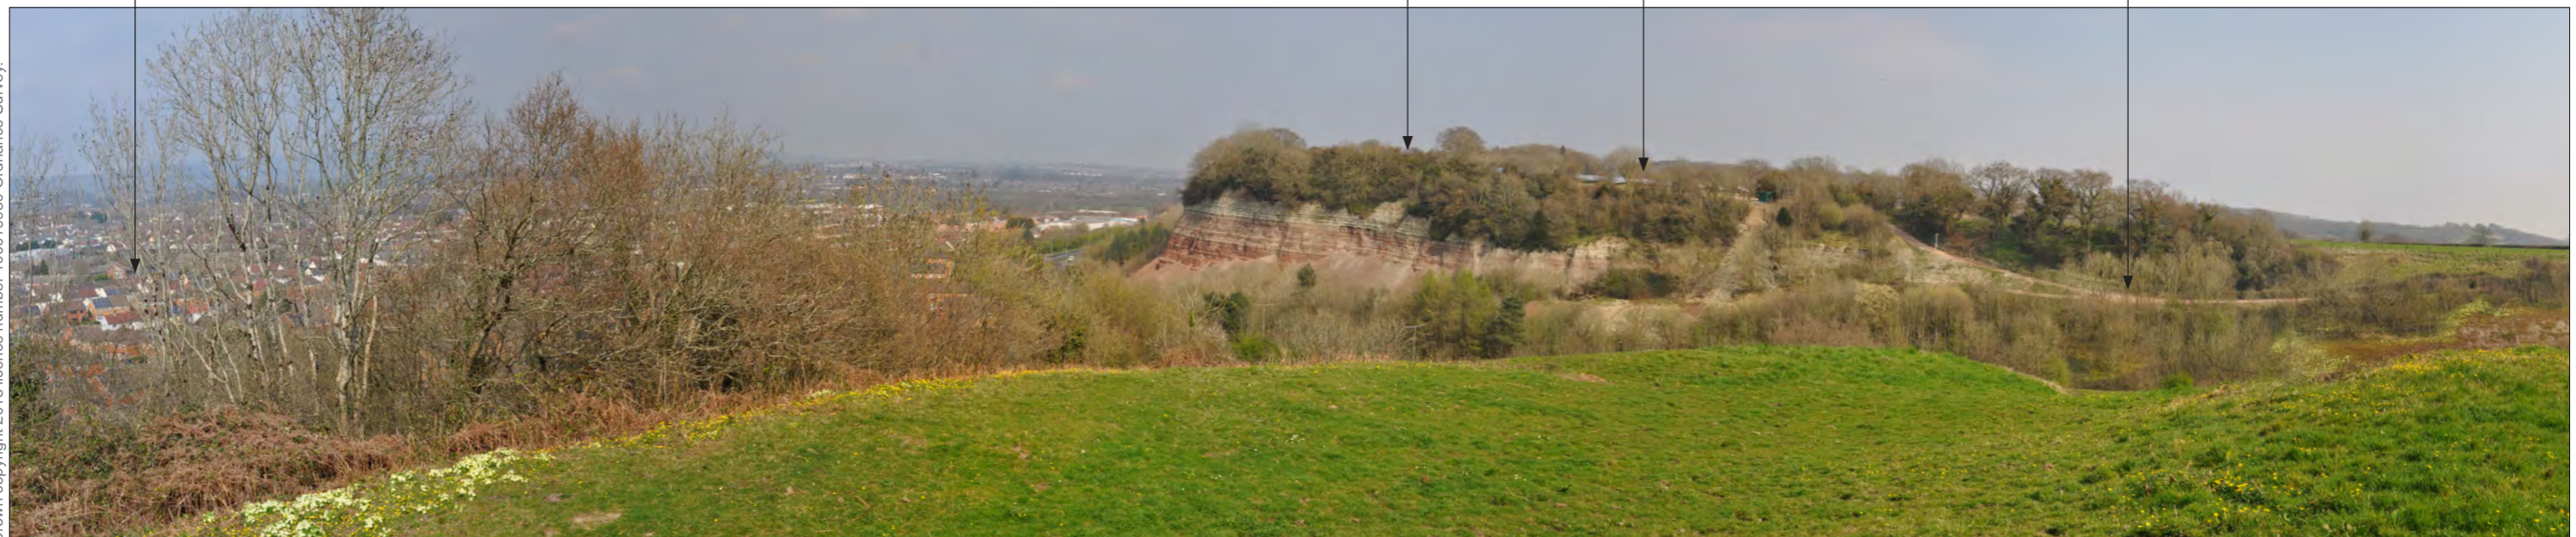
Viewpoint 2: From Caerau Camp

Glimpses of the adjacent urban fringes of Cardiff are possible from this elevated and open location, from gaps in the vegetative enclosure

Due to enclosure by mature vegetation and intervening landform, any views of the proposed restoration area, even from the open and elevated location will be restricted

Existing solar park, although glimpsed, is largely enclosed by surrounding mature vegetation

Existing access road is largely enclosed by mature vegetation
